**FEDERAL HIGHWAY ADMINISTRATION  
Long Term Pavement Performance (LTPP)  
Specific Pavement Studies**

**MONTANA SPS-1 CONSTRUCTION REPORT**

**Prepared for:  
Montana Department of Transportation**

**November 2001**

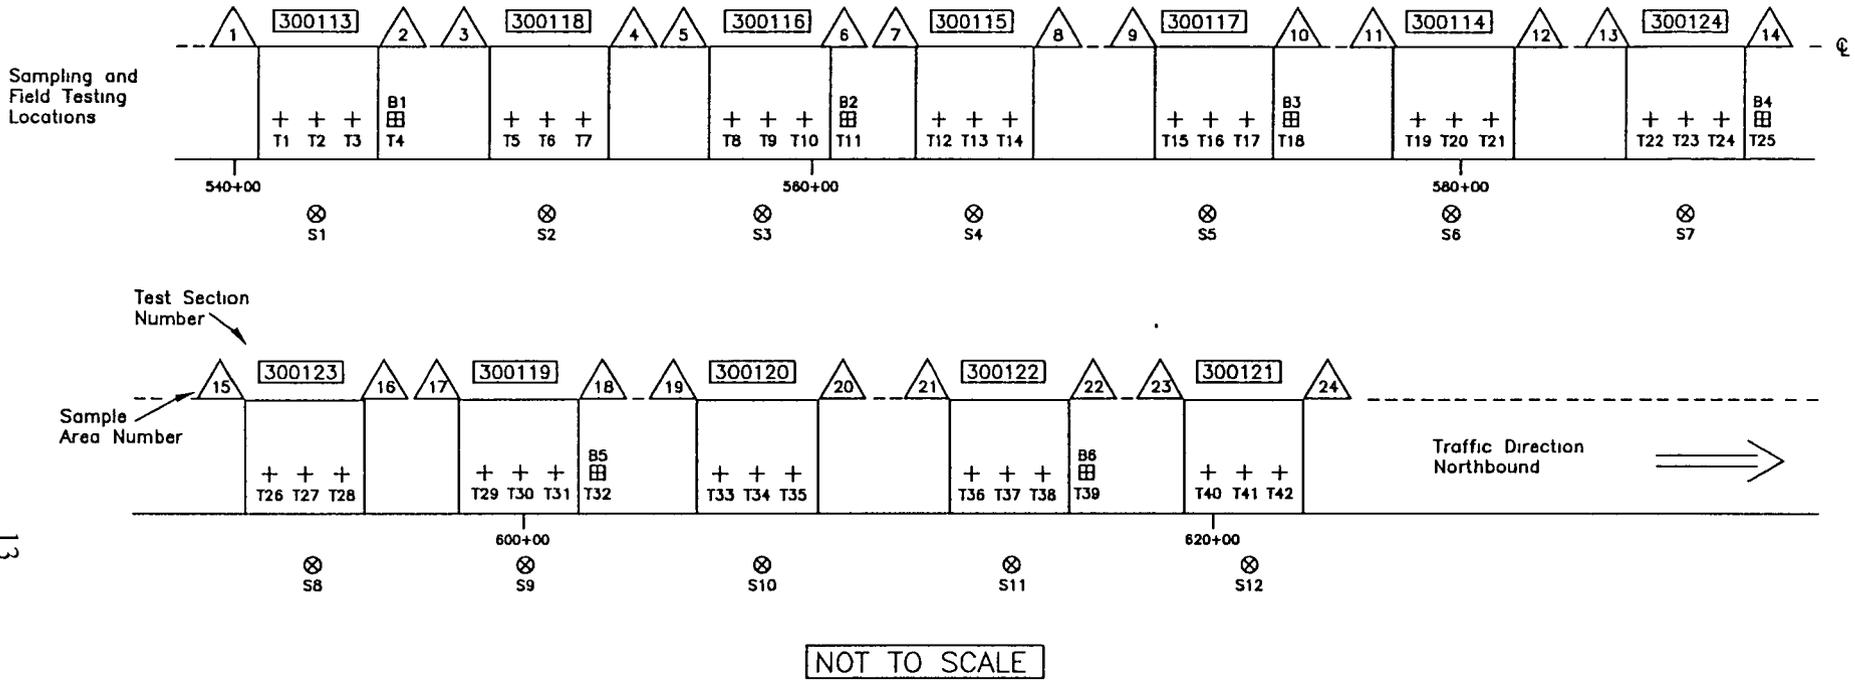
Figure 5. Overview of material sampling and testing on Existing Embankment, SPS-1 Montana.

- 2' x 2' bulk sampling location (B1–B6) to 12" below top of Existing Embankment
- ⊗ Shoulder probe (S1–S12)
- + Location of nuclear moisture–density tests (T1–T42)
- △ Sample areas

Field density and field moisture tests were performed on the existing embankment and prepared subgrade layers. The density tests were carried out using nuclear gauge (ID#3440 20996) at locations indicated in figures 5 and 6 in accordance with the procedures in AASHTO T239-97. As stated earlier, additional tests were performed on the retained existing embankment material. The results of the density tests are tabulated in tables 7 and 8. As can be seen in tables 7 and 8,

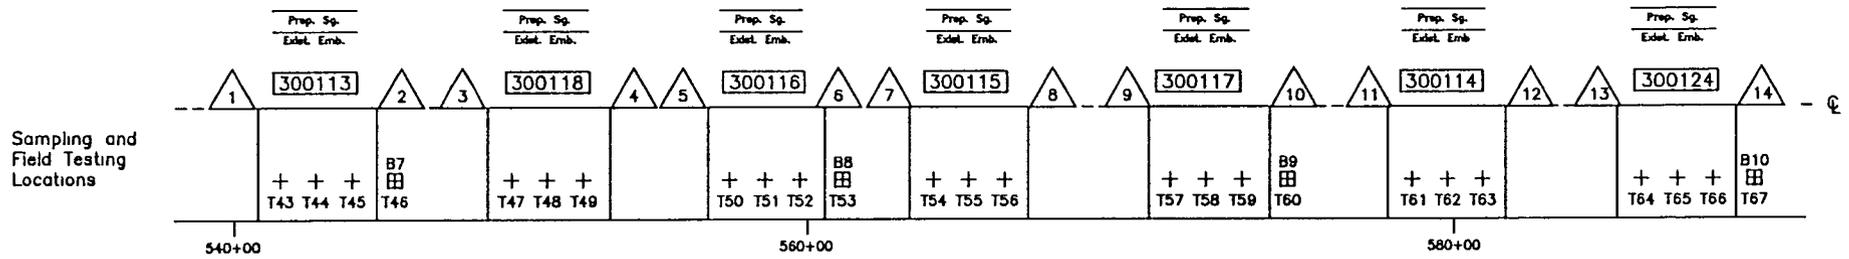
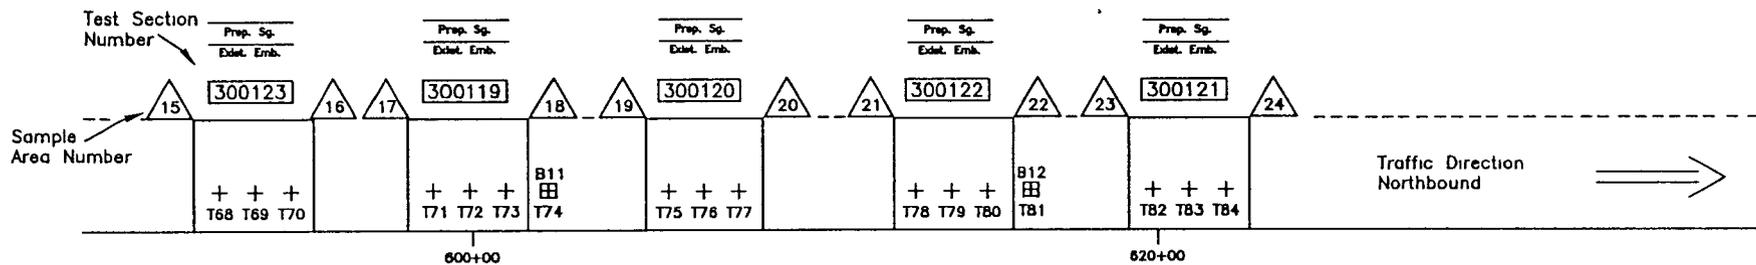
- 2' x 2' bulk sampling location (B7-B12) to 12" below top of Prepared Subgrade
- + Location of nuclear moisture-density tests (T43-T84)
- Prep Sg - Prepared Subgrade
- Exist Emb - Existing Embankment
- △ Sample areas

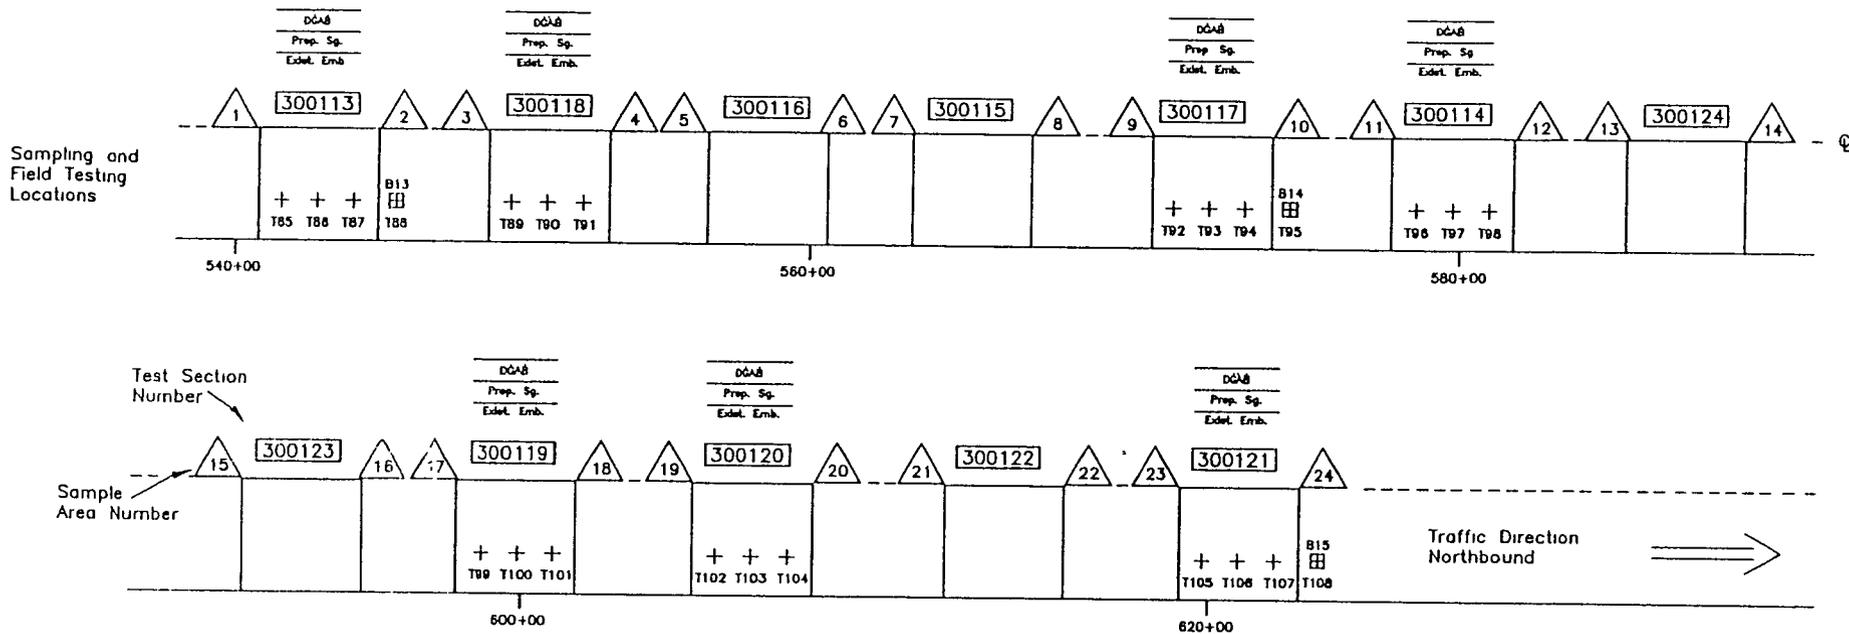
- 2' x 2' bulk sampling location (B13–B15) to 12" below top of Dense Graded Aggregate Base
- + Location of nuclear moisture–density tests (T85–T108)
- Prep Sg – Prepared Subgrade
- Exist. Emb. – Existing Embankment
- DGAB – Dense Graded Aggregate Base
- △ Sample areas

Field density and field moisture content tests were performed on the finished DGAB layer in accordance with AASHTO T 238-97 and T239-97, respectively, at the locations indicated in figure 8. The test results are tabulated in table 14. Density results show that the density and moisture levels are very consistent throughout the site no matter what the thickness of the final layer.

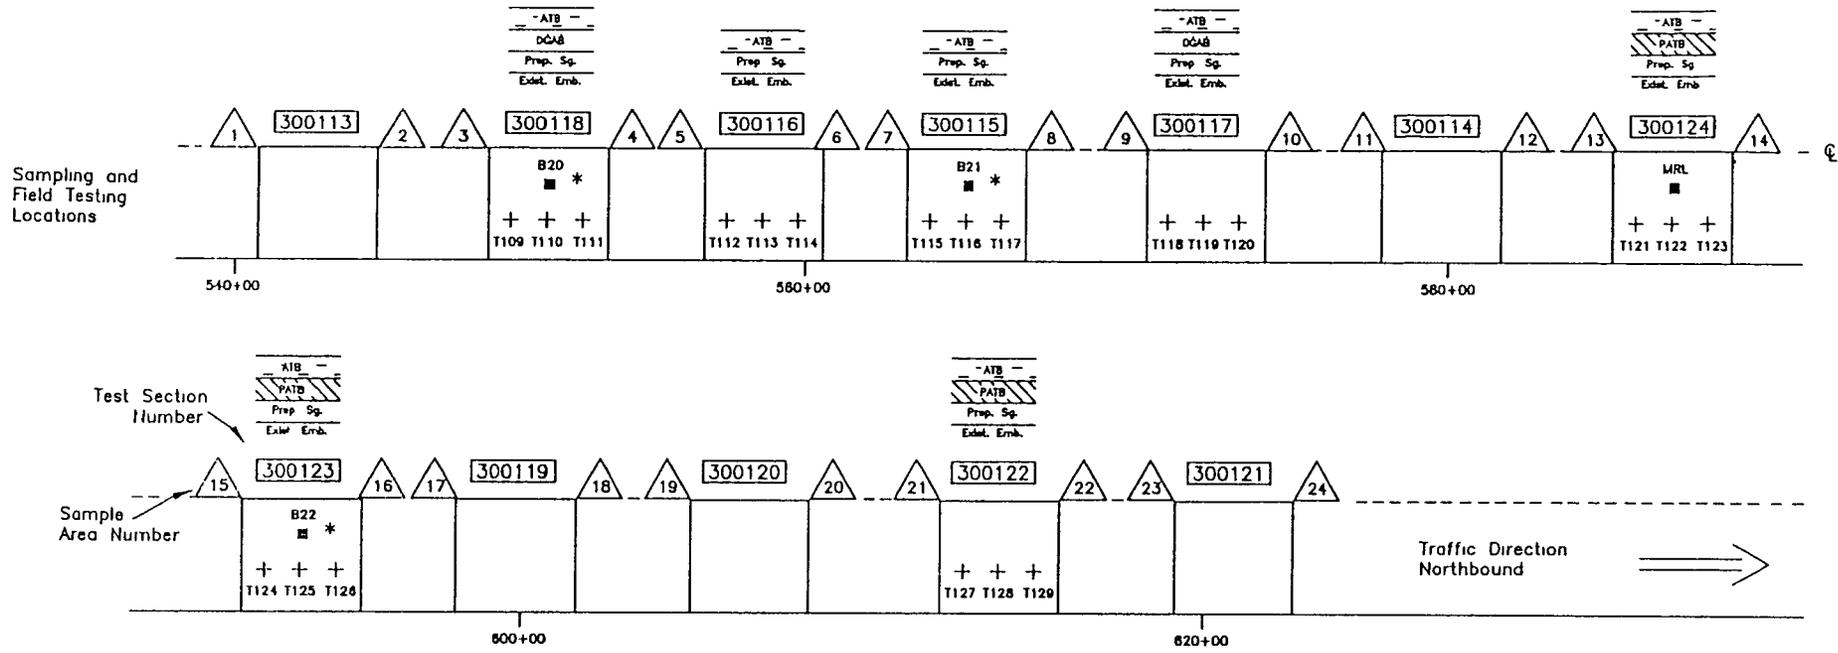
- + Location of nuclear moisture-density tests (T109-T129)
- Bulk sample of ATB (B20-B22)
- Prep. Sg. - Prepared Subgrade
- Exist. Emb. - Existing Embankment
- DGAB - Dense Graded Aggregate Base
- ATB - Asphalt Treated Base
- PATB - Permeable Asphalt Treated Base
- △ Sample areas
- \* Asphalt cement from plant (B26-B28)
- MRL Bulk mixture sample

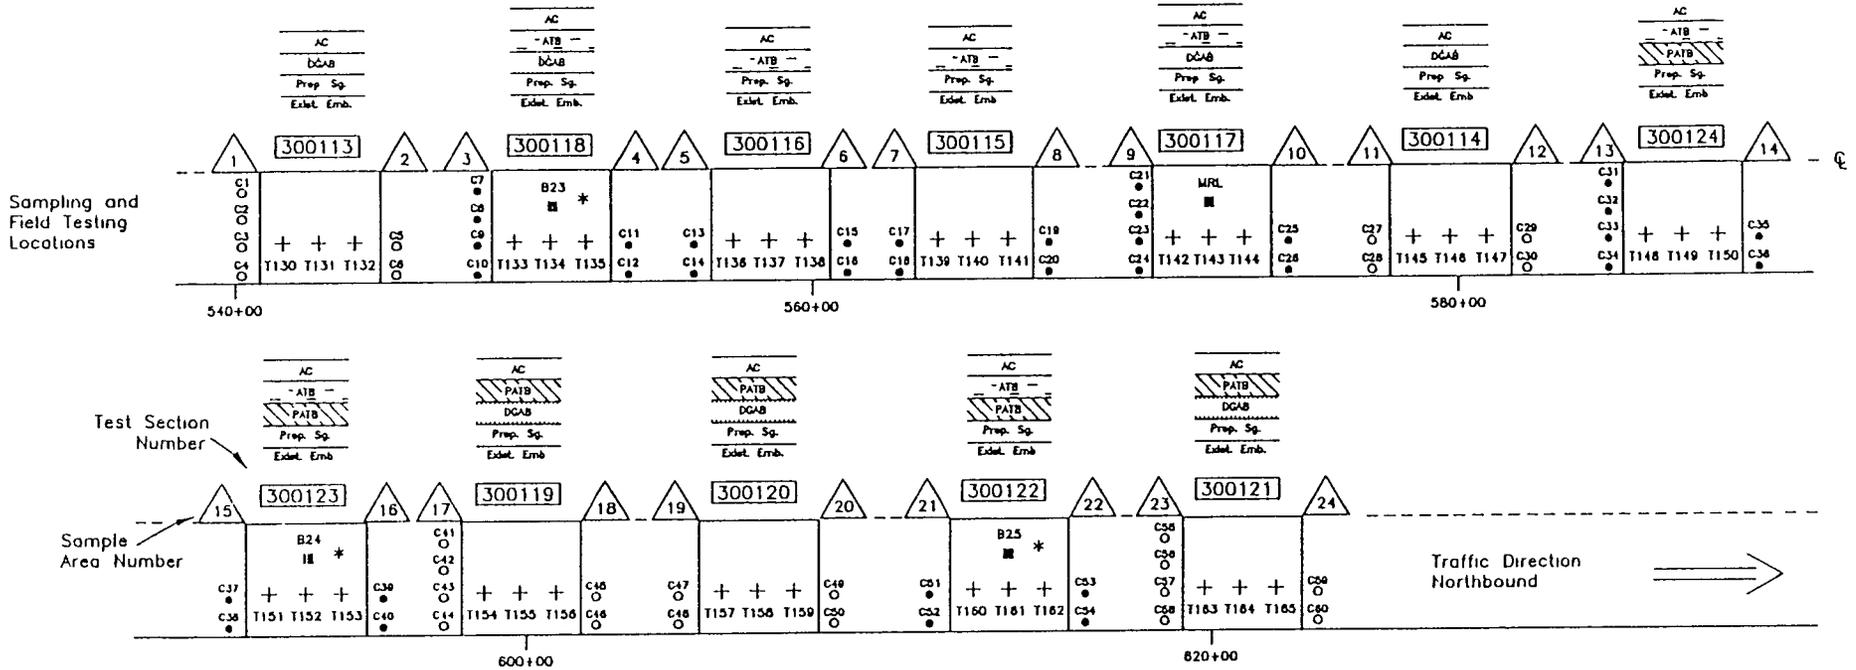
- 4" OD Core of AC Surface (C1–C6, C27–C30, C41–C50, C55–C60)
- 4" OD Core of AC Surface and Asphalt Treated Base layers (C7–C26, C31–C40, C51–C54)
- + Location of nuclear moisture–density tests (T130–T165)
- Bulk sample of AC Surface (B23–B25)
  - Prep Sg – Prepared Subgrade
  - Exist Emb – Existing Embankment
- DGAB – Dense Graded Aggregate Base
- ▨ ATB – Asphalt Treated Base
- ▧ PATB – Permeable Asphalt Treated Base
- ▩ AC – Asphalt Concrete Surface
- MRL Bulk mixture sample
- △ Sample areas
- \* Asphalt cement samples from plant (B29–B31)

Bulk samples of asphalt cement used in the asphalt concrete were collected, as were cold feed samples of coarse and fine aggregates at the plant. Bulk samples of loose mix and 102mm (4 in) diameter cores of finished AC surface were collected at sampling locations indicated in figure 11. Table 17 shows core locations for the asphalt concrete surface. Cores C7-C26, C31-C40, and C51-C54 include an ATB layer as part of the core.

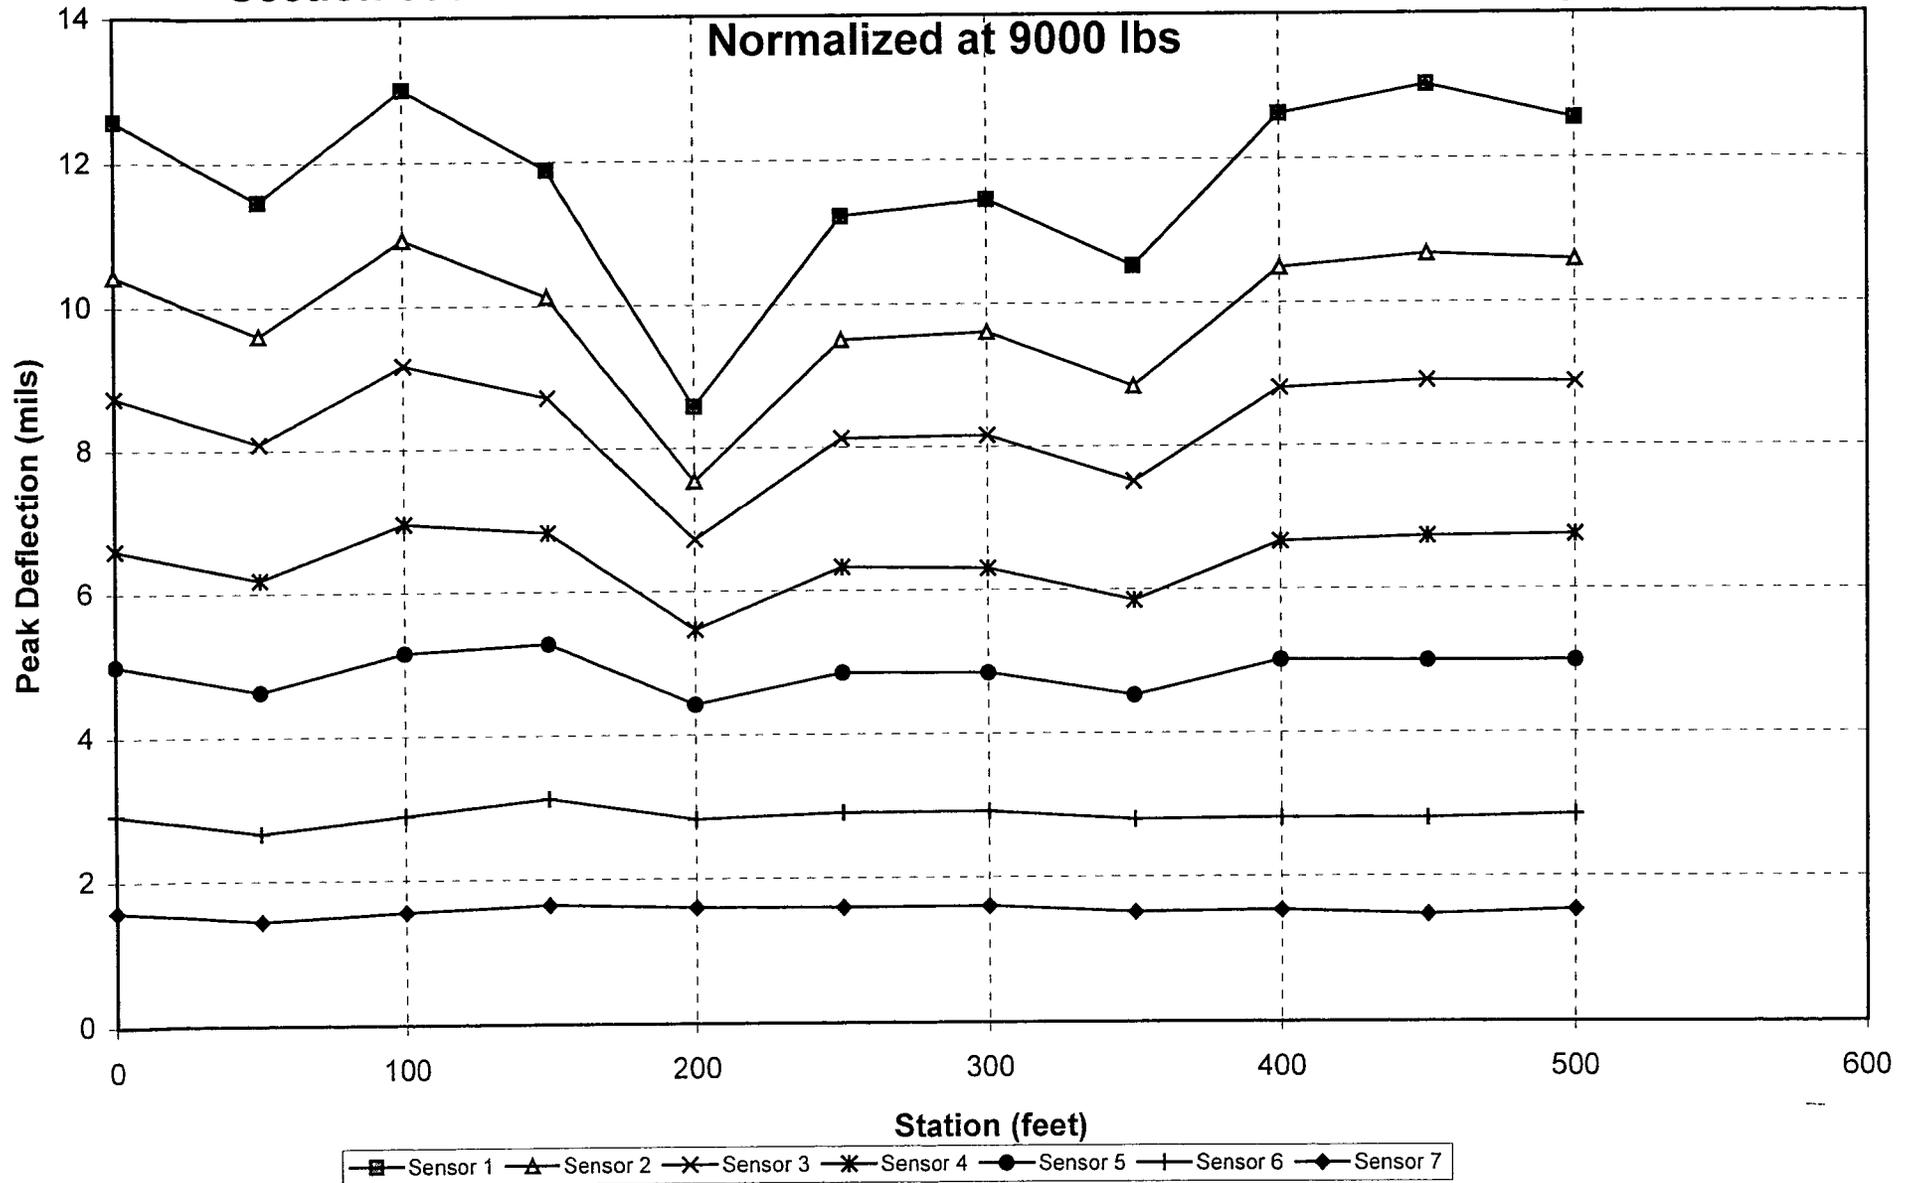
### Variation of FWD Deflection with Station Section 300113 Test Date 11/10/1998 Test Location Outer Wheelpath - Normalized at 9000 lbs

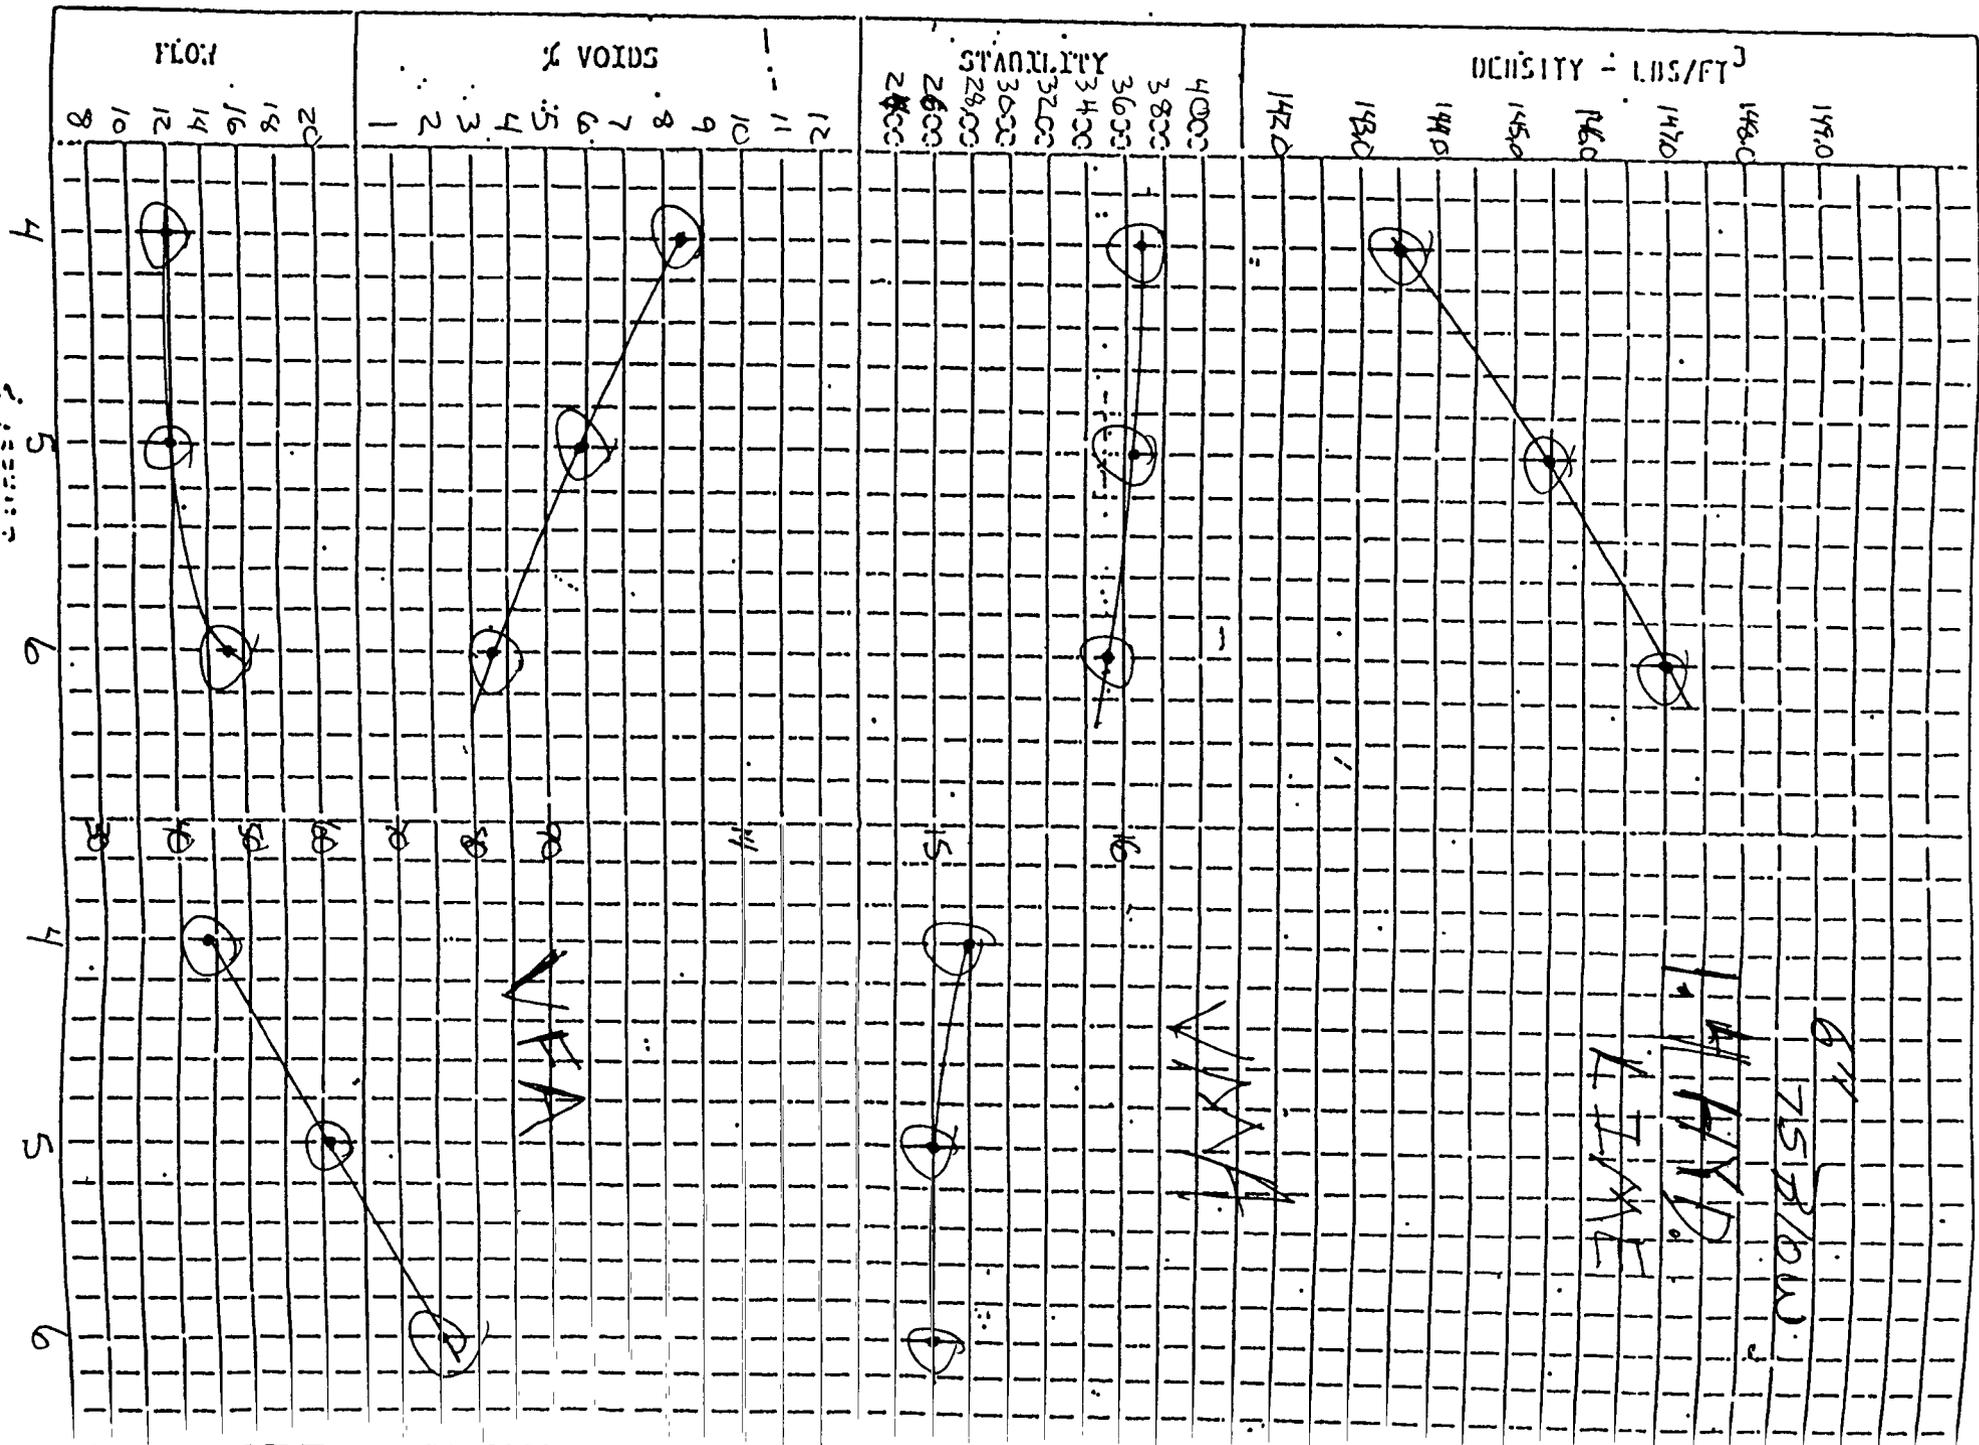
MARSHALL METHOD GRAPH

PROJECT NO. IM 15-5(193)256 LAB. NO. 749482

The asphalt mix design for the ATB prepared by Montana DOT is shown in appendix C. The mix used an 5/100 penetration grade asphalt binder. Recommended mix properties were 6% AC with 1.4 % hydrated lime at and 75 blow Marshall compaction. This resulted in a theoretical compacted Marshall specimen with a Rice Specific Gravity of 2.445, a unit weight of 2354 kg/m<sup>3</sup> (147.0 pcf), 3.7% air voids, Marshall stability of 15.6 kN (3515 lbs.), and Marshall flow of 15.

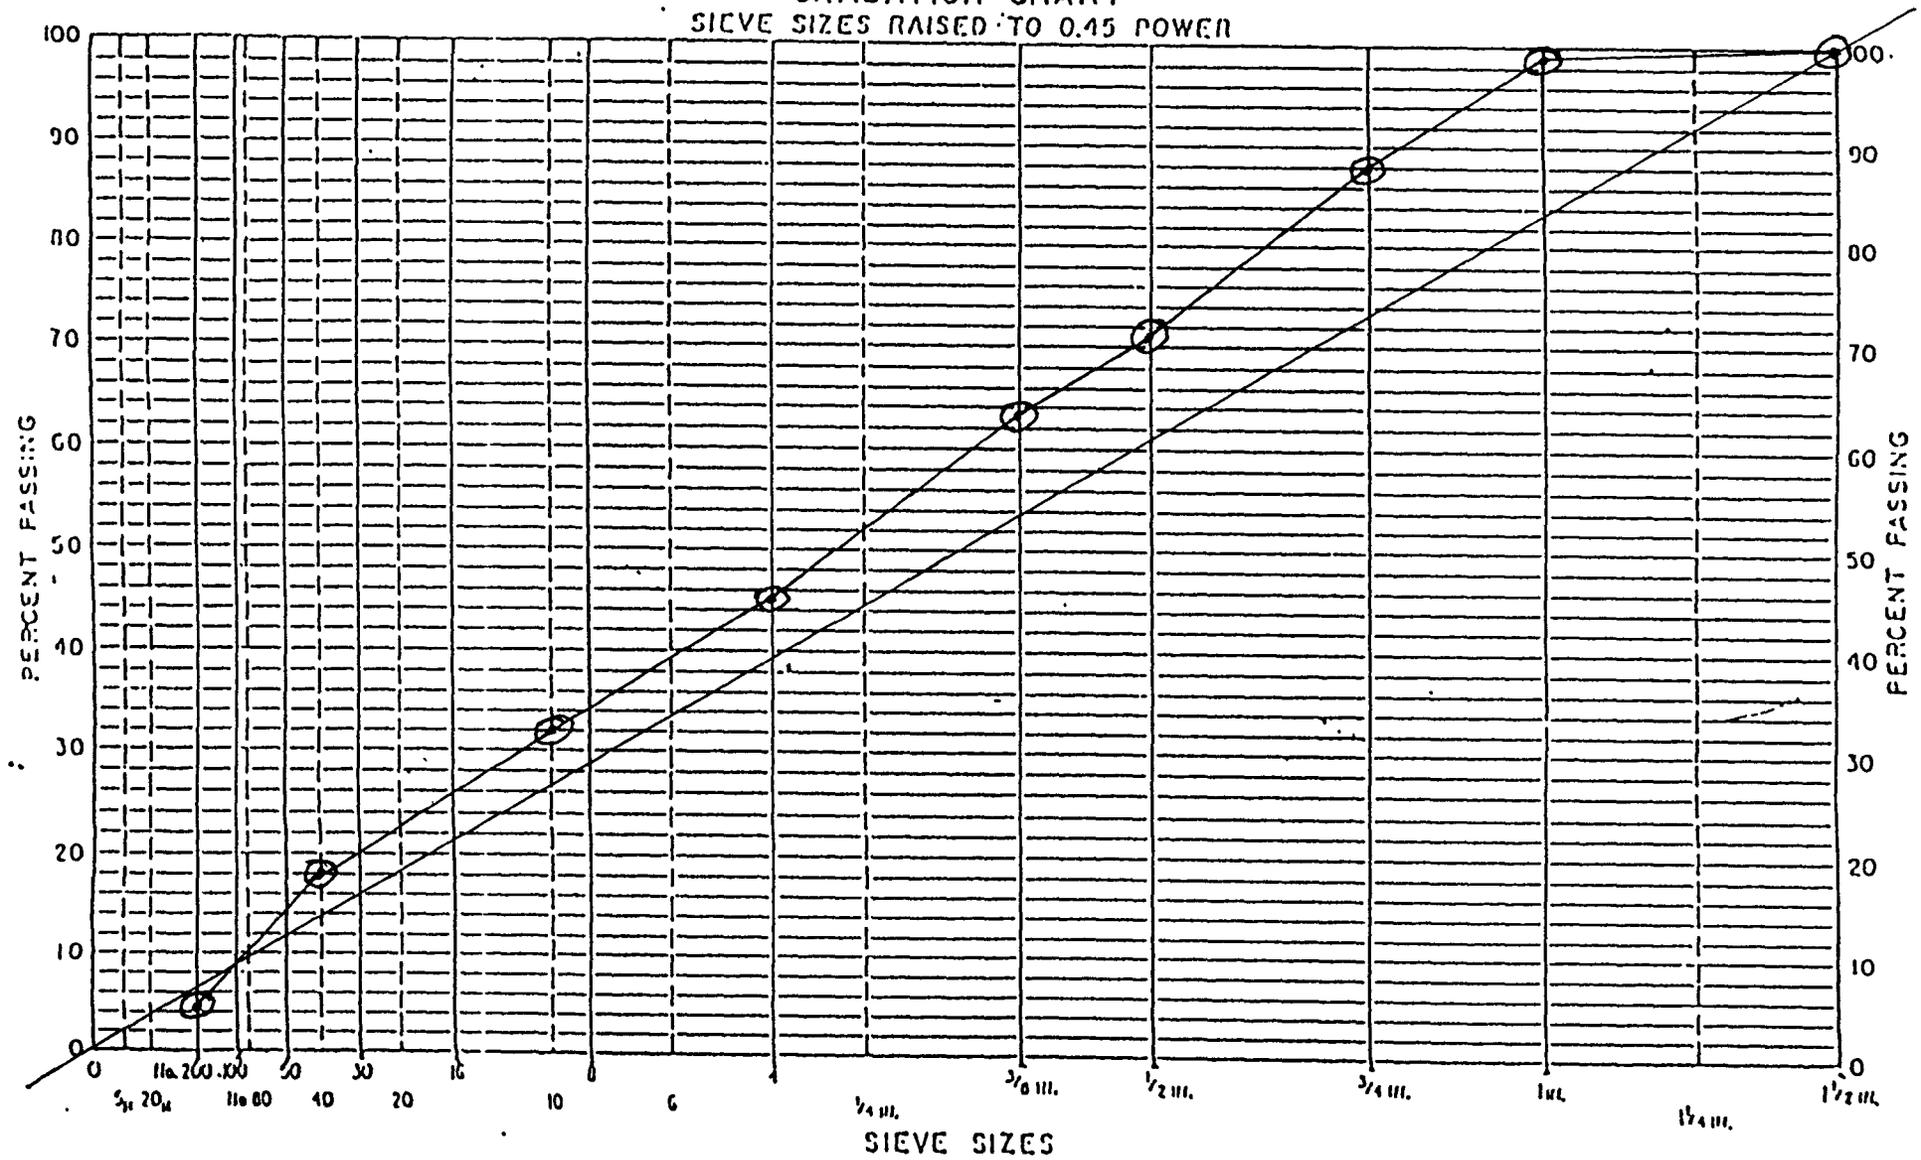
GRADATION CHART  
SIEVE SIZES RAISED TO 0.45 POWER

Ideal color of gradations:  
**HARDY CREEK - WIM (NB)**  
 ZM 15-5 (93) 256  
 74948Z

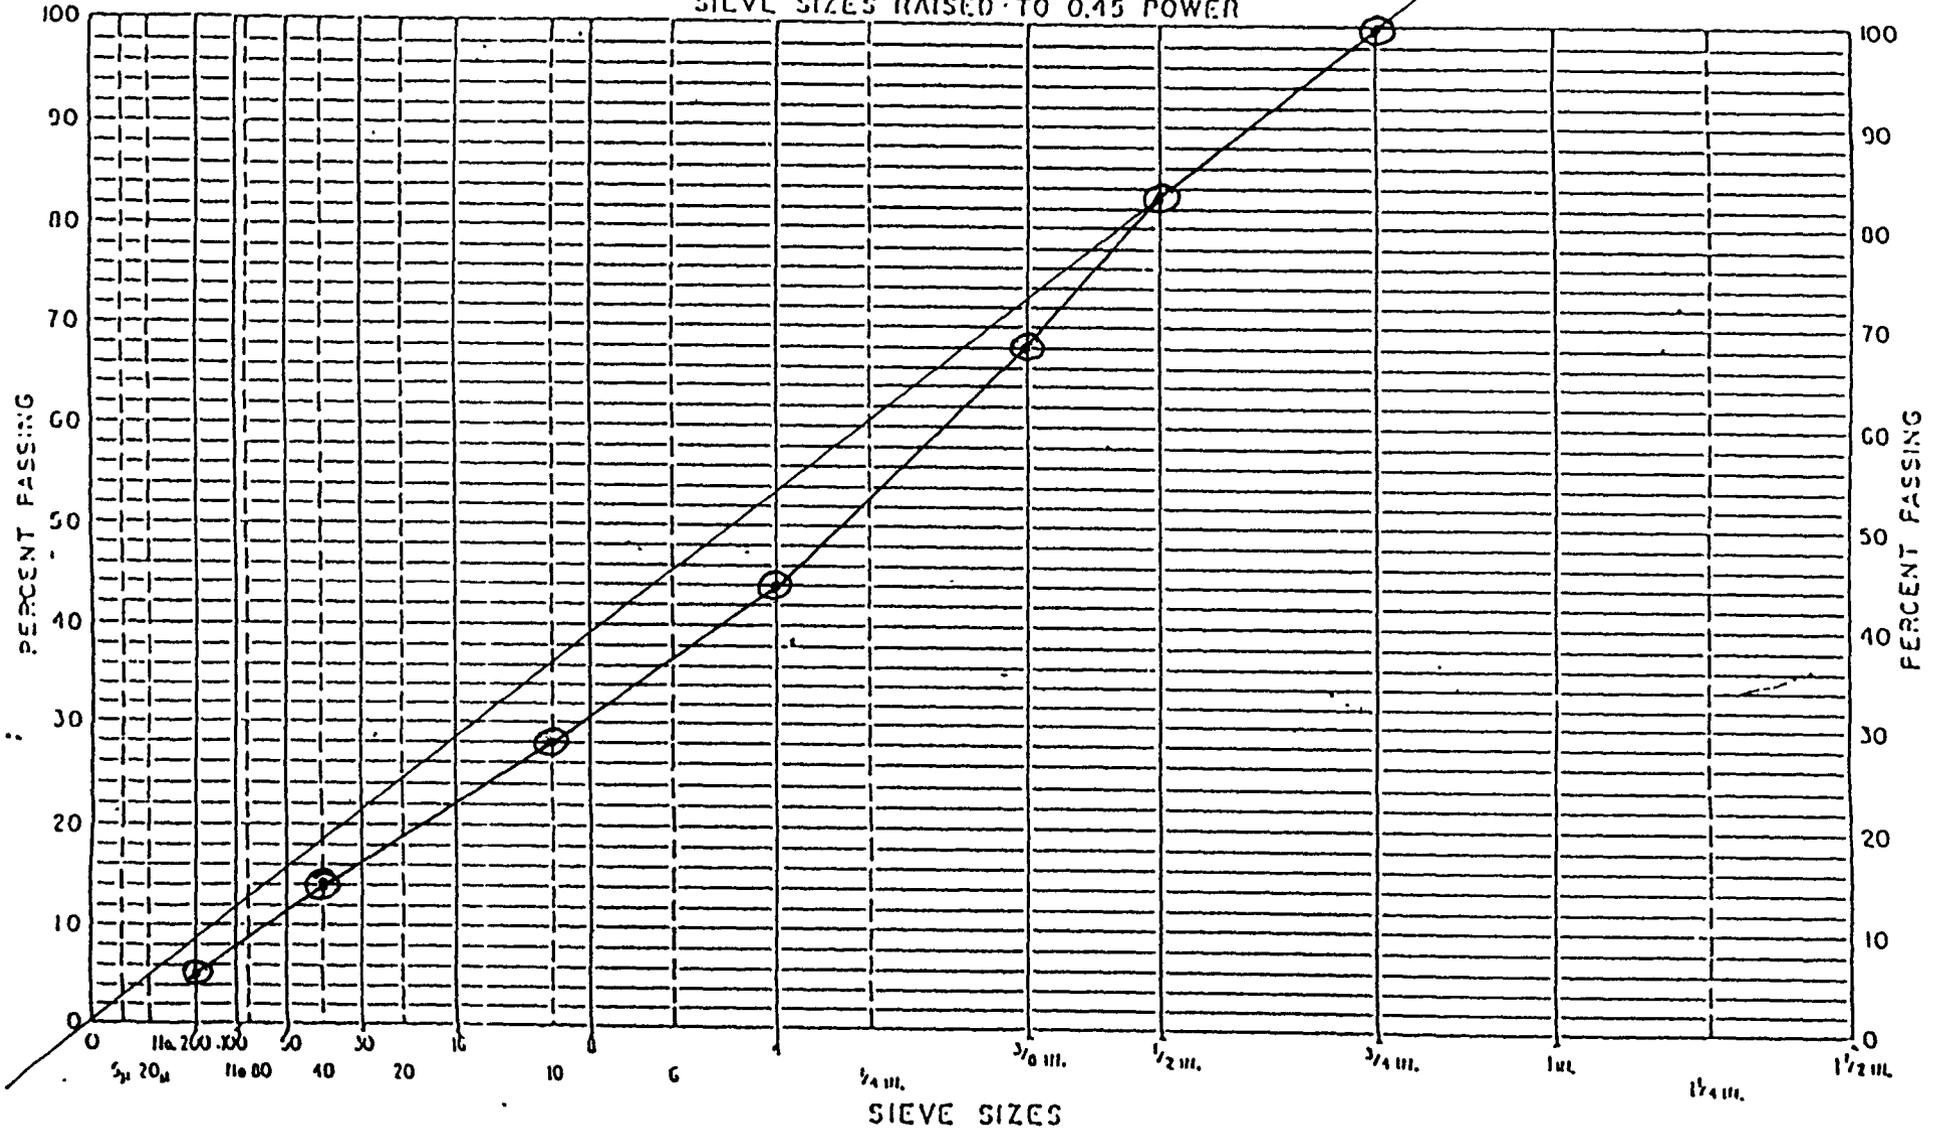
GRADATION CHART  
SIEVE SIZES RAISED TO 0.45 POWER

Identification of gradations: *Hardy Creek - U1M*  
*IM 15-5(93) 256*  
*749481*
