LTPP Specific Pavement Studies

Construction Report on SHRP
100200, SPS-2 Project,
Ellendale, Delaware
Spring 1994 - Spring 1996

Report No. FHWA-TS-96-10-04

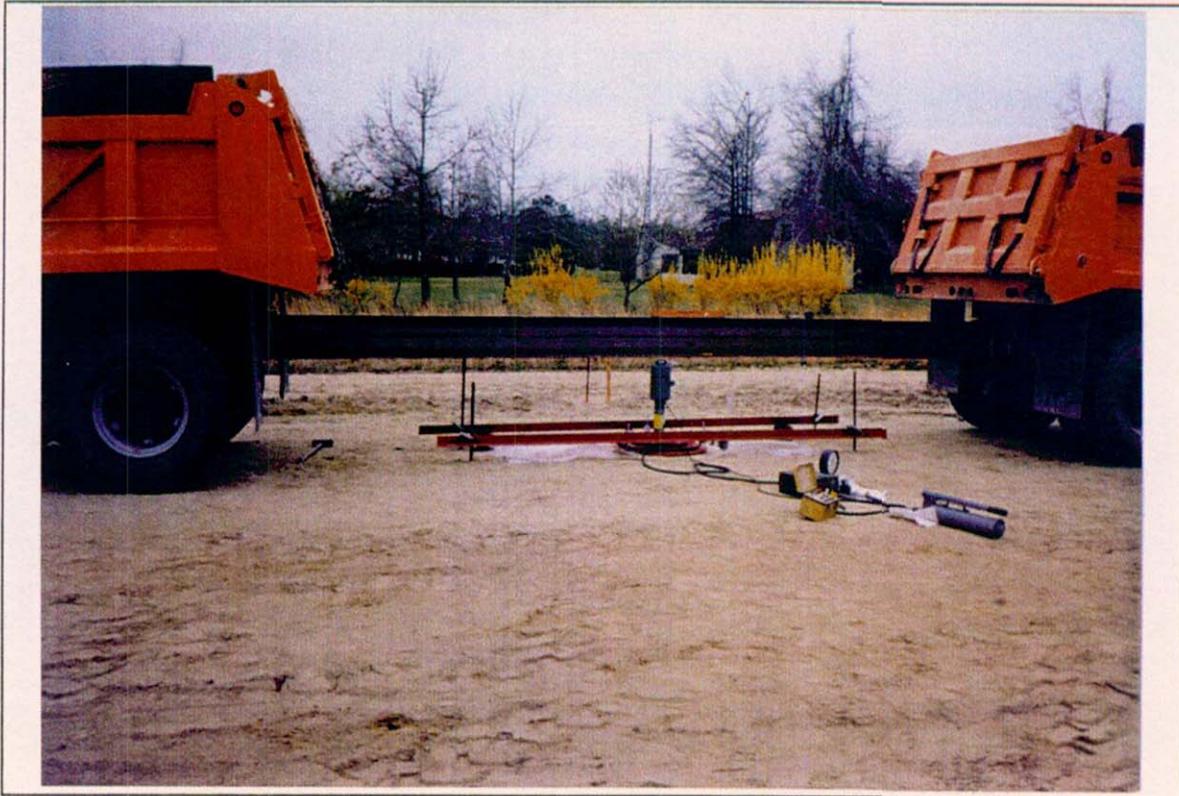
Photo 1 - Plate Load Bearing Test Equipment in place just prior to testing.

During the first plate load bearing test, the 20' beam failed by buckling and it was replaced with a 16' beam reinforced in the Delaware DOT machine shop. When the trucks were loaded, there was insufficient clearance between the jack and the beam but it was possible to shave an inch or so from the sandy subgrade. On the DGAB test sections the trucks had to be partially unloaded to obtain an adequate clearance.

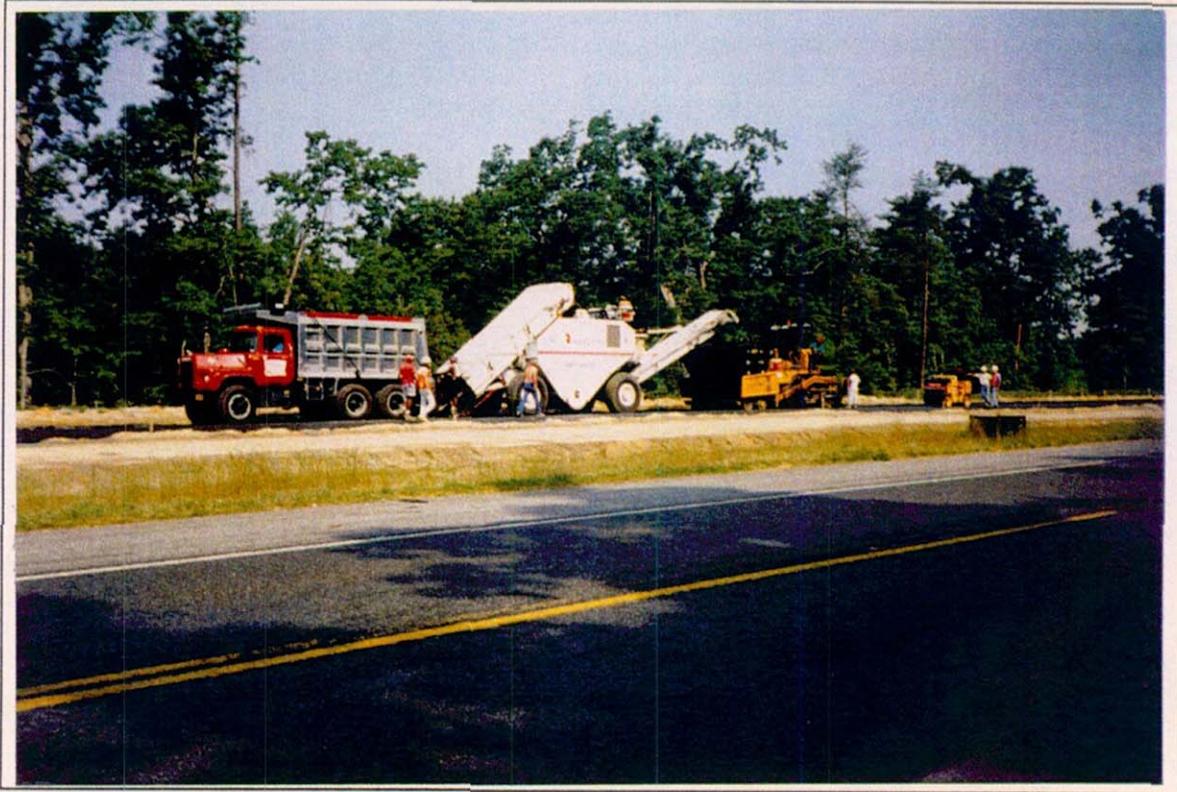
Photo 3 - Station 681+00. PATB paving train-truck, shuttle buggy, paver and roller.

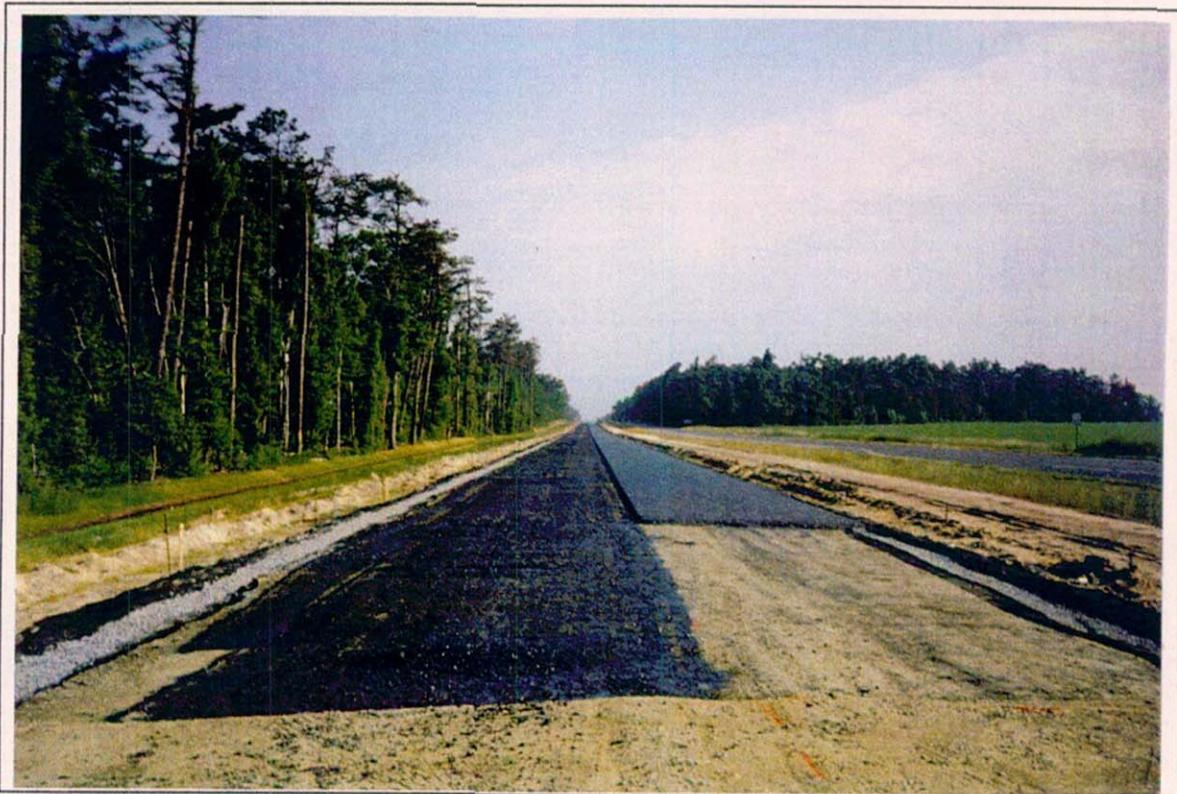
Photo 4 - Station 667+25 facing north. PATB has been placed on the passing lane.
Driving lane is primed and awaiting PATB.

The PATB was obtained from Tilcon Plant 4 and placed on the driving lane of test sections 100209, 100210, 100211 and 100212 on June 5, 1995. The PATB was placed on a primed DGAB layer. Subsequently, the concrete was removed on section 100209 taking all of the PATB with it, the PATB was replaced on Sept. 19, 1995. To avoid damage to the under-drains, a 4" saw cut was made in the PATB at the edge of the pavement to form a clean cut.

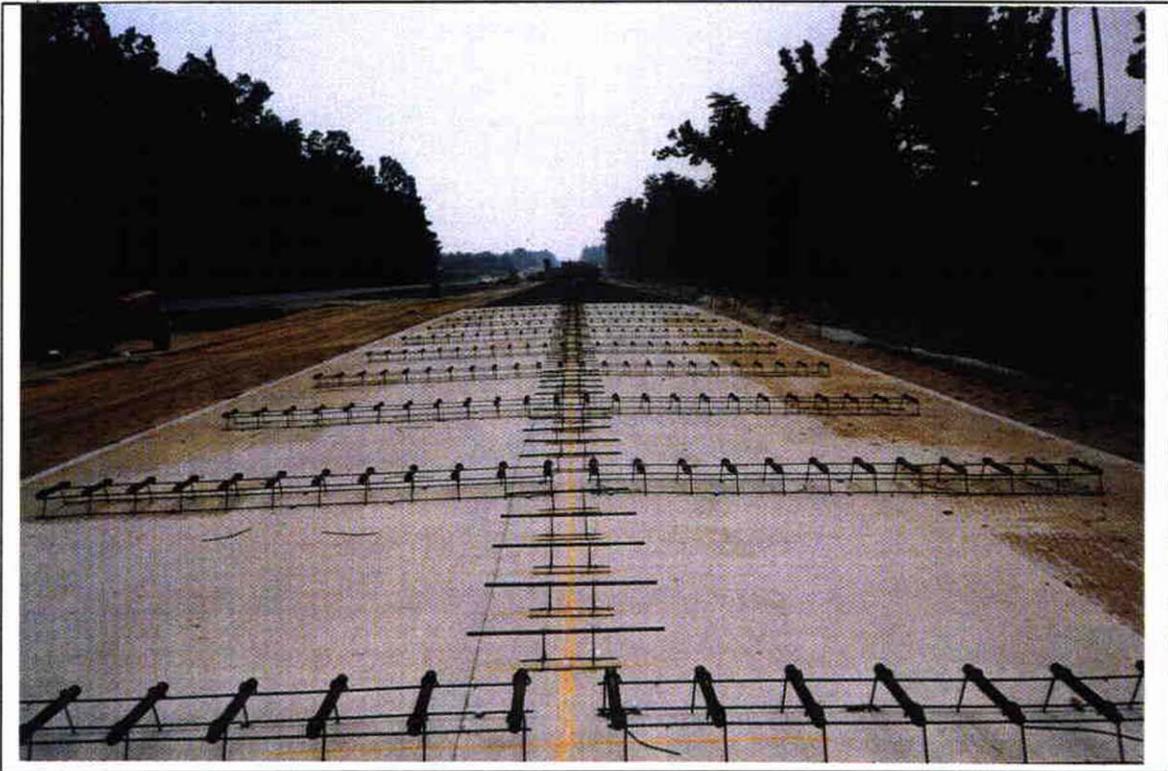
Photo 6 - Station 689+70 facing south. Partial view of test sections 100208 and 100212 showing dowel baskets on LCB. Note milling in both lanes required for paver.

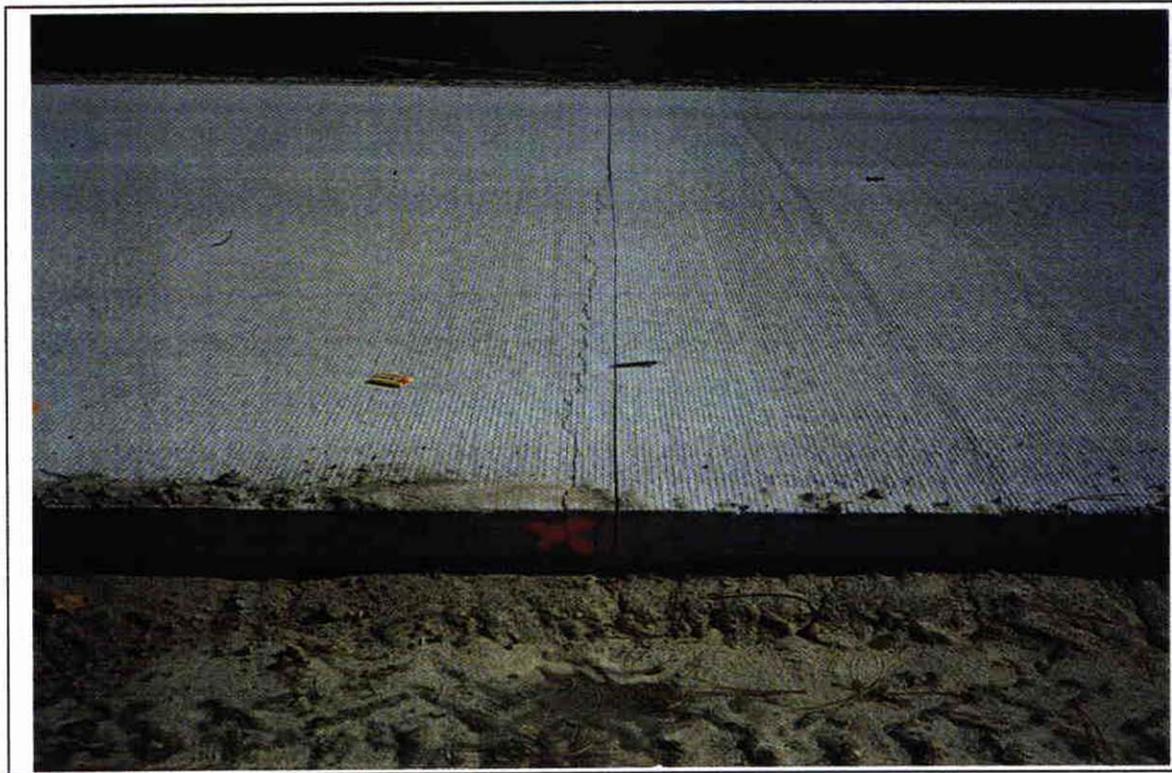
Photo 10 - Station 623+95. Outside shoulder. The crack at the edge is 4" from the joint and extends to the center line.
