RE: SPS-2 Draft Report

**FEDERAL HIGHWAY ADMINISTRATION
Long Term Pavement Performance (LTPP)
Specific Pavement Studies**

***CALIFORNIA SPS-2*
“Strategic Study of Structural Factors for Rigid Pavements”**

December 2001

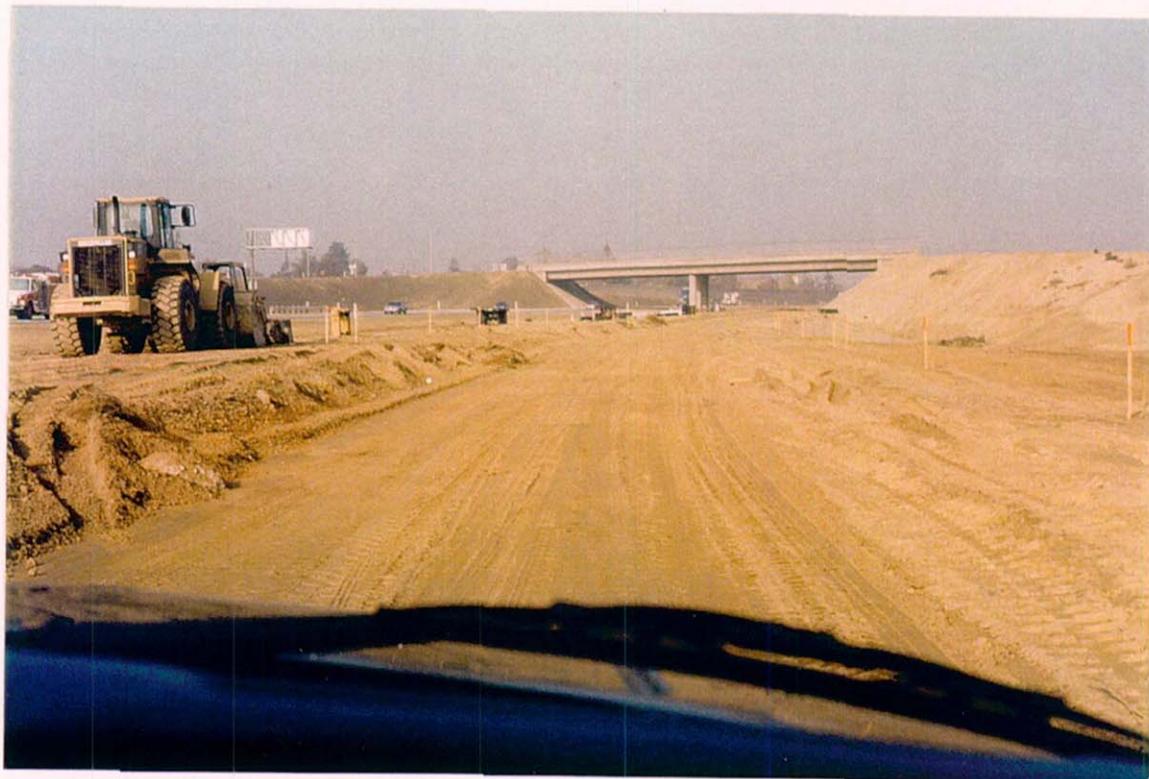
Photo 2. Subgrade work.

This project was constructed in two phases. Sections 060201, 060202, 060204, 060205, 060206, 060207, 060208, 060209, 060210, and 060212 were constructed in phase I. Construction of sections 060203 and 060211 were included in phase II. Initial subgrade work for both phases began in January 1999. Early efforts were focused on obtaining grade and involved cut in some areas used to fill others. Water trucks and steel rollers were used to attain the target compaction and moisture content. Subgrade work was completed on March 30, 2000 (phase I) and August 9, 2000 (phase II). Photograph 1 in appendix A shows the site conditions before construction. Photograph 2 in appendix A shows the work on the subgrade layer.
