FEDERAL HIGHWAY ADMINISTRATION
Long Term Pavement Performance
Specific Pavement Studies

SPS-2 CONSTRUCTION REPORT
SHRP 080200

Prepared for:
Colorado Department of Transportation
Federal Aid Project No. I 076-1 (138)
I-76 Eastbound, Milepost 18.43
Adams County

Prepared by:
Western Region Contractor
Nichols Consulting Engineers, Chtd.
Reno, Nevada

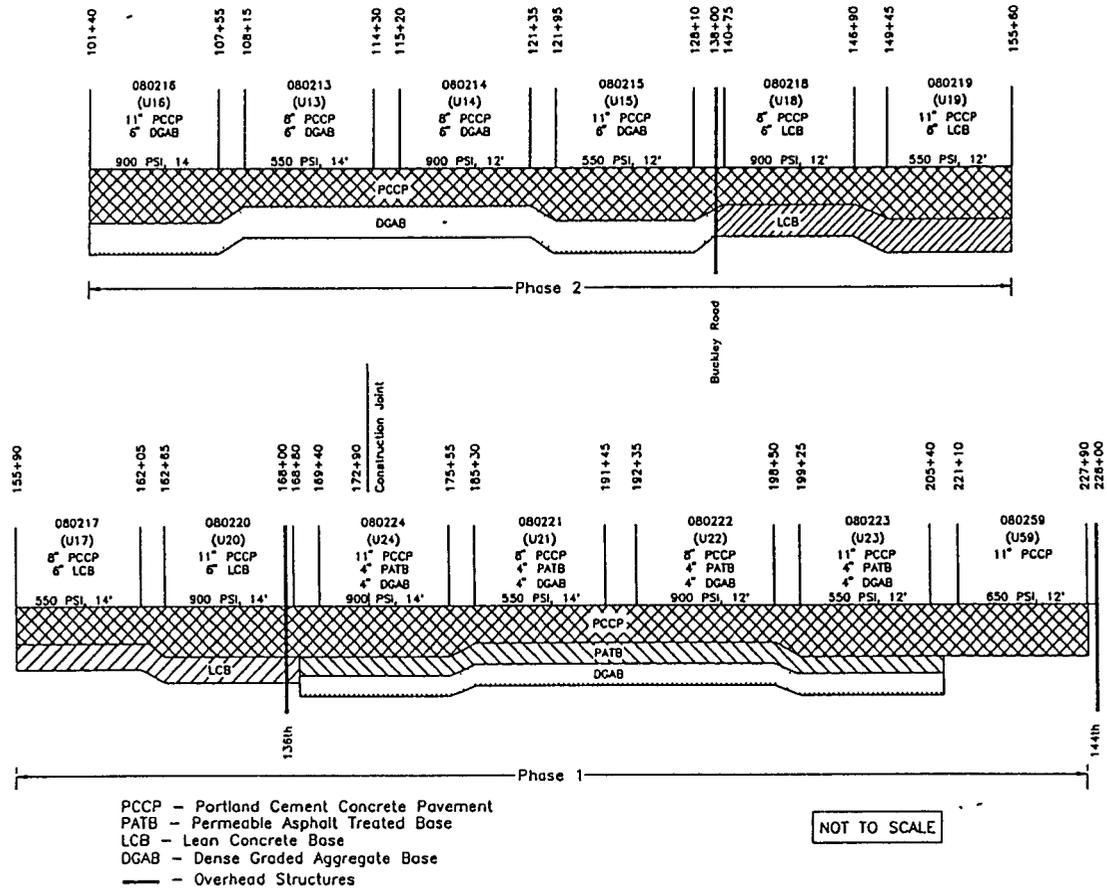
Figure 2. Layout and construction sequence of experimental test sections, Colorado SPS-2 project.

I-76 EASTBOUND
 REVISED 08/23/94
 DIRECTION OF TRAFFIC
 →

The construction sequencing and layout of the test sections is shown in figure 2 and described in table 3. In addition to the 12 primary SHRP sections, a state supplemental control section, 080259, was also constructed from station 221+10 to 227+90. This section was built using Colorado's standard design criteria: 11 in of PCCP on subgrade, 650 psi flexural strength, and a 12 ft lane width.
