**SPS-3 CONSTRUCTION REPORT**  
SHRP North Atlantic Region

October 1990

## SPS-3 CONSTRUCTION REPORT North Atlantic Region

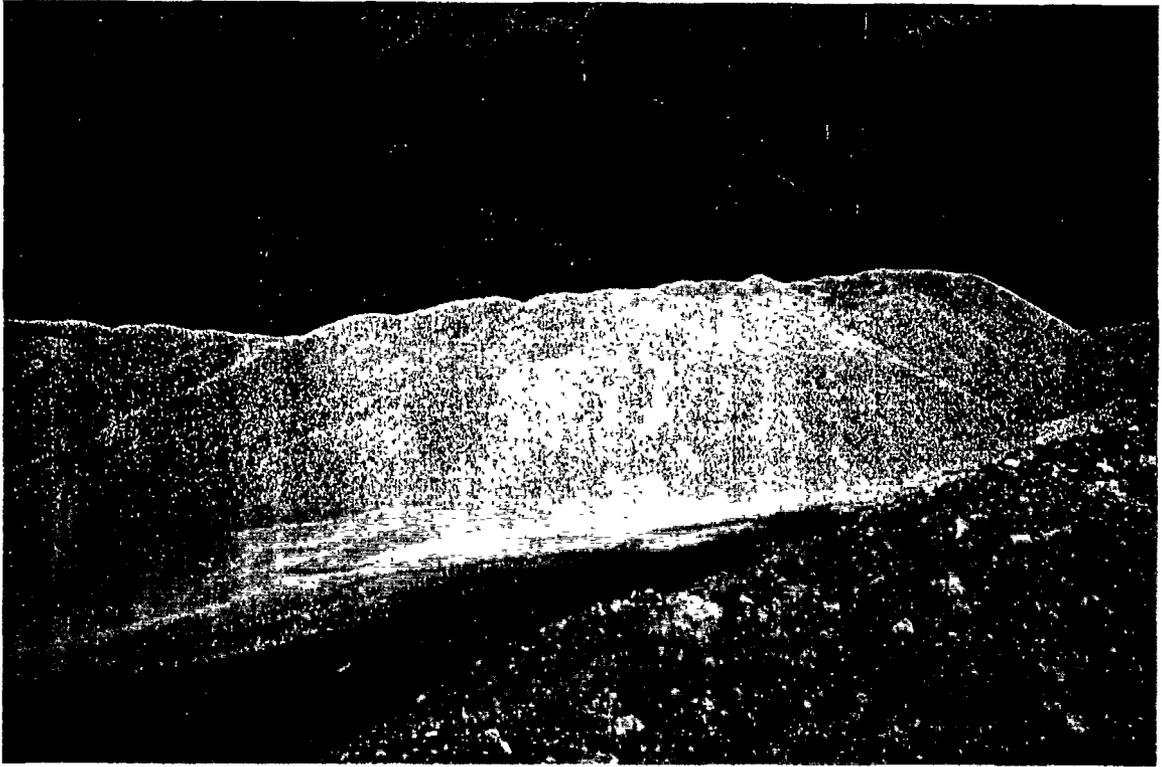
PHOTO 1

STOCK PILE - CHIP SEAL AGGREGATE  
EASTERN ROCK PRODUCTS  
LITTLE FALLS, NY AUG. 15/90

Chip Seal Aggregate	Eastern Rock Products, Little Falls, NY (photo 1)
Emulsion (HFRS2)	T.D. Pounder Emulsions Ltd Brampton, Ontario

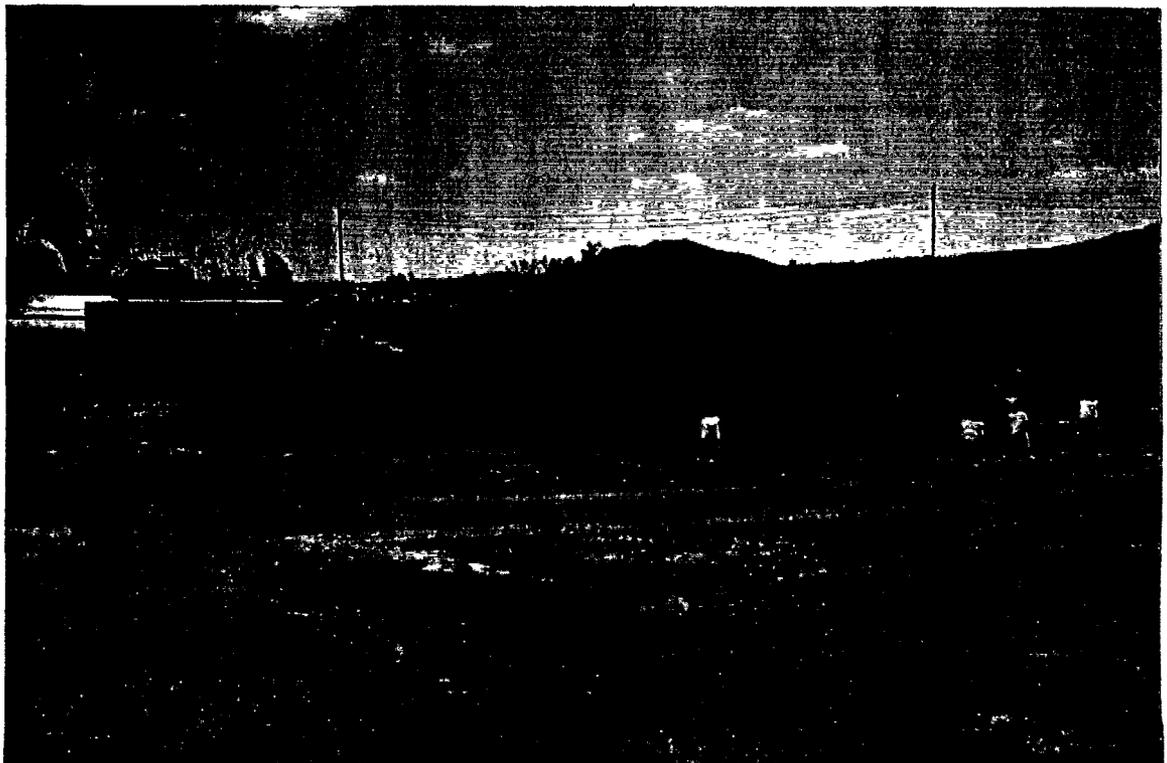
PHOTO 2

STOCK PILE - SLURRY AGGREGATE  
GENERAL CRUSHED STONE  
HONEOYE, NY AUG. 15/90

Slurry Seal Aggregate	General Crushed Stone Co. Honeoye, NY (photo 2)
Mineral Filler	Hydrated lime from Lee Lime Corp., Mass
AC-10	Exxon Corp. in Bayonne, NJ
Emulsion (CSS-1h)	Produced by Suit-Kote at Cortland, NY

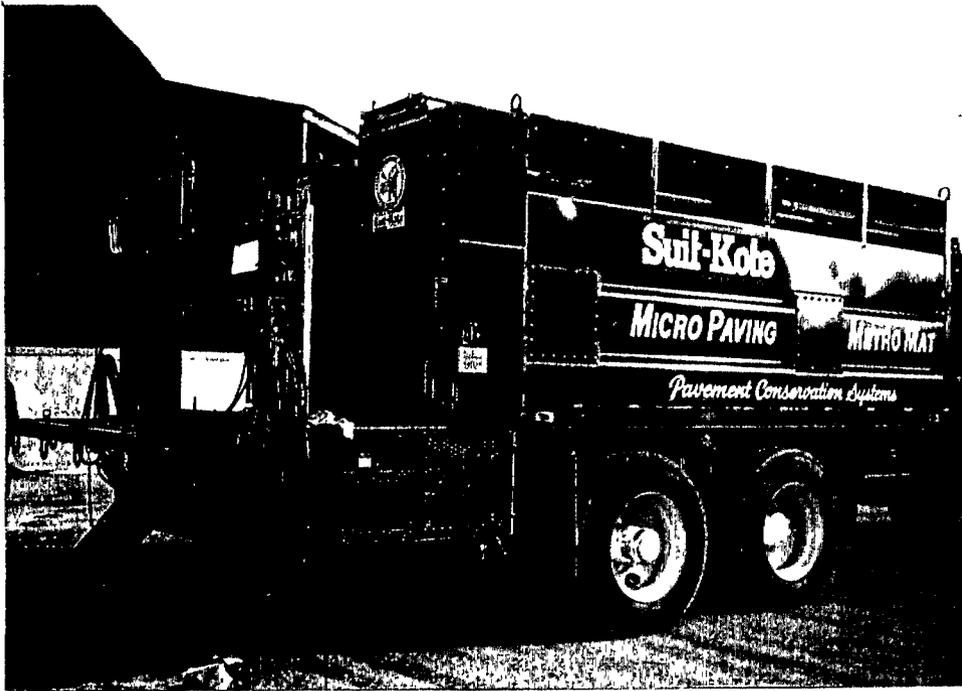
PHOTO 3  
SLURRY SEAL MIXER WITHOUT SCREED DURING CALIBRATION

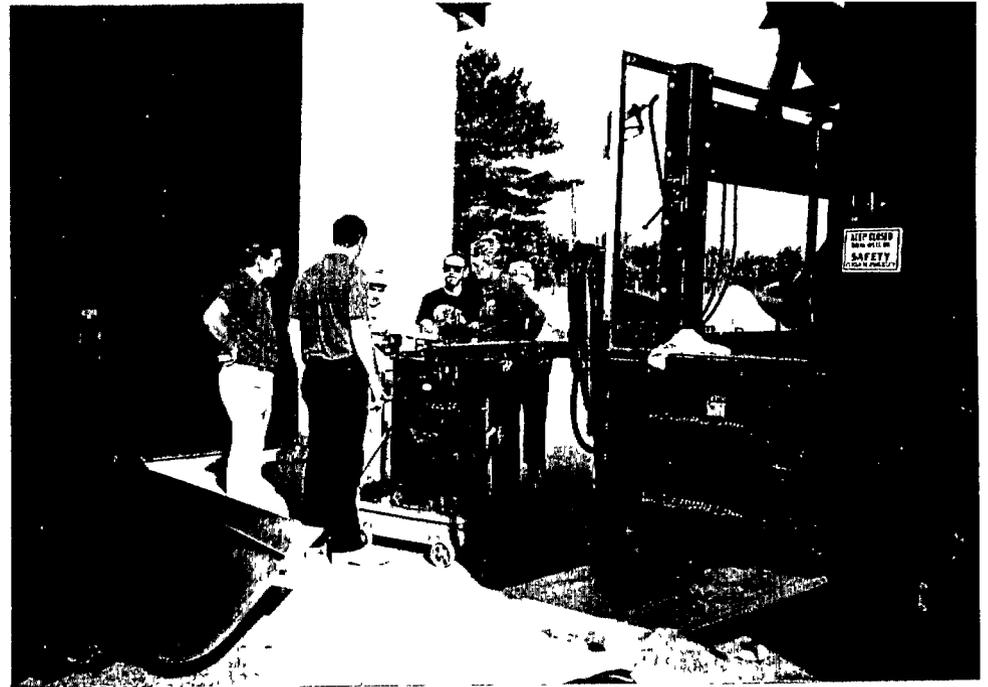
PHOTO 4  
WEIGHING EMULSION DURING CALIBRATION

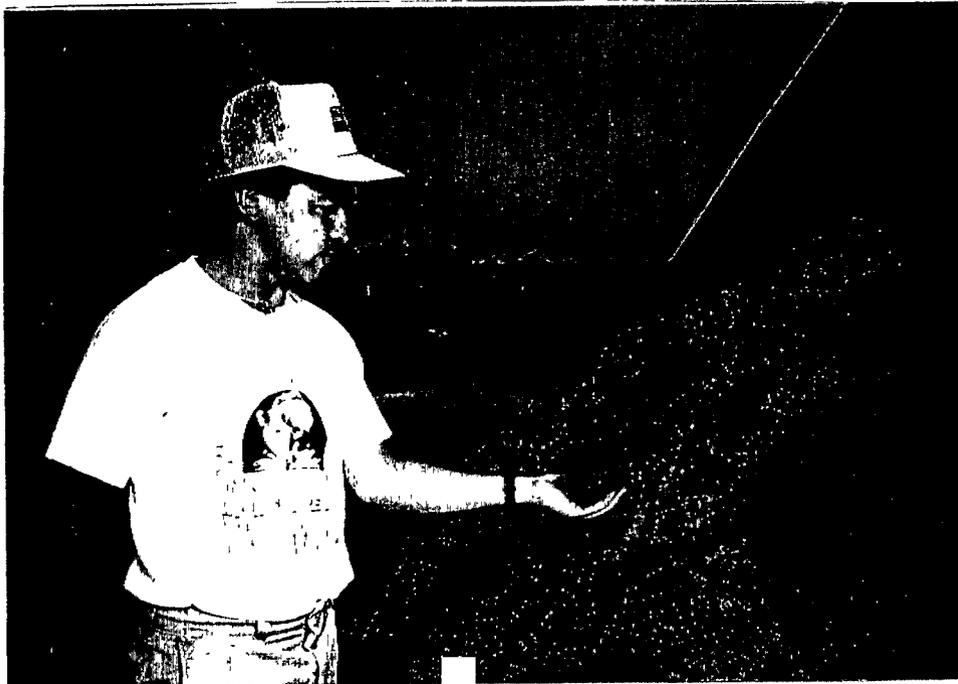
PHOTO 5  
SLURRY SEAL AGGREGATE AT CALIBRATION SITE

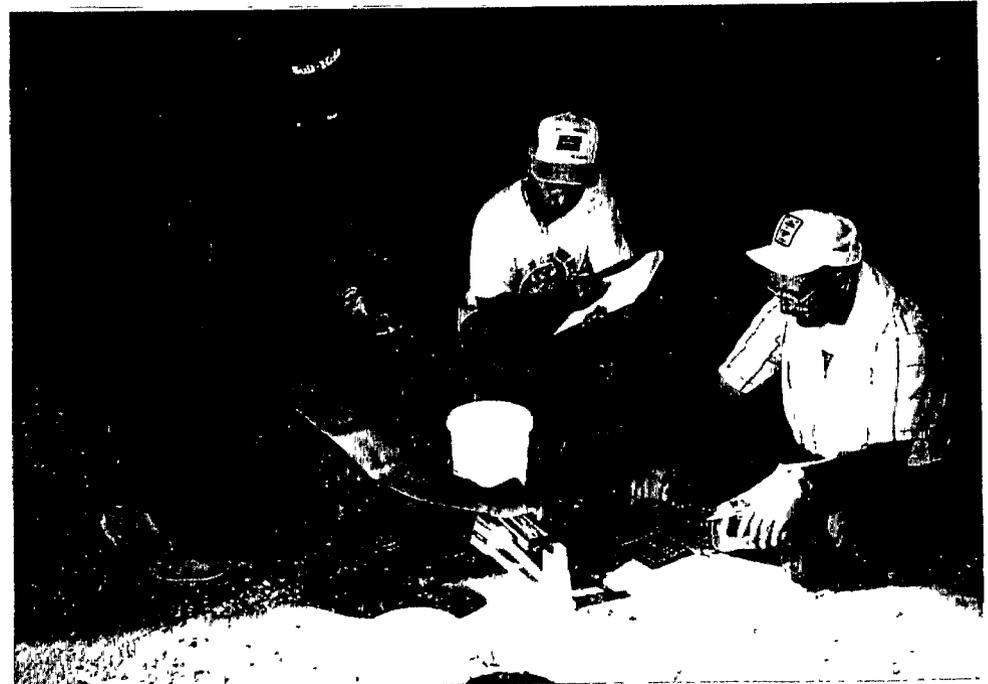
PHOTO 6  
WEIGHING HYDRATED LIME DURING CALIBRATION

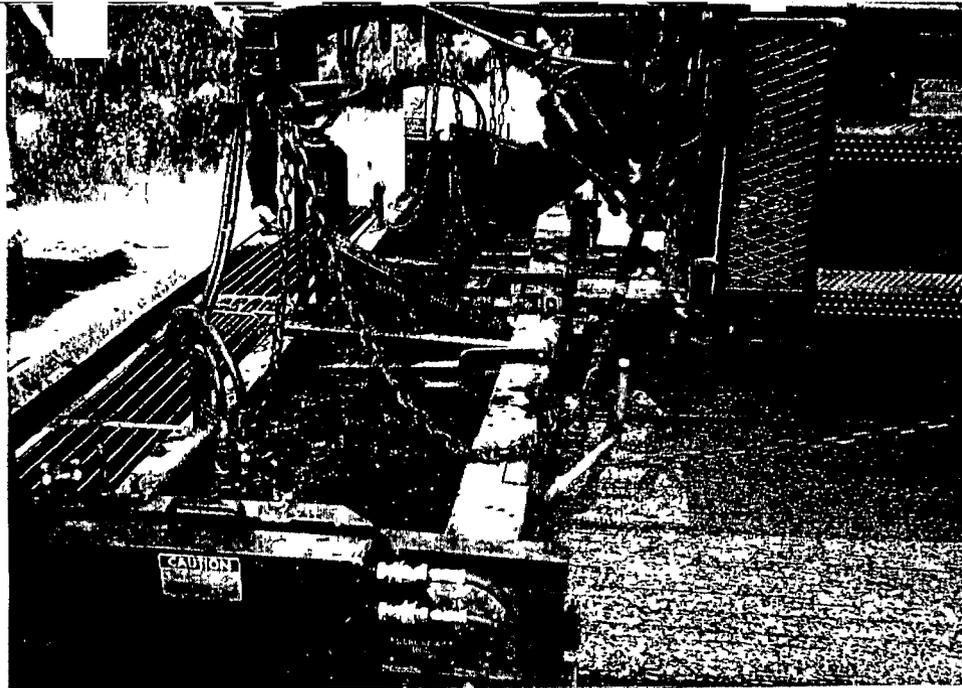
PHOTO 7  
SLURRY SEAL SCREED IS FILLED DURING CALIBRATION TRIALS

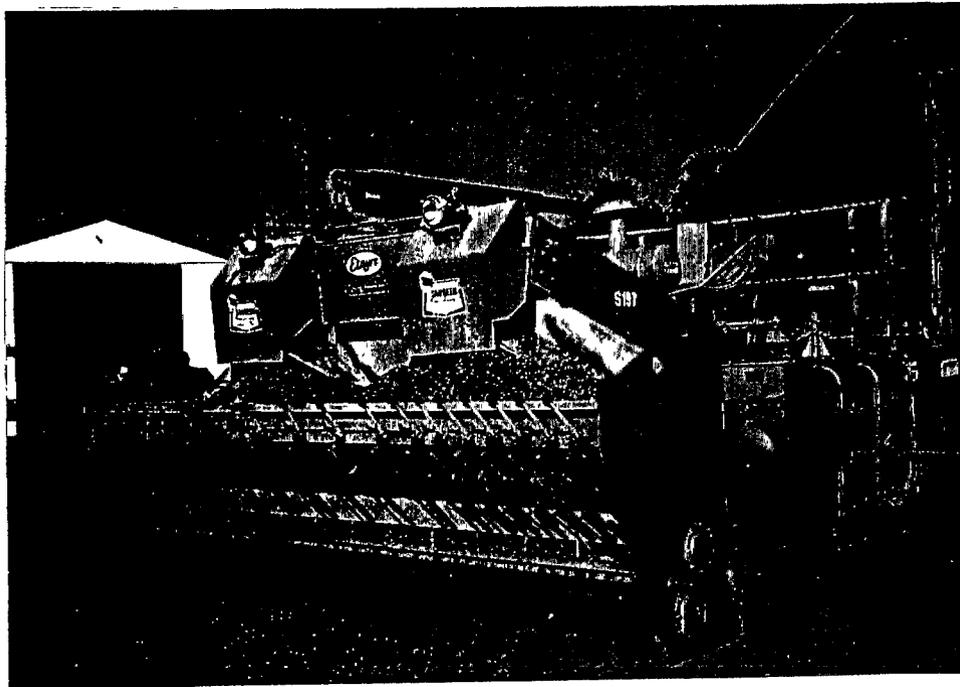
PHOTO 9  
CHIP SPREADER DURING CALIBRATION

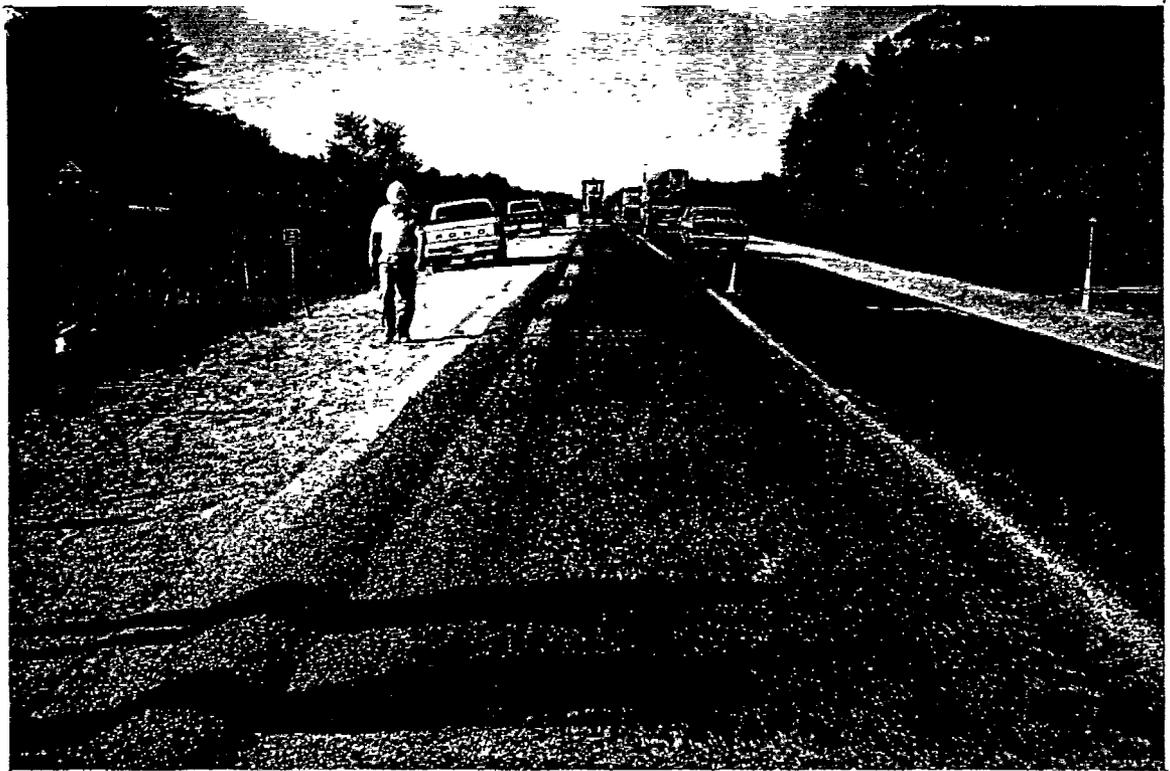
PHOTO 10

On Tuesday August 21, a new load of emulsion was obtained from Pounder for the Highway 11 Bracebridge, Ontario site 87B350. It was used on the trial lane around noon hour. By 4:00 pm it was not setting up properly so it was bladed off the road (photos 10 and 11). A new batch was brought in by Pounder on Wednesday August 22 (photos 17 and 18). From a small demonstration site, it was evident that this emulsion would also not set up properly. It was then decided that Suit-Kote would take over the chip sealing work from Saugeen and they brought in a fresh batch of emulsion from their plant in Cortland, N.Y. on Thursday, August 23. From a small demonstration it was again evident that the chip seal emulsion was not setting up properly so Suit-Kote decided to study the problem over the weekend and arrive with a new batch on Monday, August 27.

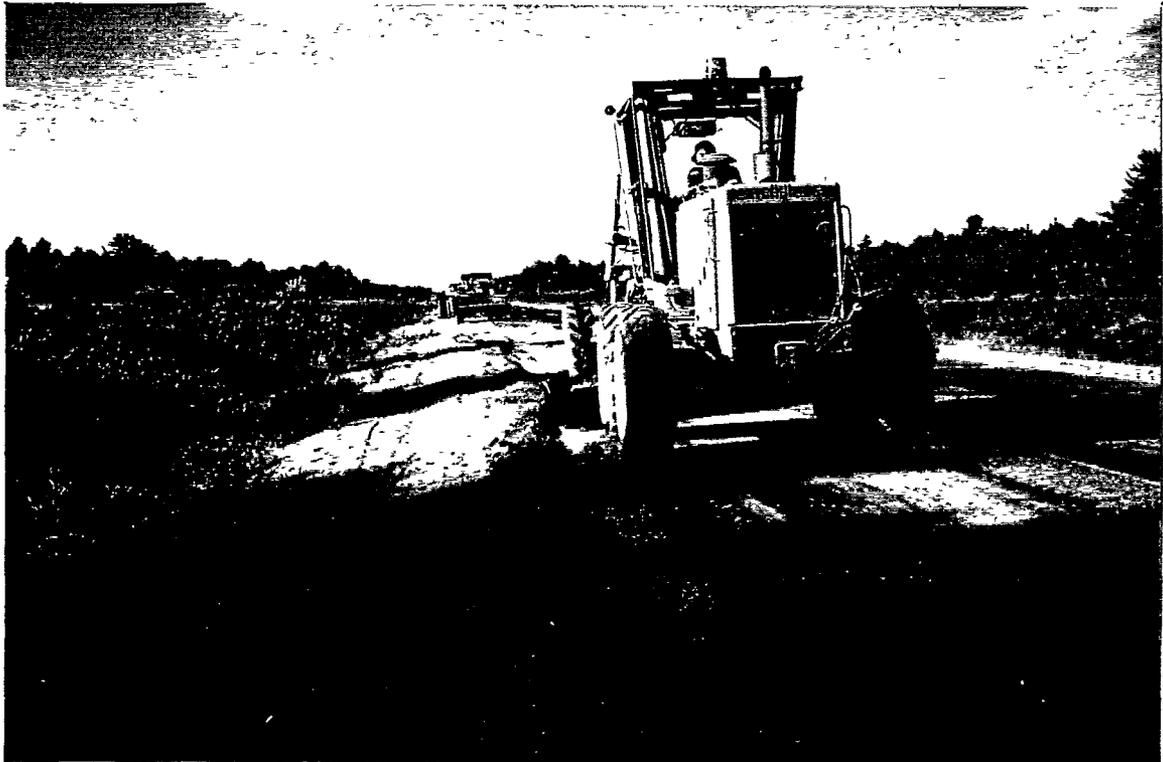
PHOTO 11

HWY. 11 BRACEBRIDGE, 87B350 AUG. 21/90  
THE TRIAL LANE CHIP SEAL DID NOT SET UP PROPERLY. IT WAS BLADED OFF,  
AND FOR SAFETY REASONS SAND WAS ADDED, COMPACTED AND THEN BLADED OFF

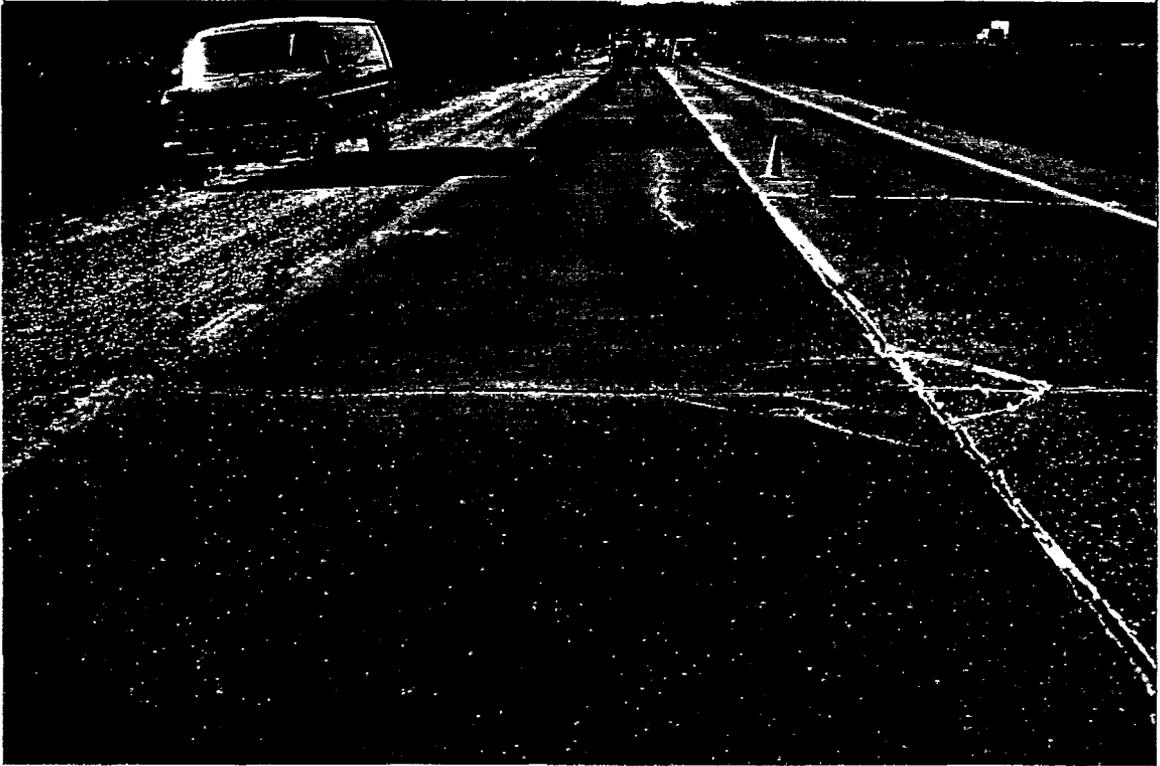
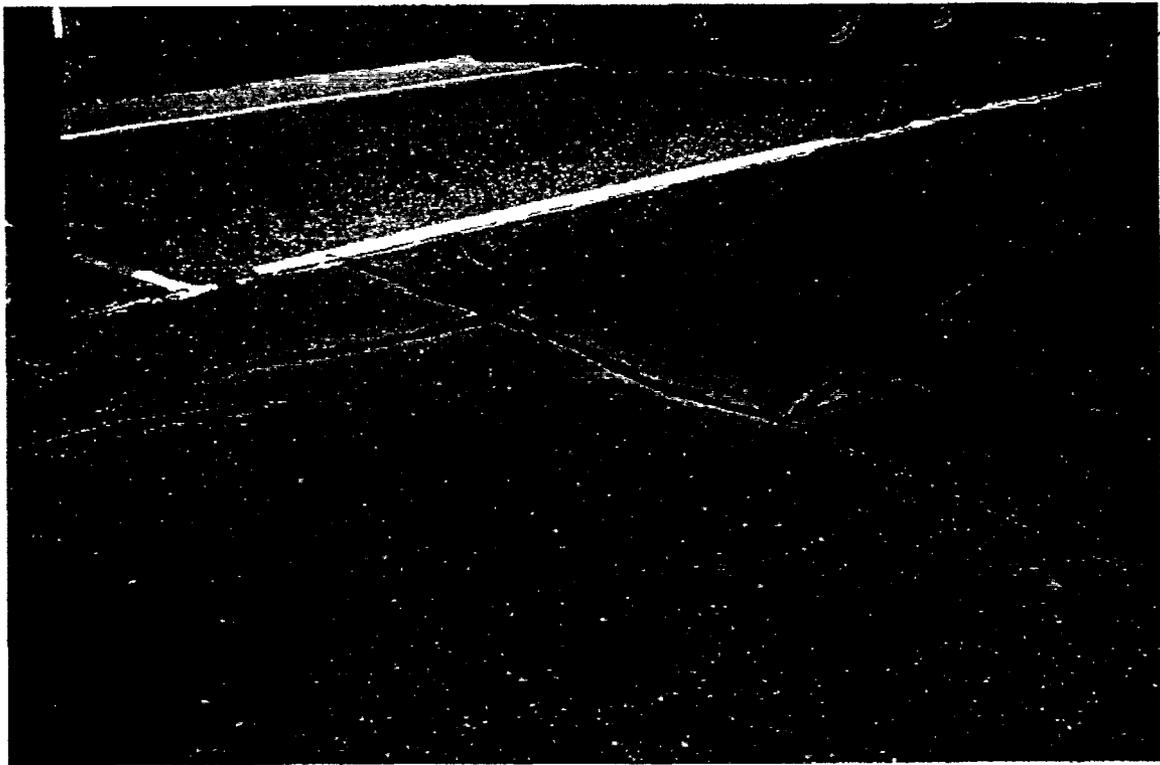
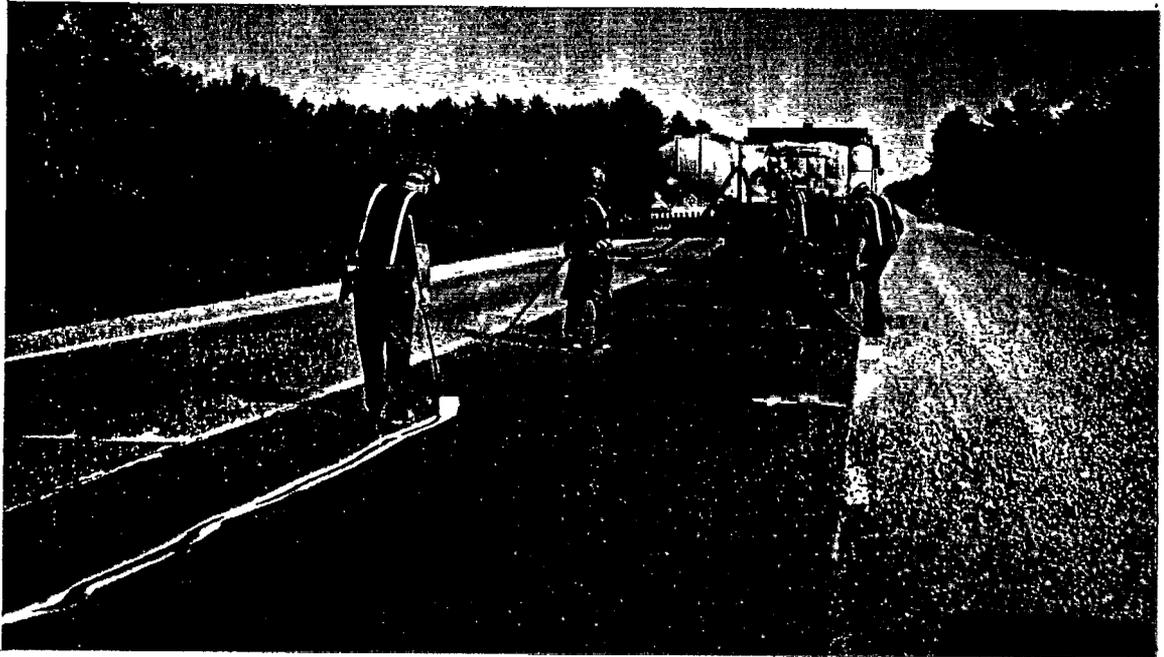
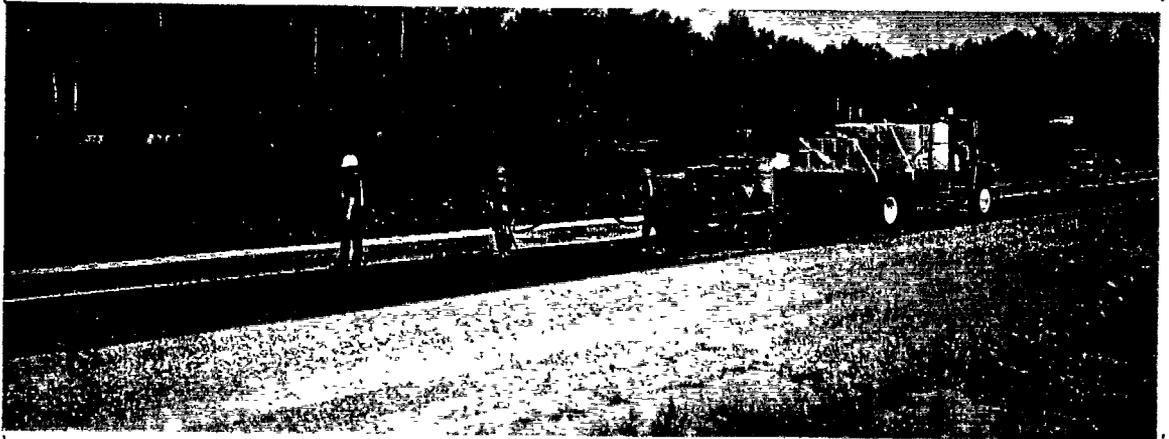
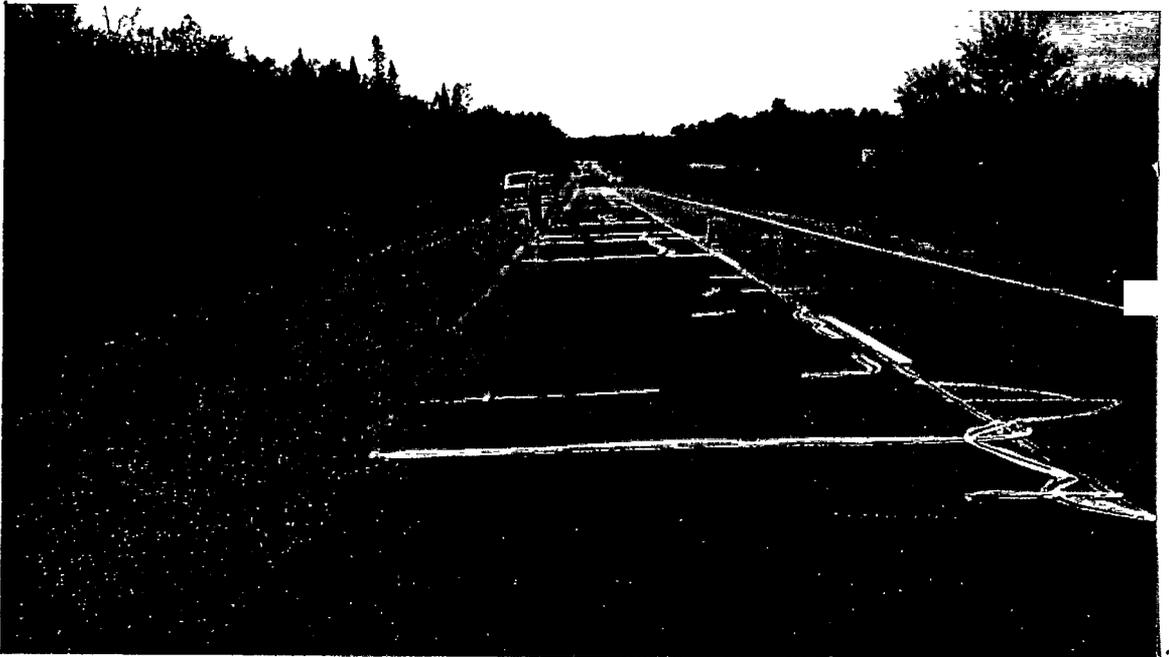
HWY. 11 BRACEBRIDGE 87B330 (PHOTOS 12 THROUGH 16)  
SHOWS COMPLETE OPERATIONS - ROUTED, CRACK FILLING,  
PLACING TOILETTISSUE AND OVERALL VIEWS

The crack routing and crack sealing operation went smoothly from start to finish. The length of the cracks in the test lane varied from a low of 189' on Highway 90 at Ocean City to a high of 1059' on Highway 400 at Moonstone. During the first half of the project the average width of routing was slightly more than 1 3/8" and the depth slightly more than 3/8". Then new blades were installed and the average width was a full 1 1/2" and the depth closer to 1/2". The sealant was placed slightly above the pavement but in general it levelled off at the pavement level. Toilet tissue was used to prevent the streaking of the sealant (photos 12 through 16, 23, 24)

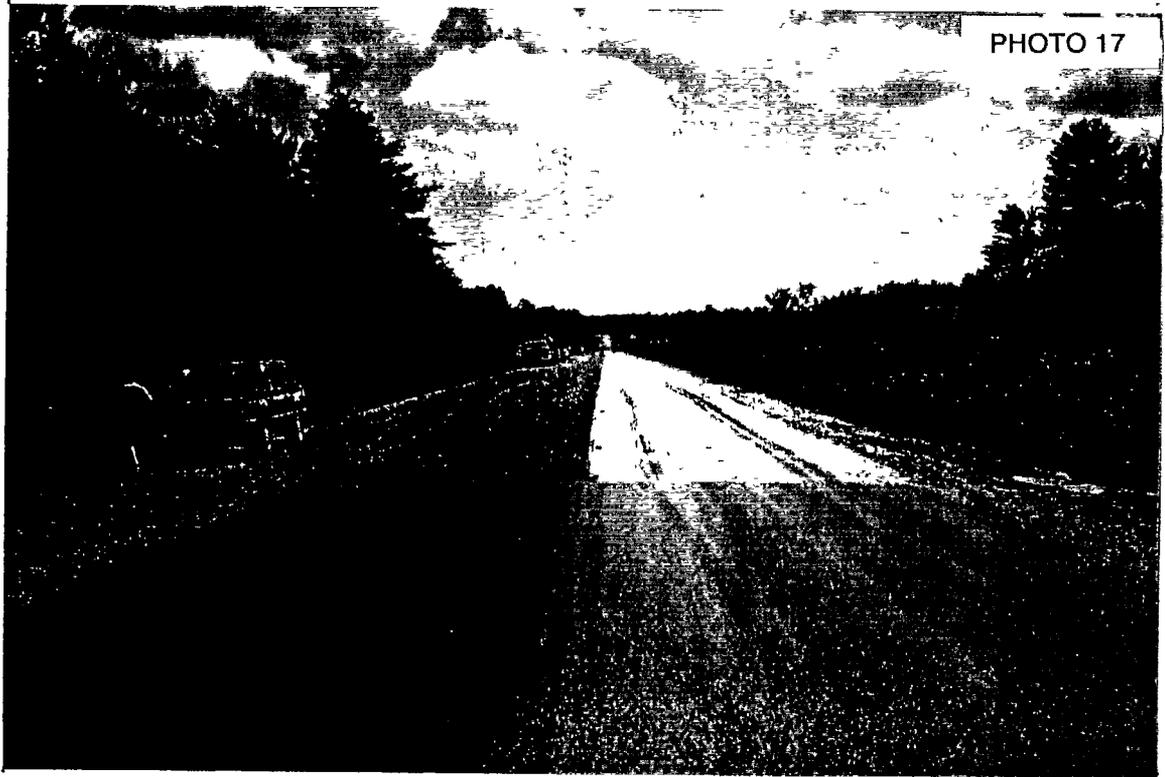
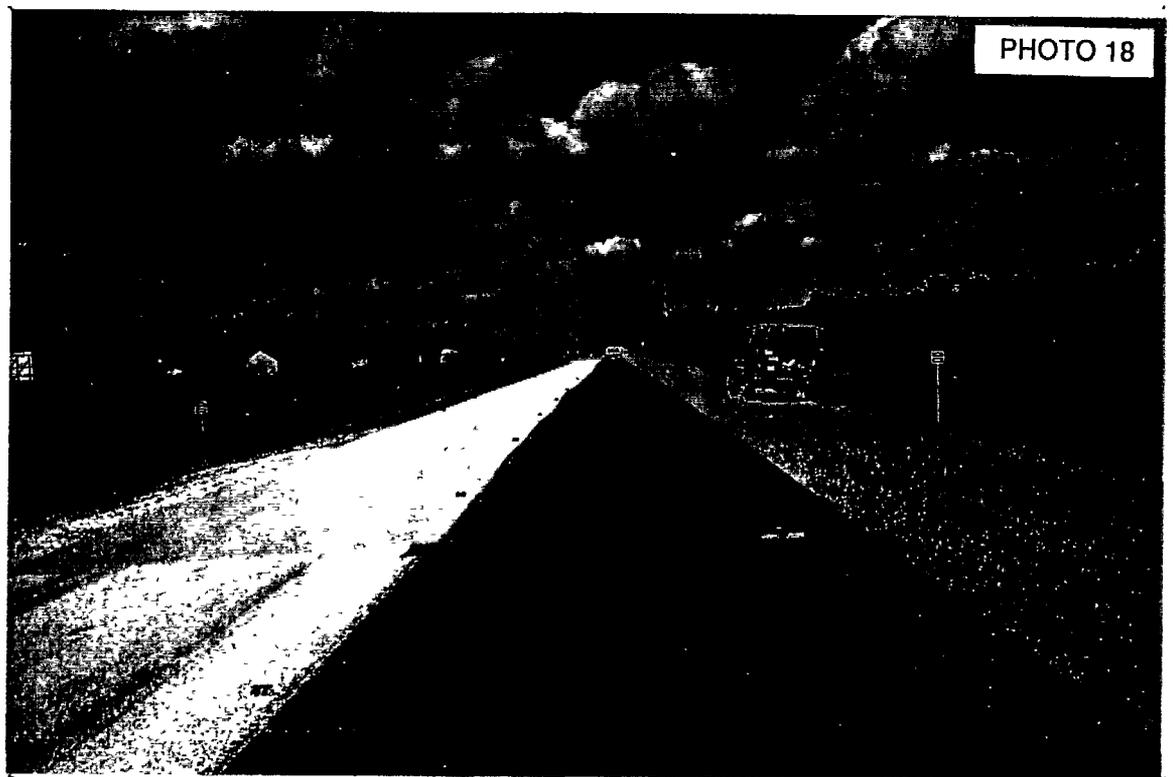
HWY. 11 BRACEBRIDGE, ONTARIO AUG. 22/90 (PHOTOS 17, 18)  
ONTARIO HAD PROBLEMS WITH THEIR EXPERIMENTAL TEST SITE (MICRO  
SURFACING) AND COVERED IT UP WITH THEIR CHIP SEAL (SMALLER  
AGGREGATE) IT ADJOINED THE SHRP CHIP SEAL SITE

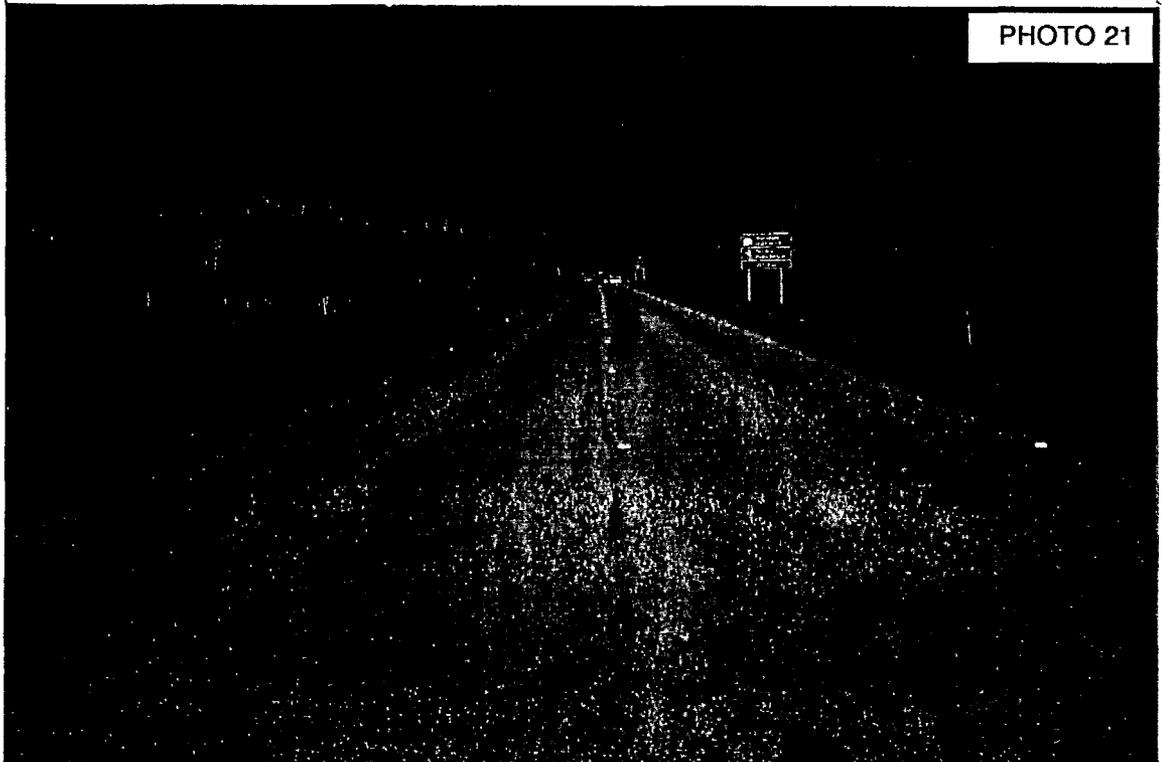
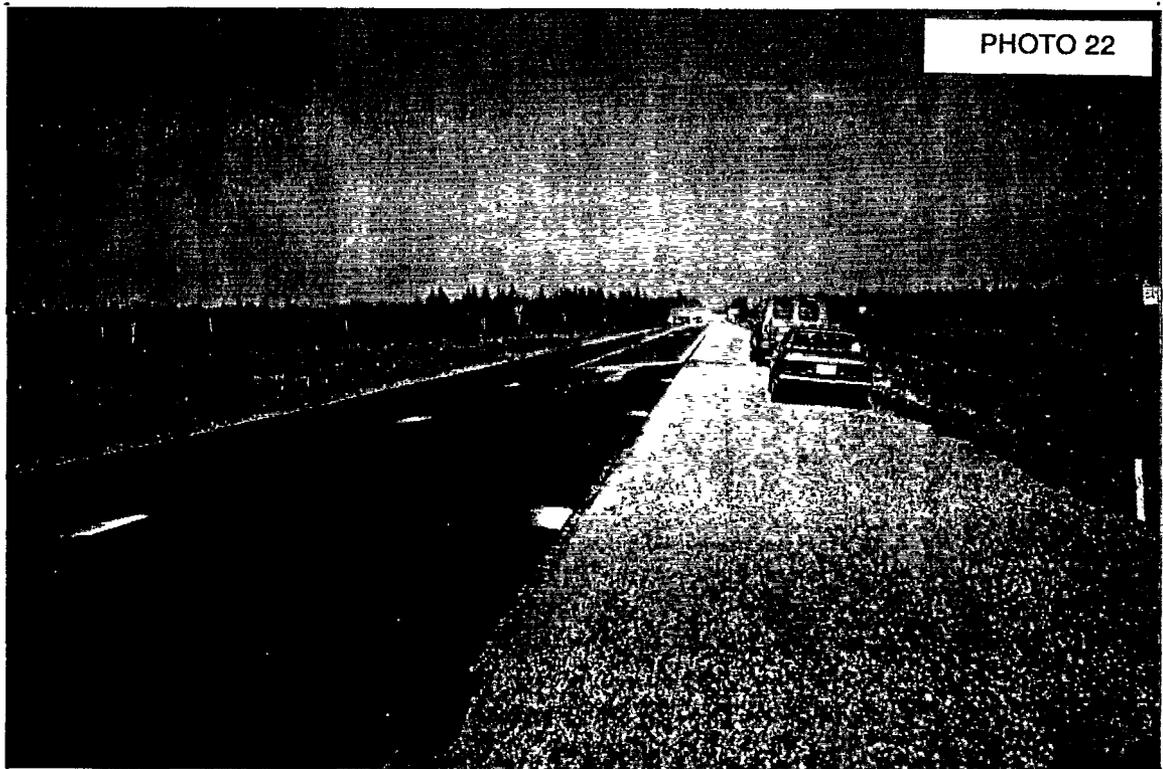
- HWY. 40 THREE RIVERS, QUEBEC 89A350 AUG. 31/90 (PHOTOS 21, 22)
1. CHIP SEAL JOB WAS CONSIDERED GOOD – BUT NOTE THE DARKENING OF THE WHEEL PATHS IN THE TRIAL LANE
  2. SLURRY SEAL WAS GOOD BUT NOW OUT OF AGGREGATE AT 4+75 OF THE TEST LANE

This new batch on August 27 did not set up quickly either, so it was decided due to scheduling limitations to forego the chip seal treatment on Highway 11 and move to Three Rivers, Quebec on Highway 40 89A300 (photos 21 and 22).

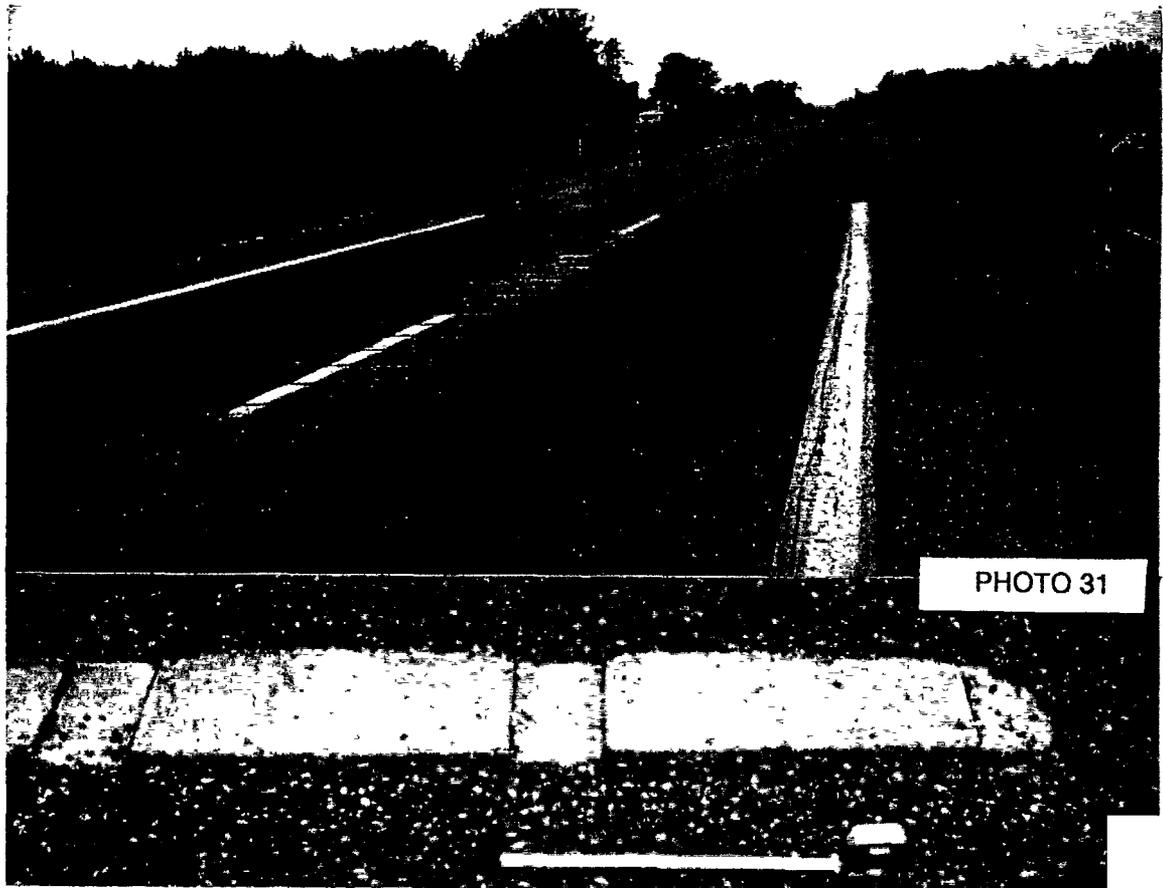
HWY. 90 OCEAN CITY, MD 24A350 SEP. 12/90 (PHOTOS 31, 32)  
PROBABLY THE SMOOTHEST SITE OF ALL. CHIP SEAL WAS PLACED DIRECTLY  
OVER RUMBLE STRIPS WHICH WILL BE ROUTED. EVIDENCE OF RUMBLE STRIPS  
IN CHIP SEAL TREATMENT

This was the smoothest test of all. The rumble strips will be rerouted and the tapes covering the reflectors will be found and removed. No brooming was done.

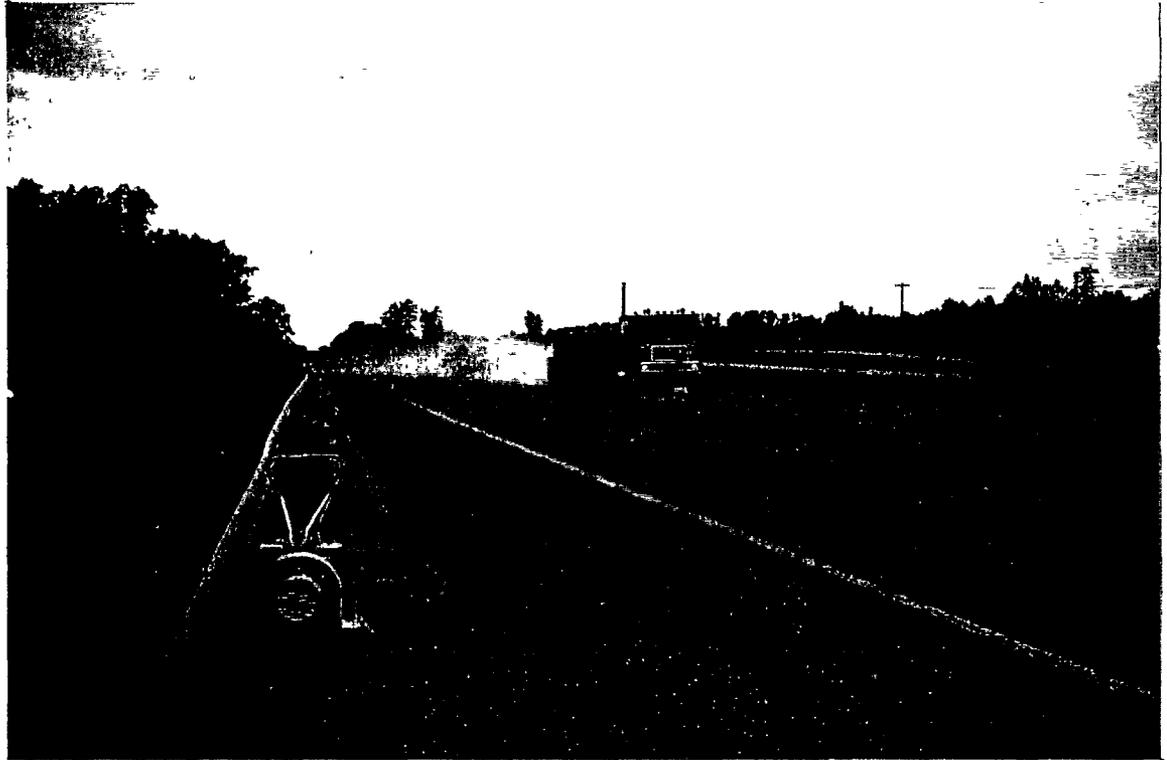
HWY. I-95 PETERSBURG, VA 51A350 SEP. 18/90 (PHOTO 33)  
THIS PHOTO IS THE RESULT OF EXCESSIVE CHIP AND LATE ROLLING

This section could not have been done on Friday or Monday because of heavy traffic. Everything was going nicely until we came to the chip seal on the test lane. The chips were bunching up at the center and the spreader was stopped for eight minutes before continuing. The rolling was also stopped for 46 minutes to allow the contractor to level out the chips. When it was opened to traffic, there were a lot of loose chips. It was being knocked about with traffic and a lot of dust was created. Doug Mahone from Virginia Council has all of this on video.

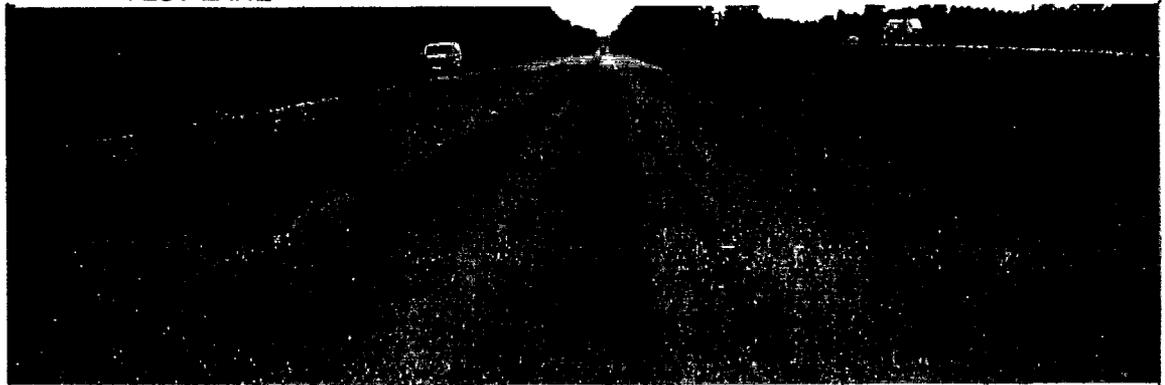
PHOTO 36  
AN AREA WITH LOSS OF AGGREGATE  
TEST LANE

From here on the chip seal treatment performed well except for the Highway 147 Lewisburg, PA site 42A350. Here the trial lane did not set up quickly as expected so a new batch was brought in for the test lane the next day. No further emulsion problems were experienced (photos 25 through 30). However, a major chip seal problem developed on Highway I 95 Petersburg, VA. Here there was a malfunctioning of the chip spreader and the chips were not placed until about three quarter of an hour after the emulsion was sprayed. There was a considerable amount of dust flying chips at this site when it was opened to traffic (photo 33). It is not expected that this treatment will survive for very long (photos 34 through 37).

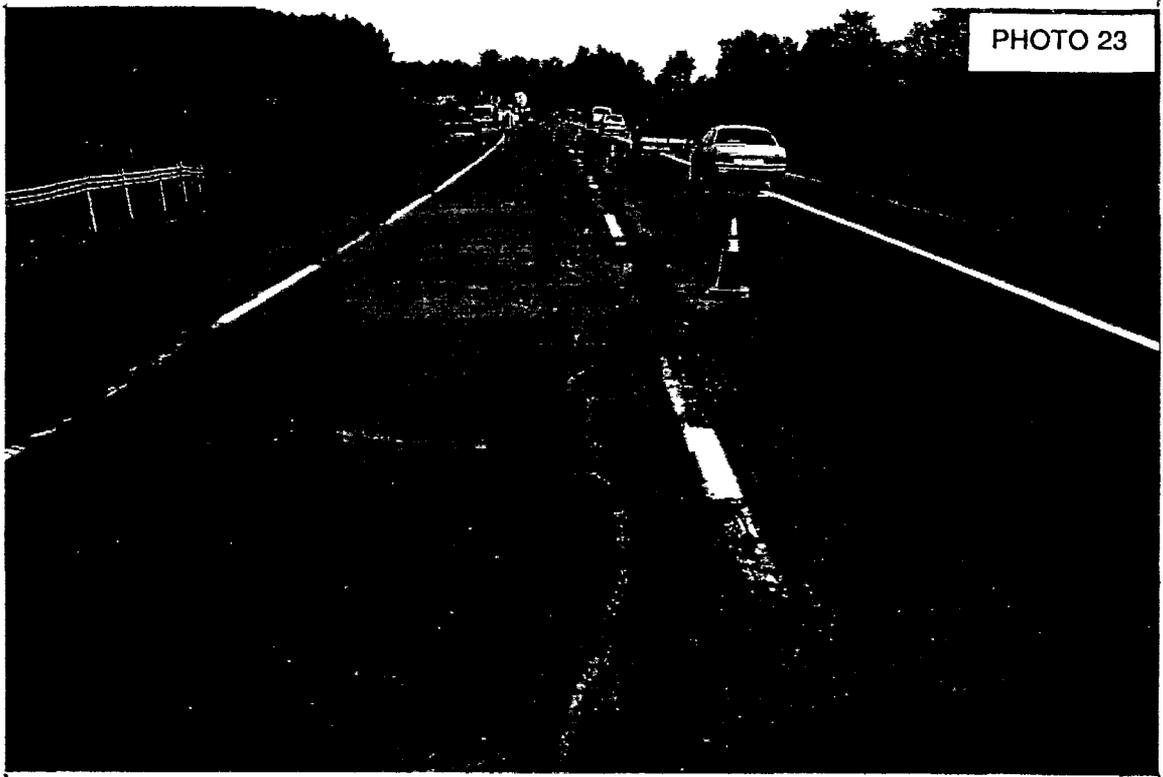
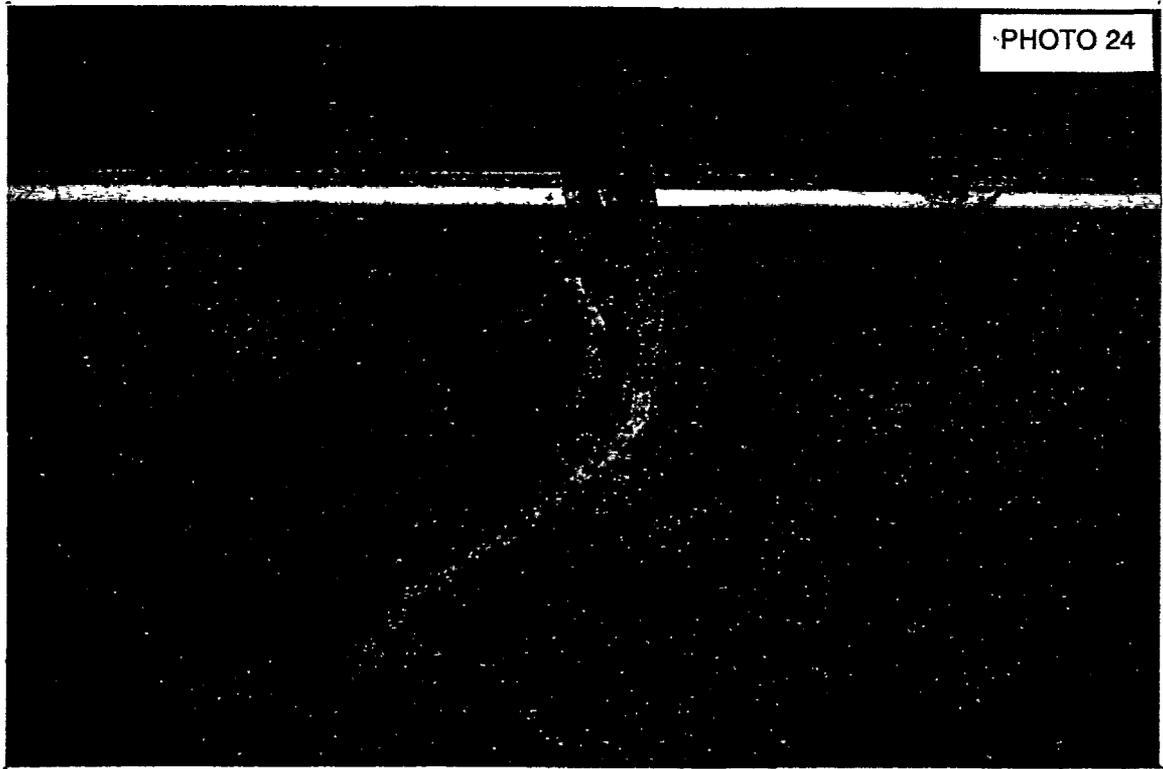
HWY. 4 FORT ANN 36A330 SEP. 06/90 (PHOTOS 23, 24)  
TRIAL LANE AND CENTER LINE HAD BEEN PREVIOUSLY CRACK FILLED  
WITH A SQUEEGEE TYPE EQUIPMENT. CRACK FILLER IS WELL  
SPREAD OUT - ALL CRACKS VISIBLE WERE ROUTED AND SEALED

- Sep. 06/90  
36A300  
Fort Anne  
Hwy. 4 September 5 looked as if it might rain, so construction was postponed until today. All test sections went smoothly. It should be noted that crack seal trial lane including the center line had been cracked filled previously. Most of the cracks if they were visible were routed and sealed. This previous sealing had spread out up to 6" or more. Tom Wolschied came in the afternoon and Suit-Kote was well represented by Frank and Dan Suits, Rod Birdsall and Margaret the public relations officer who took a lot of video.

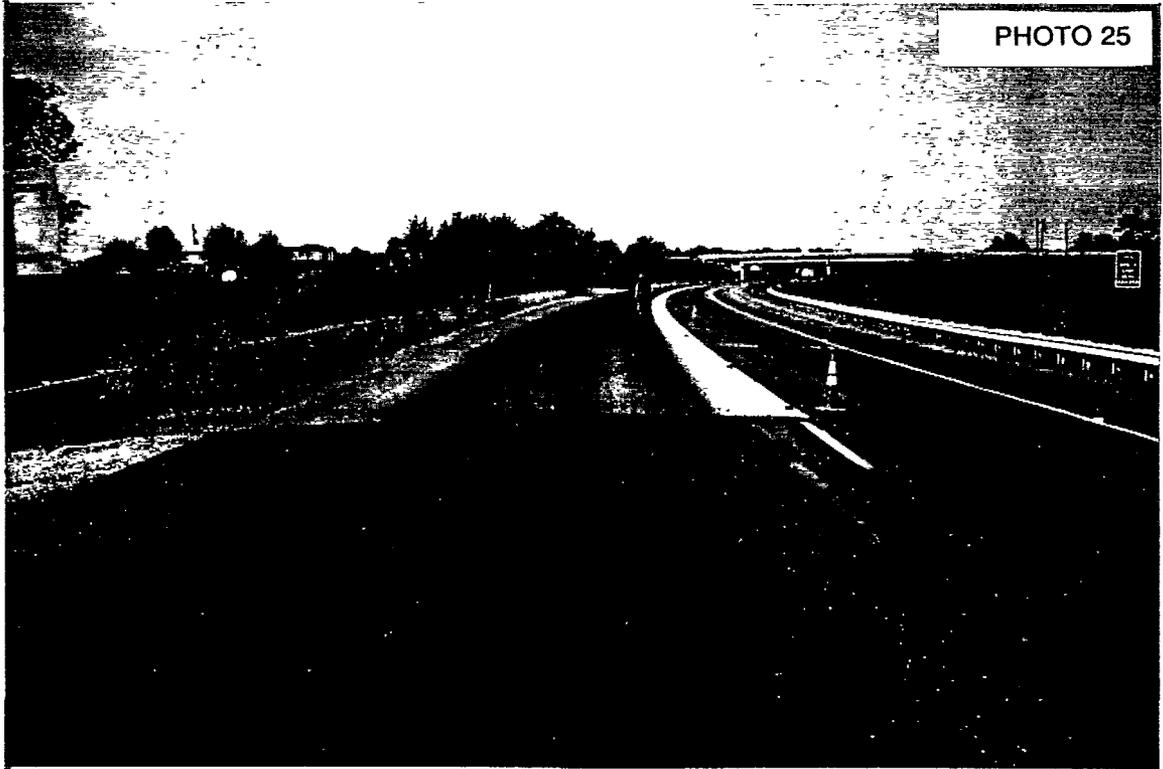
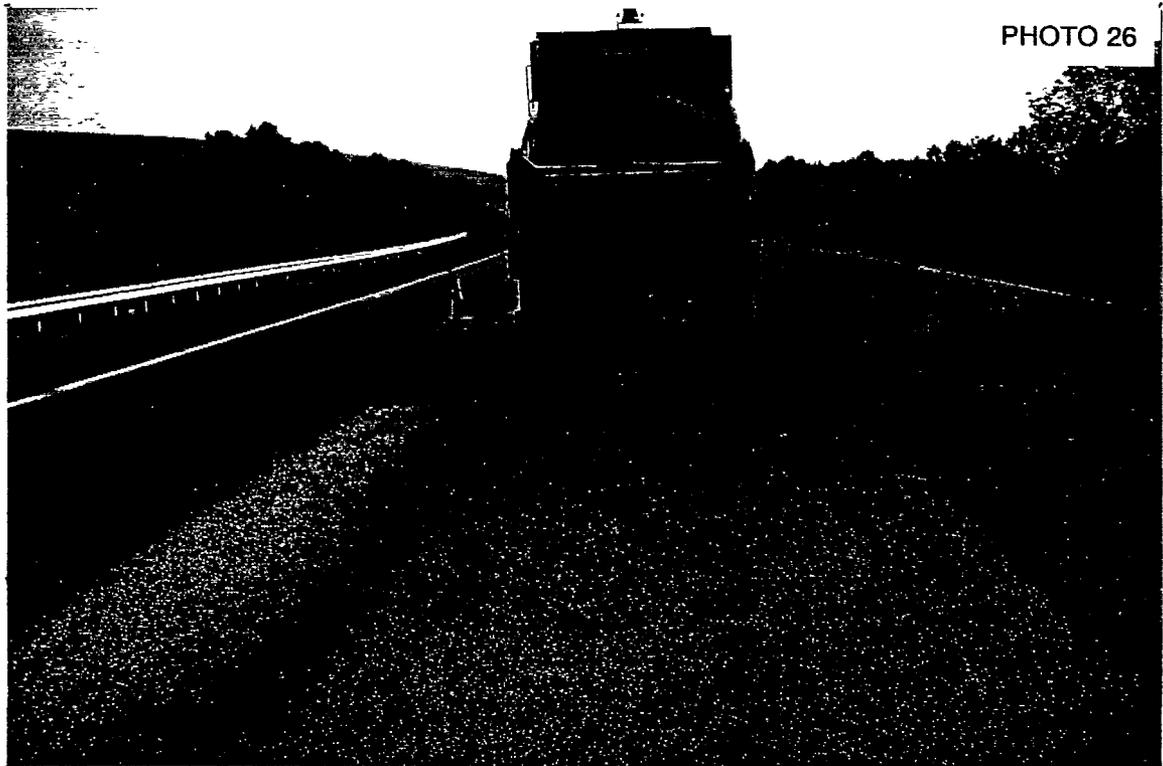
HWY. 147 LEWISBURG, PA 42A350 SEP. 10/90 (PHOTOS 25, 26)  
TRIAL LANE WAS SOFT AND DARKENING UNDER WHEEL PATHS.  
PLACED SAND TO STOP IT FROM TRACKING

- Sep 10&11/90  
Hwy. 147  
42A300  
Lewisburg
- We laid out the test sites and Dan Sheftick had taken the condition surveys last May so they did not have to be redone. The trial slurry seal and crack sealing went down smoothly but the chip seal did not set up too quickly. Traffic was allowed on the trial lane and the slurry and crack filling was carried out on the test lane. Butch decided that a new emulsion had to be obtained for the chip seal. A new blade was inserted into the router and the crack widths are now generally a full  $1\frac{1}{2}$ " and the depths average closer to  $\frac{1}{2}$ "
