**SPS-3 CONSTRUCTION REPORT**  
SHRP North Atlantic Region

October 1990

## SPS-3 CONSTRUCTION REPORT North Atlantic Region

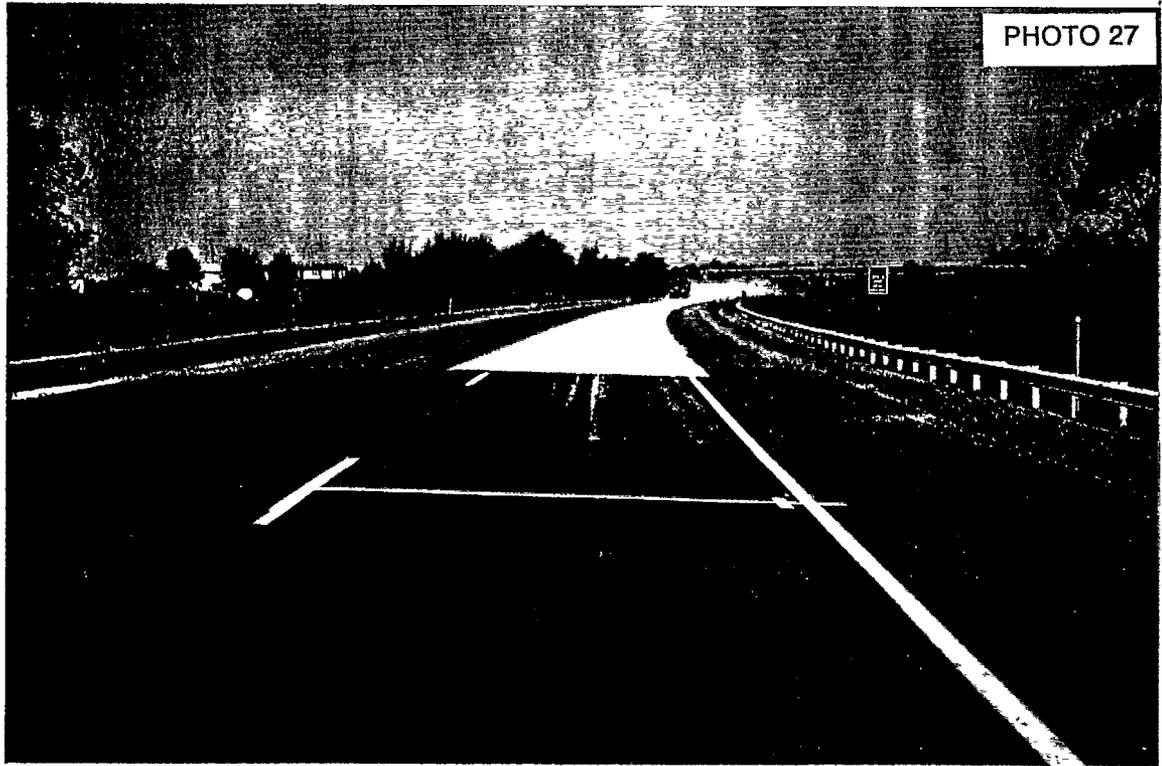
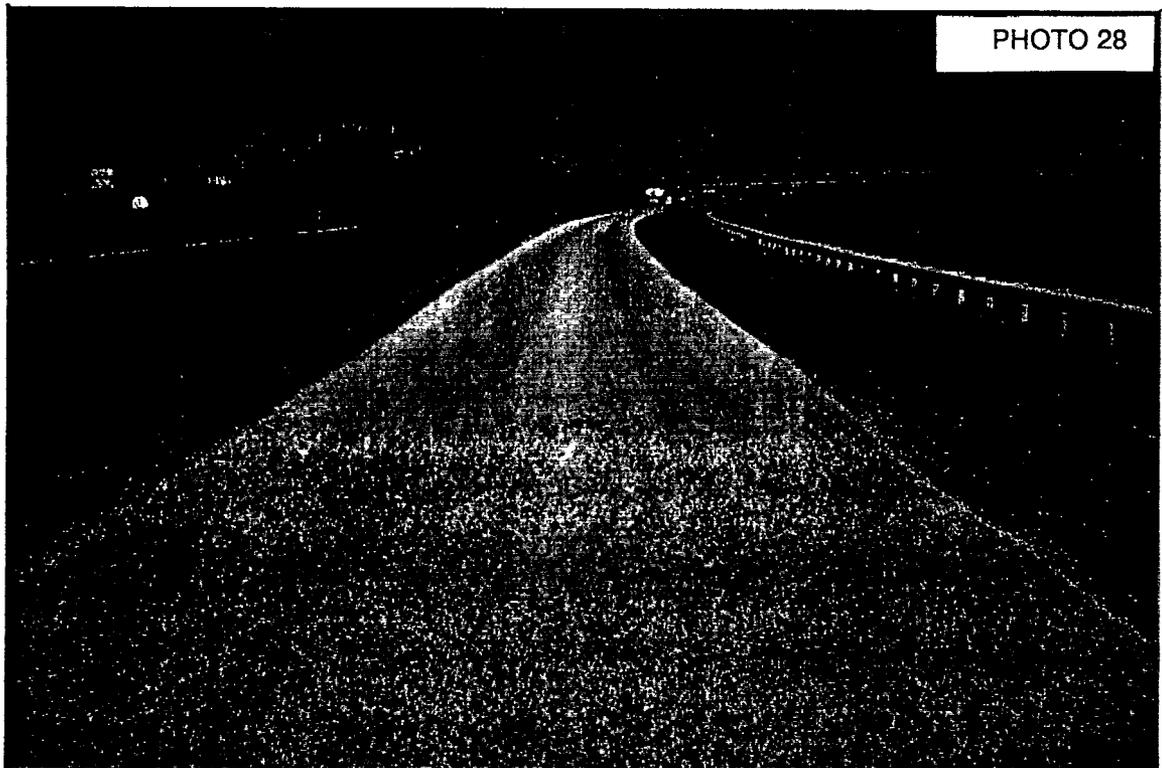
HWY. 147 LEWISBURG, PA 42A350 SEP. 11/90 (PHOTOS 27, 28)  
THE TEST LANE WAS PLACED ONE DAY AFTER THE TRIAL LANE. NOTE THE  
CONTRAST IN COLOR (A NEW EMULSION)

- Sep 11/90
- A new emulsion was obtained and placed. It was very foggy until 10 00 am. It was placed at 11 30 and open to traffic at 1 15 pm before everyone headed for Ocean City, MD. It should be noted that rutting is very noticeable. Dan had the skid tester check the skid resistance of the trial chip seal and it was OK.

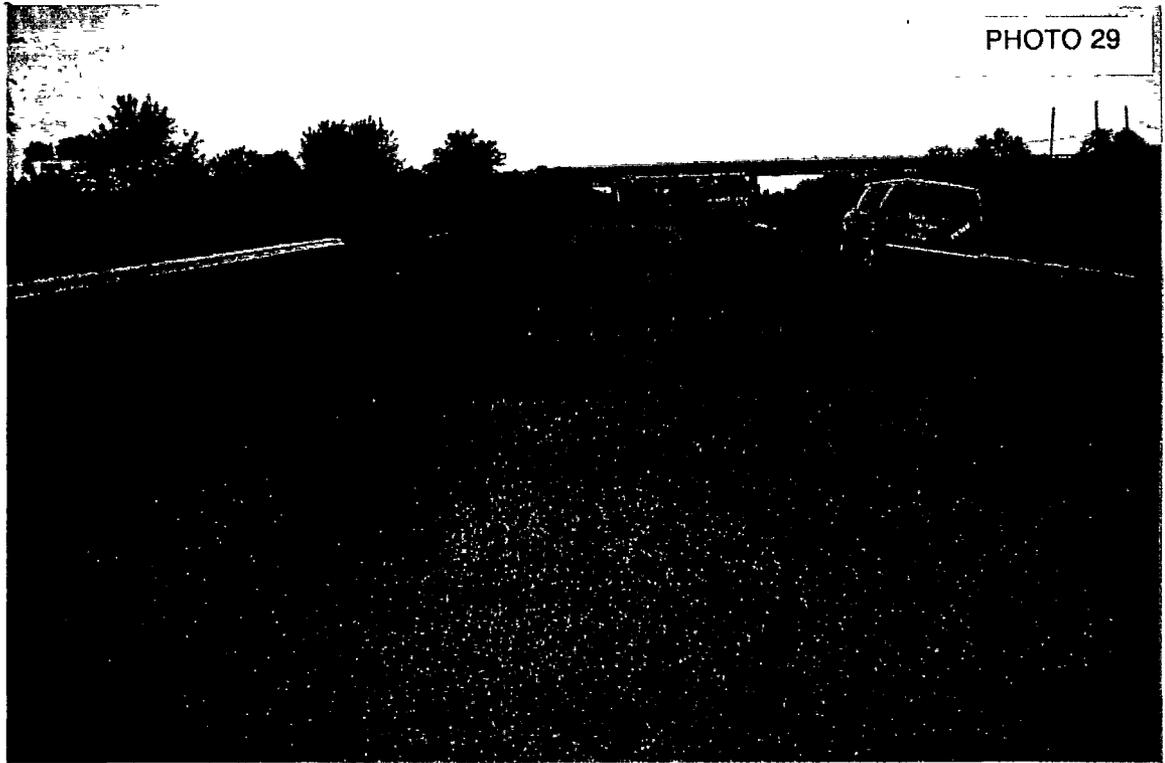
HWY. 147 LEWISBURG, PA 42A350 SEP. 20/90 (PHOTOS 29, 30)  
NINE DAYS AFTER TREATMENT, THERE IS STILL A CONTRAST IN COLOR. THE  
PHOTO BELOW IS THE STATE CHIP SEAL. IT IS DARKER AGGREGATE  
AND LAID IN THREE PASSES, WHICH IS THE REASON FOR THE TWO STREAKS

- the chip seal in the trial lane was much darker throughout than the test lane with it being slightly darker under the wheel paths.
- the test lane was light colored and uniform throughout.
- rutting was still very obvious.
- the state chip seal section adjacent to the SHRP using darker and smaller aggregate was very good. Two streaks were present caused by the overlap.
