**FEDERAL HIGHWAY ADMINISTRATION**

Long Term Pavement Performance  
Specific Pavement Studies

**California SPS-5**

**CONSTRUCTION REPORT ON SECTION 060500  
CALIFORNIA DEPARTMENT OF TRANSPORTATION**

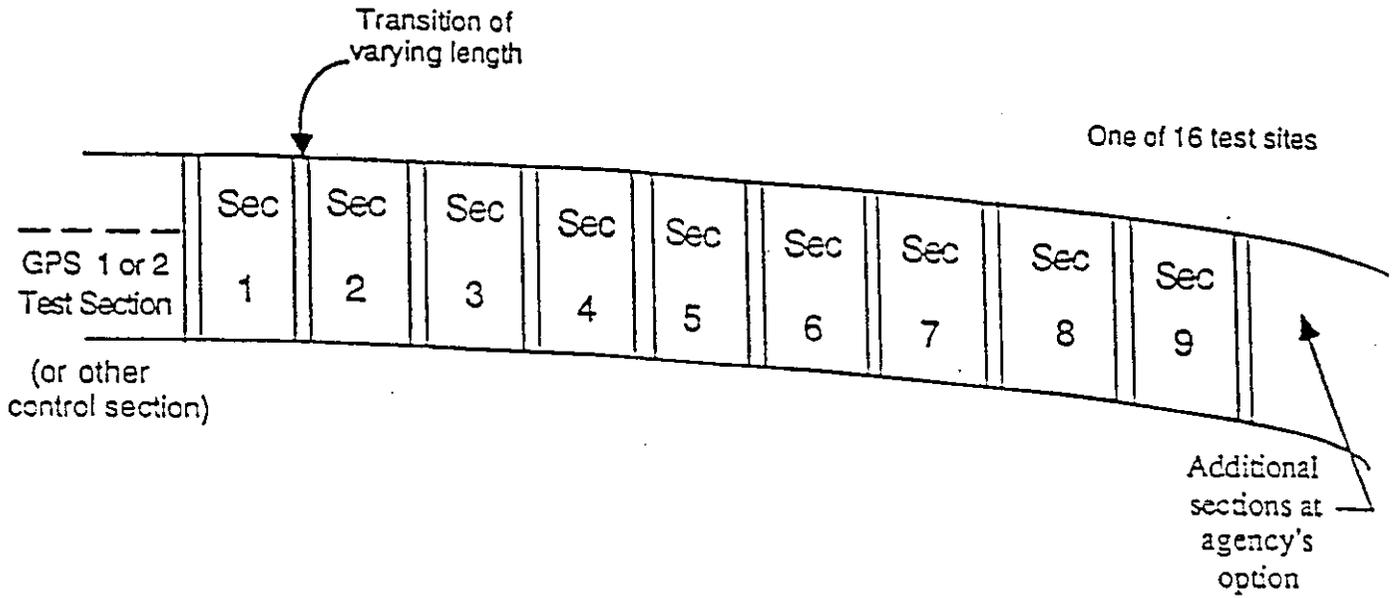
Figure 1. Experimental Design for SPS-5, Rehabilitation of Asphalt Concrete Pavements

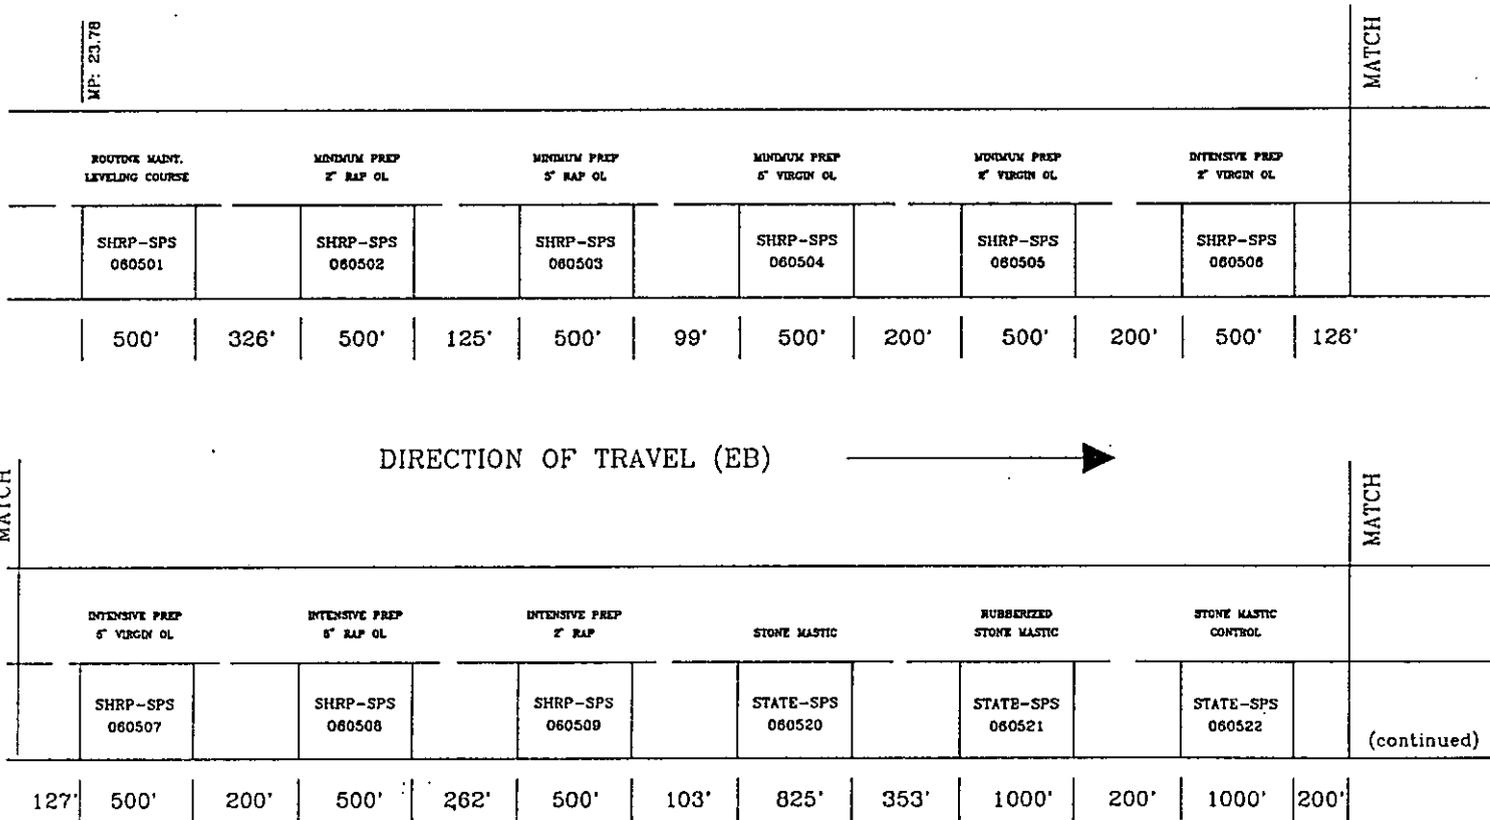
SPS-5 SHRP TEST SECTION LAYOUT  
 060500, EAST OF BARSTOW, CALIFORNIA  
 I-40 EASTBOUND

Figure 2a. Test Section Layout, California SPS-5

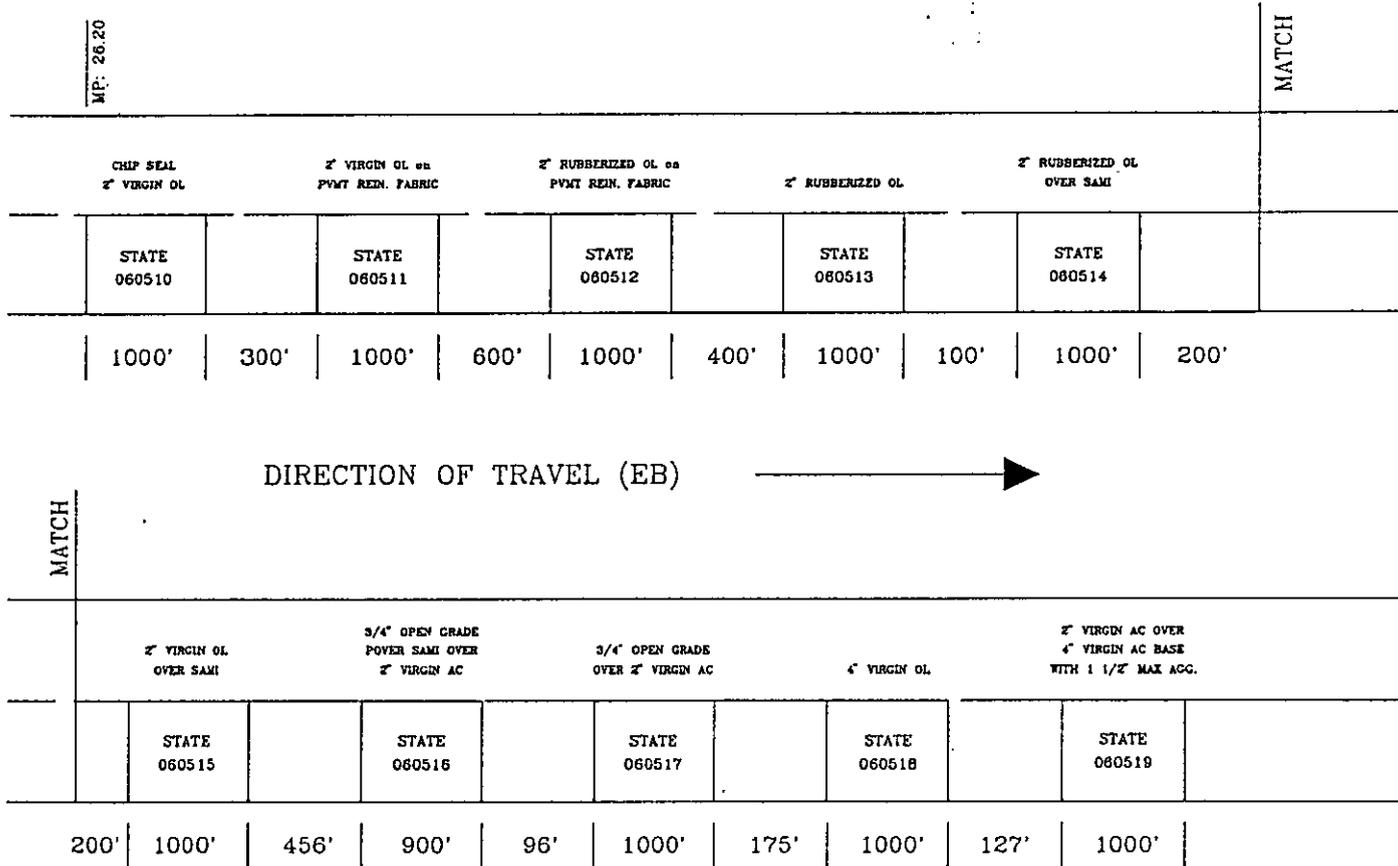
SPS-5 CALTRANS TEST SECTION LAYOUT (continued)  
 060500, EAST OF BARSTOW, CALIFORNIA  
 I-40 EASTBOUND

Figure 2b. Test Section Layout, California SPS-5 (cont.)

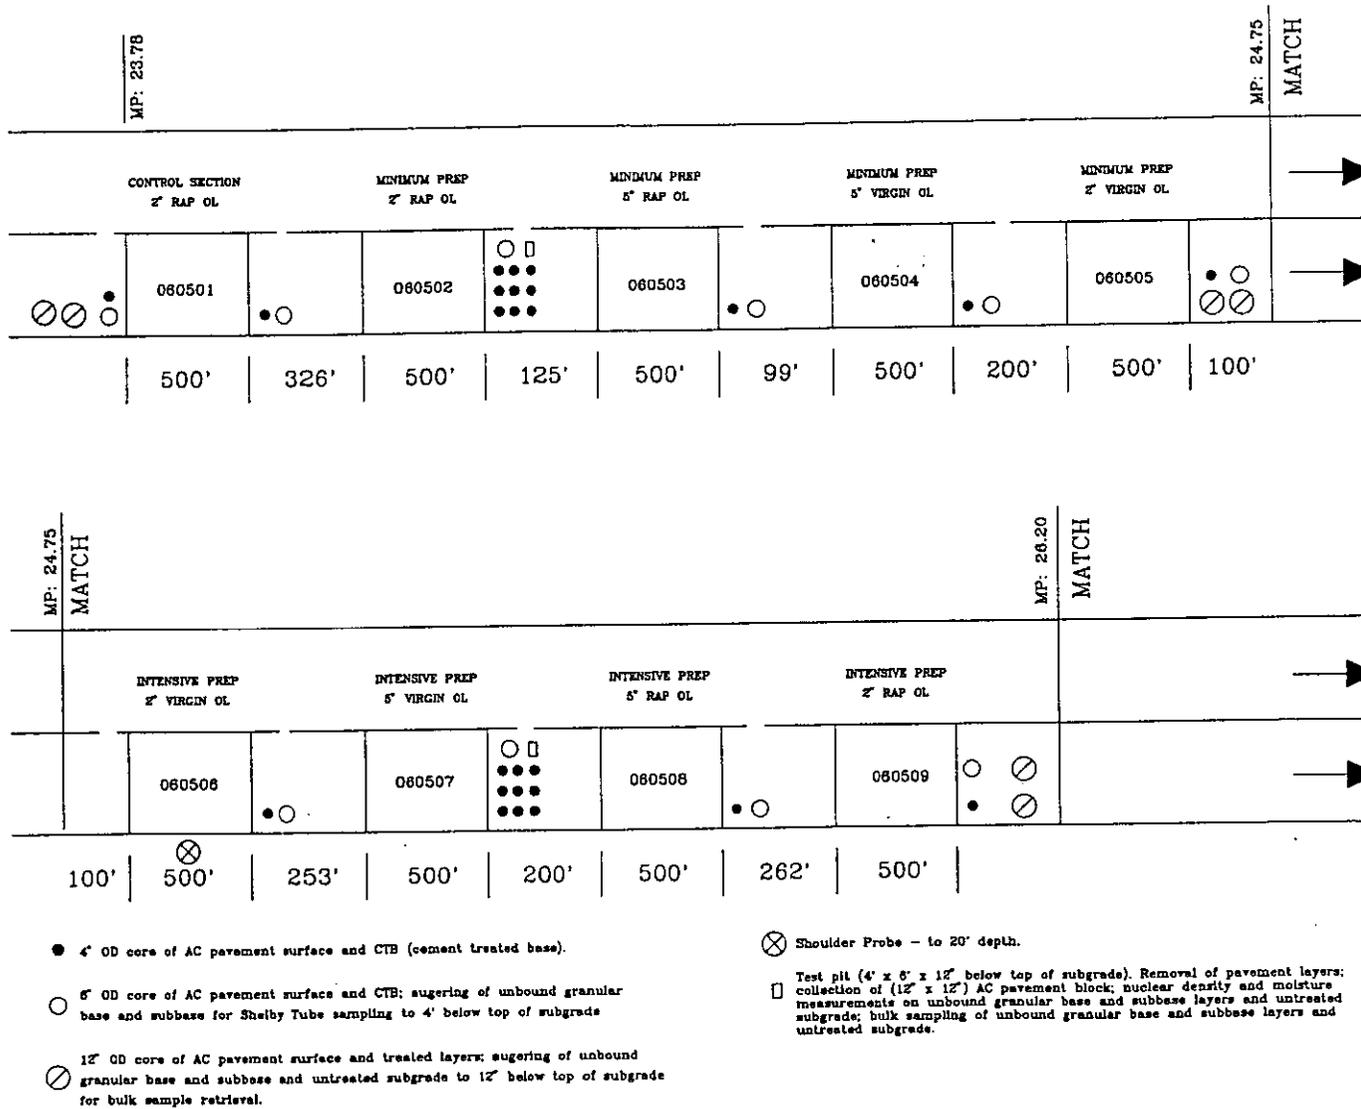
Figure 3A Pre-Construction Sampling Layout

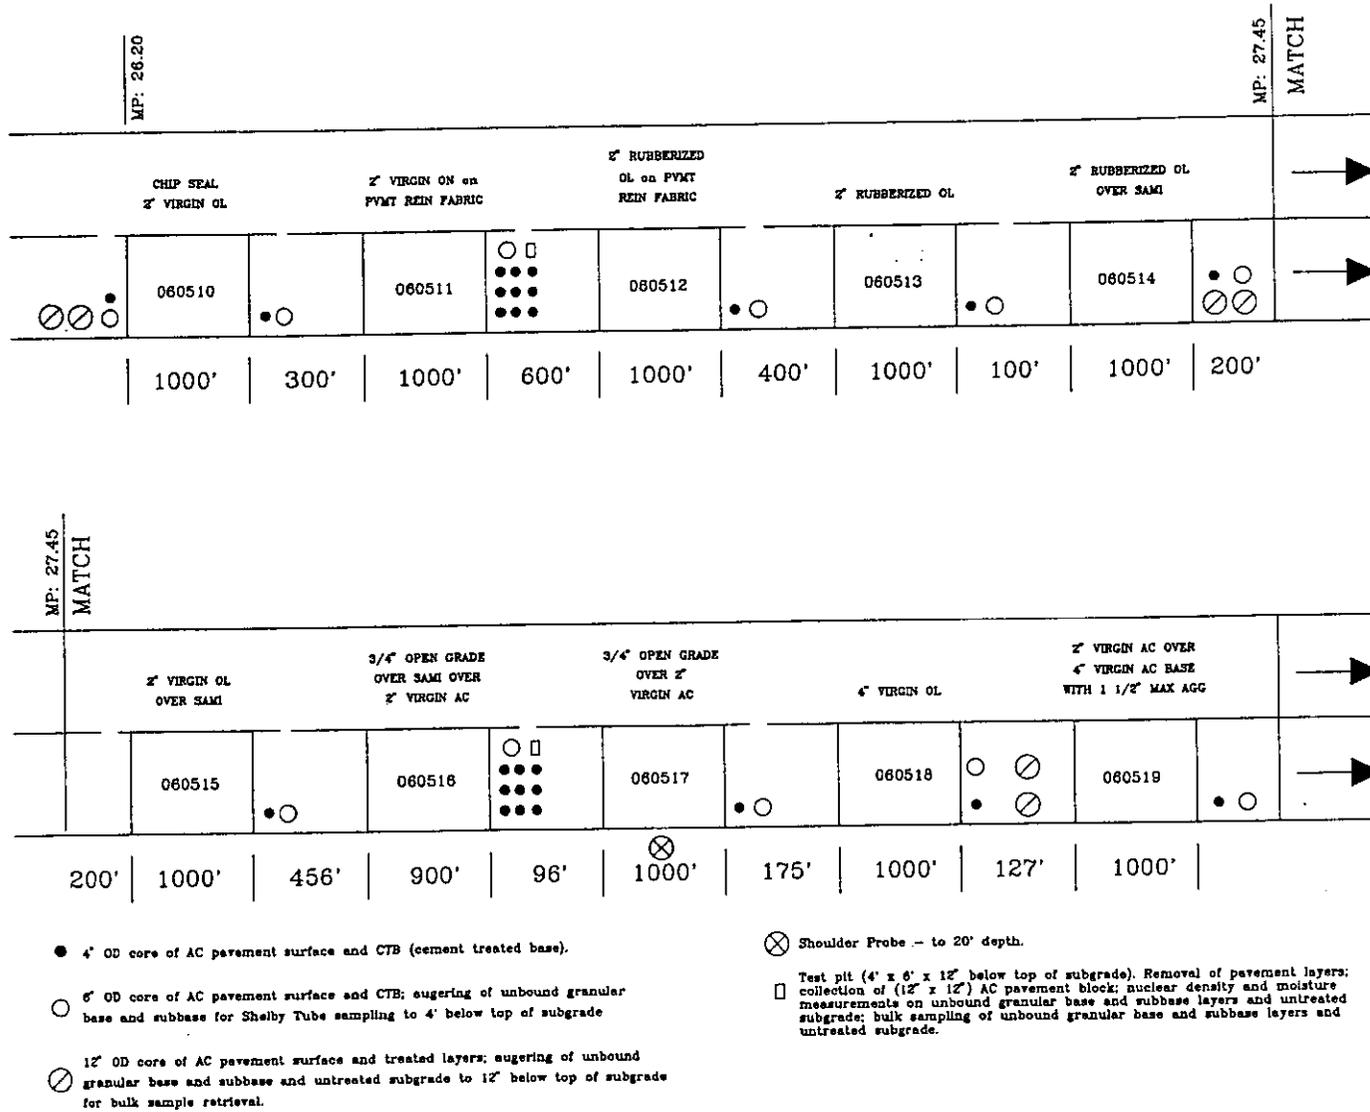
Figure 3B Pre-construction Sampling Layout (cont.)

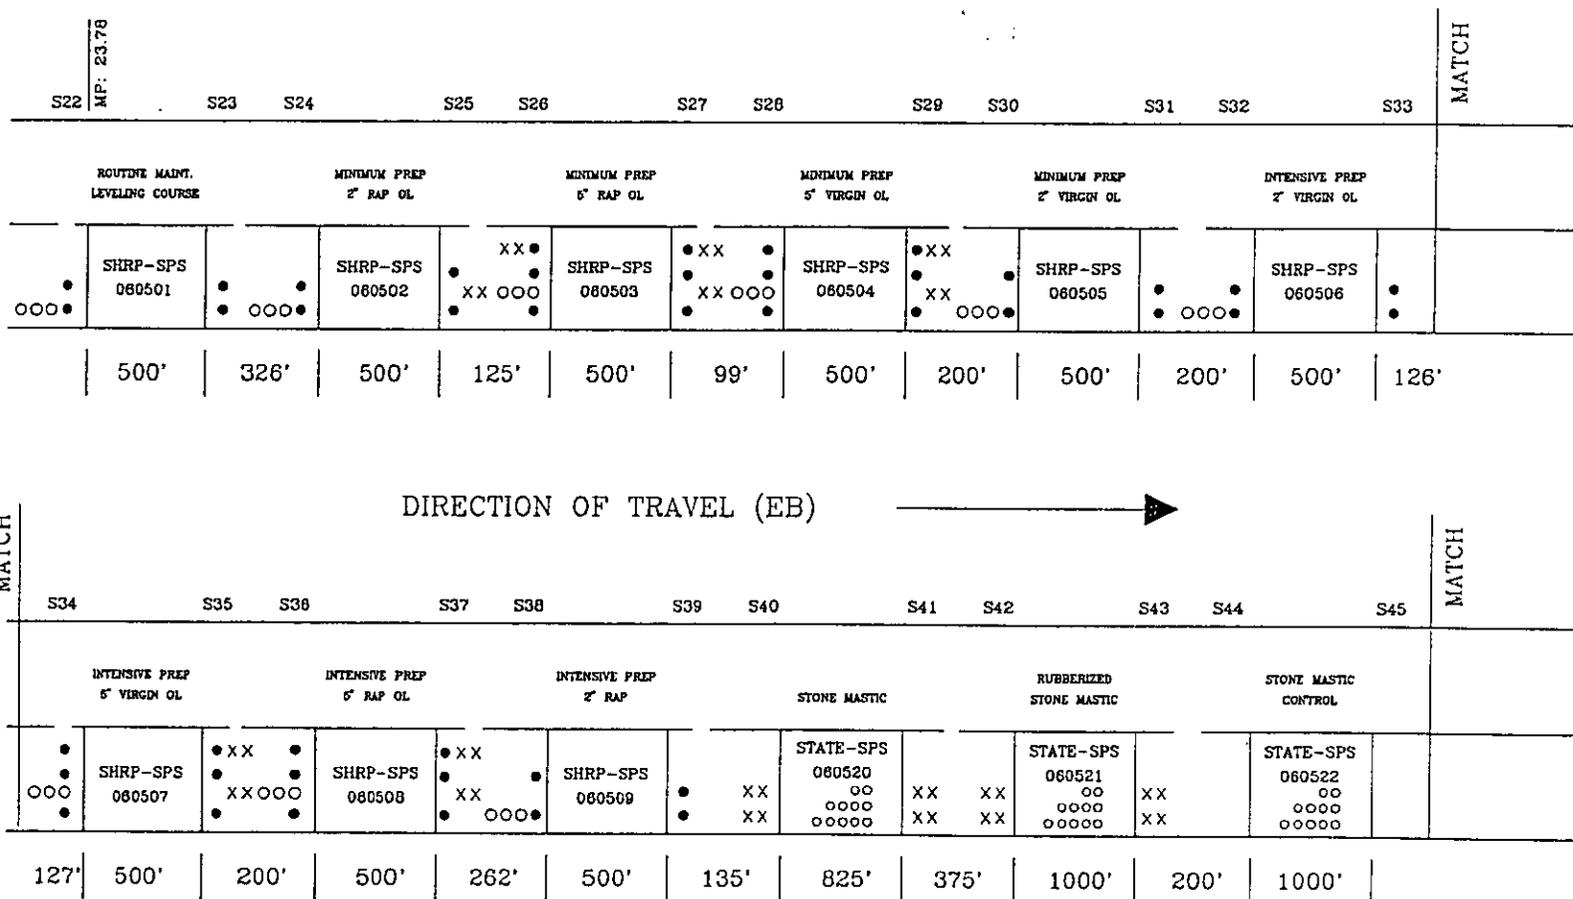
SPS-5 POST CONSTRUCTION SAMPLING LAYOUT  
 060500 I-40, EAST OF BARSTOW, CALIFORNIA  
 EASTBOUND

- 4 inch cores for SHRP-LTPP
- x 6 inch cores for Berkeley
- o 4 inch cores for CalTrans

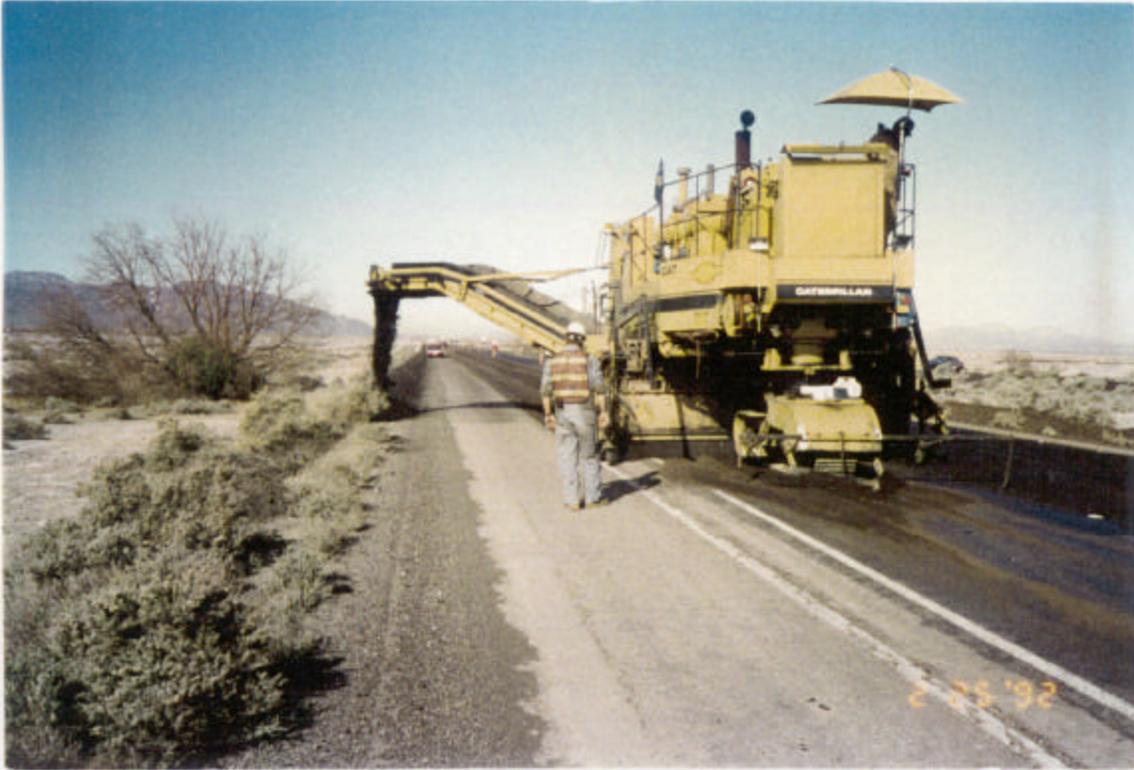
**Figure 6. Milling Operations**

Minimum preparation consisted of cold milling the open graded friction course, while intensive preparation consisted of cold milling 2 inches of the entire surface layer. It should be noted that

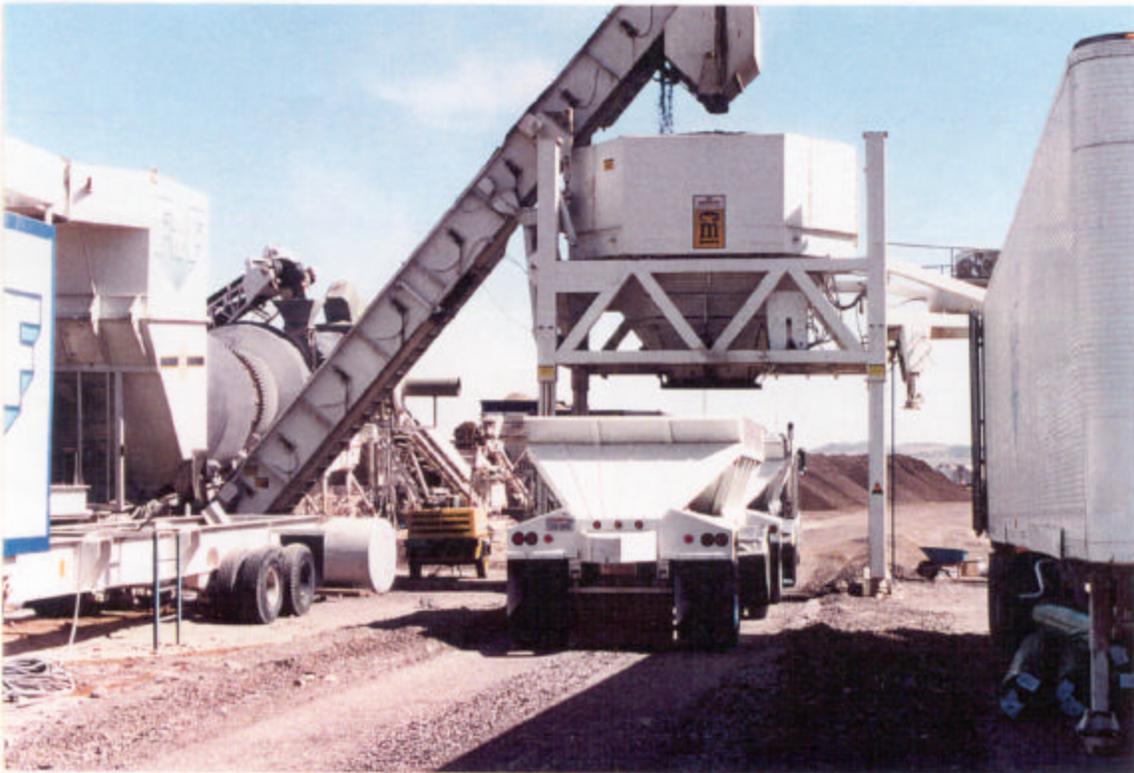
**Figure 7. CMI AC Hot Plant**

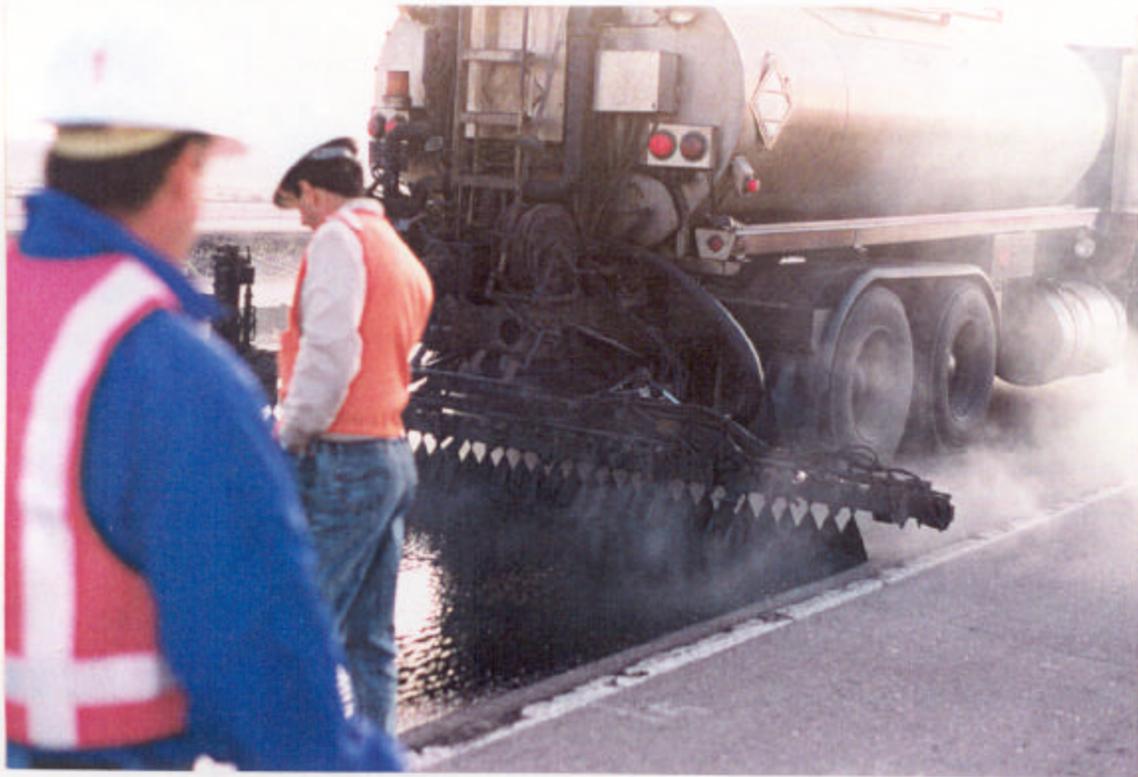
**Figure 8. Tack Coat Prior to Placement of the Pavement Reinforcing Fabric**

*Passing Lane.* Milling and trench replacement paving were completed prior to the arrival of SHRP Representatives. April 22, the PRF was placed at 3:32 PM on a tack coat applied at 0.25 gallons per square yard. The PRF was placed 35 feet prior to station 0+00. April 22, after a tack coat application, virgin overlay paving started at 5:05 PM and ended at 5:52 PM. During

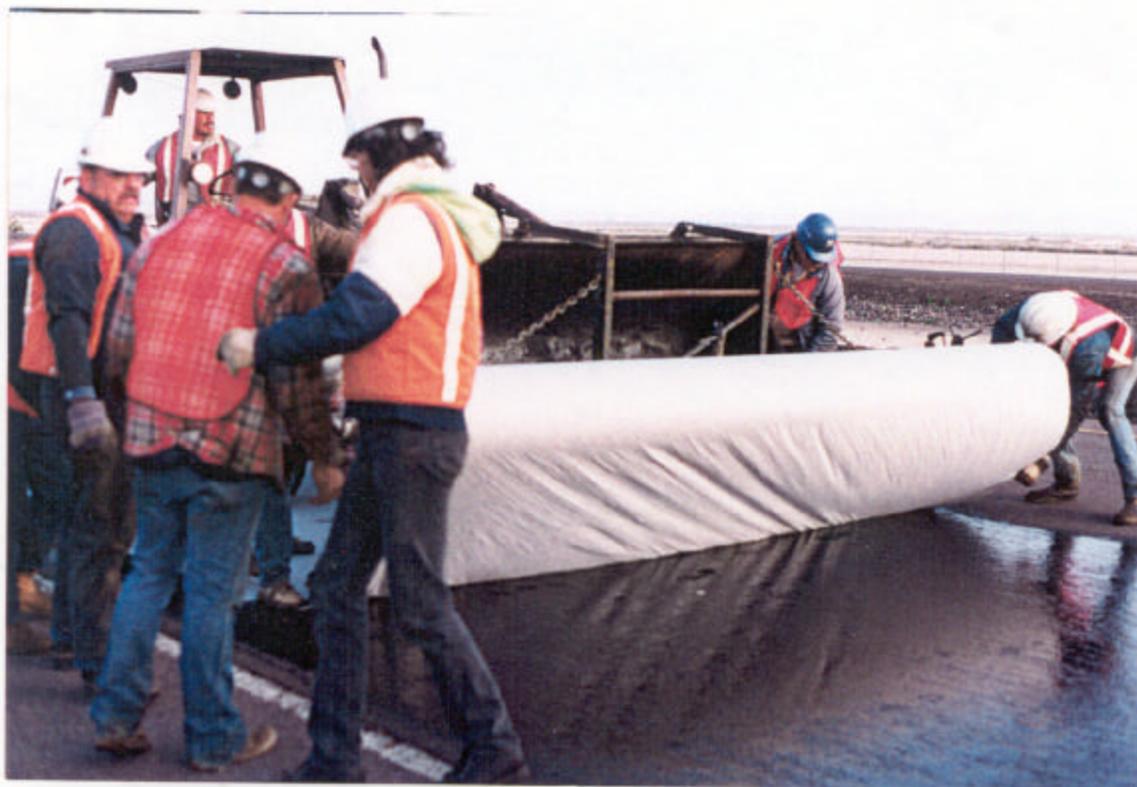
**Figure 9. Placement of the Pavement Reinforcing Fabric**

virgin overlay paving the paver slipped on the PRF, resulting in torn fabric at stations 4+00 and 8+00. However, the PRF tearing was not significant. The average windrow and laydown temperatures were 274°F and 248°F, respectively. Loose lift thicknesses ranged from 2.9" to 3.1", averaging 3.0".

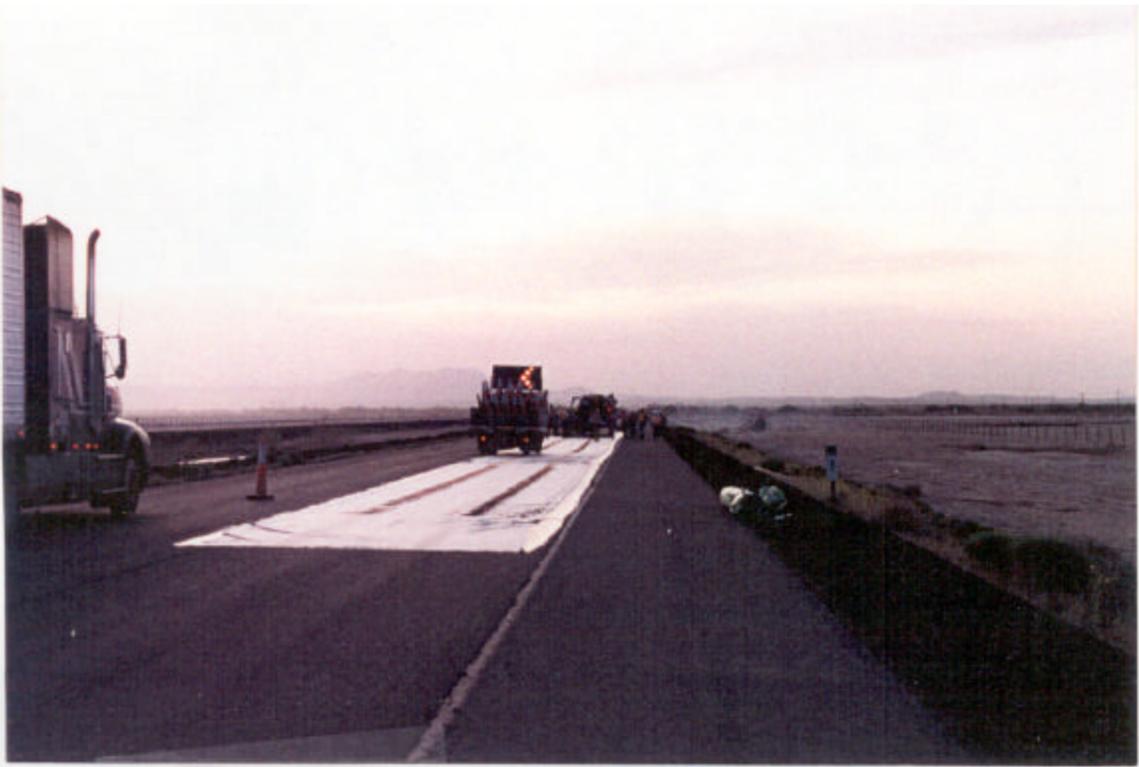
**Figure 10. Pavement Reinforcing Fabric in Place**

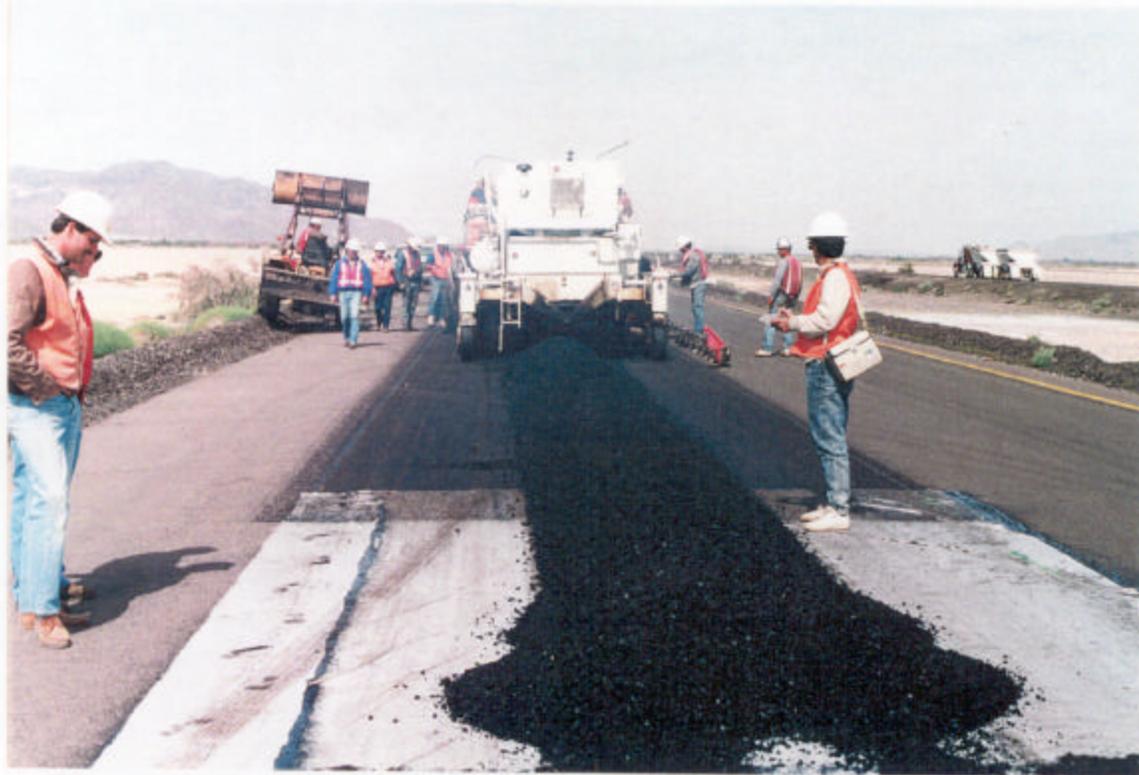
**Figure 11. Rubberized AC Windrow over the Pavement Reinforcing Fabric**

***Passing Lane.*** Milling and trench replacement paving were completed prior to the arrival of SHRP Representatives. April 22, the PRF was placed. PRF placement extended 35 feet beyond station 10+00. The same day, rubberized overlay paving started at 6:24 PM and ended at 7:45 PM. The average windrow and laydown temperatures were 286°F and 259°F, respectively. Loose lift thicknesses ranged from 2.3" to 2.9", averaging 2.5". During rubberized overlay paving the paver slipped on the PRF, resulting in several torn areas. Station 4+50 had a small tear. Station 8+70 had a 10 x 7 foot strip, located 1 foot off the shoulder of the passing lane, removed and not replaced. An 8 x 4 foot strip of PRF, near the center of the lane at station 9+75, was removed and not replaced. Stations 10+15 to 10+35 (approximately the end of PRF placement) had a 2' wide strip ripped out at the center of the passing lane.

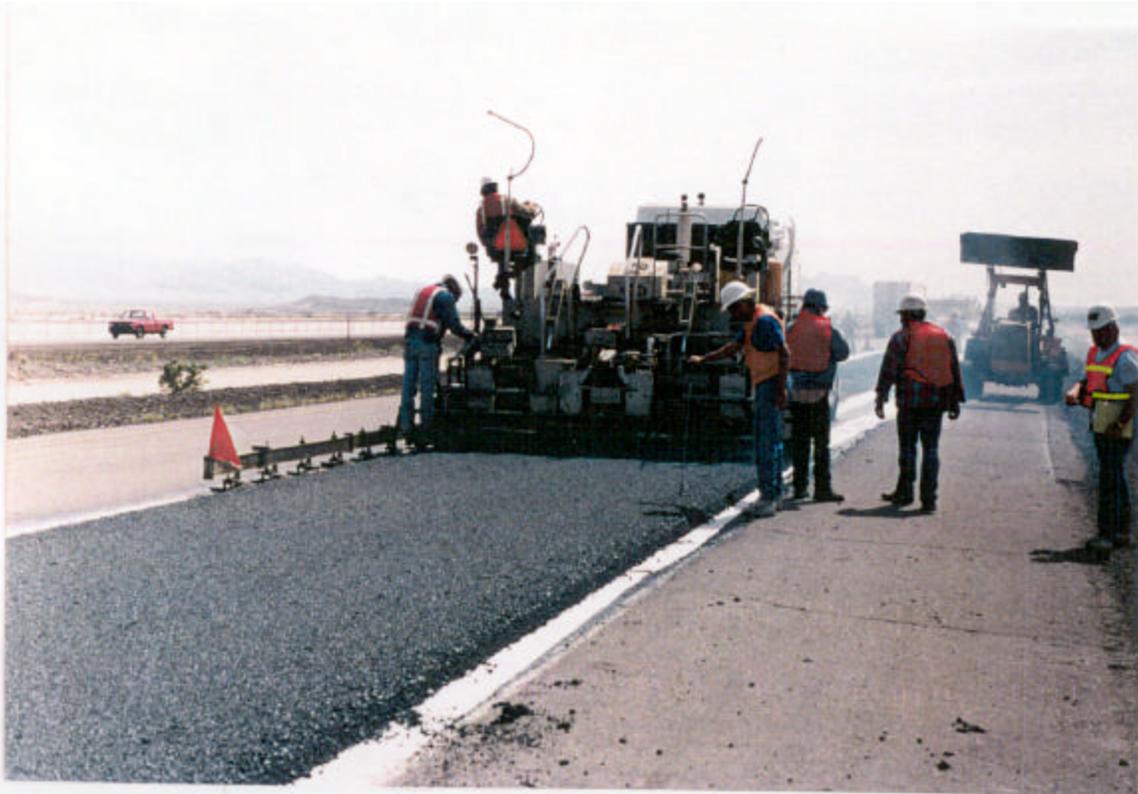
**Figure 12. Rubberized Overlay Paving on the Pavement Reinforcing Fabric.**

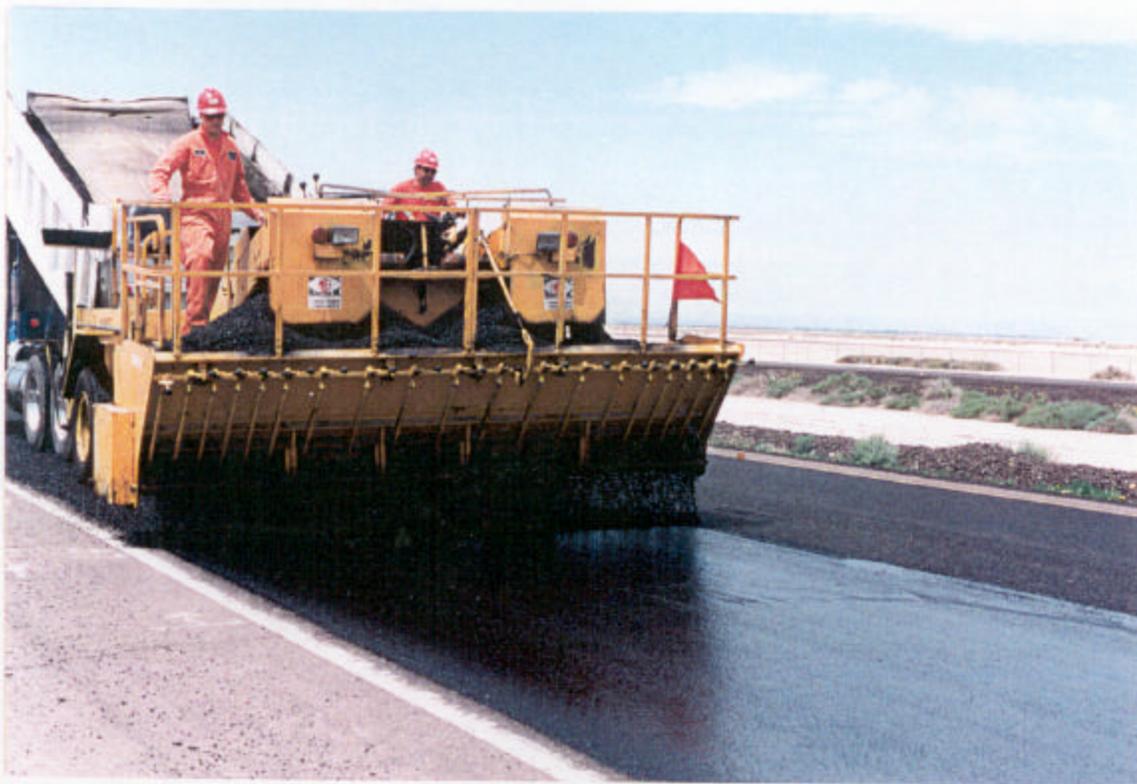
**Figure 13. Placement of the Stress Absorbing Membrane Interlayer**

*Passing Lane.* Milling and trench replacement paving were completed prior to arrival of SHRP Representatives. April 21, the SAMI was laid over an applied tack coat. April 22, from 9:01 PM to 9:37 PM, rubberized overlay paving was completed. Laydown temperatures were not recorded, however the average windrow temperature was 285°F. Loose lift thicknesses ranged from 2.8" to 3.5", averaging 3.0".

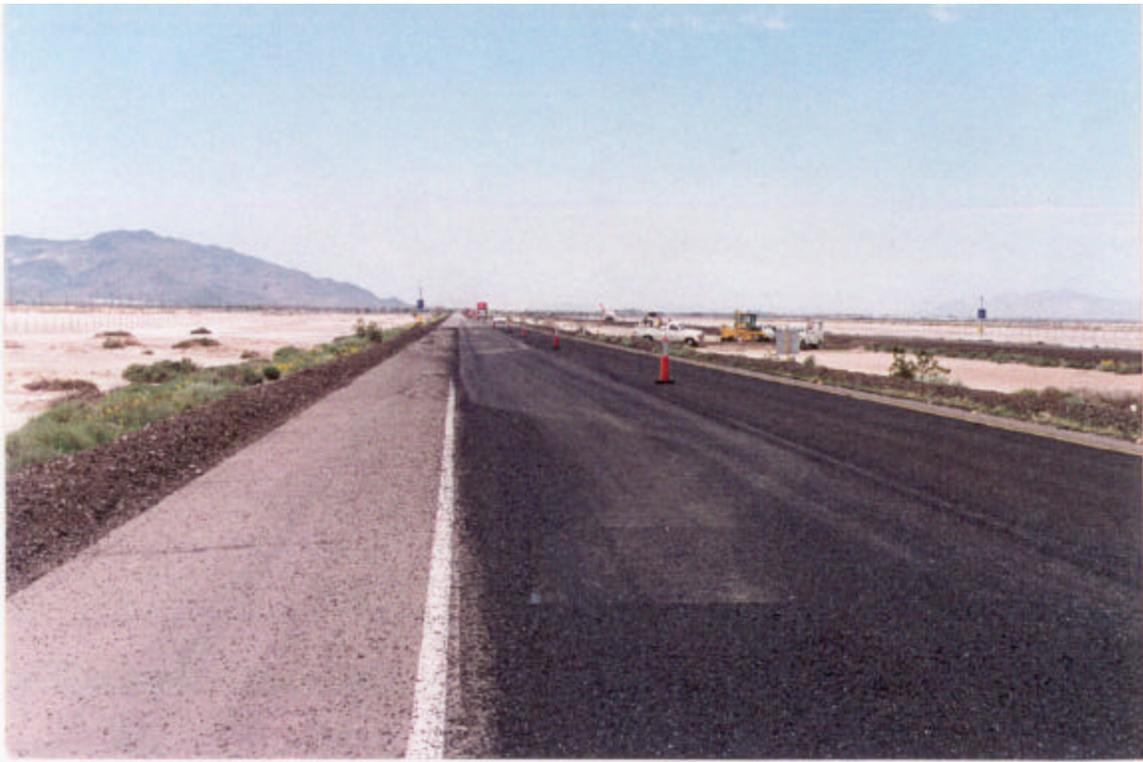
**Figure 14. Partially Rolled Stress Absorbing Membrane Interlayer**

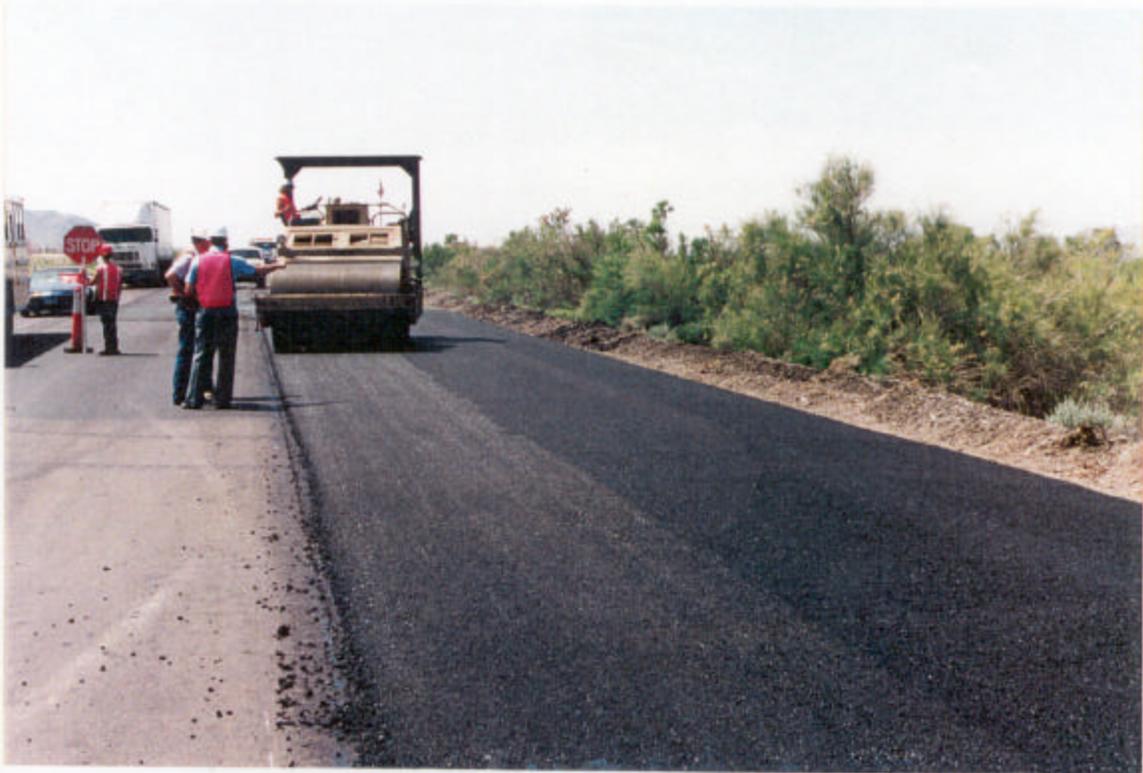
**Figure 15. Rolling of Vestoplast Stone Mastic Asphalt**
