**CONSTRUCTION REPORT ON SPS-6 PROJECT**  
**Pennsylvania Department of Transportation**  
**State Highway Administration**

Project 420600  
I-80 WBL, Snowshoe, PA  
Fall of 1992

**Construction Report  
PA SPS-6 Project  
I-80 WBL, Snowshoe, Pennsylvania  
Fall of 1992**

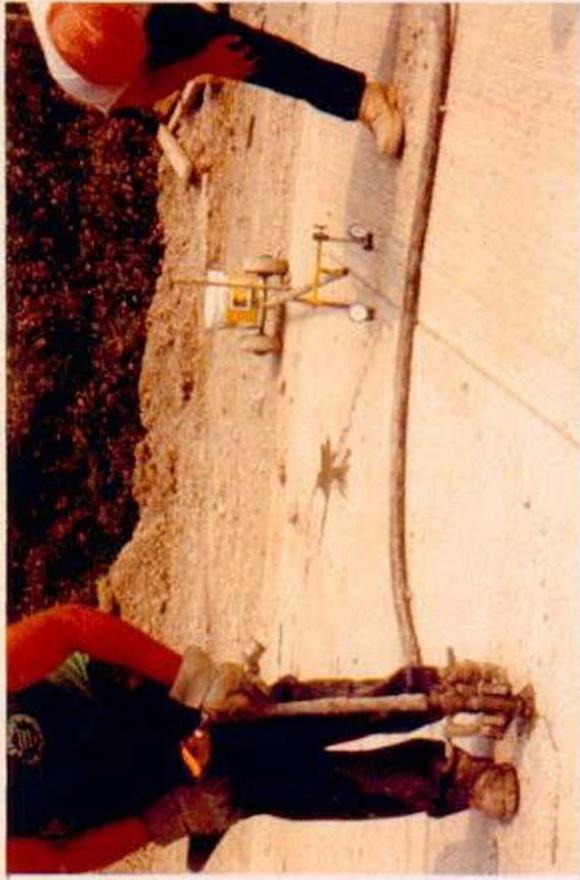
PHOTO #5

Sub-Sealing at Full CPR Surface Preparation Site

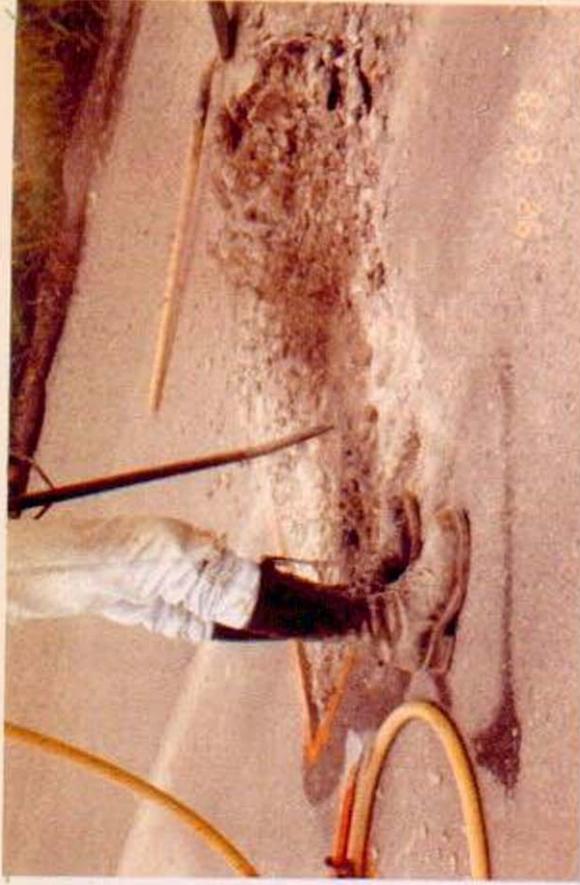
PHOTO #6

Cleaning Debris for Partial Depth Patching

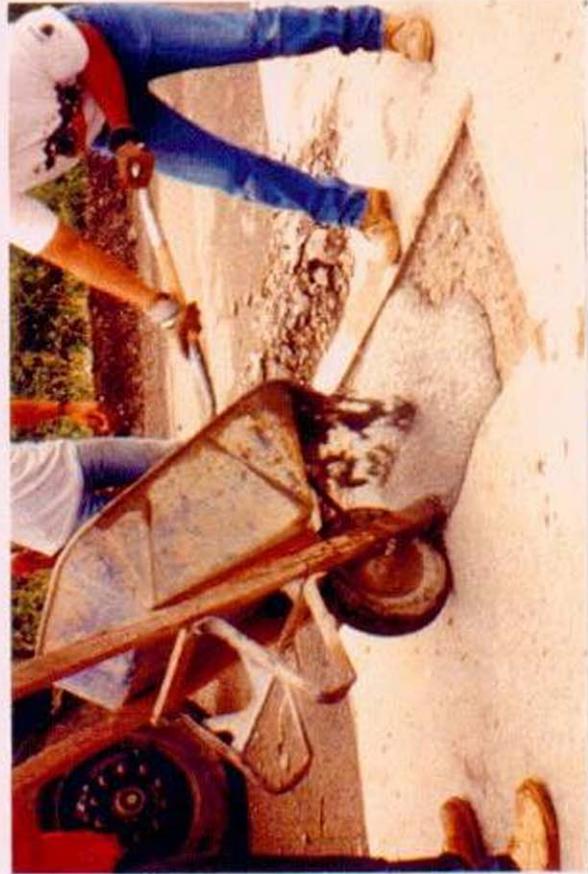
PHOTO #7

Placing Concrete for Partial Depth Patch

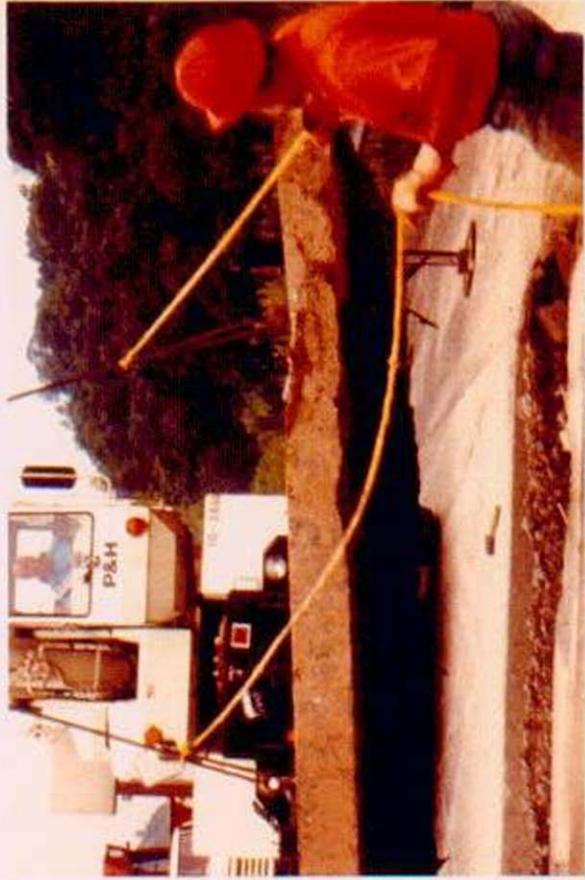
PHOTO #8

Removing Slab for Full Depth Patch

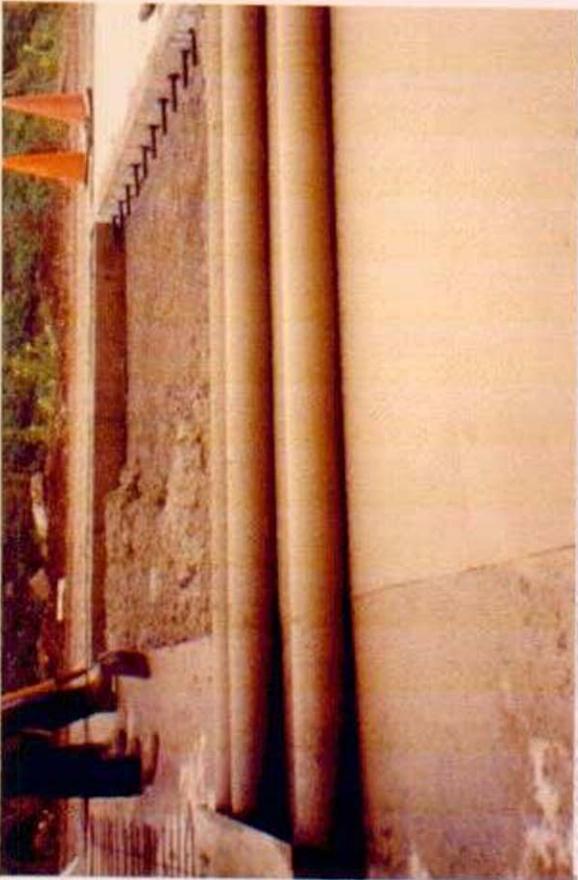
PHOTO #9  
Full Depth Patch Repairs with Load Transfer Restored

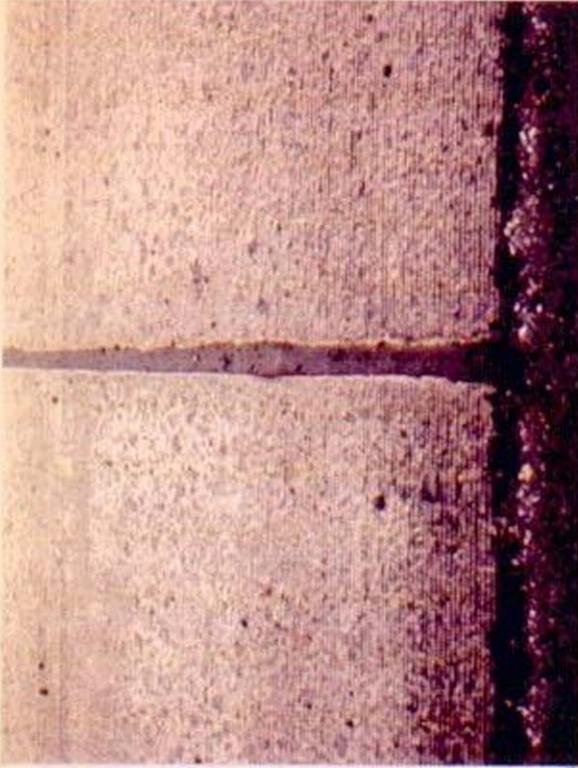
PHOTO #10  
Intensive Diamond Grinding Surface Preparation

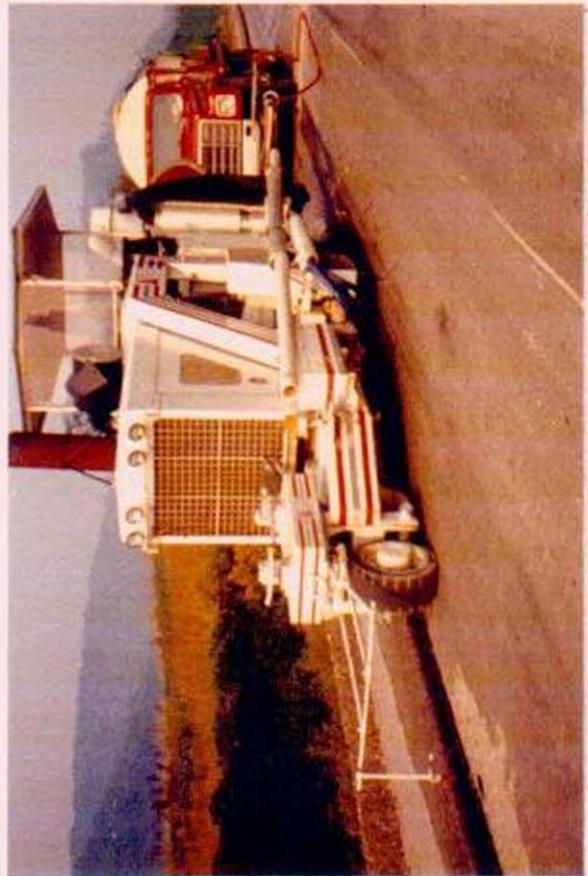
PHOTO #11  
Diamond Grinding Equipment Train

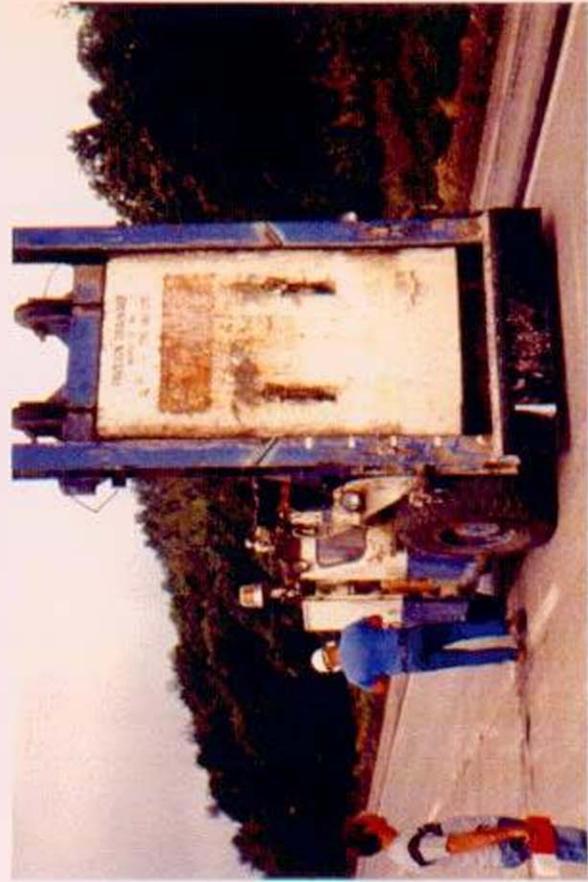
PHOTO #12  
Break-and-Seat Guillotine Equipment

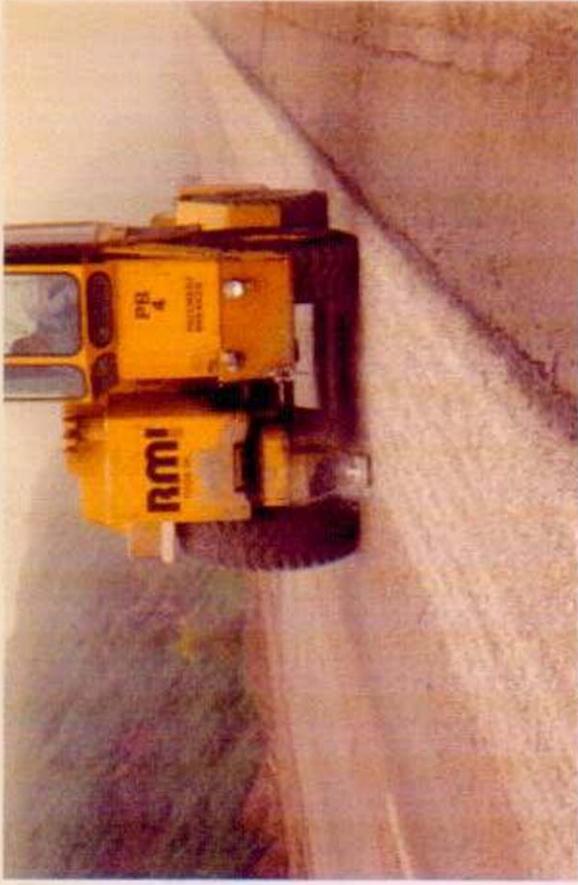
PHOTO #14  
Rubblizing Pavement Breaker

The pavement rubblizing machine was a RMI PB-4 (Resonant Machines Inc ,  
Tulsa, Oklahoma) with 229mm (9") breaker head The 6 Megagram (6 1/2 ton)  
breaker machine was supplied and operated by a subcontractor, Pavilion Drainage  
A power broom was used to control dust during milling and patching

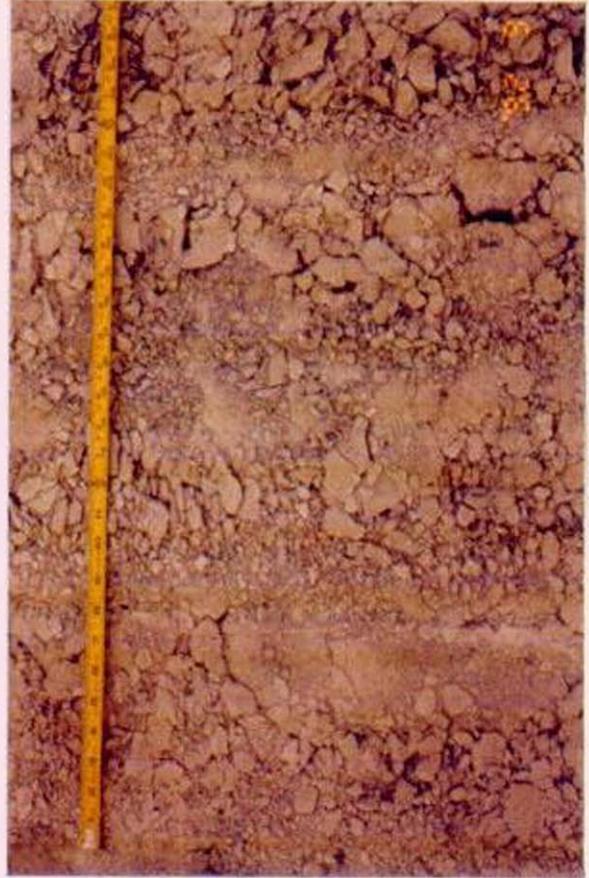
PHOTO #15  
Pavement after Rubblizing

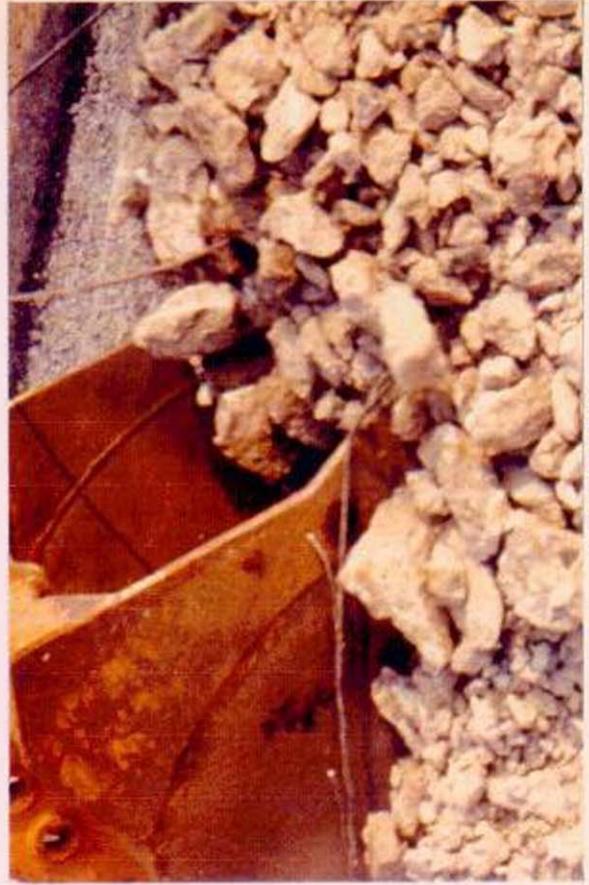
PHOTO #16  
Product of Rubblizing Operation

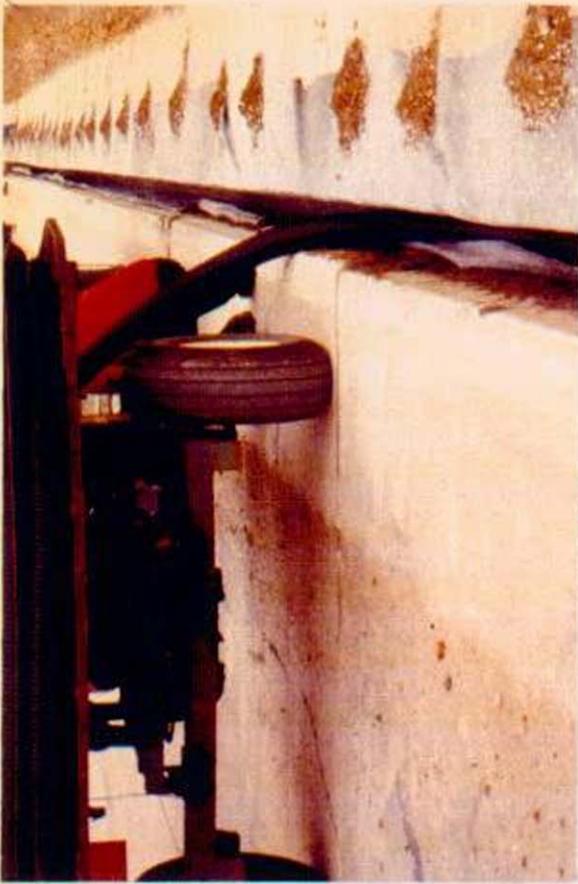
PHOTO #17  
Fabric-Wrapped Pavement Edge  
Plastic Pipe Drain

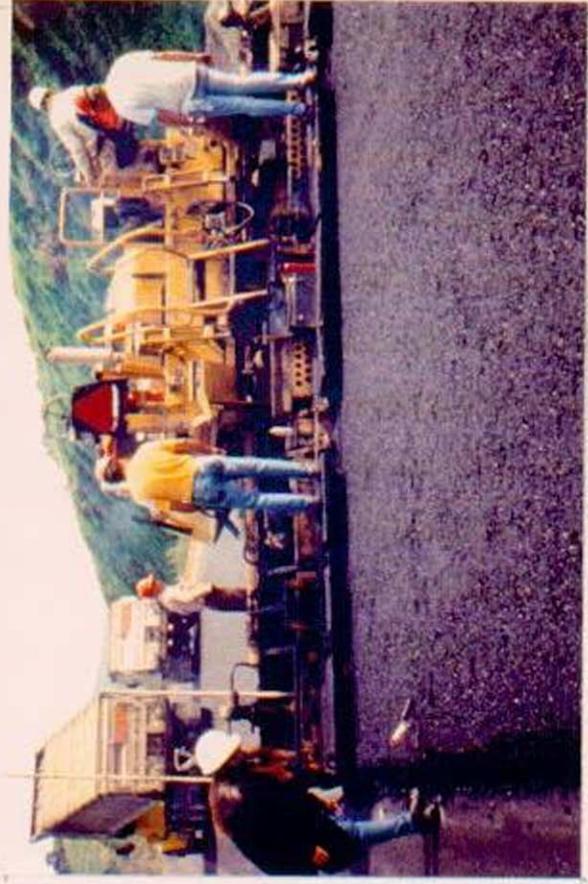
PHOTO #19  
Two-Lane Wide Paver with  
Virgin Base Course Mix

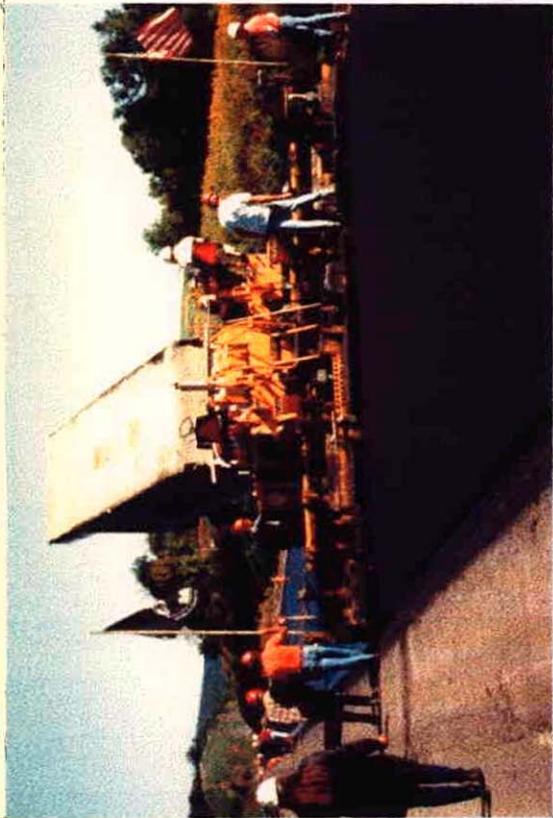
**PHOTO #20**  
Paving with Surface Course Mix  
Two Lanes Wide

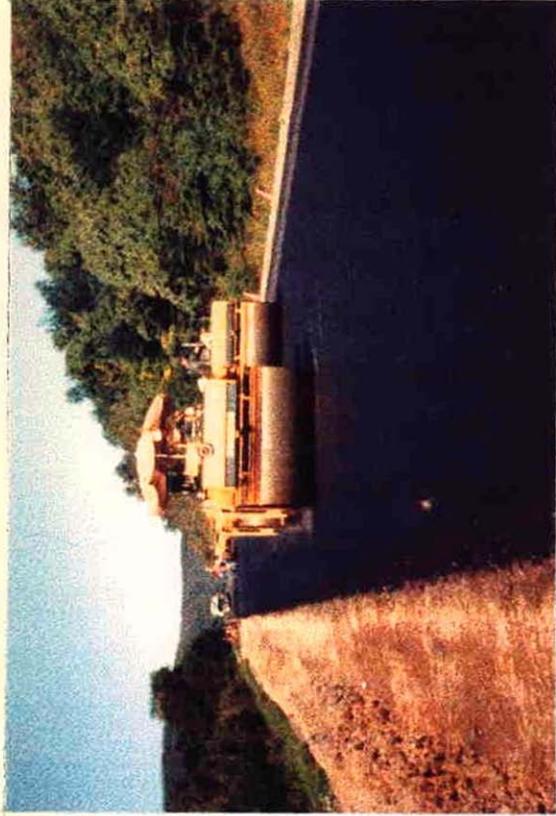
**PHOTO #21**  
Compacting the Asphalt Mixes with  
10 Ton Steel Wheel Vibratory Rollers

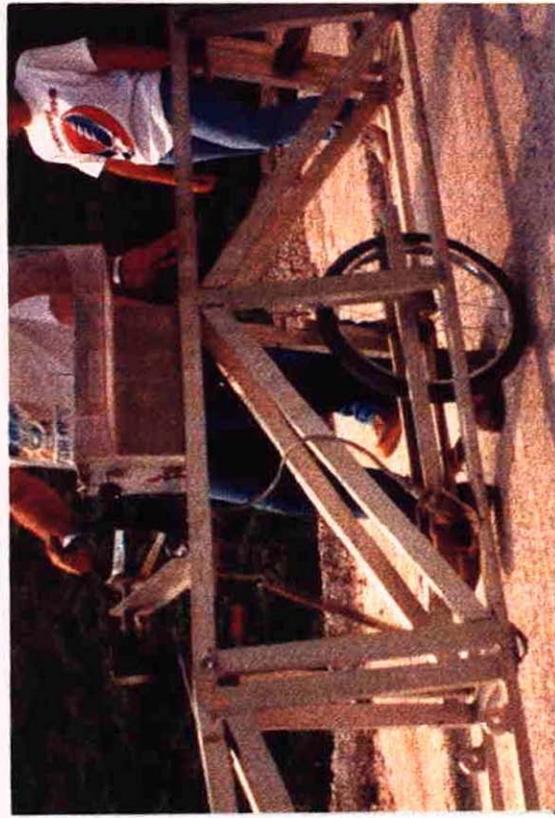
**PHOTO #22**  
Measuring the Roughness of the Pavement with a  
Profilograph
