# Construction Report for Saskatchewan SPS-9A

DTFH61-96-C-00013

**SPS-9A Construction Report  
Yellow Head Highway, Westbound  
Radisson, Saskatchewan**

**Sections 900901 to 900903 and 900959 to 900962**

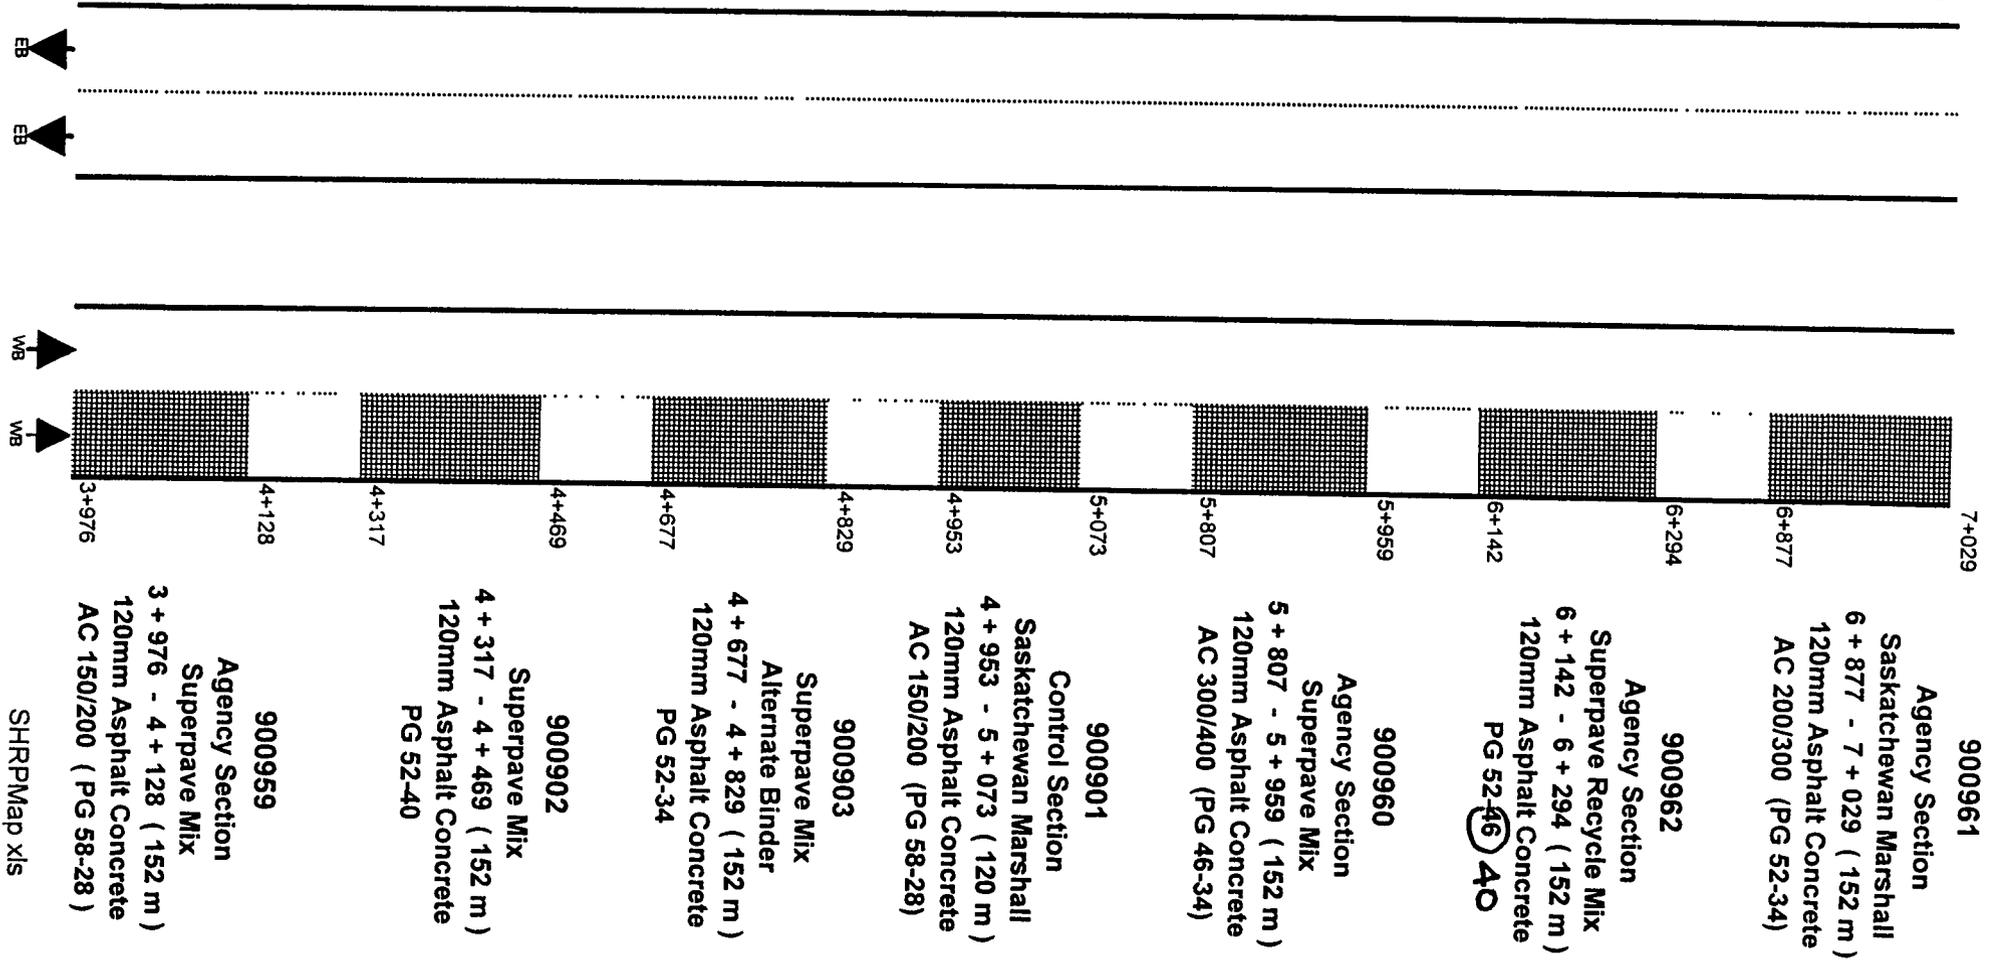
Figure B-1. Test Section Layout.

<u>Limits In Km(including coring area)</u>	
Starts Km 3 900	Ends Km4 204
Starts Km 4 250	Ends Km4 550
Starts Km 4 600	Ends Km 4 905
Starts Km 4 929	Ends Km 5.275
Starts Km 5 730	Ends Km 6 035
Starts Km 6 065	Ends Km 6.370
Starts Km 6 800	Ends Km 7 105

<u>Test Sec No</u>
#900959
#900902
#900903
#900901
#900960
#900962
#900961

To  
 Saskatoon  
 75 KM  
 WIM  
 At  
 3 + 100

The Saskatchewan SPS-9A project consists of seven test sections. Three of these are the core SPS-9 sections, and four are supplemental. Attachment B shows the test site layout. Description of materials used are shown in figure B-1.

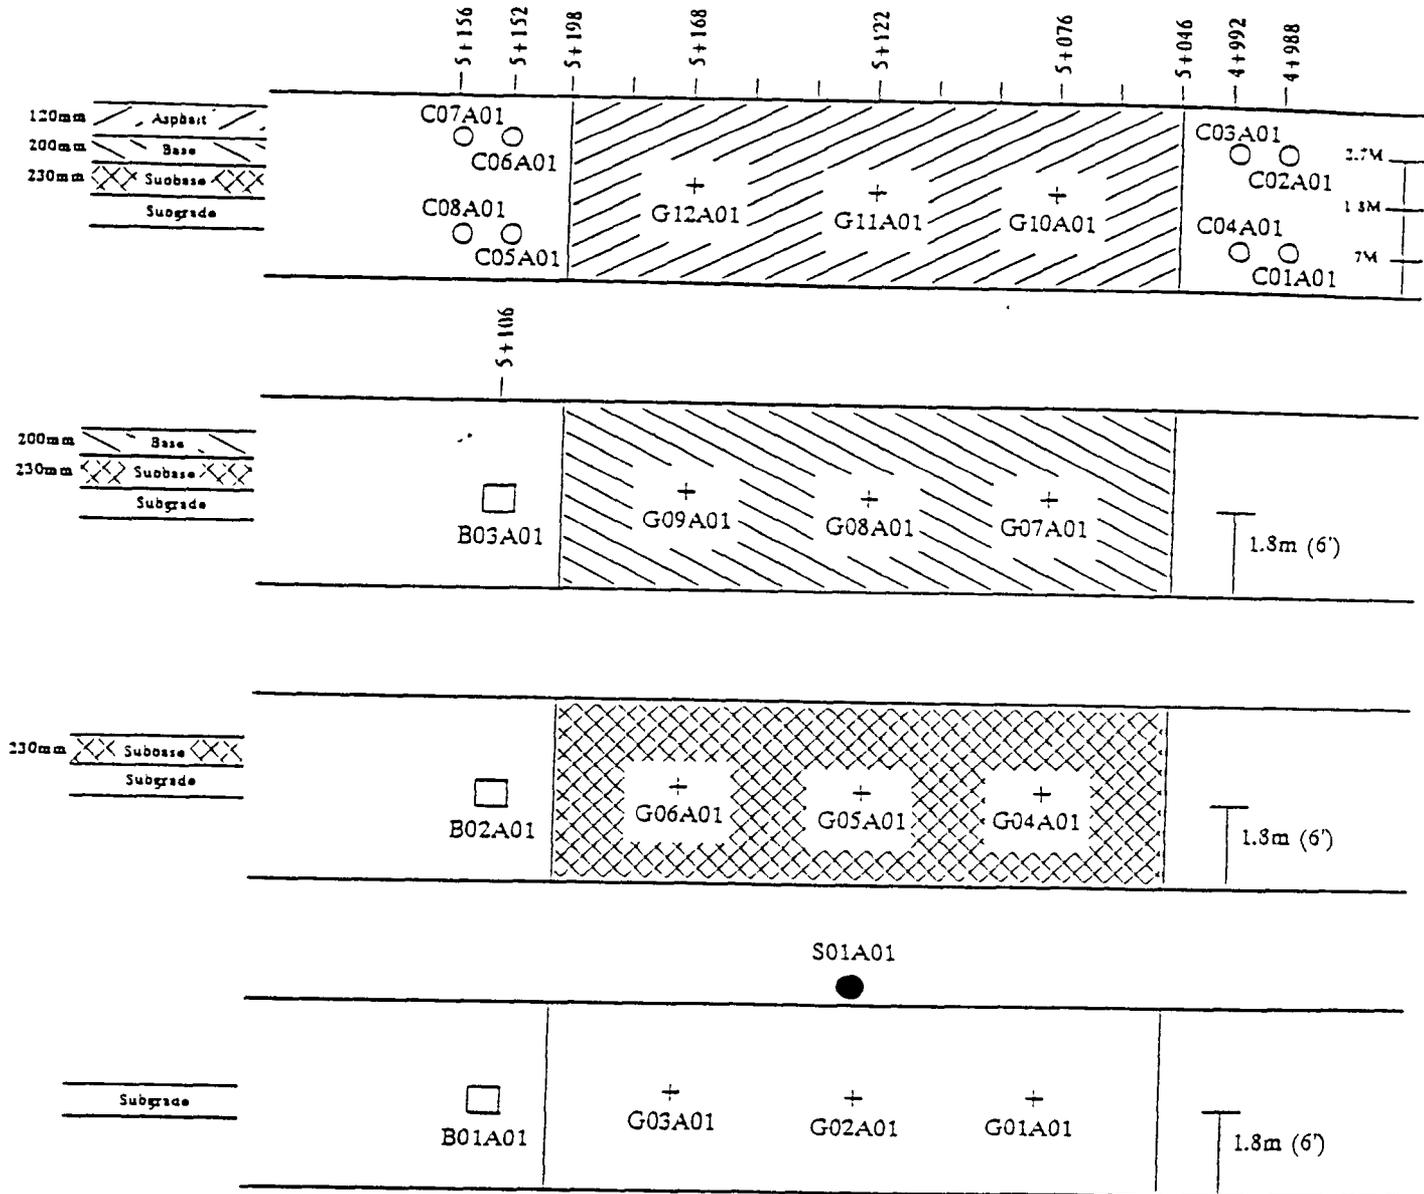
Figure C-1. Material Sampling and Testing Layout for Section 900901.

- Shoulder Probe 6M (20ft)
- Bulk Sample Location (25Kg Bulk - 5Kg Moisture)
- IN SITU Density Testing
- Core Location 150mm (6in) Diameter (full depth core)

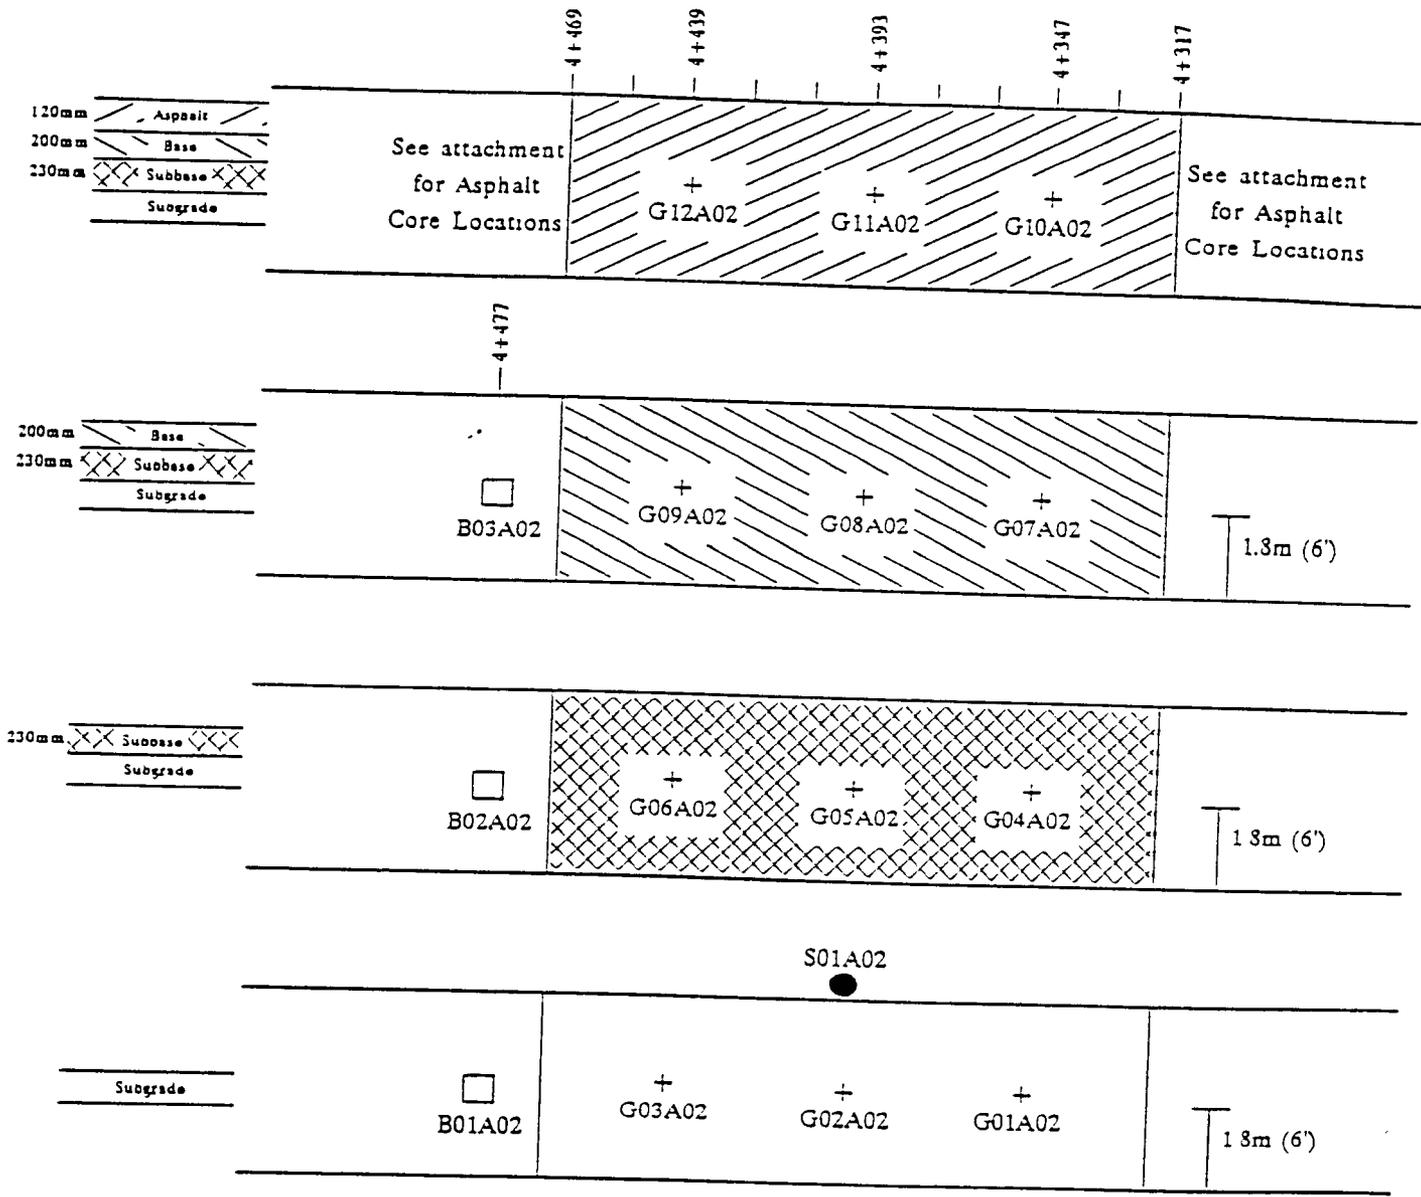
Figure C-2. Material Sampling and Testing Layout for Section 900902.

- Shoulder Probe 6M (20ft)
- Bulk Sample Location (25Kg Bulk - 5Kg Moisture)
- IN SITU Density Testing
- Core Location 150mm (6in) Diameter (full depth core)

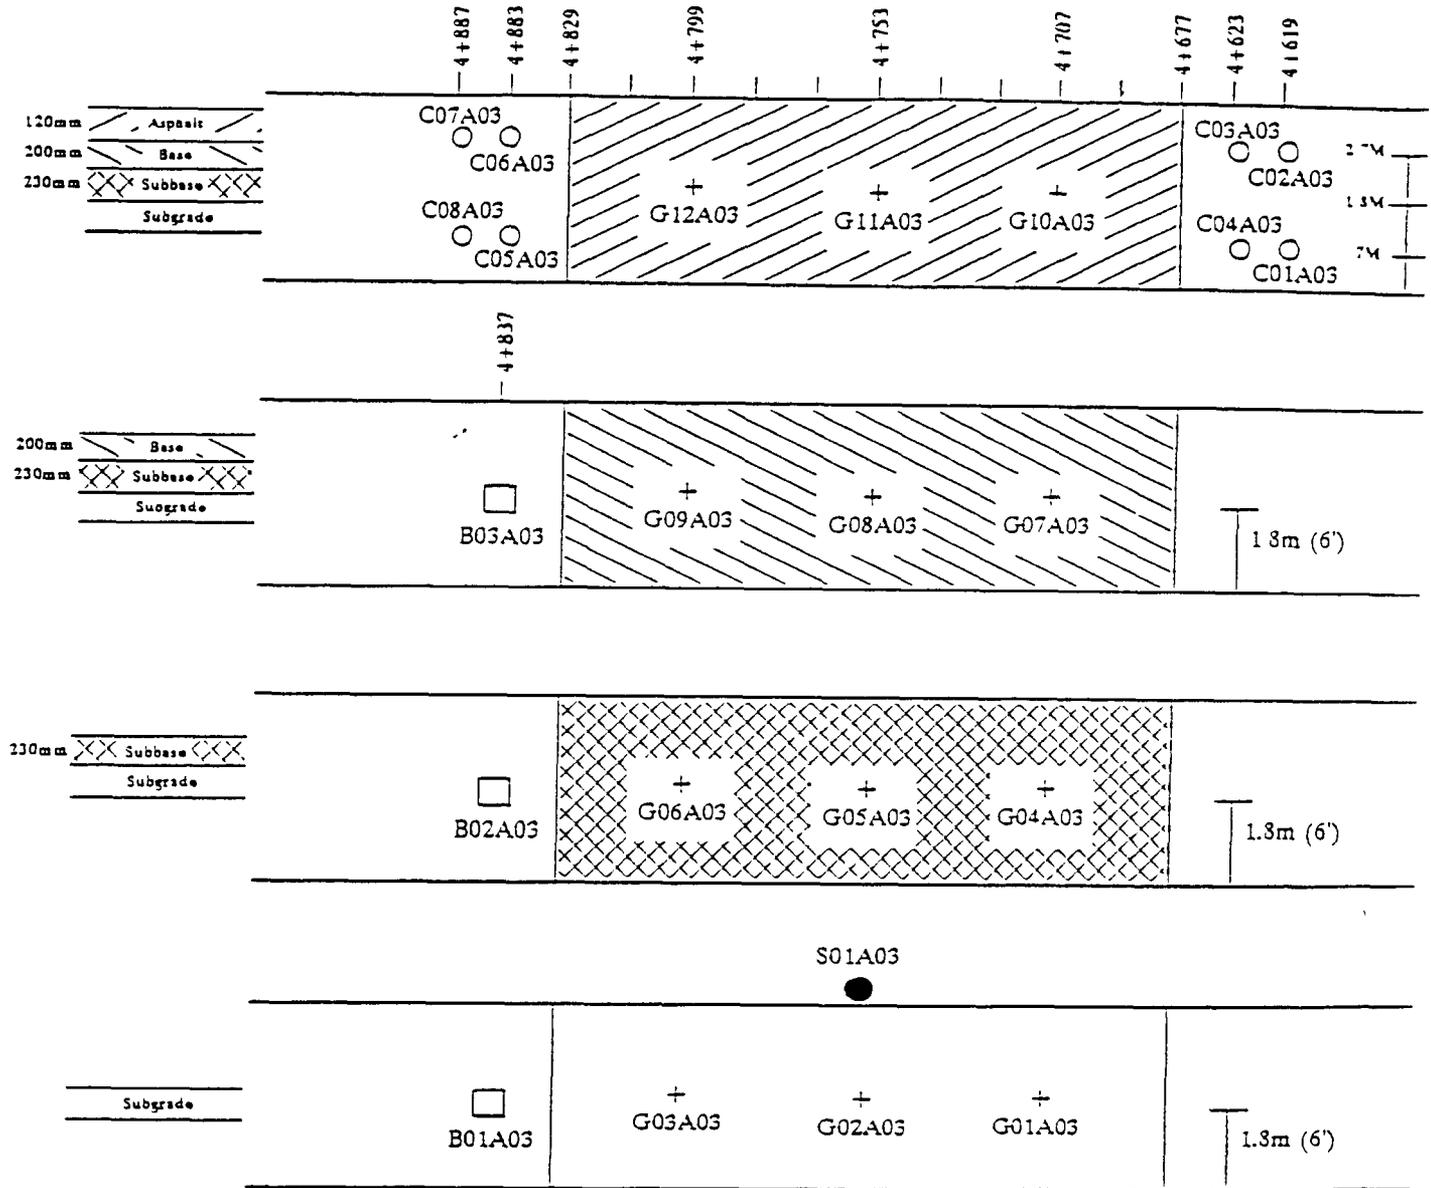
Figure C-3. Material Sampling and Testing Layout for Section 900903.

Shoulder Probe 6M (20ft)
-

Bulk Sample Location (25Kg Bulk - 5Kg Moisture)
-

IN SITU Density Testing
-

Core Location 150mm (6in) Diameter (full depth core)

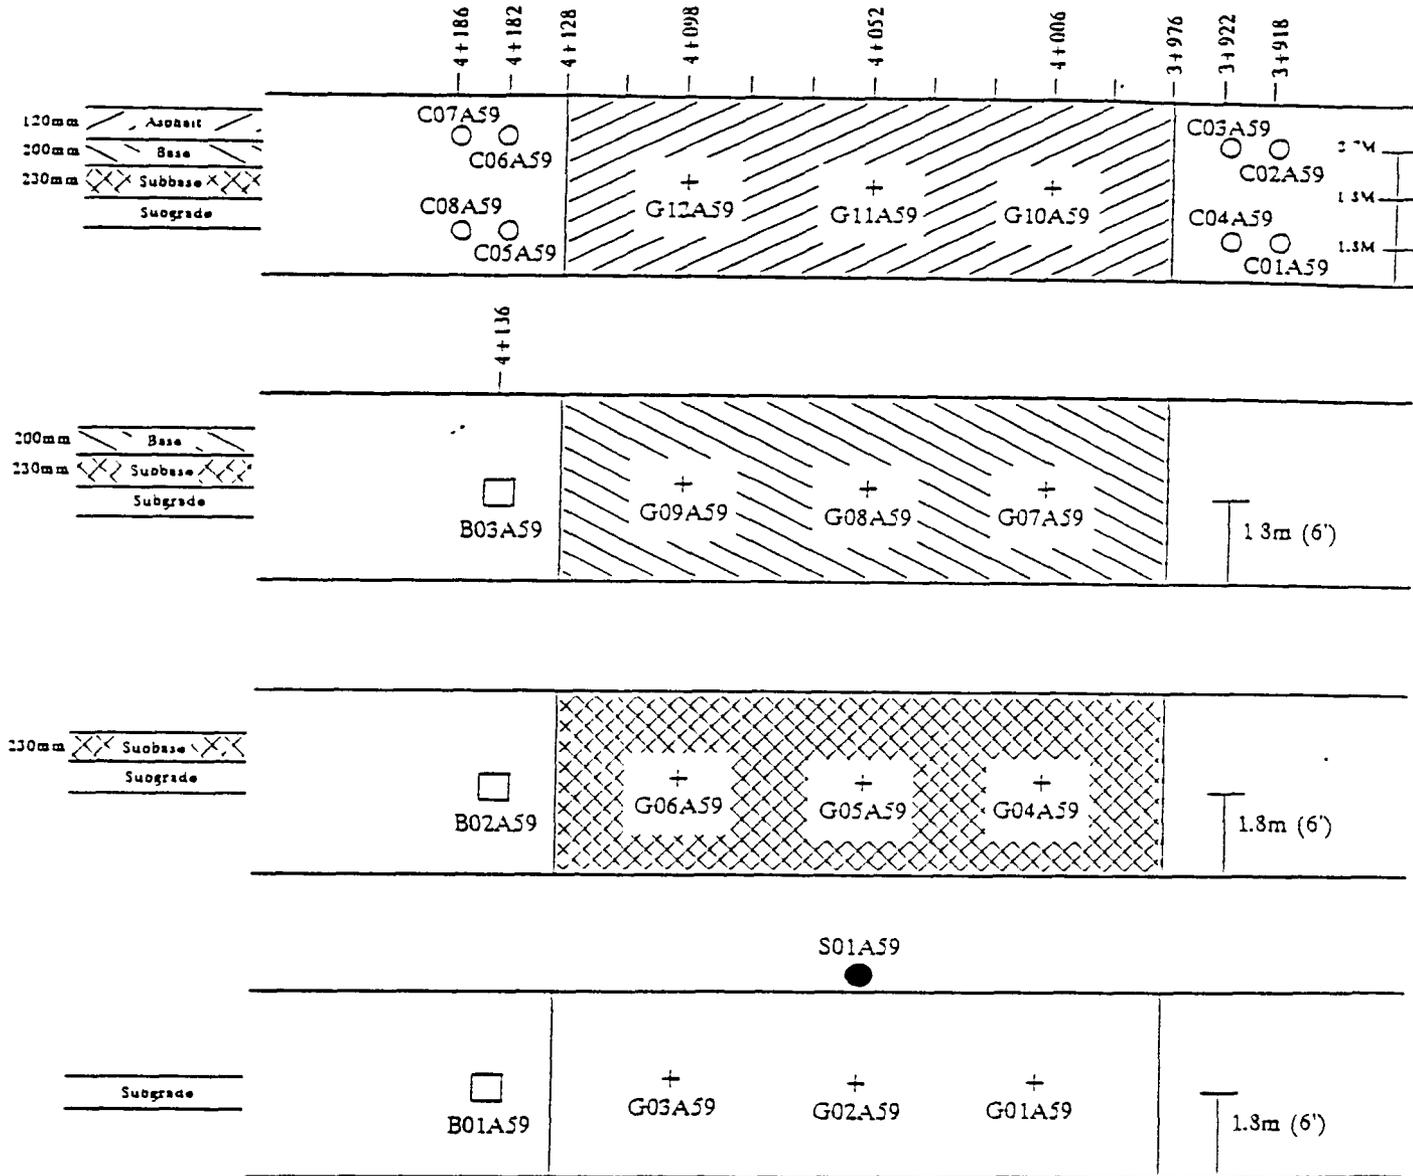
Figure C-4. Material Sampling and Testing Layout for Section 900959.

Traffic
- Shoulder Probe 6M (20ft)
  - Bulk Sample Location (25Kg Bulk - 5Kg Moisture)
  - + IN SITU Density Testing
  - Core Location 150mm (6in) Diameter (full depth core)

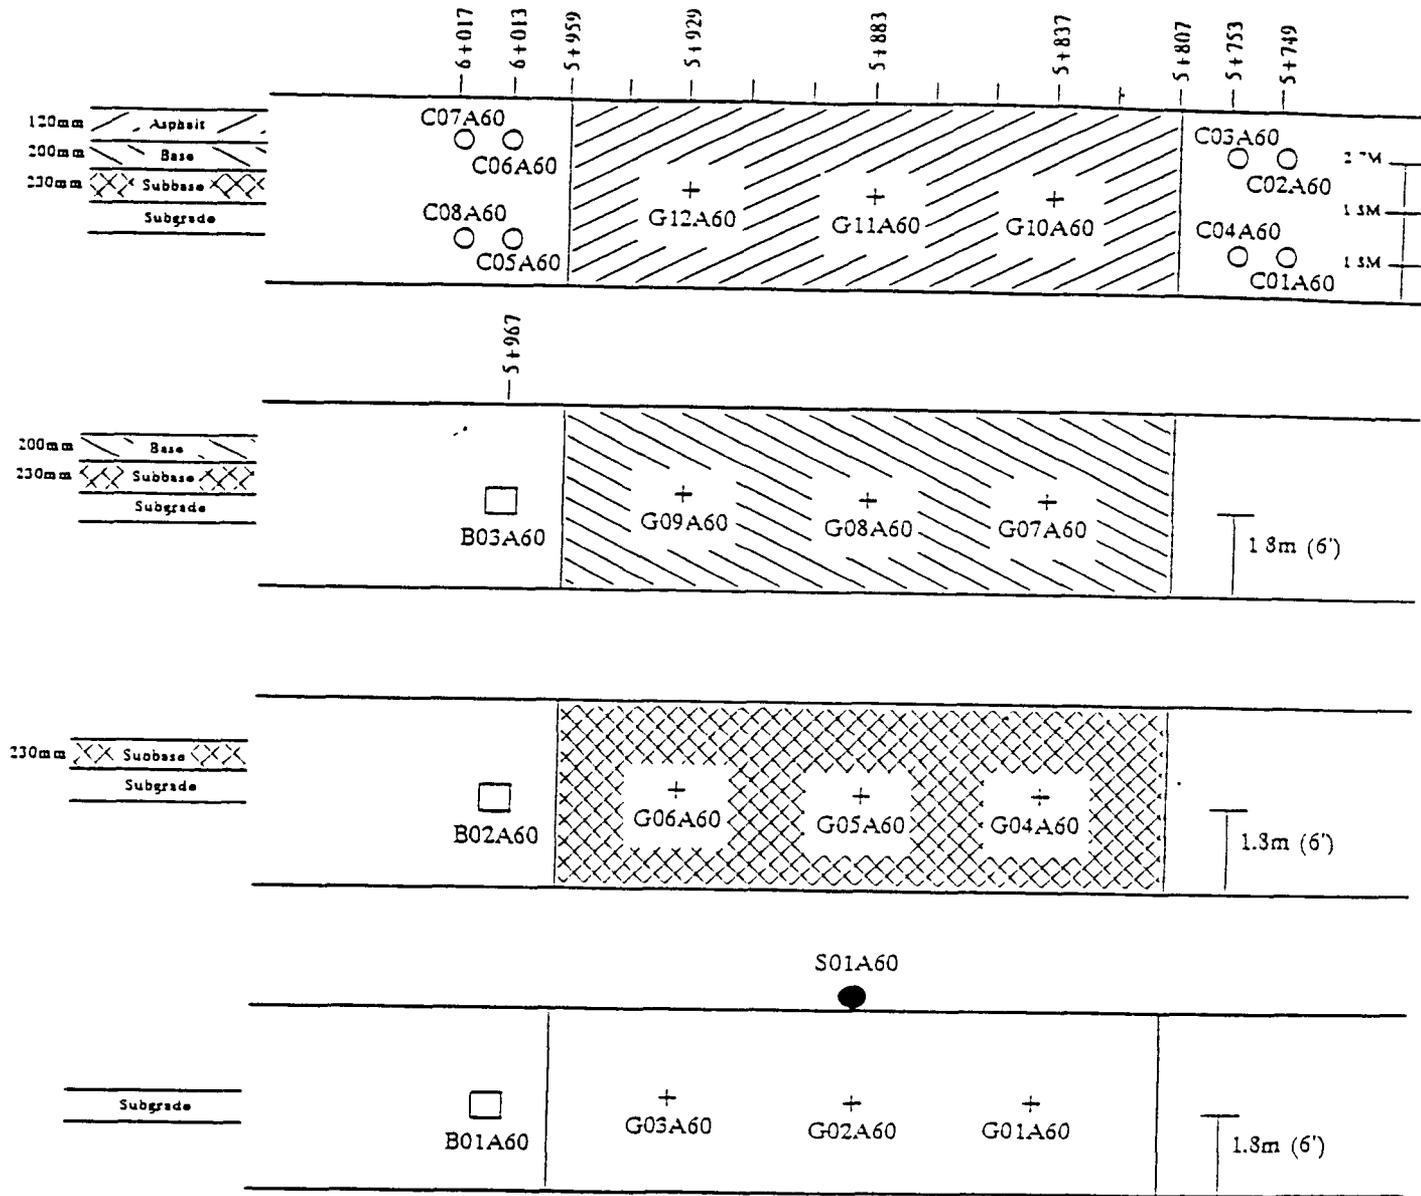
Figure C-5. Material Sampling and Testing Layout for Section 900960.

- Shoulder Probe 6M (20ft)
- Bulk Sample Location (25Kg Bulk - 5Kg Moisture)
- ⊕ IN SITU Density Testing
- Core Location 150mm (6in) Diameter (full depth core)

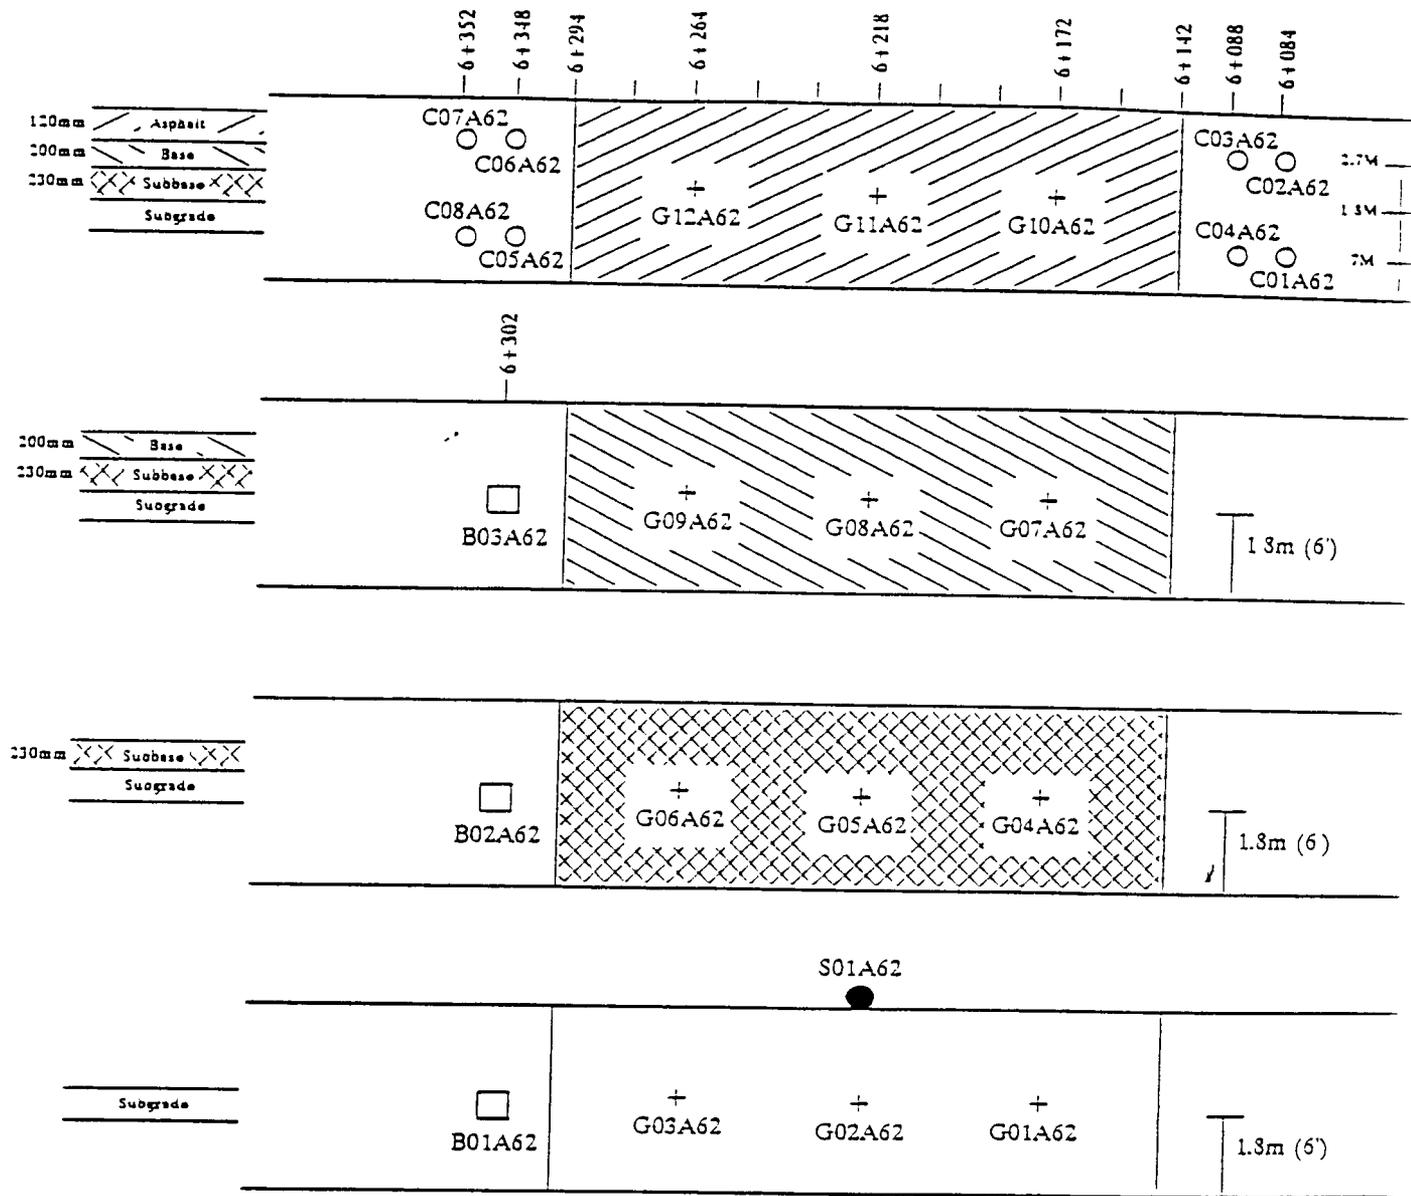
Figure C-7. Material Sampling and Testing Layout for Section 900962.

Shoulder Probe 6M (20ft)
-

Bulk Sample Location (25Kg Bulk - 5Kg Moisture)
-

IN SITU Density Testing
-

Core Location 150mm (6in) Diameter (full depth core)
