Subject: **ACTION**: LTPP Directive D-34
Distress Survey Photographs

LONG TERM PAVEMENT PERFORMANCE PROGRAM DIRECTIVE

Directive Number: D-34

Subject: Distress Survey Photographs

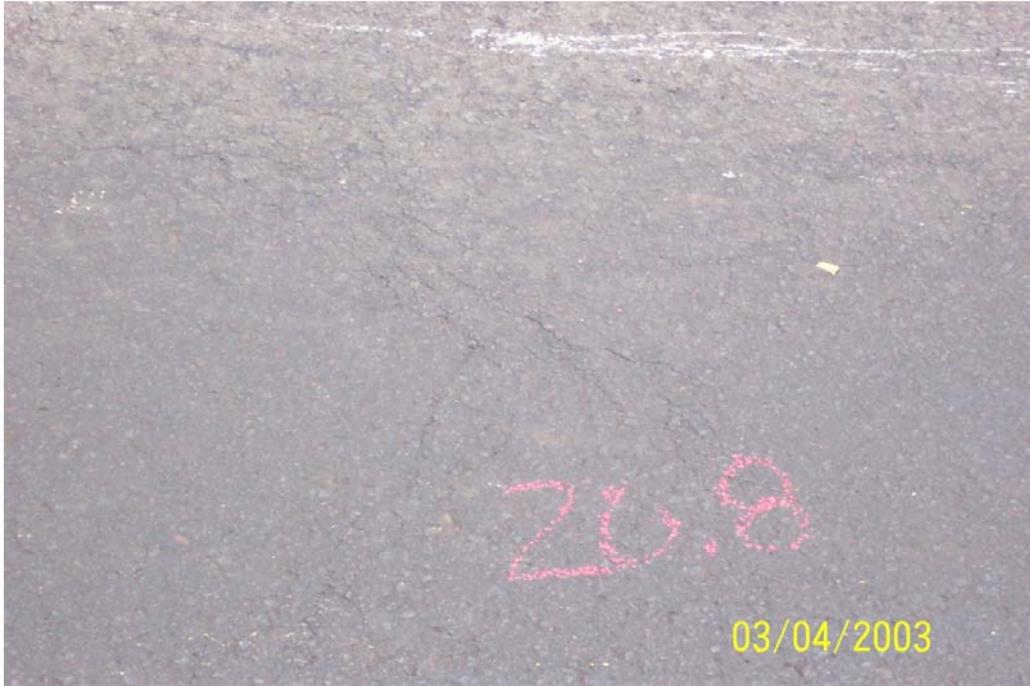
Image 1

This photo has nothing to indicate scale or direction. When such a photo is taken, these need to be included within the description. An example of a good description is provided below.

Description: “Non-standard photo - AC surface with several unusual low severity cracks running transverse to lane.”

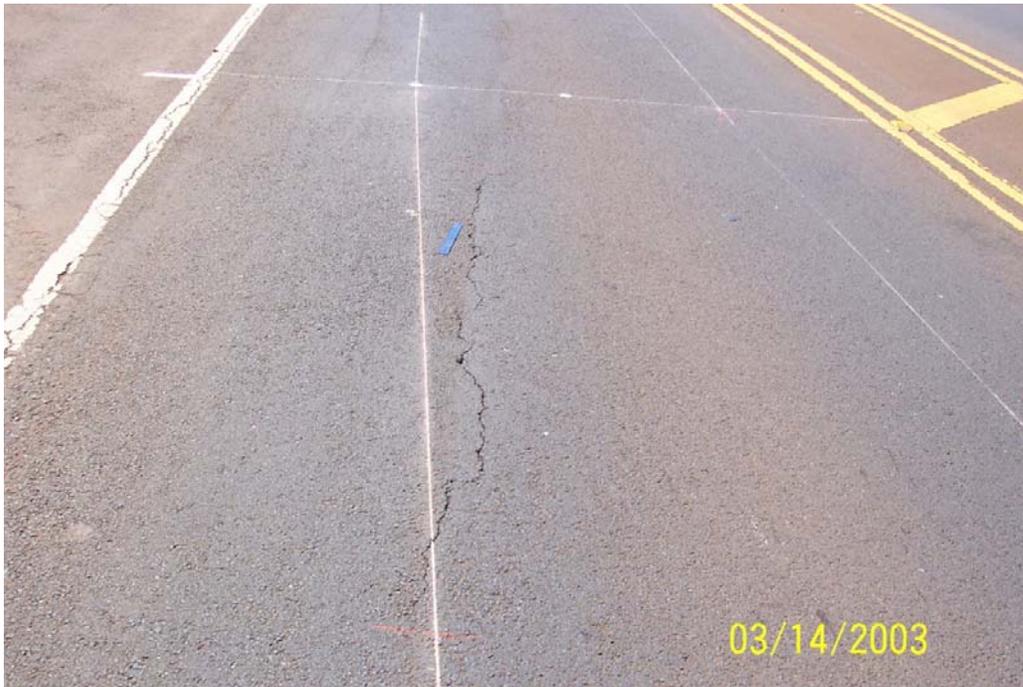
Image 2

Description: “Non-standard photo - a crack in the AC surface developing along an unconventional longitudinal paving seam.”

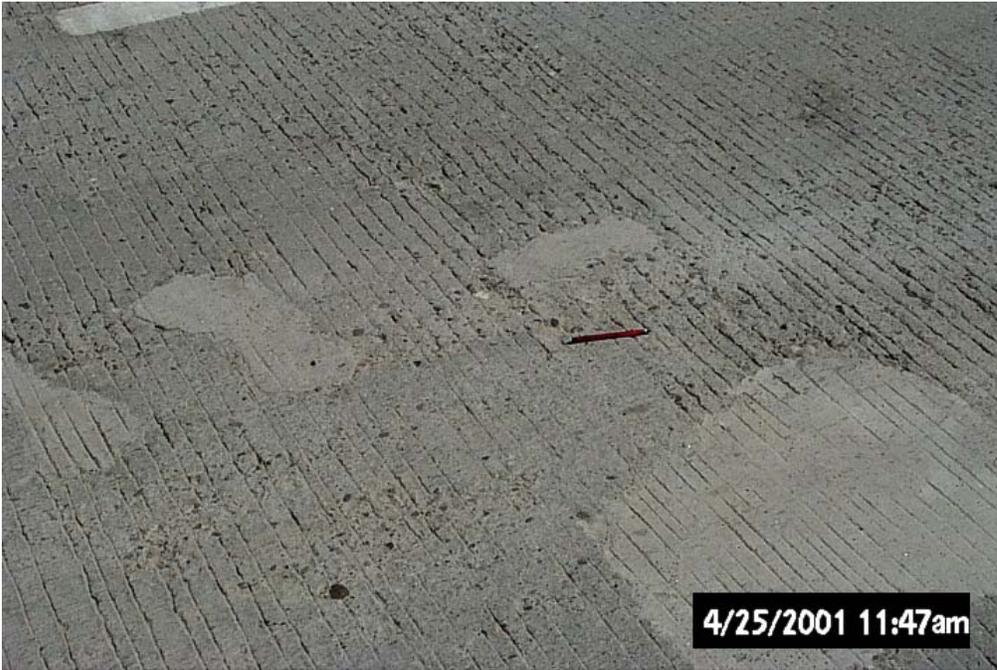
Image 3

The Portland cement concrete patches in this image will have been noted on the survey maps and forms. There does not appear to be a reason why this photo is necessary and thus it may be omitted unless the surveyor feels that it is noteworthy in some other respect. Nonetheless, a possible description is provided below.

Description: "Non-standard photo - small closely spaced PCC surface patches."

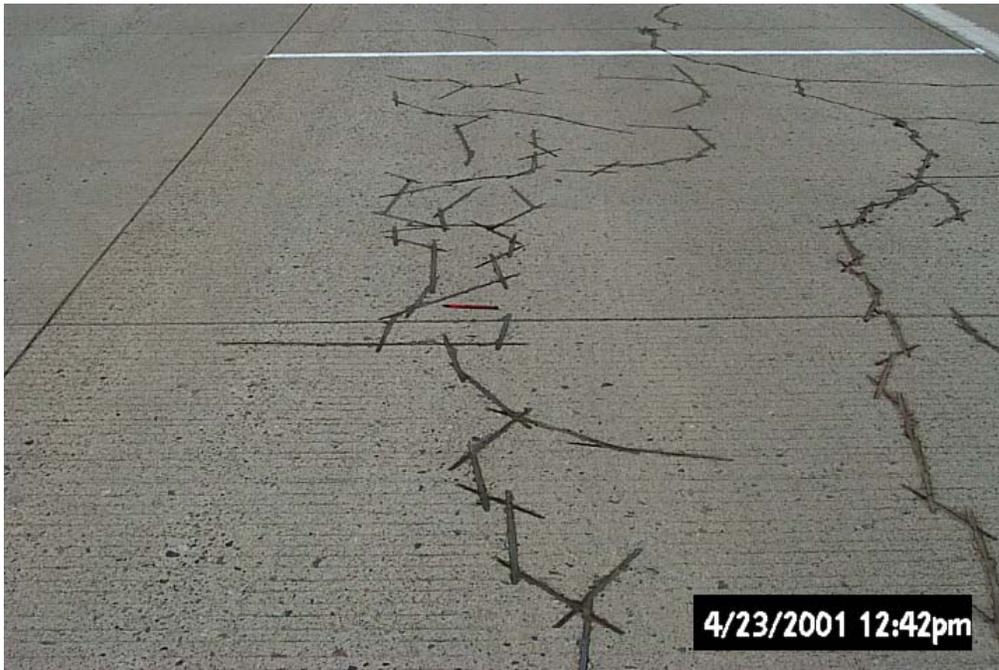
Image 4

Description: “Non-standard photo - PCC pavement with a series of short interconnected cracks that have been saw-cut and sealed.”

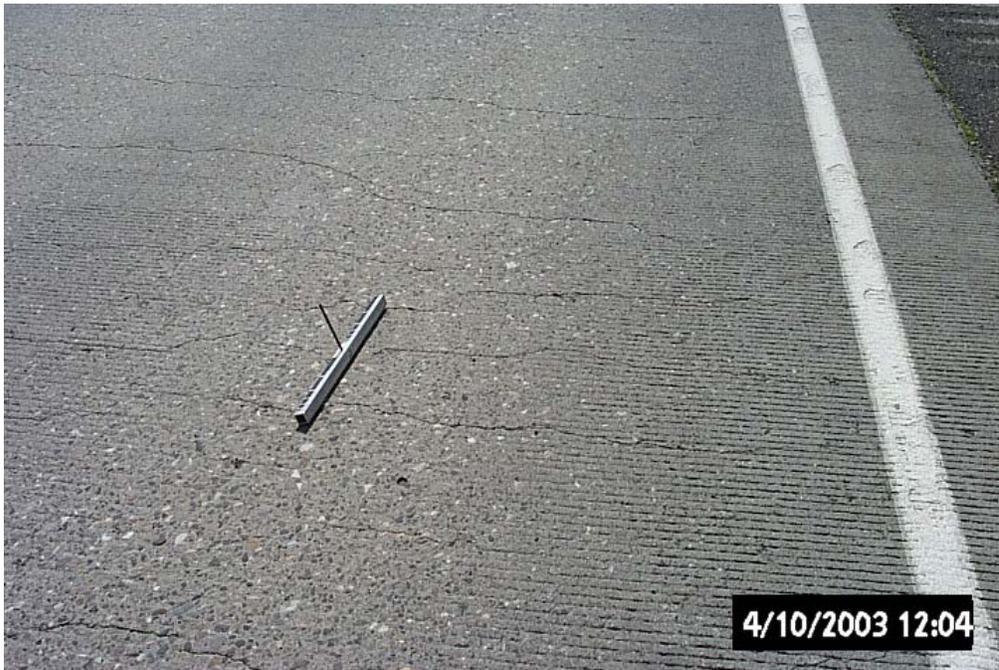
Image 5

These transverse cracks will have been noted on the survey forms and maps. A non-standard photo is not warranted unless the surveyor feels that this photo is noteworthy for another reason. If this was the case, the reason should be included in the description of the photo. A possible description is provided below.

Description: “Non-standard photo - transverse cracks on CRCP pavement lacking apparent interconnection between adjacent cracks or extension to the outer pavement edge.”

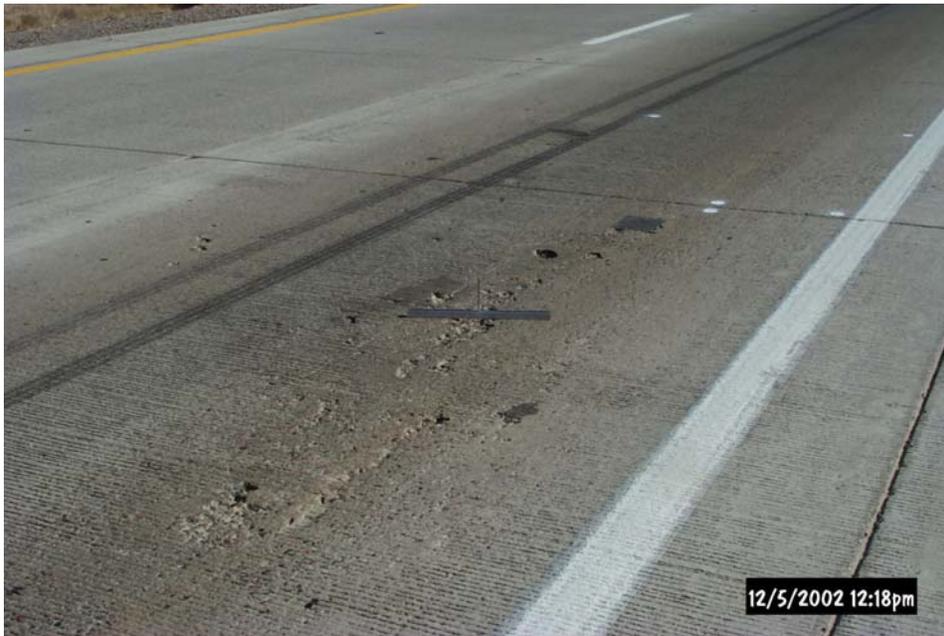
Image 6

Description: "Non-standard photo - PCC pavement with surface material missing from the left wheel path."

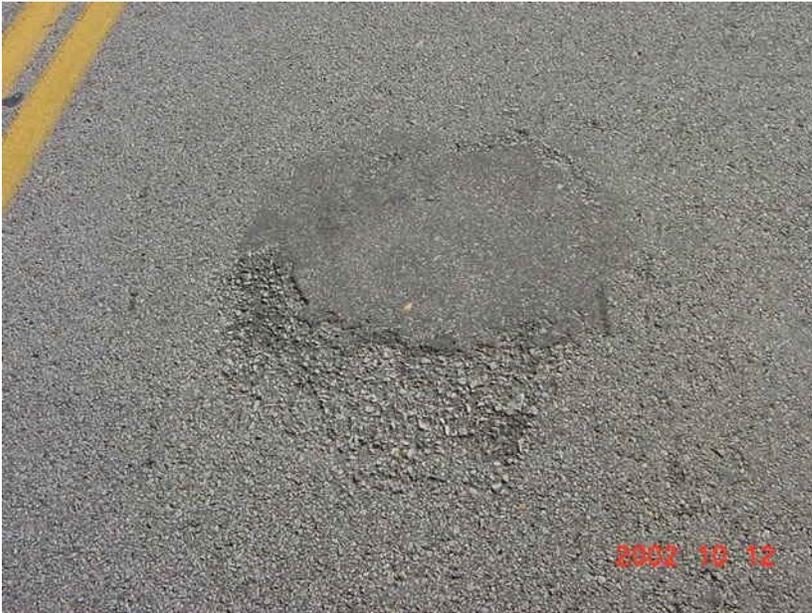
Image 7

The distresses in this photo are easily recognizable and should have been recorded on the distress maps and forms. Unless the surveyor feels that the photo is noteworthy or of particular interest to users of the distress survey data, then the photo is not warranted under D-34. Nonetheless, a possible description is provided below.

Description: “Non-standard photo - circular AC patch with small area of adjacent raveling.”

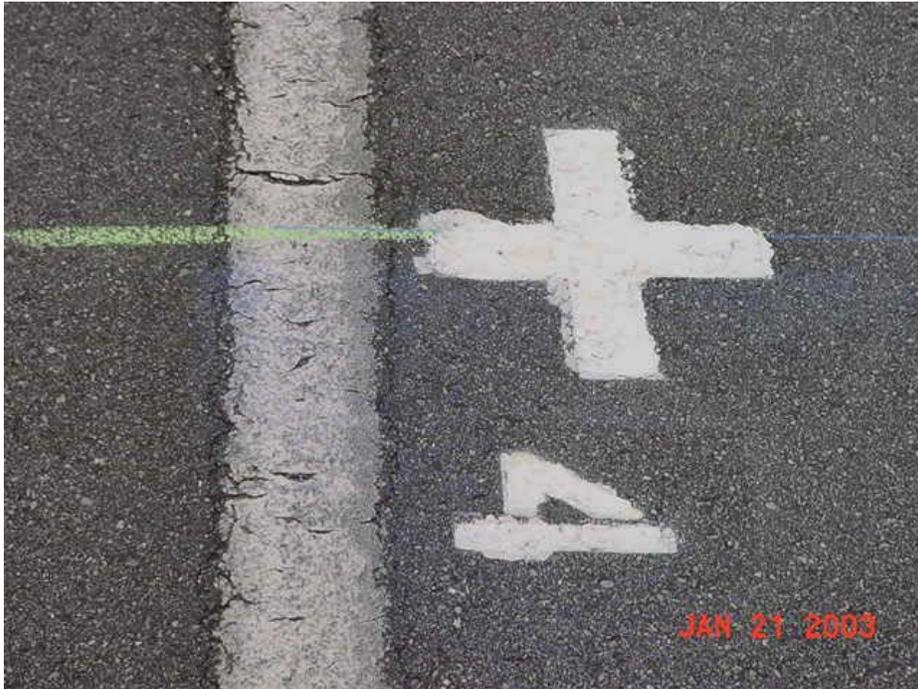
Image 8

Description: “Non-standard photo - fine cracks propagate across the painted edge line as well as longitudinally along both sides.”

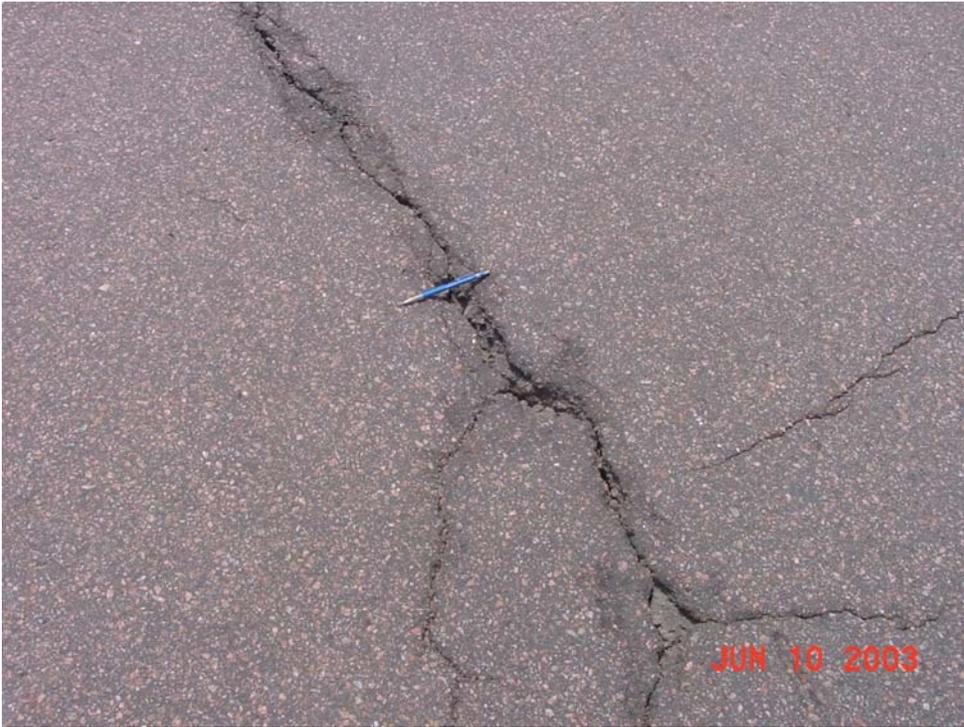
Image 9

This photo lacks an indication of direction. It is important that the orientation of the cracks can be determined. The description should clearly state this. A possible description is provided below.

Description: “Non-standard photo - severe transverse crack extending across the lane and a series of smaller cracks radiating from it, perpendicular and diagonal to the lane.”

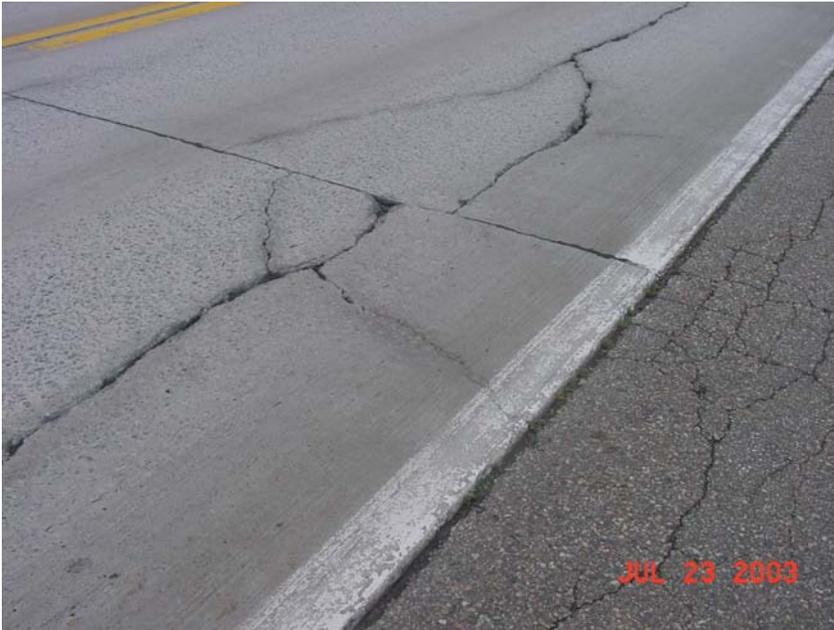
Image 11

Note: If the diamond grinding in this image is visible in standard photos, then this non-standard one is not required.

Description: “Non-standard photo - transverse joint, a severe longitudinal crack with polished aggregate to the left and striations caused by diamond grinding to the right of it.”

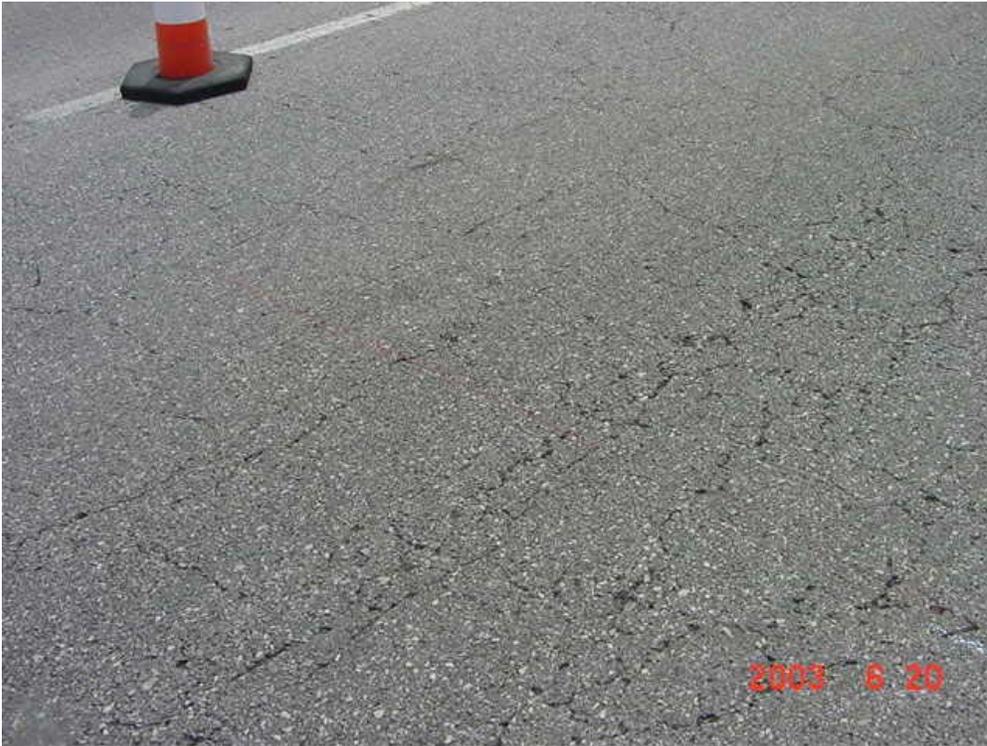
Image 12

“Non-standard photo – a chicken wire pattern of cracking across the whole lane.”
