# SUMMARY REPORT

## Analysis of Cracking in Jointed Plain Concrete Pavements

FHWA Publication No.: FHWA-HRT-16-073  
FHWA Contact: Deborah Walker, HRDI-30, 202-493-3068,  
deborah.walker@dot.gov

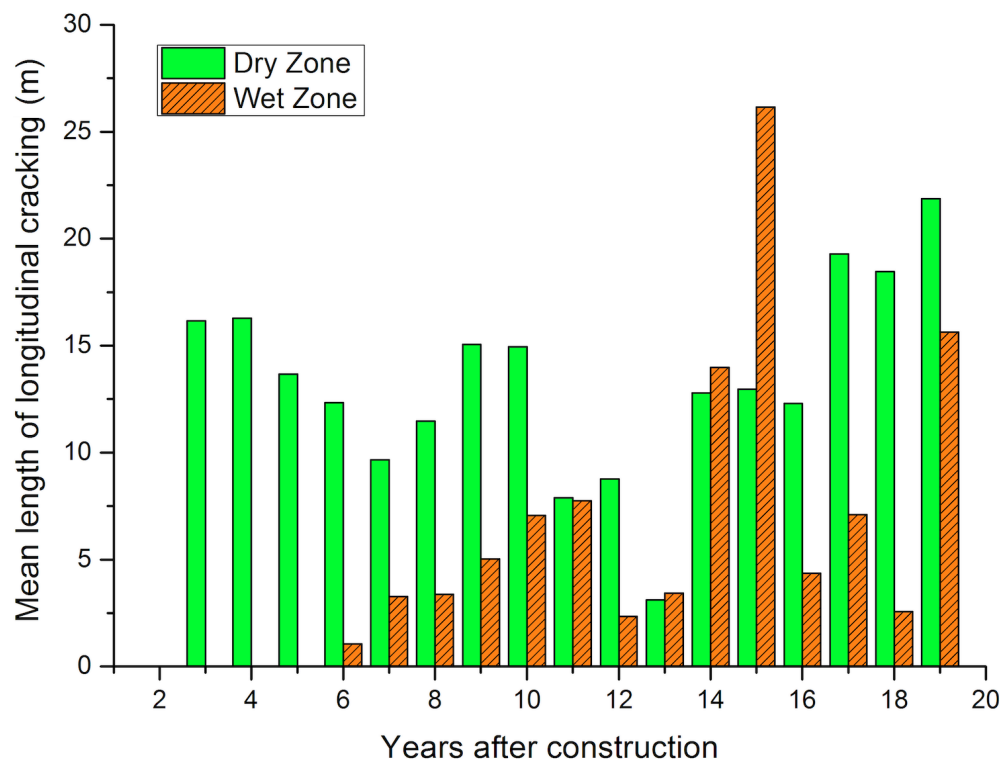
Figure 1. Mean crack length of longitudinal cracking per section for two climatic zones.

Figure 1 and figure 2 show the mean length of longitudinal and transverse cracking in all SPS-2 sections as a function of the year post construction for two climatic zones, respectively. Sections in the dry zone cracked sooner and more extensively than those in the wet zone for both longitudinal and transverse cracks. Significant cracks appeared in the dry zones in year 3. Pavements in the wet zones cracked more gradually, with minor transverse cracking from year 4. However, major longitudinal and transverse cracks were only present from about year 8 onward. Maintenance work was performed at various times but particularly in years 10 and 12, when a significant reduction in crack lengths was apparent.

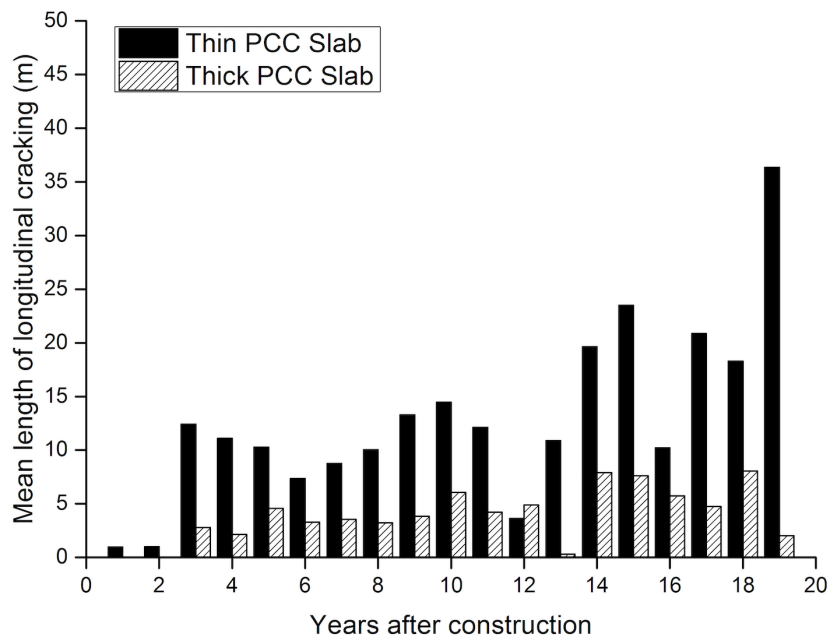
Figure 5. Mean longitudinal crack length per section over time for thin PCC slabs and thick PCC slabs.

design and construction values.<sup>(5)</sup> Figure 5 and figure 6 demonstrate that thicker PCC slabs have better cracking resistance—they develop fewer cracks later in life than the thinner ones.

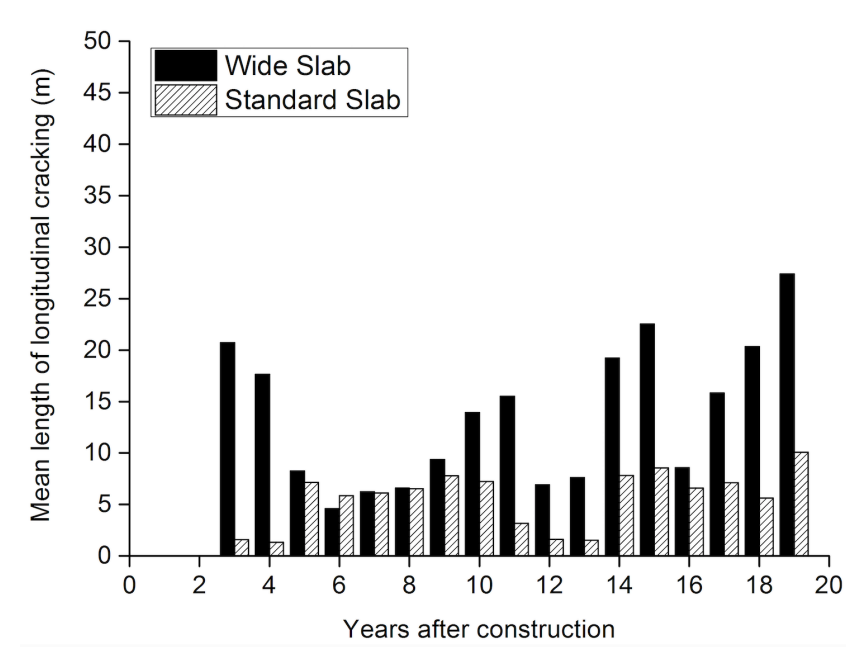
Figure 7. Mean longitudinal crack length per section over time for wide PCC slabs and standard PCC slabs.

The SPS-2 pavement sections were constructed with two different slab widths: “standard” slabs of 3.66 m and “wide” slabs of 4.27 m.<sup>(5)</sup> Figure 7 and figure 8 show that, on average, the sections with widened PCC slabs developed more extensive

longitudinal cracking. Conversely, standard slabs appeared to start cracking transversely earlier in life. Overall, the long-term levels of transverse cracking were approximately the same for both slab widths.

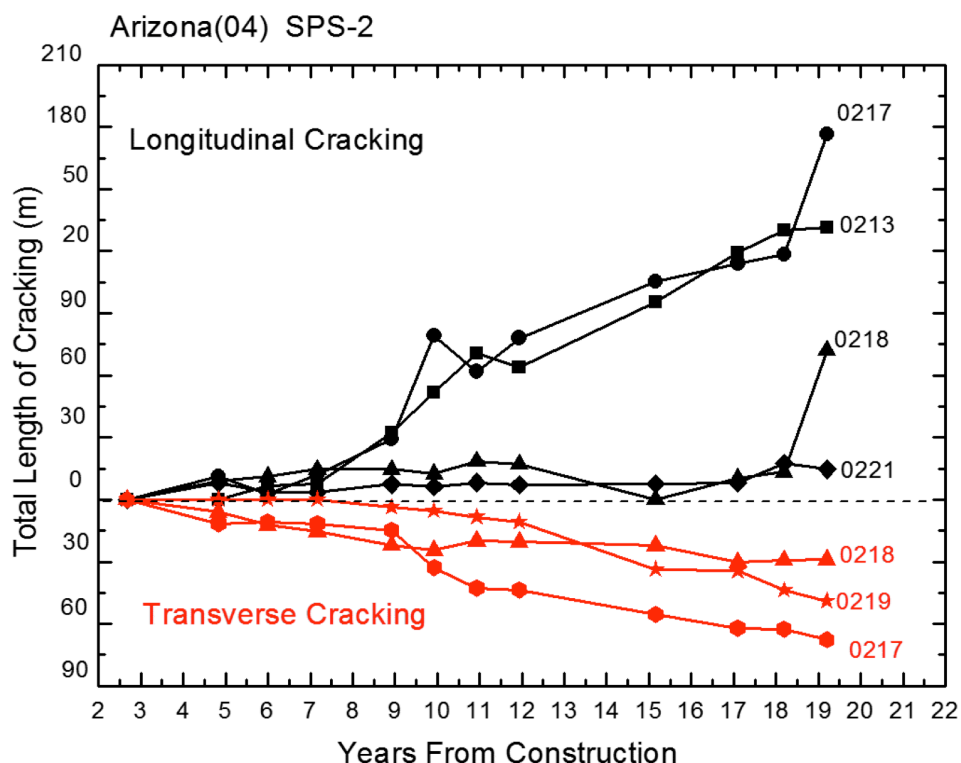
Figure 14 shows the total length of longitudinal cracking and transverse cracking over time in Arizona. The following can be seen:

- Sections 0217 and 0218 had longitudinal and transverse cracks.
- Sections 0213 and 0221 had only longitudinal cracks.
- Sections 0214, 0215, 0219, 0220, and 0222 had very small magnitude of cracking.
- Sections 0216 and 0223 had no cracks.

Figure 14. The total length of cracking over time in the Arizona SPS-2 sites. (Transverse cracking is plotted below the axis for convenience.)

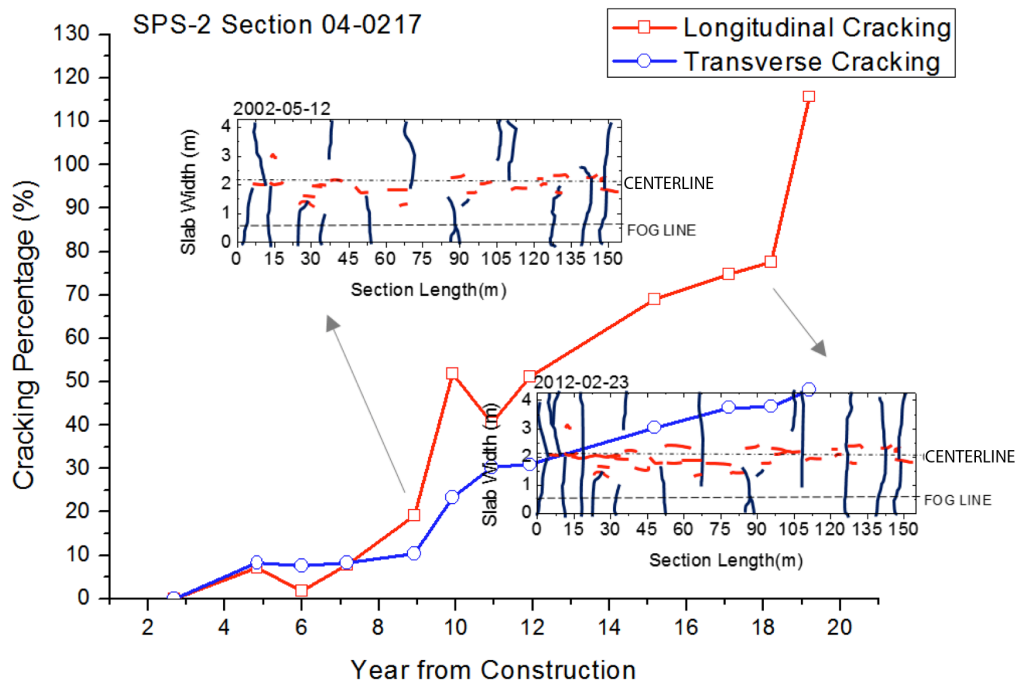
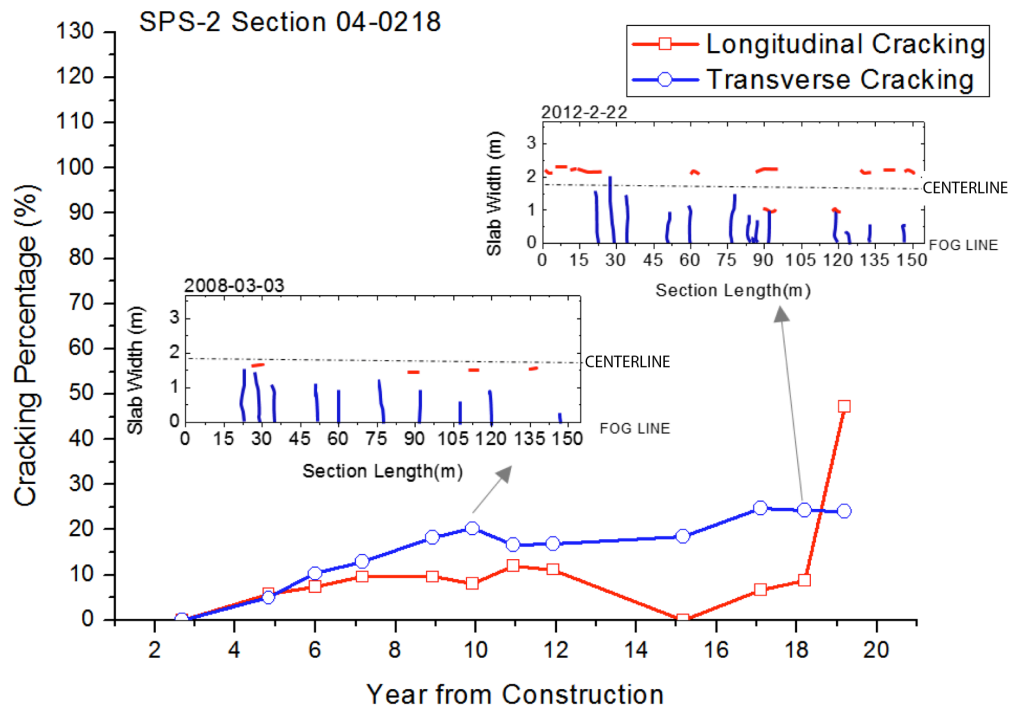
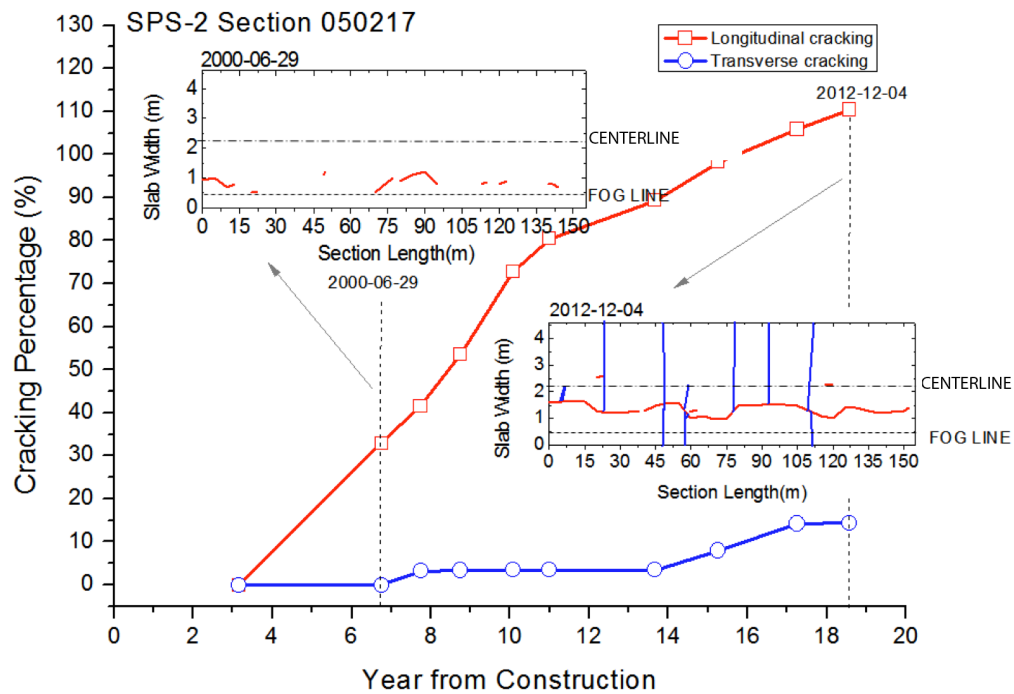
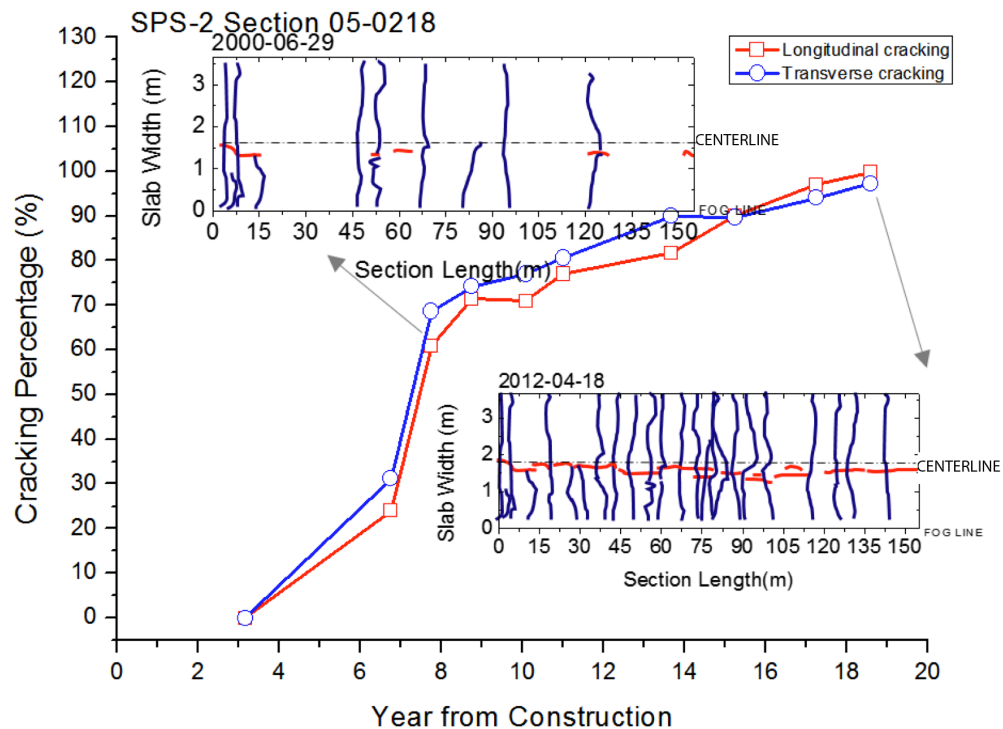
Figure 15 through figure 20 display details of the cracking process in three sections (0213, 0217, and 0218) for Arizona and Arkansas, respectively. Each figure shows the percentage cracking along with recorded snapshots of the patterns of longitudinal and transverse cracks.

The crack patterns revealed that most longitudinal cracks initiated at slab transverse edges, and the rest initiated from transverse cracks. Most transverse cracks initiated at the concrete slab edge close to the shoulder, and the rest initiated either at the slab edge in the middle of the lane (i.e., with the longitudinal joints) or from longitudinal cracks.

The following two patterns of longitudinal cracks were apparent at 20 years of service:

- Almost continuous single crack relatively near the shoulder (as seen for sections 04-0213, 05-0213, and 05-0217).

- A set of discrete cracks closer to the longitudinal centerline of slabs (as seen for sections 04-0217, 04-0218, and 05-0218).

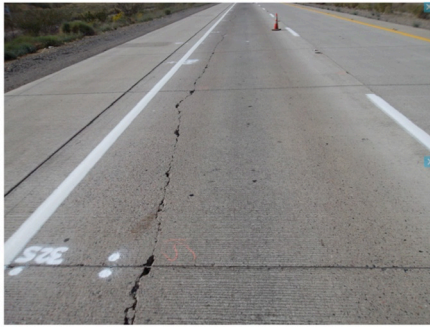
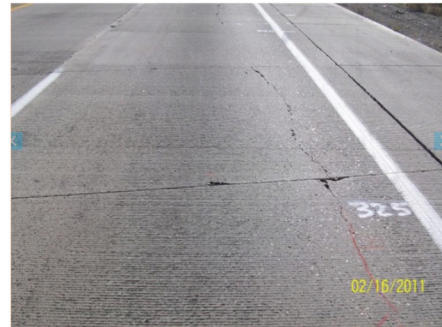
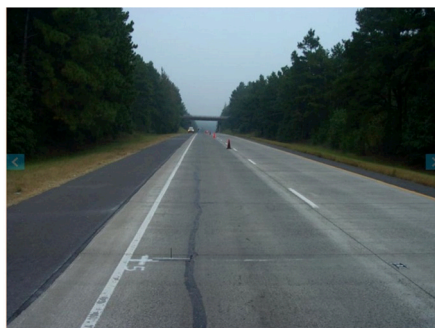
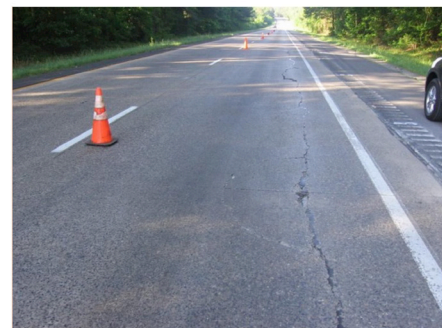
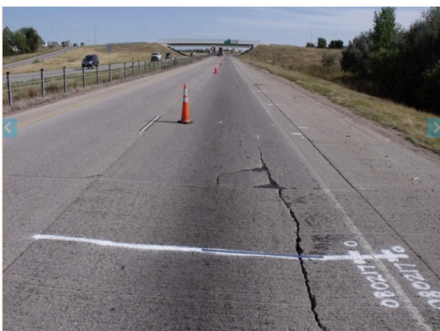
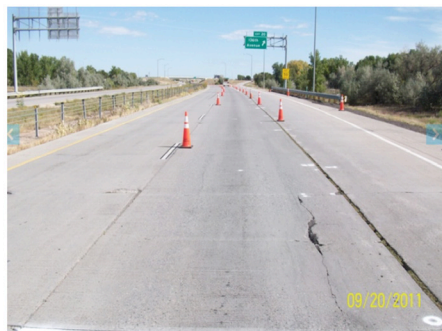
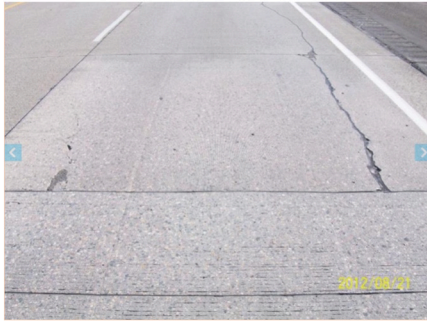
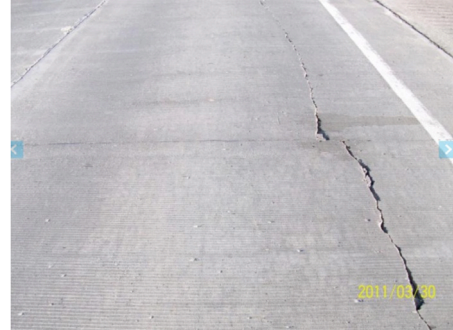
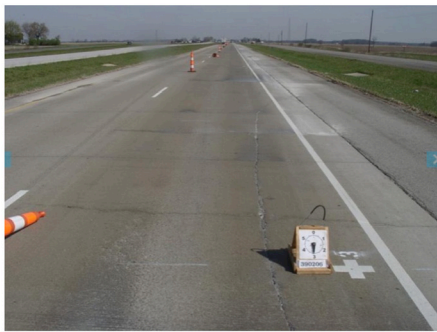
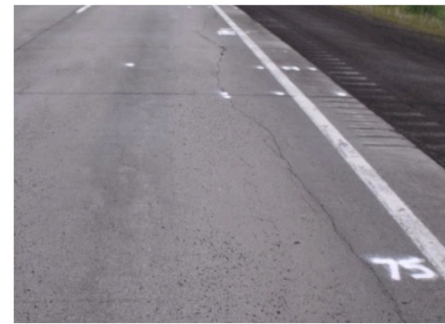
The snapshots featured in figure 21 through figure 30 were selected from 10 different sections in 7 sites (States). They share almost continuous single cracks relatively near the shoulder. These cracks occurred only

in the sections with DGAB (section 0213) and LCB (sections 0217, 0218, and 0206). This pattern of cracking was only found in the 10 sections in LTPP SPS-2 (according to monitoring results updated in 2013).

Details of the structural factors and climatic conditions of these sections are presented in table 3. The table shows that the pattern of longitudinal cracking was only exhibited in thinner pavements (design depth: 203 mm). By contrast, other sections with thick slabs (design depth: 279 mm) did not exhibit such longitudinal cracking. The table also shows

that this pattern of longitudinal cracking occurred mainly in sections constructed with wide slabs (with the exception of section 08-0218). This longitudinal cracking pattern (single cracking near the shoulder) occurred for soil types, shoulder types, and climatic conditions.
