FHWA/LTPP Monitoring Program
Post-Diagnostic Investigation Report
Seasonal Monitoring Section 091803
Groton, Connecticut

Report No. FHWA-TS-07-09-01

16. Abstract This report provides a description of the post-diagnostic activities conducted at the Long Term Pavement Performance (LTPP) General Pavement Study (GPS) section 091803, located on northbound RT 117, approximately 1.5 kilometers north of the Center Groton town limits and 5 kilometers north of the Groton city limits. The post-diagnostic survey was conducted to provide supplemental data for evaluation of material properties and condition assessment for the Seasonal Monitoring Program (SMP) instrumentation that was installed on August 19, 1993. On May 3, 2000 the asphalt surface was removed from the area where the environmental instrumentation was installed. A portable hand held pavement saw was used to cut an area from the edge of the paved shoulder to 0.5 meters on the other side of the existing instrument hole (Station 5+21), to the depth of the granular base (0.189m). The pavement slab was then lifted with the backhoe bucket; broken into moveable pieces and removed from the instrument hole location and trench. A test pit

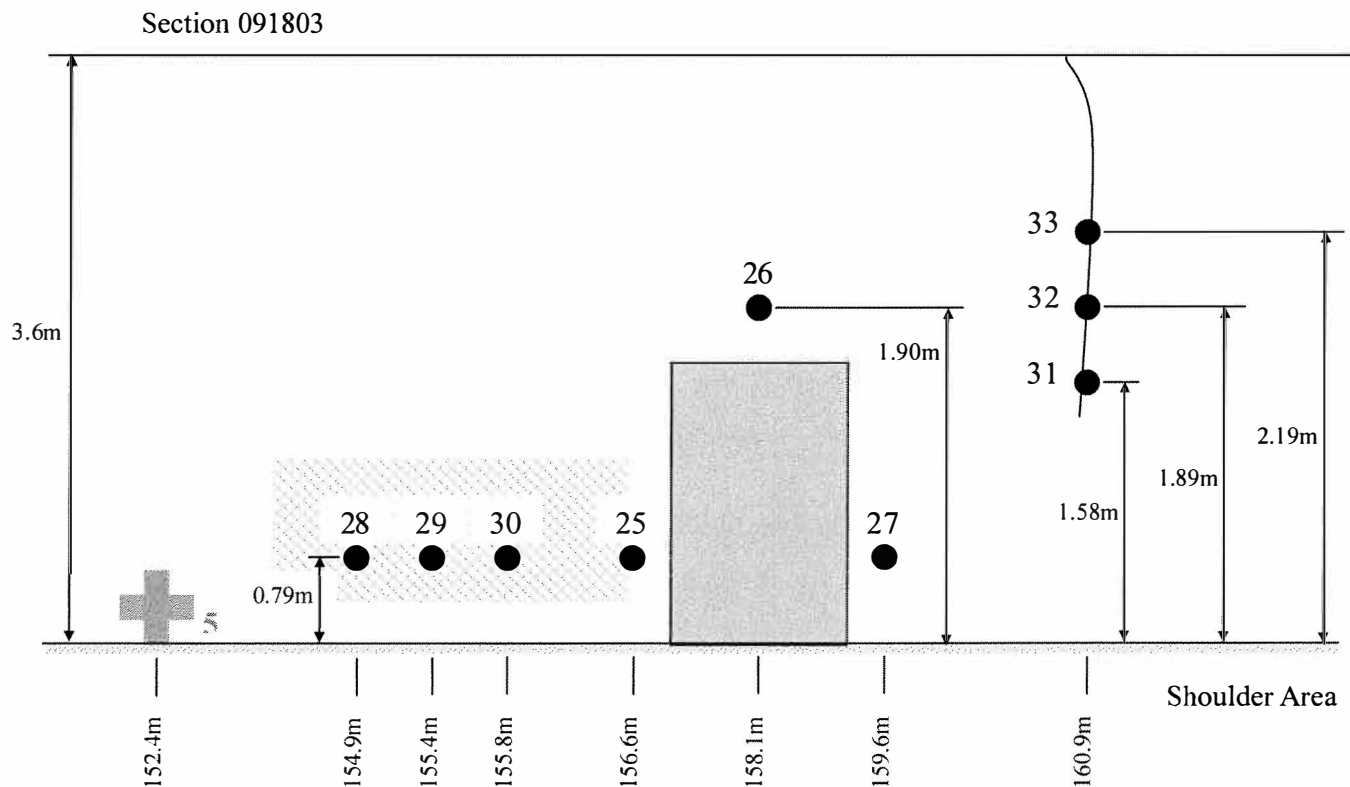
Figure 2: Diagram of Core Sample Locations

To examine the surface thickness at the FWD test locations and along cracks that had formed in the pavement surface layer, nine 4-inch cores were extracted near the test pit location at the 5+00 end of the GPS section. No samples were possible at the FWD test locations within the section as this site was to remain in the LTPP program as a GPS-6. Figure 2 provides a diagram outlining the location for the 4-inch cores. Cores 25, 26 and 27 were placed at the FWD test spots located at the instrumentation area. Cores 28-30 were placed prior to the instrument hole in the outer wheel path in an area exhibiting fatigue cracking with cores 31-33 placed along a transverse crack that was 2.1 meters north of the instrument hole. Table 6 provides a summary of the core thickness and condition. Figure B-1 through B-10, Appendix B provides photos of the coring operation and the nine cores extracted. The fatigue cracking in the wheel path initiated in the surface and extended to a depth of 12-50mm. The transverse cracks initiated in the surface and extended to a maximum depth of 152mm. The exception was core 33 which separated at the crack location. The core width ranged from 2-12mm with the larger gap at the surface. Spalling was evident on the transverse cracks. The core thickness on average was some 10mm less than that recorded for the test pit (189mm).

Core Hole No.	General Distress Type	Cracking/Spalling Information			Additional Notes	
25	Start of fatigue cracking	Cracking 26mm down one side of core				
26						
27	Fatigued FWD location	Sealed cracks - depth of 47mm & 24mm				
28	Fatigue region - cracking starting at surface	Cracks measured as deep as 12mm				
29		Cracks measured as deep as 50mm				
30		Cracks measured as deep as 44mm				
31	Transverse crack propagating through entire core	102mm & 152mm crack depth on side of core	Cracks 3-4mm wide on surface	Crack not quite through cores entire depth		
32		Crack originating at surface	Crack width 8-13mm at top, 2-3mm at bottom	Partially spalled	Material beginning to separate along failure plane	Core in various pieces
33		Transverse crack spalls off side of core				Core in various pieces, Broken along failure plane

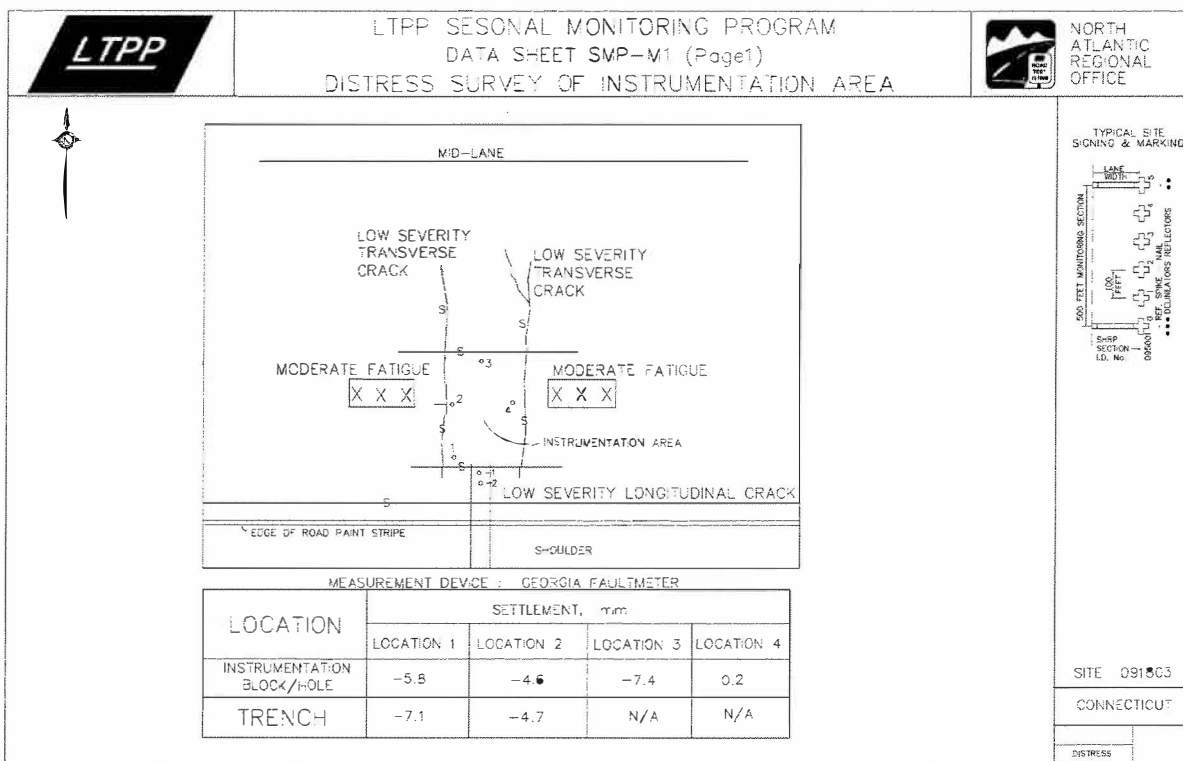
Figure 3: Distress Survey of Instrumentation area.

6. **Instrument Hole Distress** - Access for the instrument hole at 091803 was through a square block cut from the ACC surface. Over time cracks had formed at the end of the saw cuts and the slab and trench had settled as is shown in Figure 3. The cracks at the instrument hole area were well sealed (see Figure A-1, Appendix A) which would indicate that the conditions surrounding the block would have had little if any effect on the instrumentation.

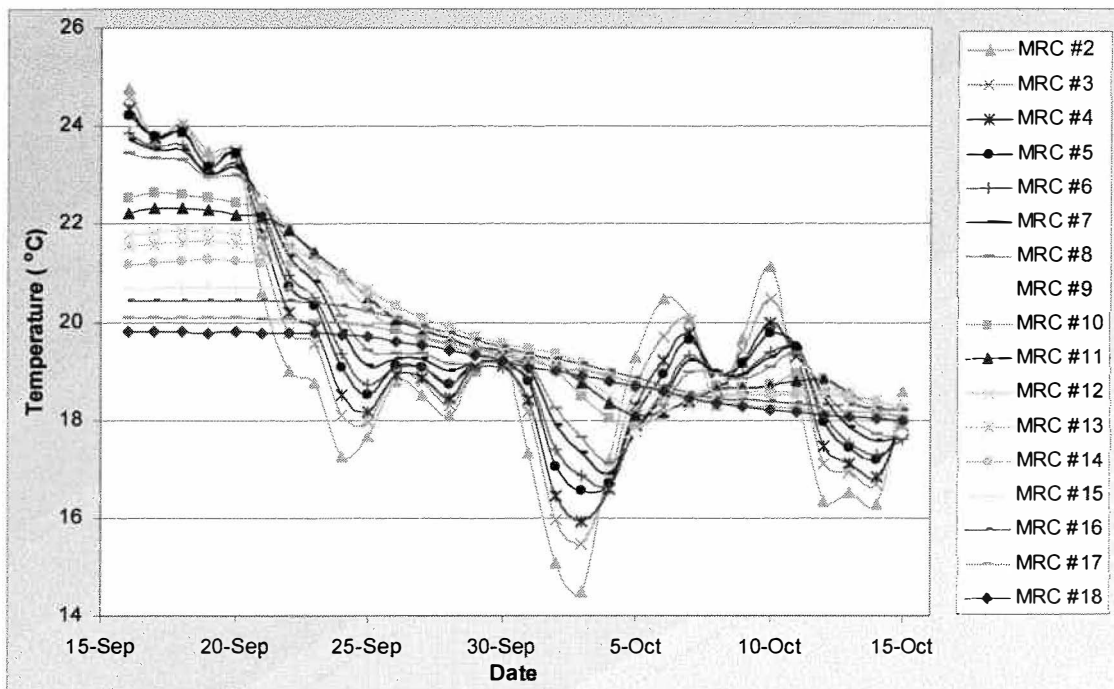
Figure 4: Temperature Profile from the MRC Thermistor Probe

7. **Temperature** - The MRC thermistor probe was connected to the CR10 datalogger and the measurements were monitored for approximately one hour. Seventeen of the eighteen MRC thermistor sensors were operational and provided reliable results. The number one MRC thermistor was inoperative, which is typical as this sensor is closest to the surface, and is the least protected from the environmental and traffic impact. The temperatures from the final month (in year 2000) as provided by the MRC thermistor probe are provided in Figure 4.

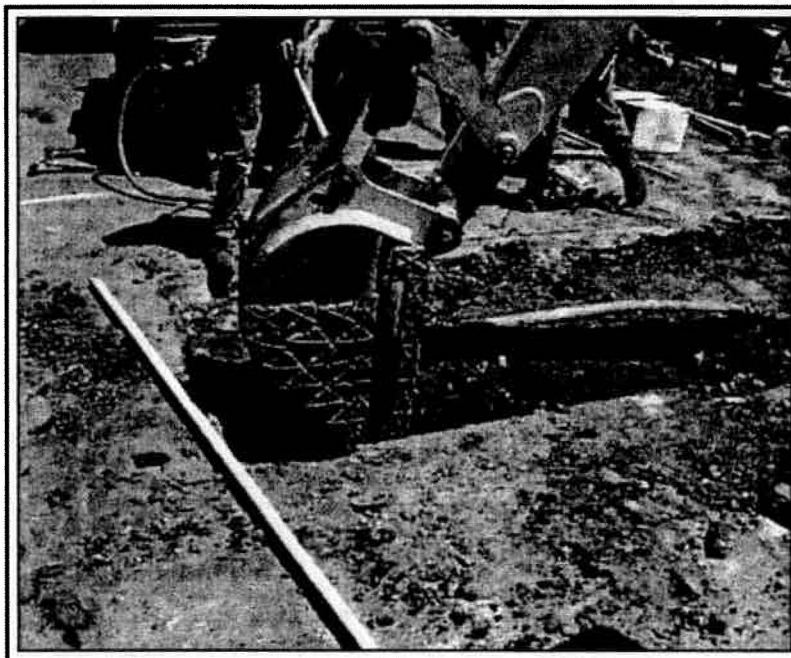
Figure A-2. Pavement slab removal

The asphalt surface was removed from the area where the environmental instrumentation was installed at Station 5+20. A portable hand held pavement saw was used to cut an area from the edge of the paved shoulder to 0.5 meters on the other side of the existing instrument hole, to the depth of the granular base (0.189m). The pavement slab was then lifted with the backhoe bucket; broken into moveable pieces and removed from the instrument hole location and trench as shown in Figure A-2, Appendix A.

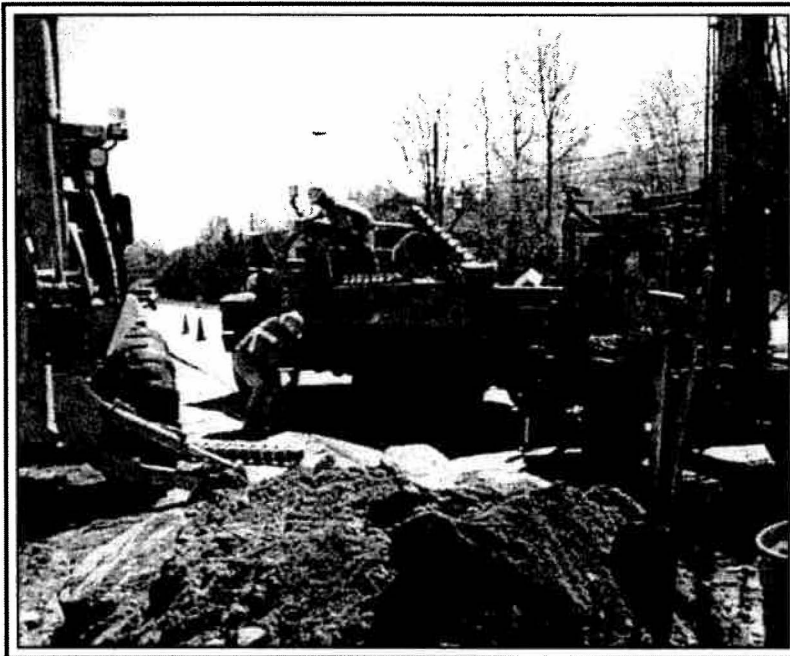
Figure A-3. Excavation of rock material

A test pit was then excavated to provide access to determine material type and depth, perform nuclear gauge tests, remove material samples for moisture and laboratory tests, and examine the sensors previously installed at the test area for condition and interface with the surrounding soil. A backhoe was used to remove the soil in layers of approximately 0.3 meters to a depth of 1.5 meters, adjacent to the location of the installed instrumentation. Many larger boulders were encountered in the removal of the subbase material, requiring patience and care in operation on the part of the backhoe operator. Figure A-3, Appendix A provides a photo of the large rocks removed during the excavation. A pick, shovel and scoop were used at the nuclear gauge test and sensor locations to level and remove material. The use of the backhoe made it easy to examine the various material layers, sample the soils and remove the environmental sensors.

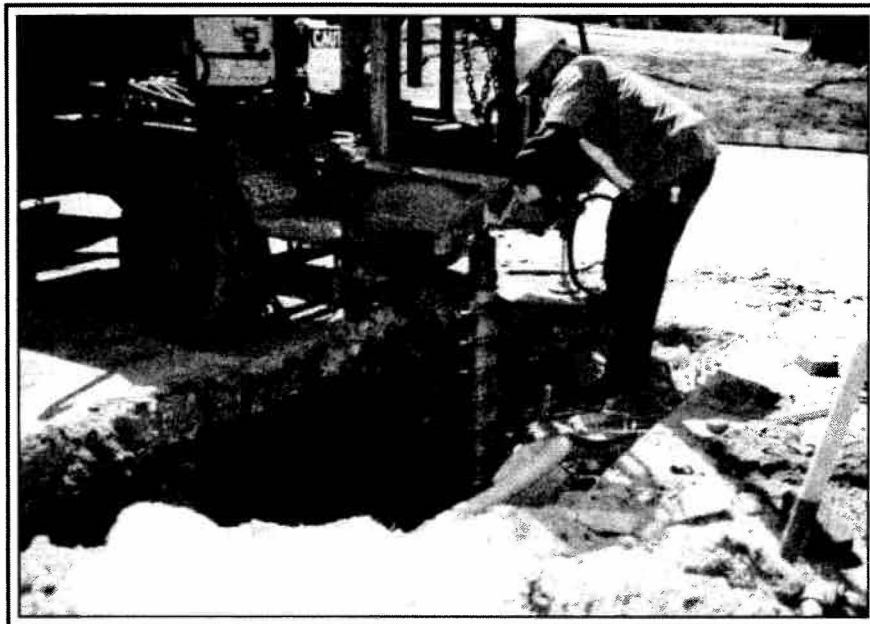
Figure A-4. Drilling operation

To gain access to the materials and sensors below 1.5 meters a portable drill rig with a 225 mm flite auger was used to remove material to a depth of slightly more than 2 meters. The auger operation was slightly hampered by water infiltration from a ground stream that seemed to flow at the interface between the subbase and subgrade layers. Additionally, there was a large rock (sandstone) at the bottom of the subbase that was augered through at the time of installation. Figure A-4, Appendix A provides a photo of the drilling operation.

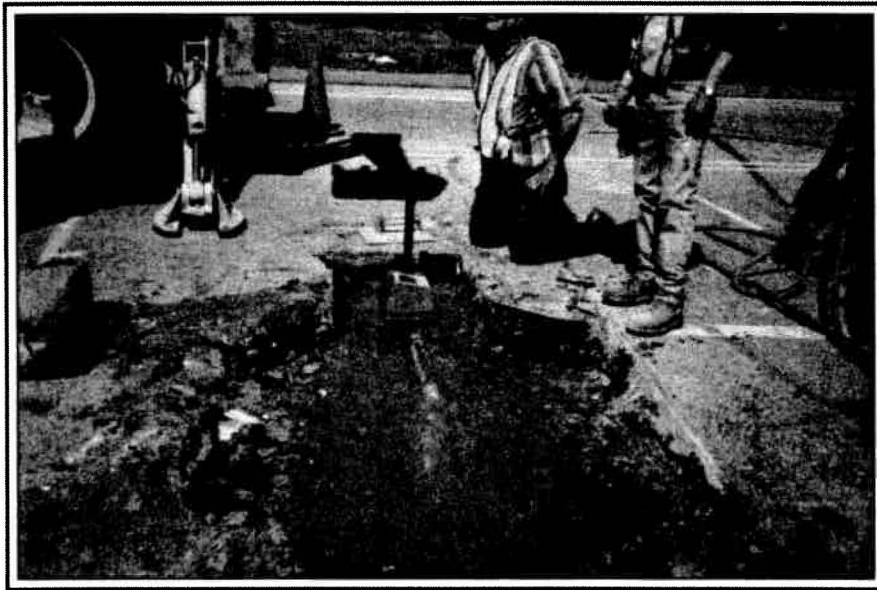
Figure A-5. Nuclear density test of base materials

Immediately after the removal of the surface layer, a nuclear gauge backscatter density and moisture sample were taken above the instrument hole at 0.191 meters below the surface (adjacent to TDR probe 1). Subsequent to this test, 150 mm direct transmission nuclear gauge samples were taken at:

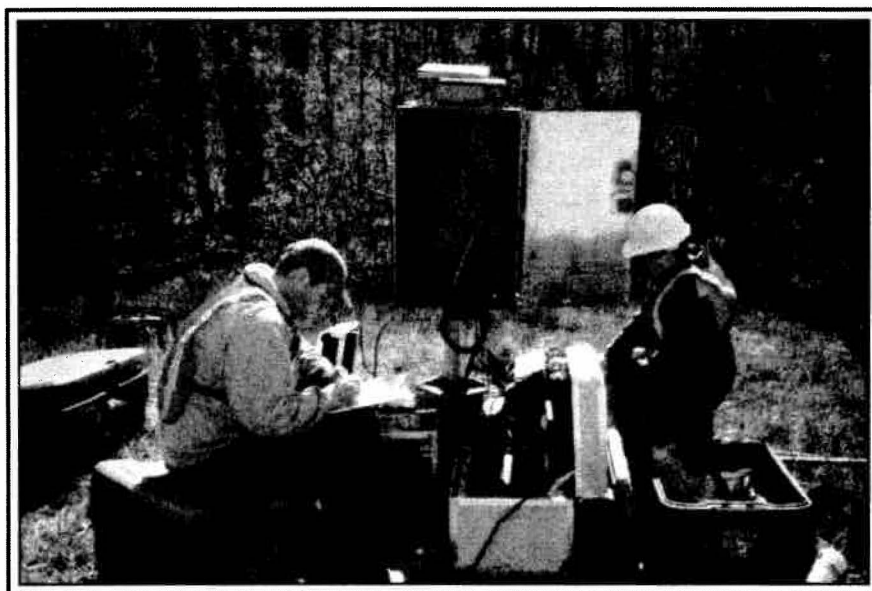
Figure A-8. Final automated data collection

1. **Automated TDR** - Three sets of Mobile automated TDR measurements initiated at 8:54 am, 9:47 am and 10:03 am. Figure A-8, Appendix A provides a photo of the operators collecting the final set of automated TDR data. All ten TDR sensors were working and provided a good trace. An intermittent trace on the Number 2 TDR sensor was considered a Mobile multiplexer problem and had nothing to do with the cable itself. There appears to be moisture in the connector at the Printed Circuit Board (PCB) mating the cable to the probe for sensors four and eight, but this has little or no affect on the probe output. The first set of TDR traces had the cables improperly connected for multiplexer 1; the probe locations were readjusted to display the probes in the correct order. Appendix C, Figures C-1 through C-3 provide the TDR traces for the three TDR data sets initiated at 8:50, 9:47 and 10:03. Table 7 provides the volumetric moisture content determined from the 3 TDR data sets.

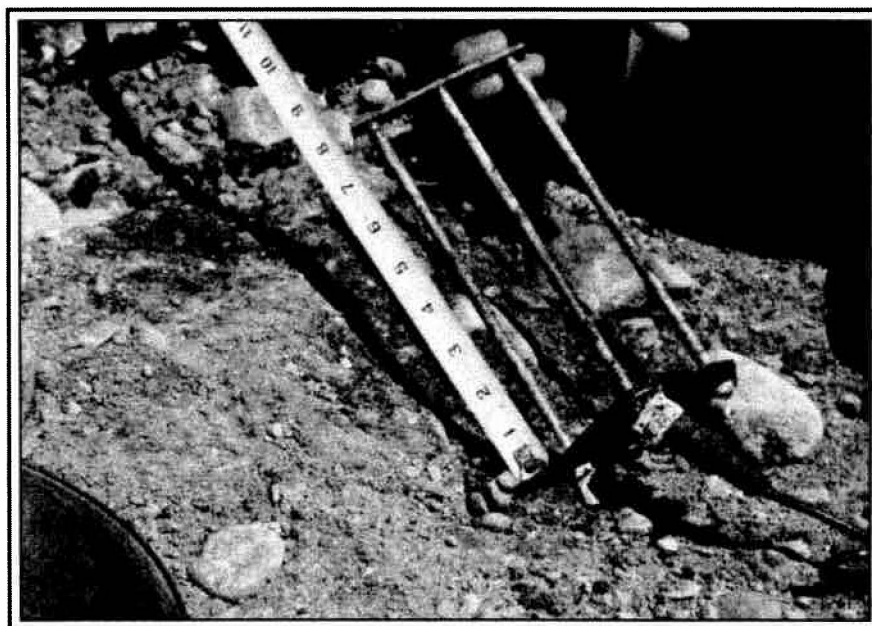
Figure A-10. Damaged TDR probe during excavation

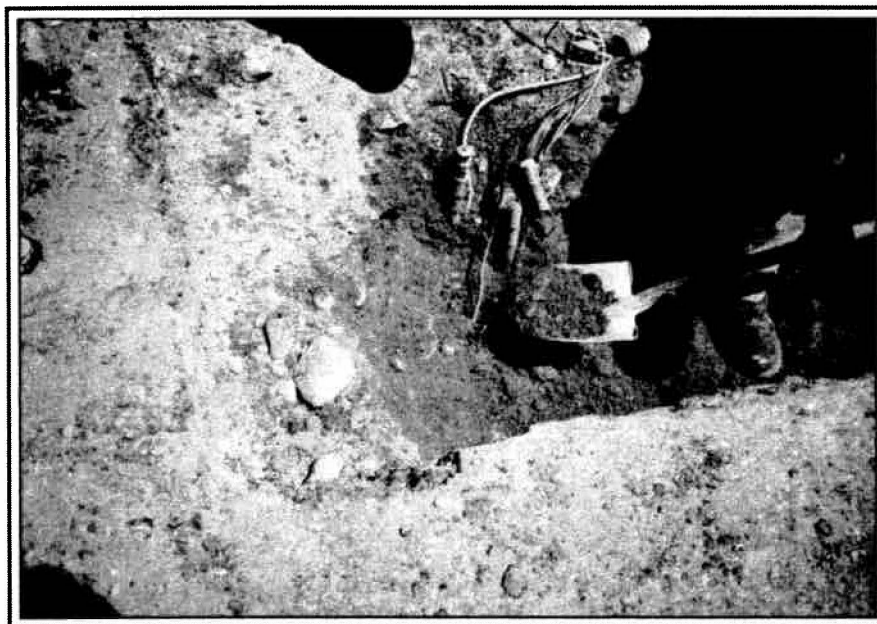
Figure A-11. MCR thermistor probe damaged during rock removal
