LOAD RESPONSE INSTRUMENTATION OF SHRP PAVEMENTS -  
THE UNIVERSITY OF CINCINNATI

Andrew Bodocsi, Ph.D., P.E.  
and  
Mark T. Bowers, Ph.D., P.E.

May 2001  
University of Cincinnati  
Cincinnati, Ohio

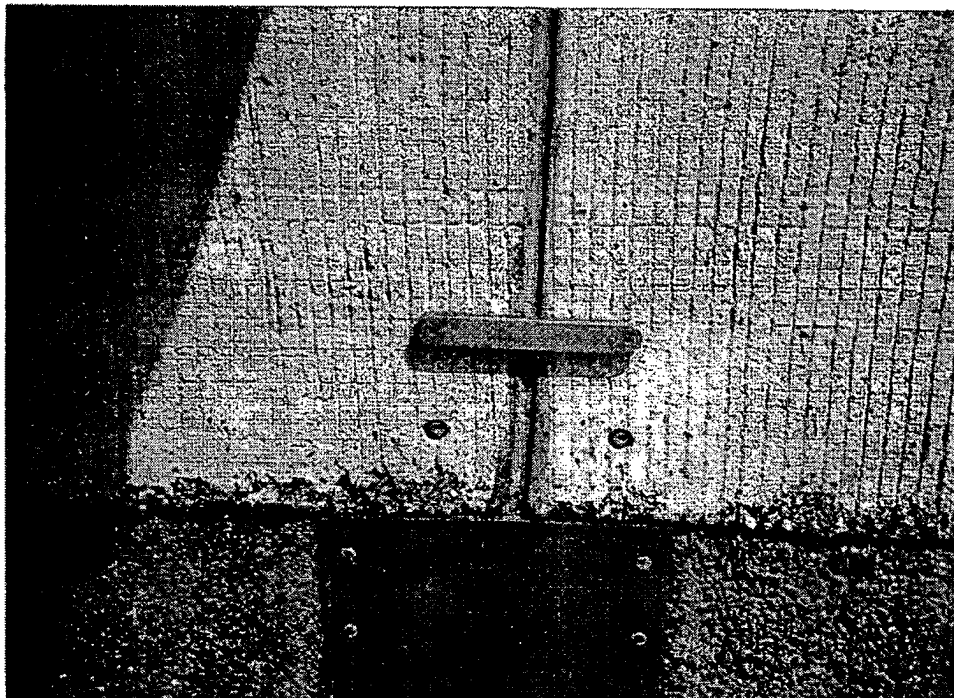
Fig. 18. Brass Plugs and Invar Calibration Bar

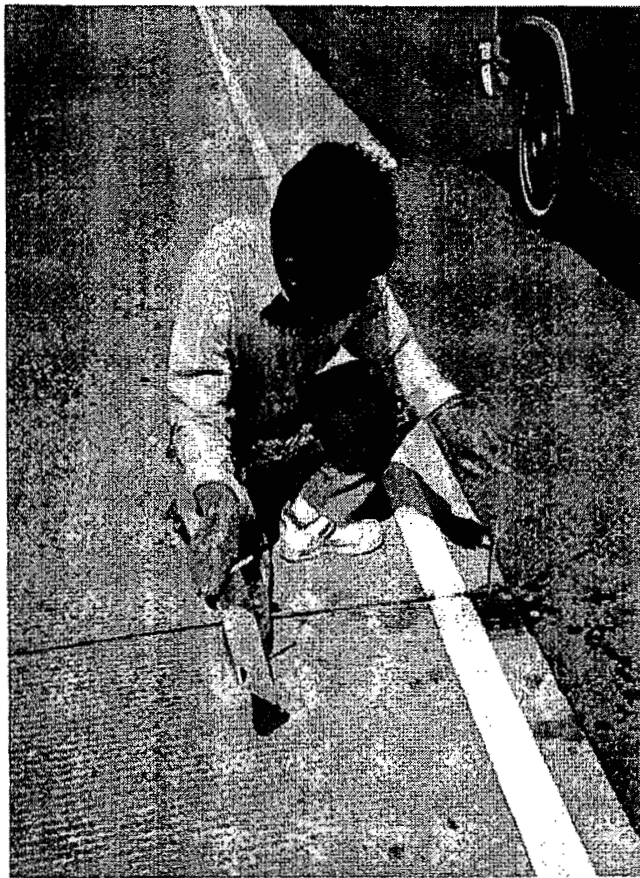
**Fig. 19. Pavement Temperature Measurements**
