EFFECTIVENESS OF BASE TYPE ON THE
PERFORMANCE OF PCC PAVEMENT ON ERI/LOR 2

INTERIM REPORT

CONTINUED MONITORING OF INSTRUMENTED
PAVEMENT IN OHIO – State Job No. 14652(0)

April 2000

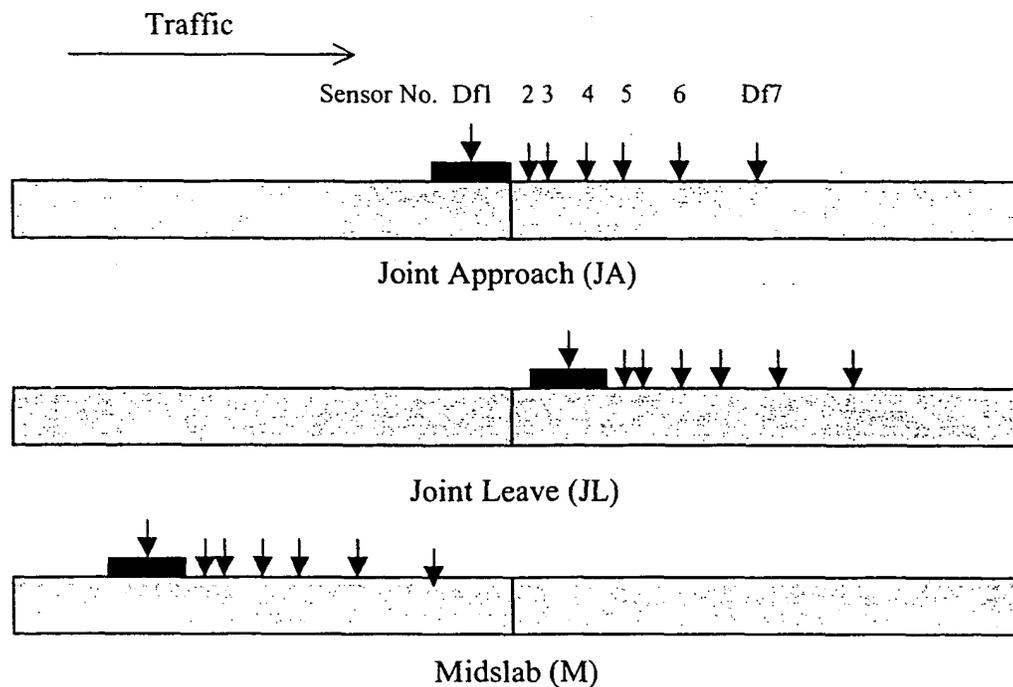
Sensor spacing from center of load plate: 0, 8, 12, 18, 24, 36 and 60 inches

Figure 4.1 FWD Load Plate and Sensor Positioning – June 1999

In this set of FWD measurements, a few slabs were selected for testing in each section containing a particular combination of joint spacing and base type. The load plate was placed on both sides of the joints and at one or more locations along the interior of the slab. In these configurations, the geophones measuring vertical surface deflection were located as shown in

Figure 4.1. Readings were initiated at 8:40 am, at which time the surface temperature of the pavement was 69° F.

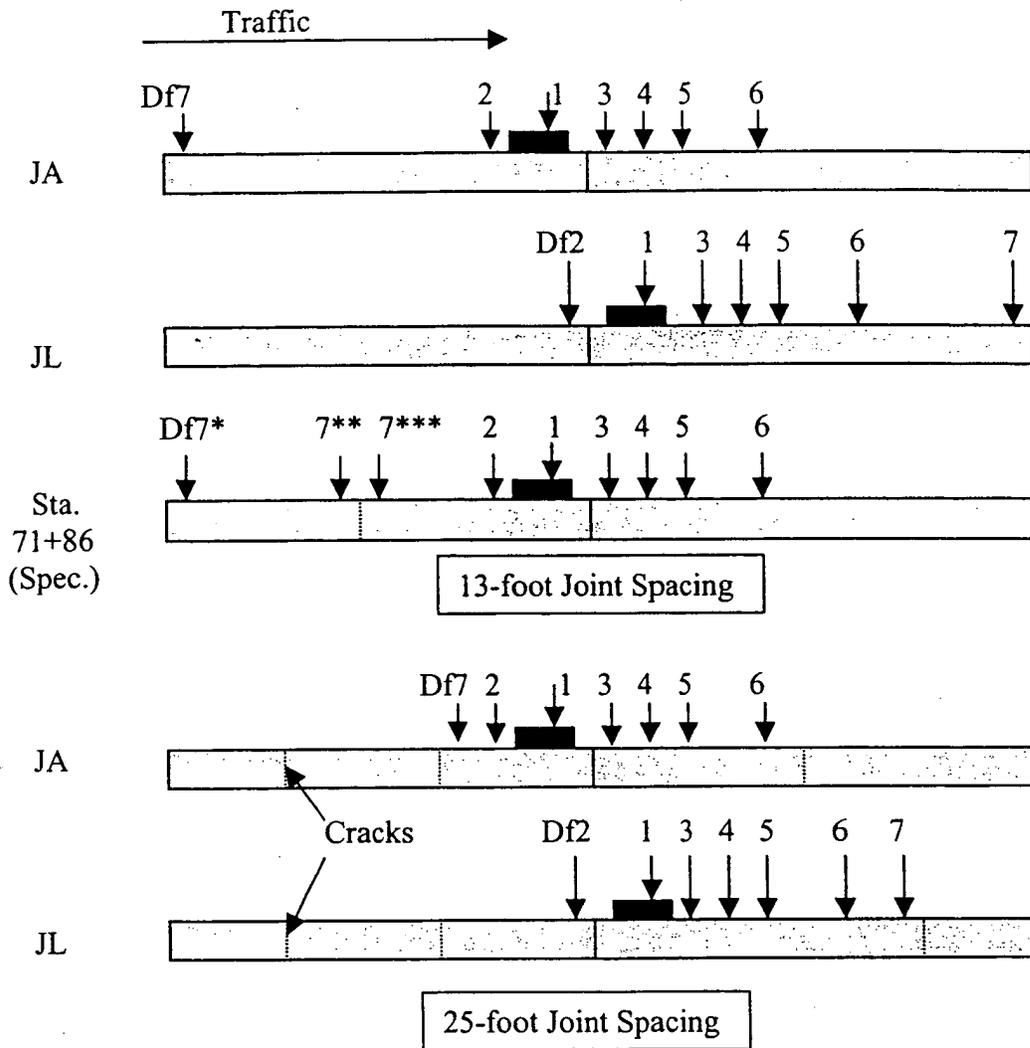
Sensor spacing from center of load plate: -12, 0, 12, 18, 24 and 36 inches, with Df7 being placed just inside the nearest crack or joint on the loaded slab

Figure 4.2 FWD Load Plate and Sensor Positioning – August 1999

As mentioned earlier, another parameter investigated during the August 1999 FWD measurements was slab rocking. To see if a cracked slab was rocking, the load plate was positioned in either the joint approach or joint leave position, and a remote geophone with a long

cable was connected to the connector for Sensor 7. This geophone was placed by hand just inside the nearest joint or crack on the slab where the load plate was located. In this configuration, the load plate with Sensor 1 was on one end of the slab and Sensor 7 was on the other end of the uncracked slab or cracked partial slab. If the slab was rocking, it was expected that there would be a measurable negative deflection at the slab end opposite the load. Unfortunately, the FWD only records the peak downward deflection for each drop and, therefore, geophones located in the area of the slab moving upward would measure zero as the peak downward deflection. In hindsight, a deflection history should have been run with the FWD during these runs to actually determine this negative deflection. Another possible test for a rocking slab would be to position the remote sensor at various distances along the length of the slab, plot the positive (downward) maximum deflections measured over that portion of the slab moving downward, and extrapolate these values across the upward moving portion of the slab. Because of the stiffness of the PCC slab, these deflections should plot as a straight line. The point of zero deflection would be the fulcrum over which the slab was rocking. Figure 4.2 shows the positioning of the load plate and geophones in the August 1999 readings.

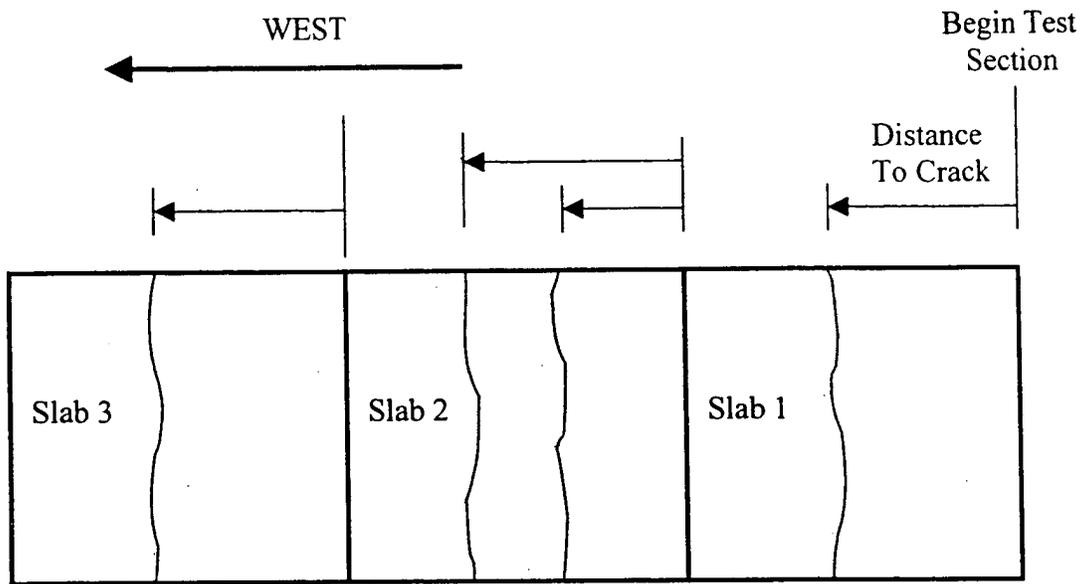
Numbering Convention

Slabs numbered from east to west
 Transverse cracks measured from east end of slab
 Slabs shaded in table have longitudinal cracks
