# 2003 Comparison Testing of LTPP Profilers Final Report

April 2004

FHWA-LTPP Technical Support Services Contractor  
Soil and Materials Engineers  
43980 Plymouth Oaks Blvd.  
Plymouth, Michigan 48170

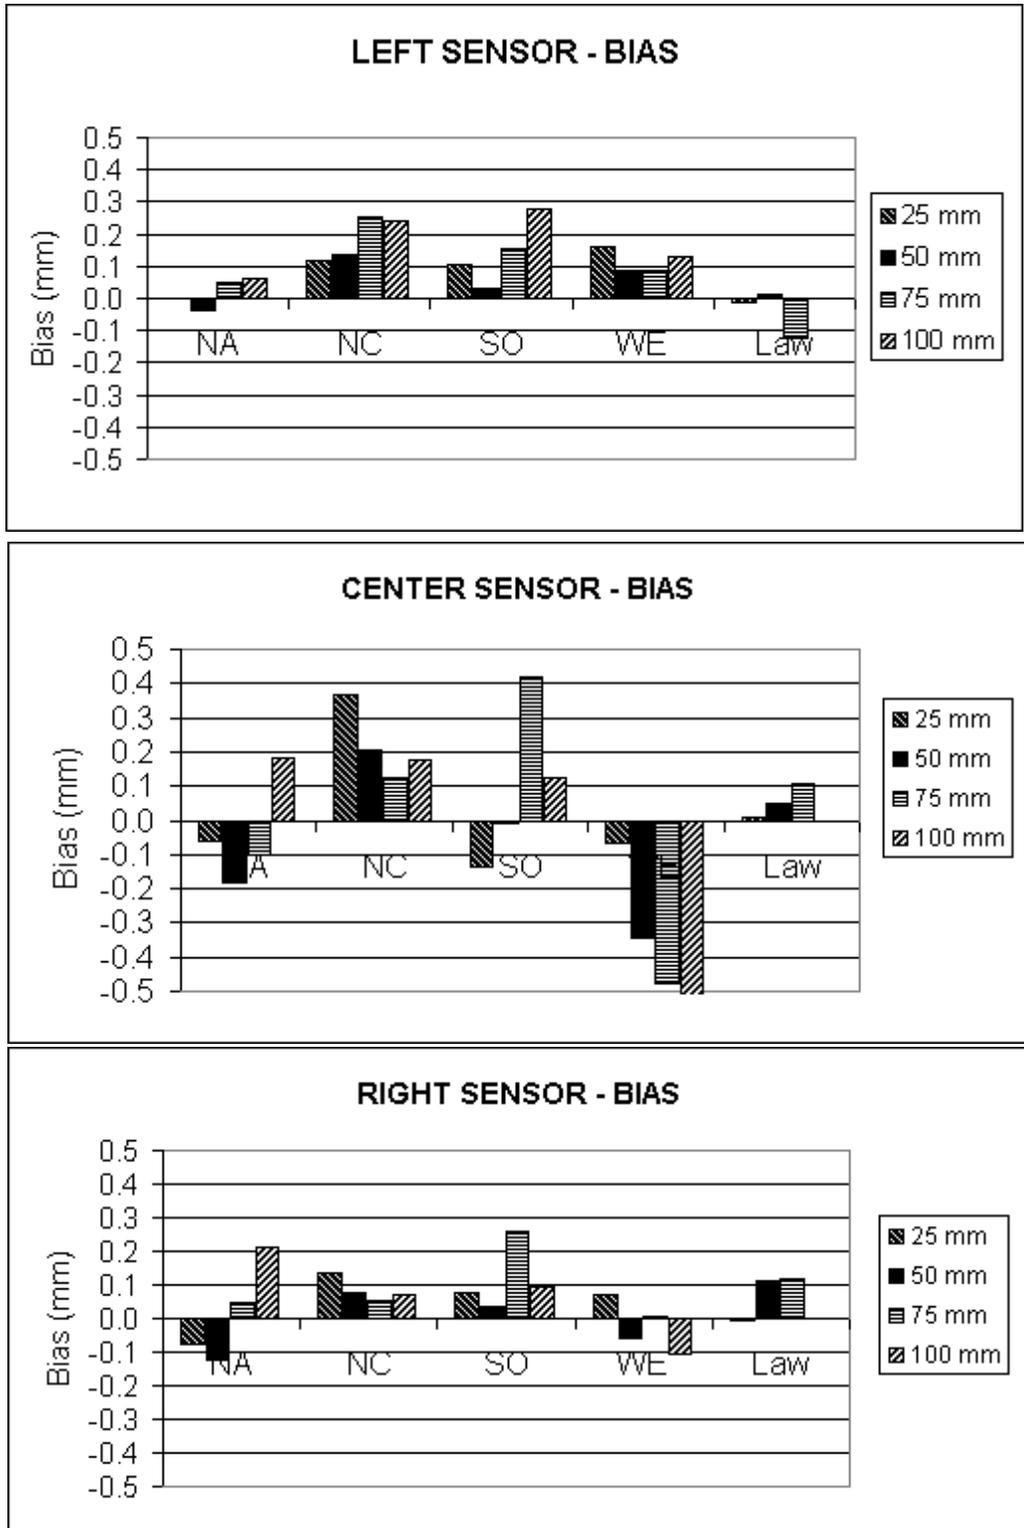
Figure 3.1. Bias values from static height sensor test (NA- North Atlantic, NC – North Central, SO – Southern, WE – Western).

The following sensors did not meet the specified bias criterion of  $\pm 0.25$  mm: (1) North Central center sensor at 25 mm, (2) North Central left sensor at 75 mm, (3) Southern left sensor at 100 mm, (4) Southern center sensor at 75 mm, (5) Southern right sensor at 75 mm, and (6) Western center sensor at 50 mm, 75 mm and 100 mm.

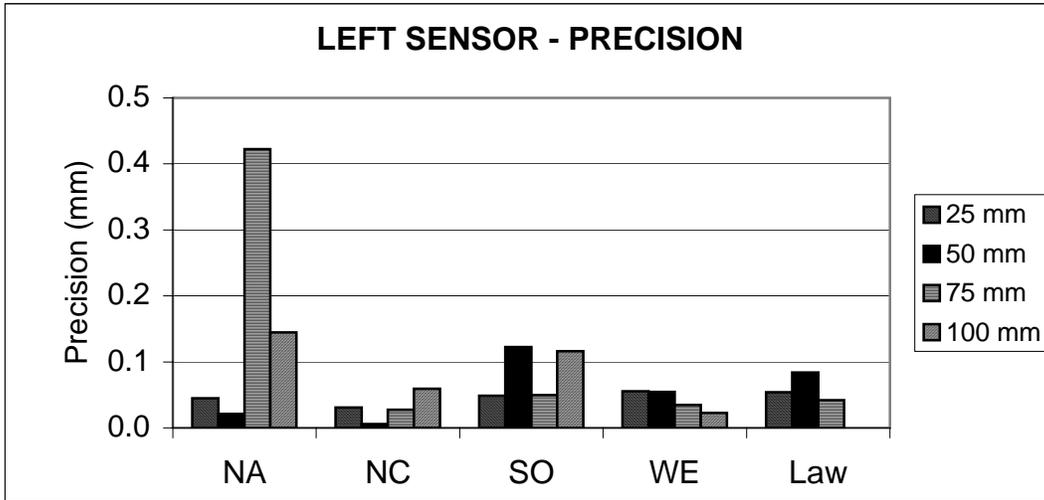
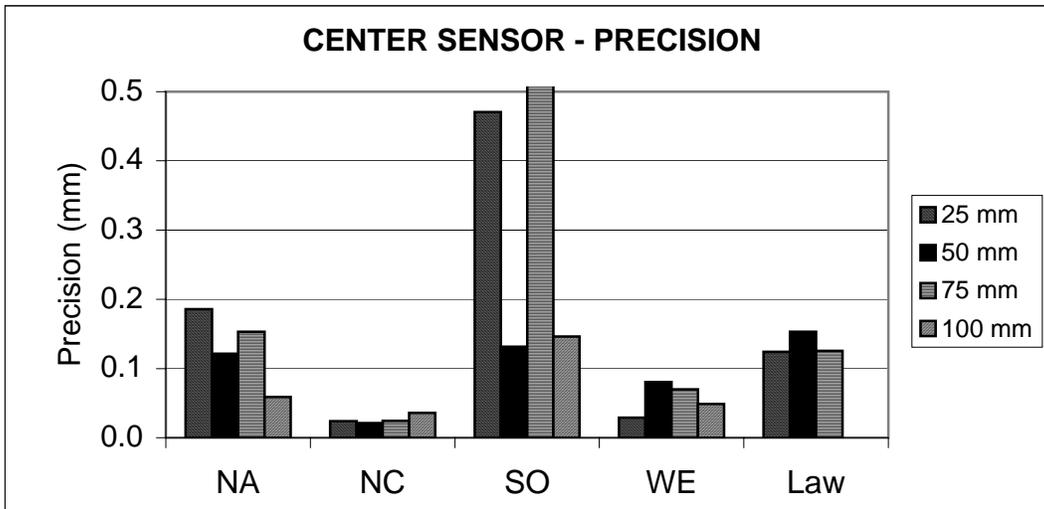
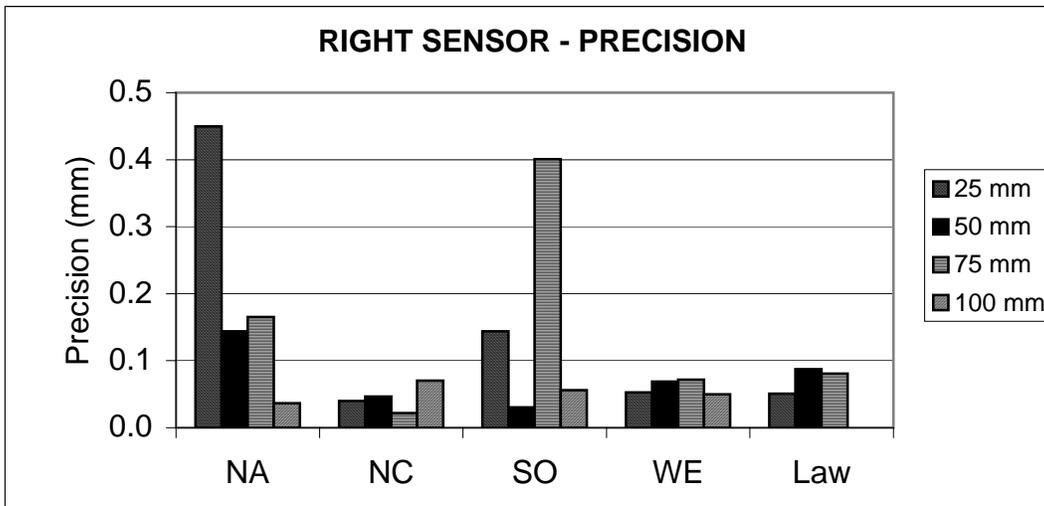
Figure 3.2. Precision values for height sensors from static height sensor test (NA- North Atlantic, NC – North Central, SO – Southern, WE – Western).

The following sensors did not meet the specified precision criterion of 0.125 mm: (1) North Atlantic center sensor at 25 mm and 75 mm, (2) North Atlantic right sensor at 25 mm, 50 mm, and 75 mm, (3) North Atlantic left sensor at 75 mm and 100 mm, (4) Southern center sensor at 25 mm, 50 mm, 75 mm, and 100 mm, (5) Southern right sensor at 25 mm and 75 mm, and (6) K.J. Law center sensor at 50 mm and 75 mm.

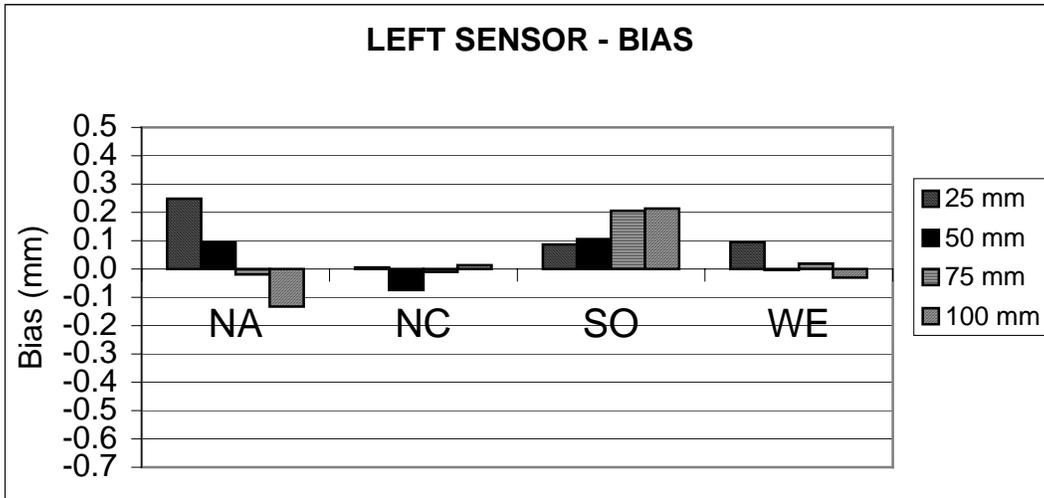
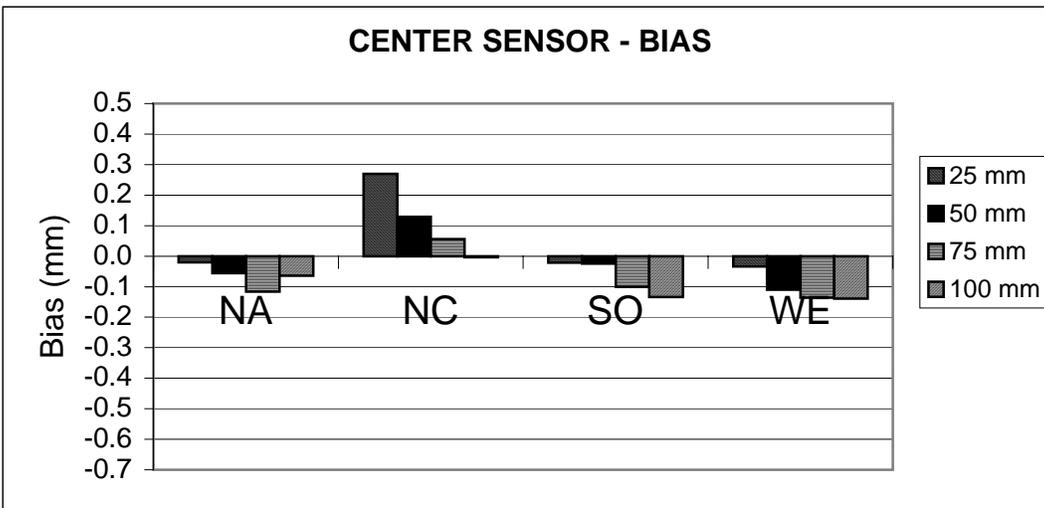
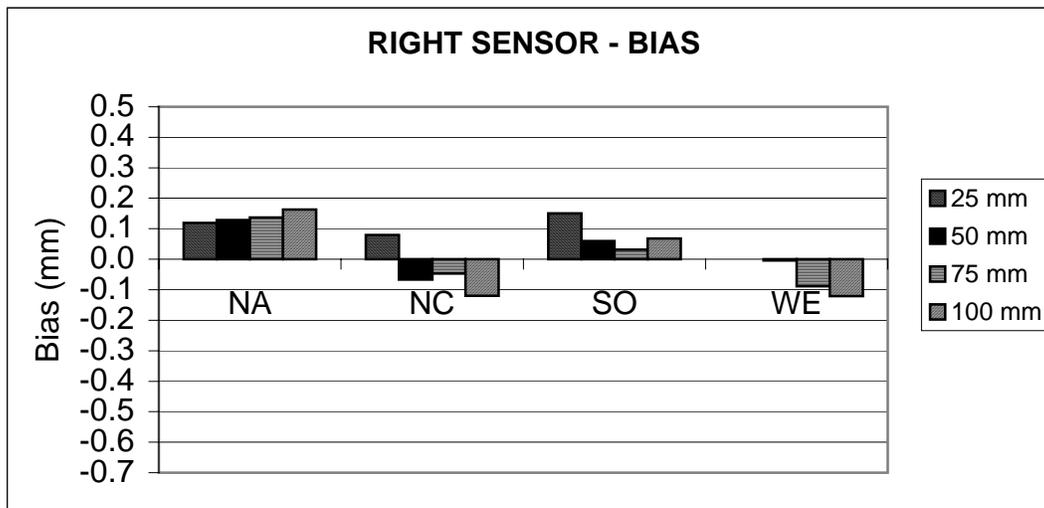
Figure 3.3. Bias values from repeat static height sensor test (NA – North Atlantic, NC – North Central, SO – Southern, WE – Western).

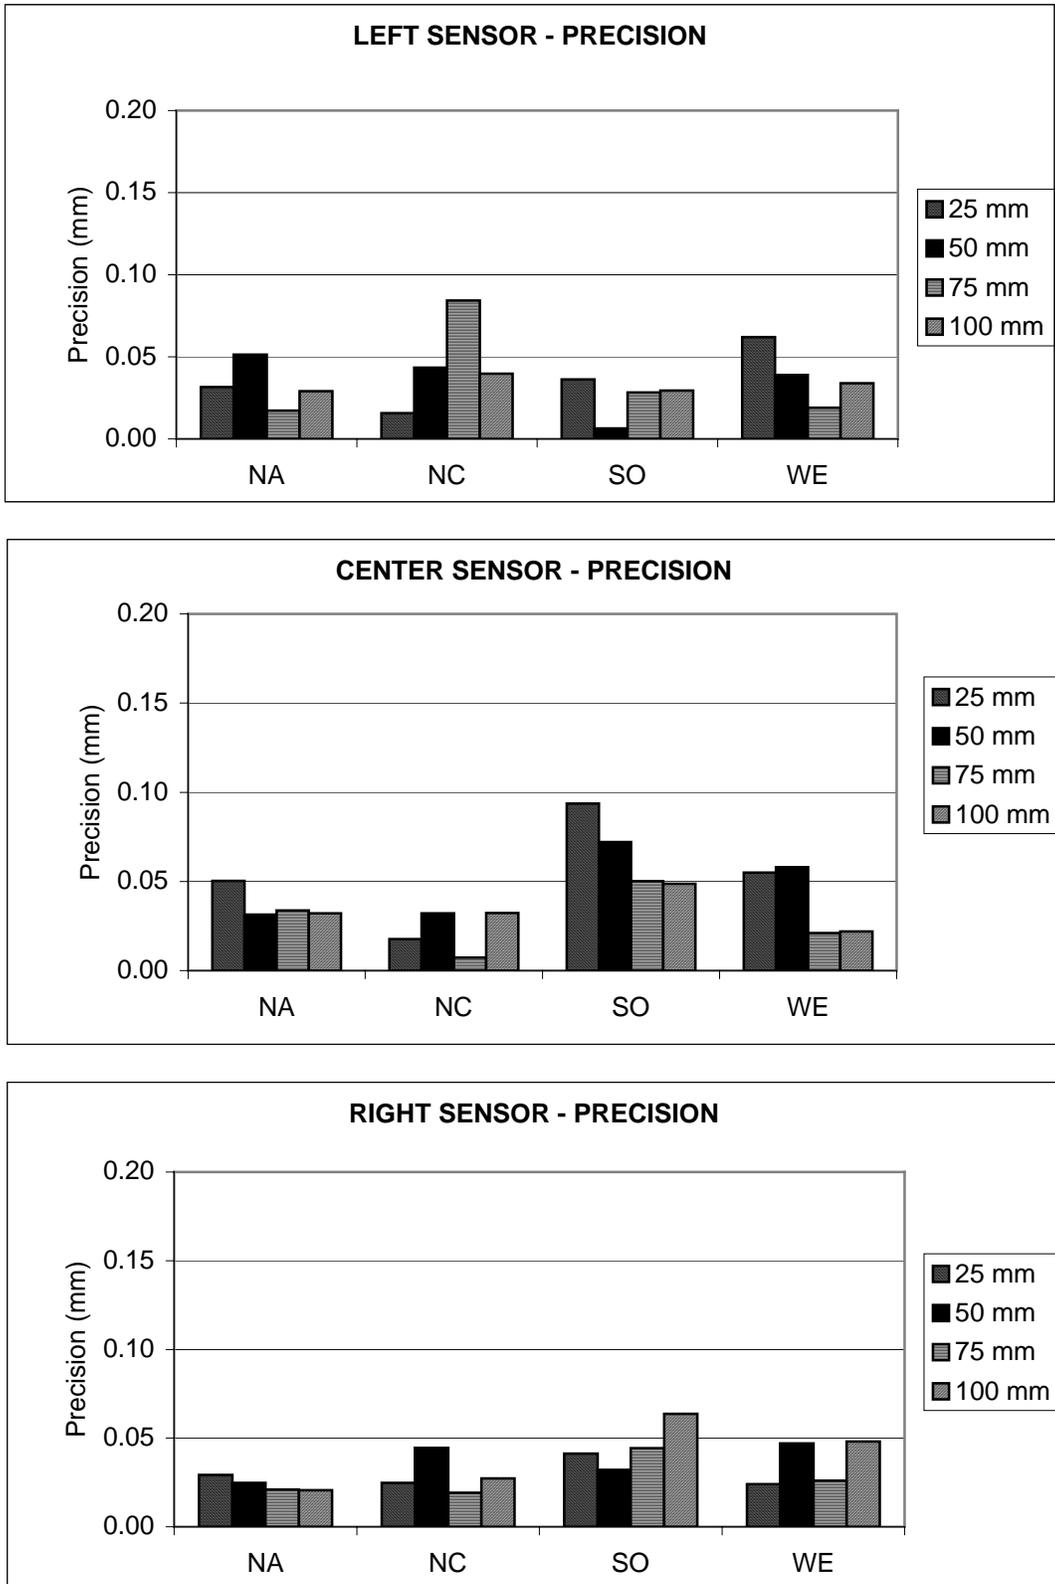
Figure 3.4. Precision values from repeat static height sensor test (NA- North Atlantic, NC – North Central, SO – Southern, WE – Western).

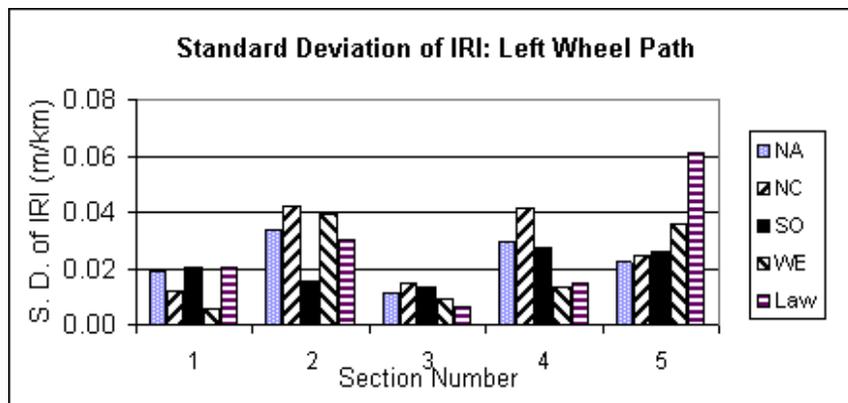
Figure 6.1. Standard deviation of IRI – left wheel path.

At section 2, the North Central profiler had an IRI standard deviation of 0.042 m/km for the left wheel path. Two other ICC profilers, North Atlantic and Western, had IRI standard deviations of 0.034 m/km and 0.039 m/km, respectively. This indicates the left wheel path of site 2 has features that can cause an IRI standard deviation close to 0.40 m/km to occur. The IRI standard deviation of the North Central profiler was close to the values obtained by the North Atlantic and Western profilers, and was over the specified criterion by 0.02 m/km. The reason for this profiler to not meet the specified criterion is attributed to variations in the wheel paths followed by the profiler for the repeat runs.

At section 4, the North Central profiler had an IRI standard deviation of 0.042 m/km, which was 0.02 m/km above the specified criterion. At section 5, the K. J. Law profiler had an IRI standard deviation of 0.061 m/km, which was 0.021 m/km above the specified criterion. For both these cases, the cause for the IRI standard deviation being above the specified criterion is not clear, and needs further investigation.

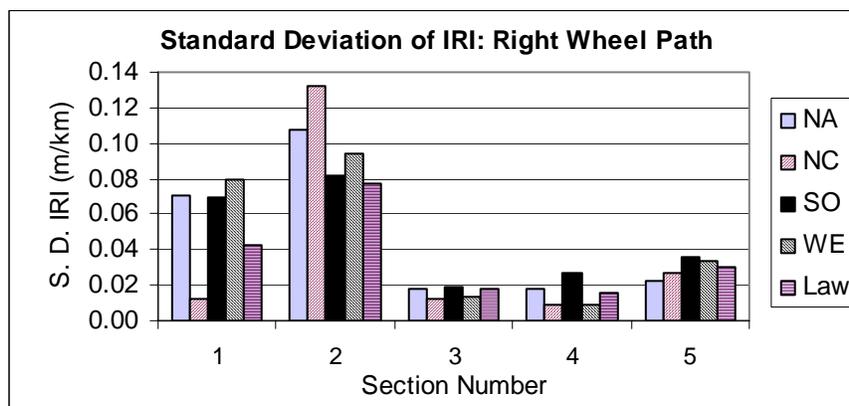
Figure 6.2 Standard deviation of IRI – right wheel path.

At section 2, all profilers failed to meet the IRI standard deviation criterion along the right wheel path, while at section 1 all profilers except for the North Central profiler failed the criterion along the right wheel path. Distresses were present along the right wheel path at sections 1 and 4, and variability in the paths profiled by the profilers was the likely cause for the profilers to fail the specified criterion. When distresses are present on the wheel path, variations in the path followed by the profiler during different runs can result in variations in the features that are recorded in the profile. This in turn will result in variations in IRI values between the runs, and contribute to a higher standard deviation of IRI.

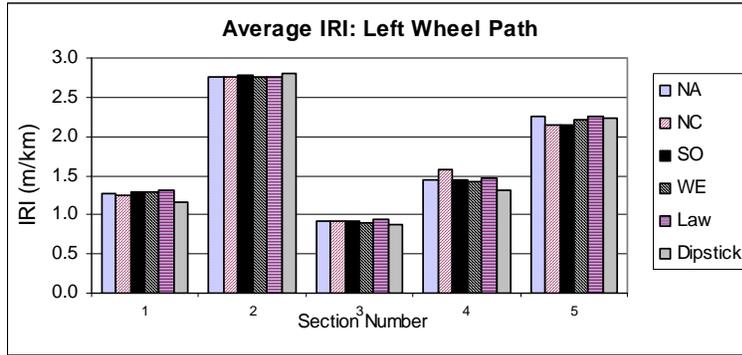
Figure 6.3. IRI values left wheel path.

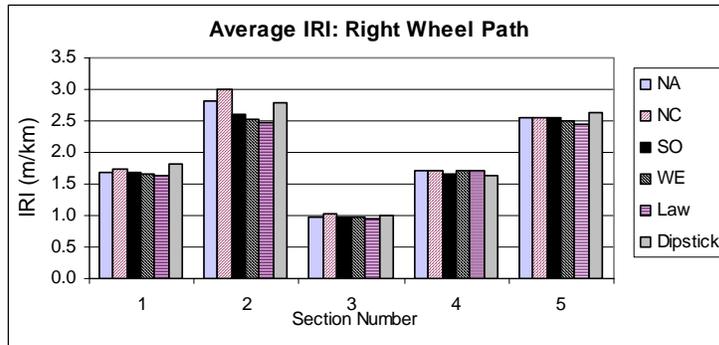
Figure 6.4. IRI values right wheel path.

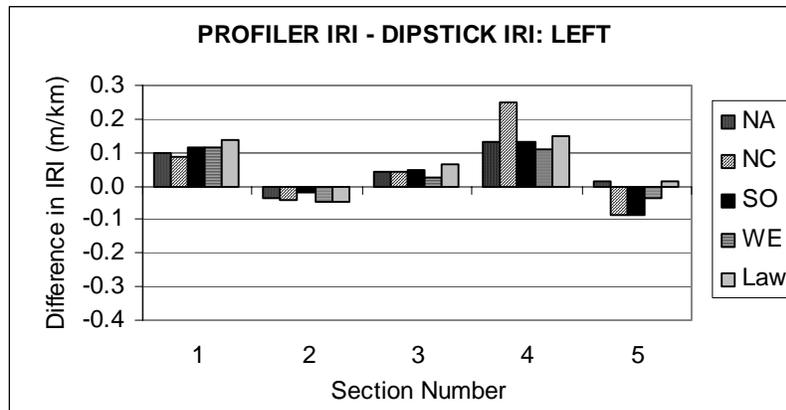
Figure 6.5. Difference between profiler and Dipstick IRI, left wheel path.

The difference between the average profiler IRI value and the reference IRI value obtained from the Dipstick (i.e., average profiler IRI – Dipstick IRI) at each test section for each wheel path are shown in table 6.6. These values for the left and right wheel paths are presented graphically in figures 6.5 and 6.6, respectively.

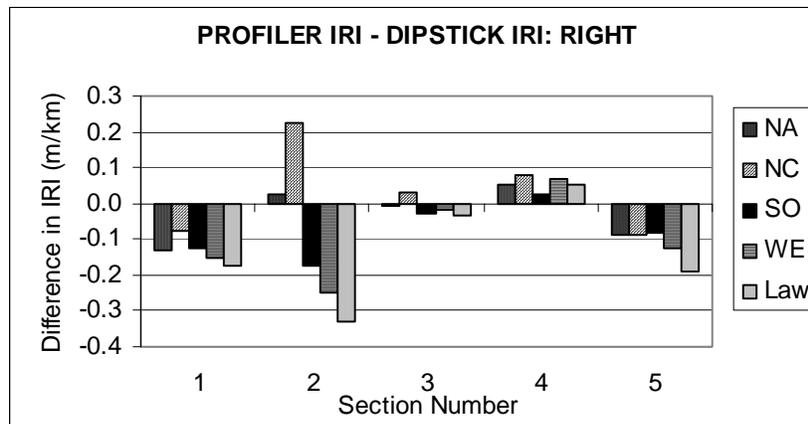
Figure 6.6. Difference between profiler and Dipstick IRI, right wheel path.

At sections 1 and 5, along the right wheel path, the K. J. Law profiler obtained IRI values that were less than the Dipstick IRI by 0.18 m/km and 0.19 m/km, respectively. The cause for the discrepancy is not apparent and needs further investigation. At section 4, along the left wheel path, the North Central profiler obtained an IRI that was 0.25 m/km greater than the IRI from the Dipstick. There are differences in magnitudes of profile features present on the profiles obtained by the Dipstick and the North Central profiler along the left wheel path at section 4 that is likely to be the cause for the difference in IRI. The probable cause is that the North Central profiler followed a path that was different than the path that was measured by the Dipstick. Further investigation is needed to look into this issue.

At section 2, along the right wheel path, all profilers except for the North Atlantic profiler failed the specified criterion for difference in IRI with the Dipstick IRI. The Southern, Western, and K. J. Law profiler obtained IRI values that were lower than the Dipstick IRI by 0.18 m/km, 0.25 m/km, and 0.33 m/km, respectively. However, the North Central profiler obtained an IRI that was 0.22 m/km higher than the Dipstick IRI. Comparison of profiles from the Dipstick and the profilers indicated the same features were present in all profiles, but the magnitudes of the features were different, which resulted in differences in IRI. Further investigation is needed to look into this issue.

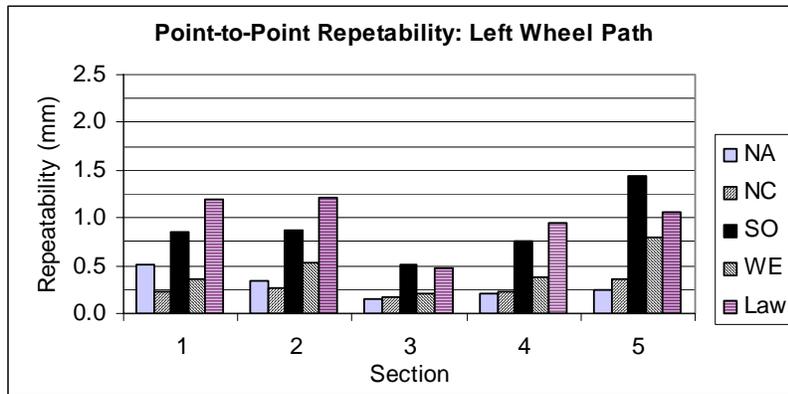
Figure 6.7. Point-to-point repeatability – left wheel path.

were noted for the following cases: (1) North Atlantic profiler, section 1 – left wheel path (value of 0.51) and section 1 – right wheel path (value of 0.56), and (2) Western Profiler: section 2 – left wheel path (value of 0.53) and section 5 – left wheel path (value of 0.80). The Southern profiler had values in excess of 0.50 along left wheel path at all sections, and had the highest value along the left wheel path at all five test sections. The Southern profiler also had point-to-point repeatability values in excess of 0.50 mm along the right wheel path at two sections (section 1 a value of 0.73 and section 5 a value of 2.08). The K. J. Law profiler had values in excess of 0.50 along the left and right wheel paths at all sections except for the left wheel path of section 3.

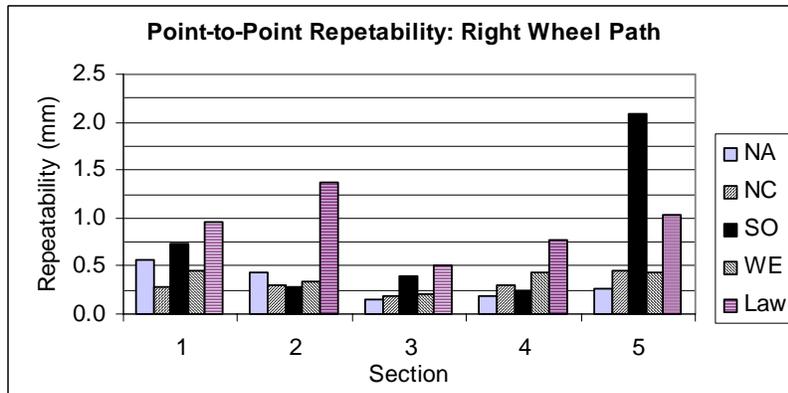
Figure 6.8 Point-to-point repeatability – right wheel path.
