# **2007 Comparison Testing of LTPP Profilers**

## **Final Report**

**October 2007**

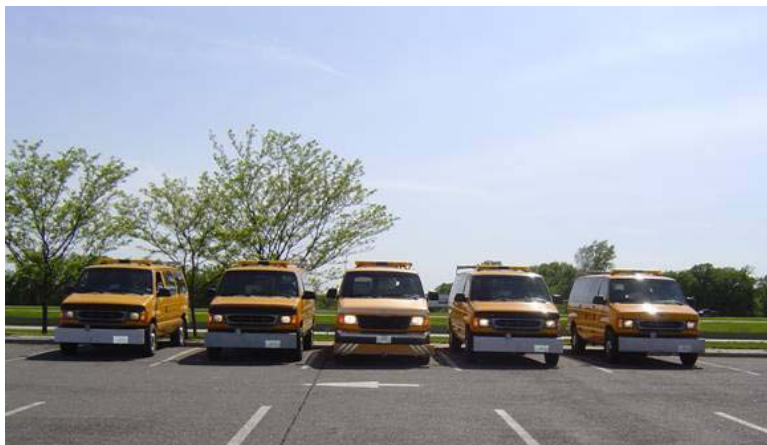
Figure 1.1. Five profilers that took part in the comparison.

A comparison test among the four ICC profilers used by the LTPP RSC's was performed from May 14 to 17, 2007. The comparison test was performed at the Mn/ROAD facility in Albertville, Minnesota. This was the second comparison of the four LTPP ICC profilers after they went into operation in August 2002. The previous profiler comparison was held at the Mn/ROAD facility in July 2003. The LTPP K. J. Law T-6600 profiler that was purchased by the Federal Highway Administration in 1996 and currently operated by the North Central RSC also took part in the comparison. This profiler is equipped with three infrared sensors that collect data along the left and right wheelpaths, and along the center of the lane. This profiler also collects profile data at 25 mm intervals. Figure 1.1 shows the five profilers that took part in the comparison.
