# LTPP Pavement Maintenance Materials: SHRP Crack Treatment Experiment, Final Report

PUBLICATION NO. FHWA RD-99-143

SEPTEMBER 1999

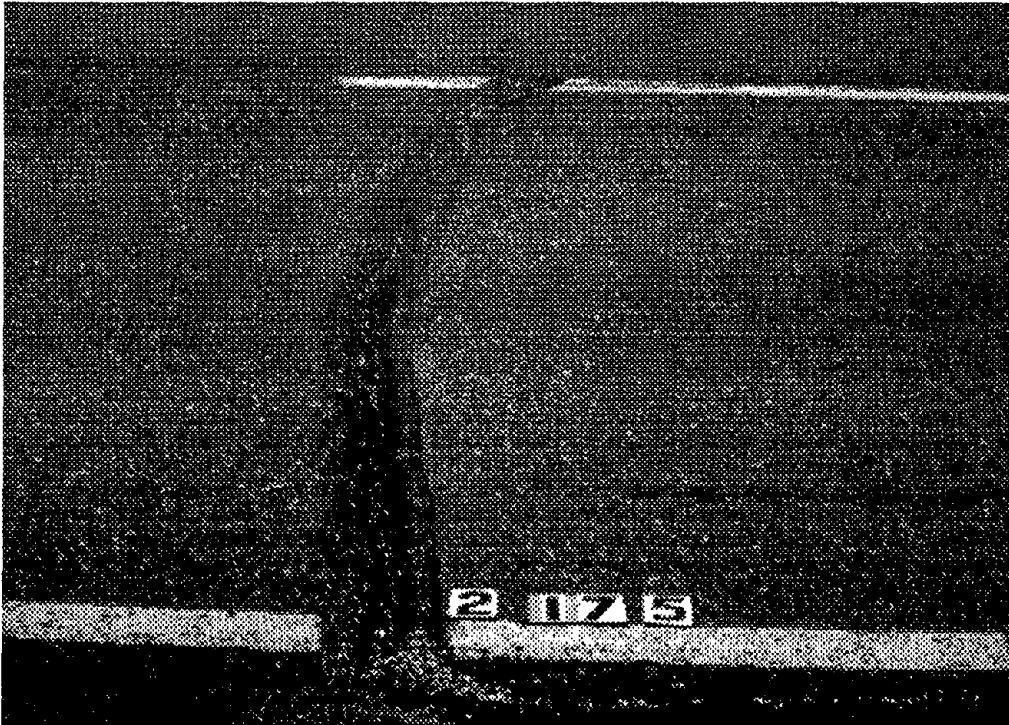
Figure 10. Hi-Spec reservoir-and-flush configuration (configuration A).

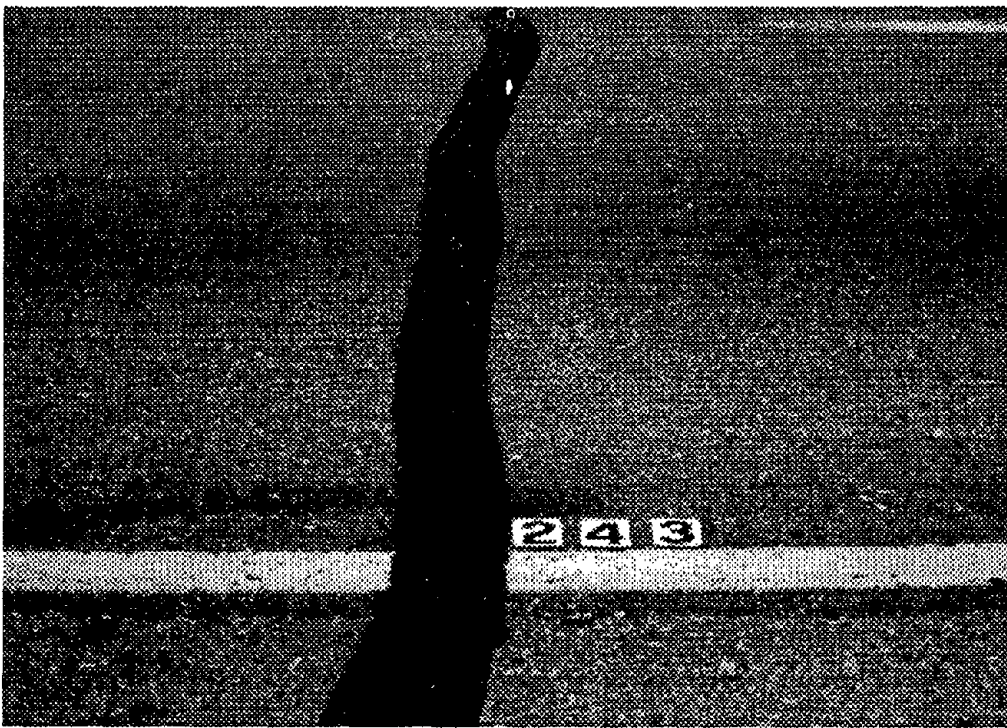
Figure 11. Hi-Spec simple band-aid configuration (configuration D).

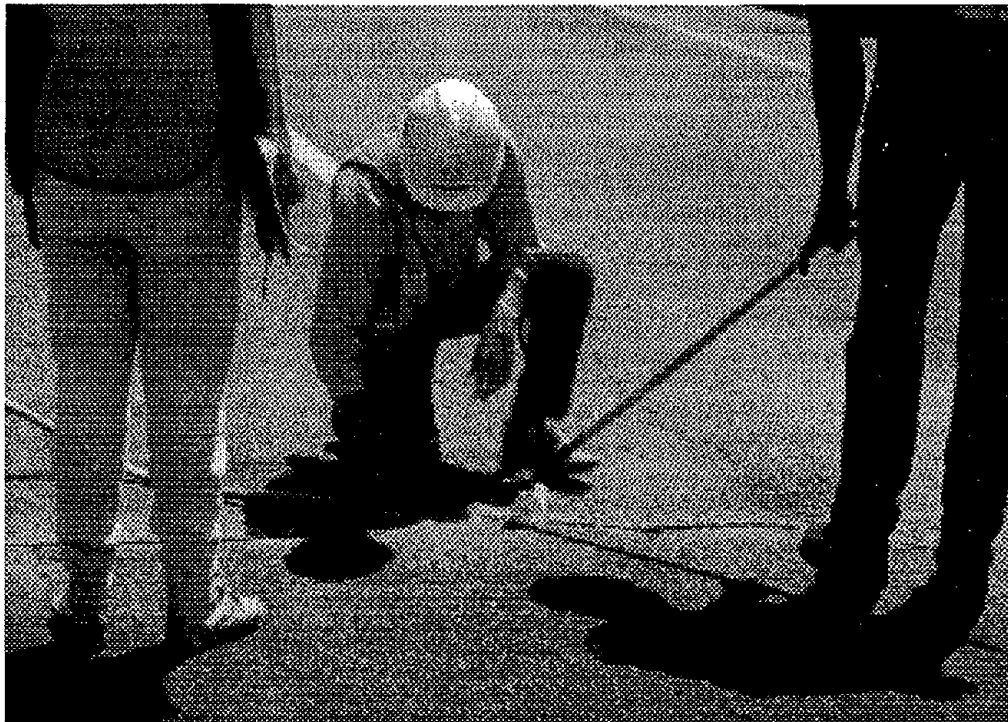
Figure 13. Backer rod installation.

The backer rod used in the experiment was 22-mm-diameter closed-cell Sof® Rod. A roller-type insertion tool was used to install the backer rod below the pavement surface. Figure 13 shows backer rod installation.

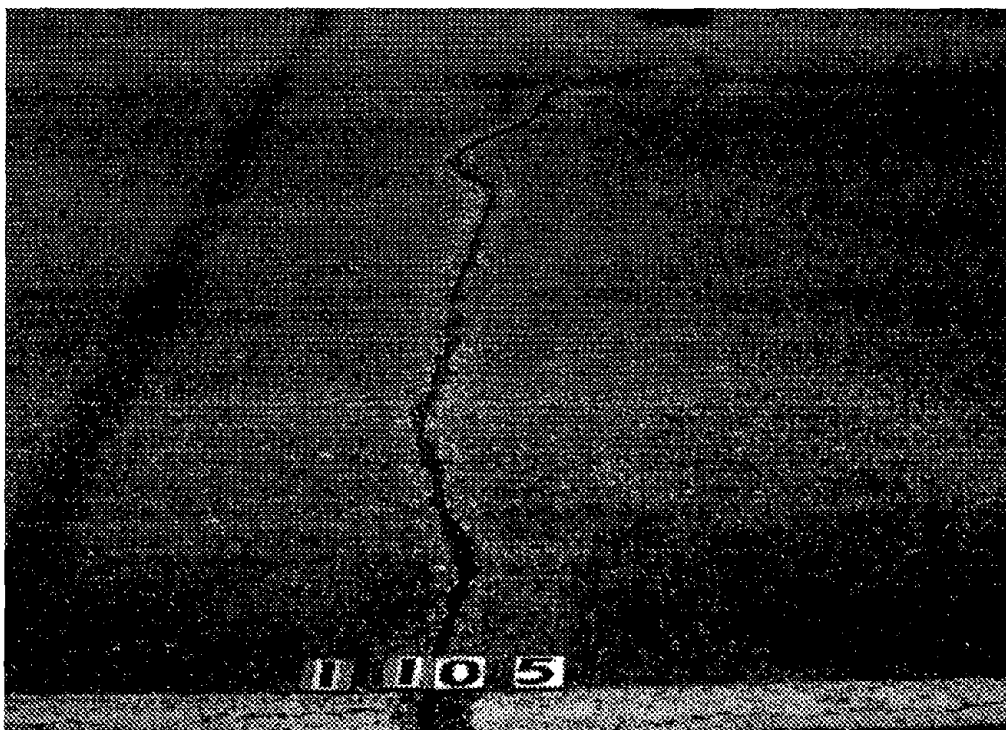
Figure 14. 890-SL deep reservoir-and-recess configuration (configuration E).

As mentioned previously, the standard 890-SL installation method (E-5) was replaced at the Wichita adverse-conditions subsite by two different methods (E-6 and F-7). In one section, method E-6 was used. This involved the elimination of light sandblasting, leaving only conventional airblasting for crack cleaning. This time-saving method was included to evaluate its cost-effectiveness. In the second section, method F-7 was employed. Here, a more shallow cut (13 mm deep) was made and the reservoir was sandblasted and airblasted. Backer tape was then placed at the reservoir bottom instead of using backer rod. Because of the irregularity of the crack reservoir, it was more difficult to place the tape than to use backer rod.

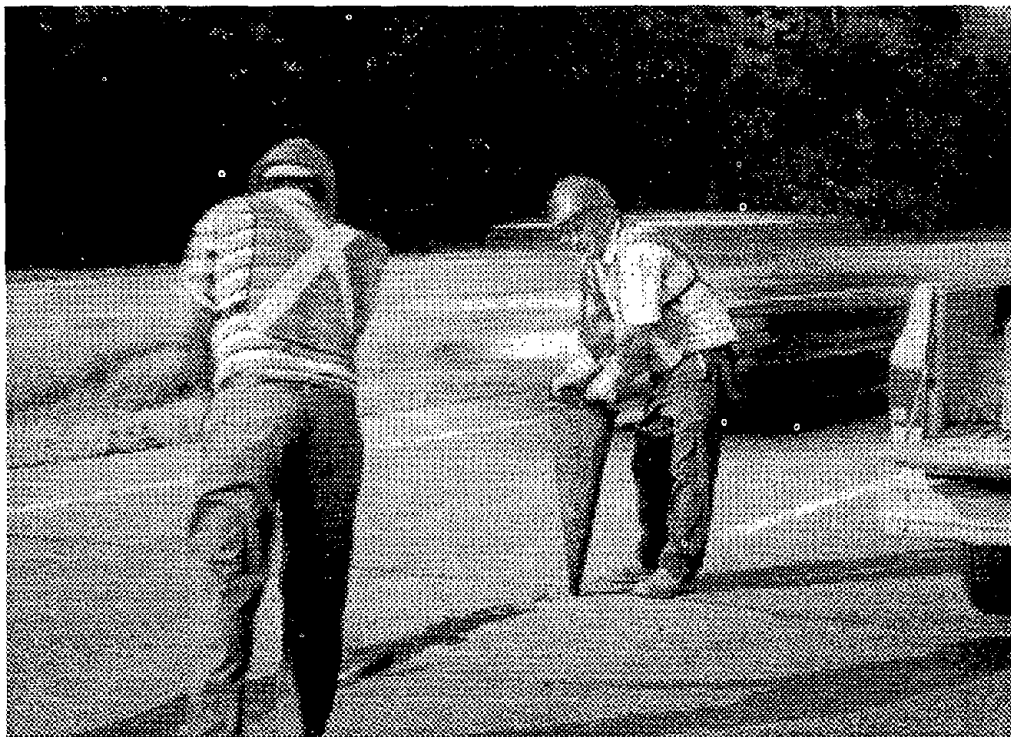
Figure 15. Placement of CRF in flush-fill configuration (configuration G).

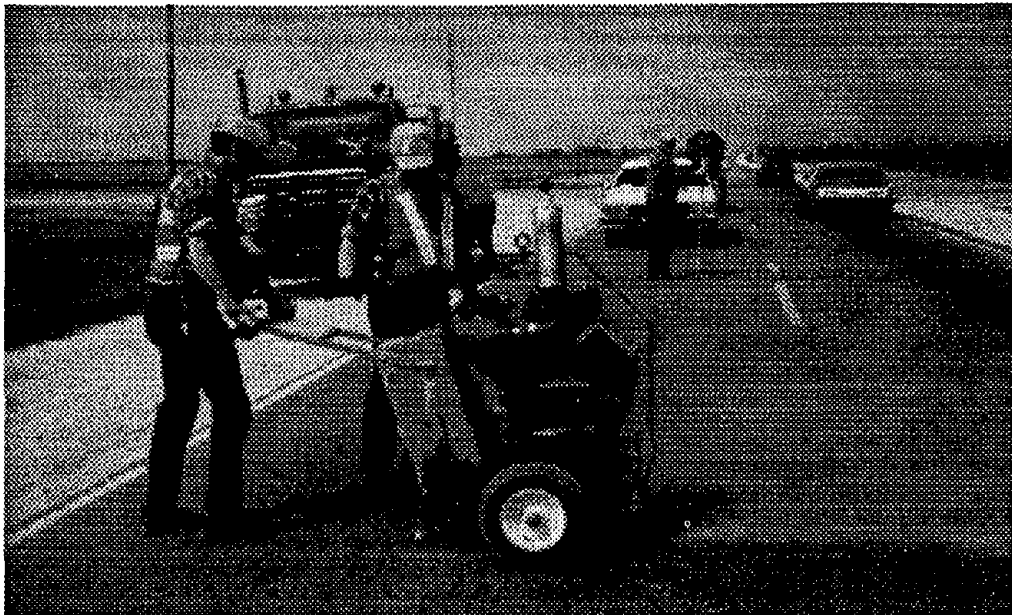
Figure 17. Random crack saw with 200-mm diamond blade.

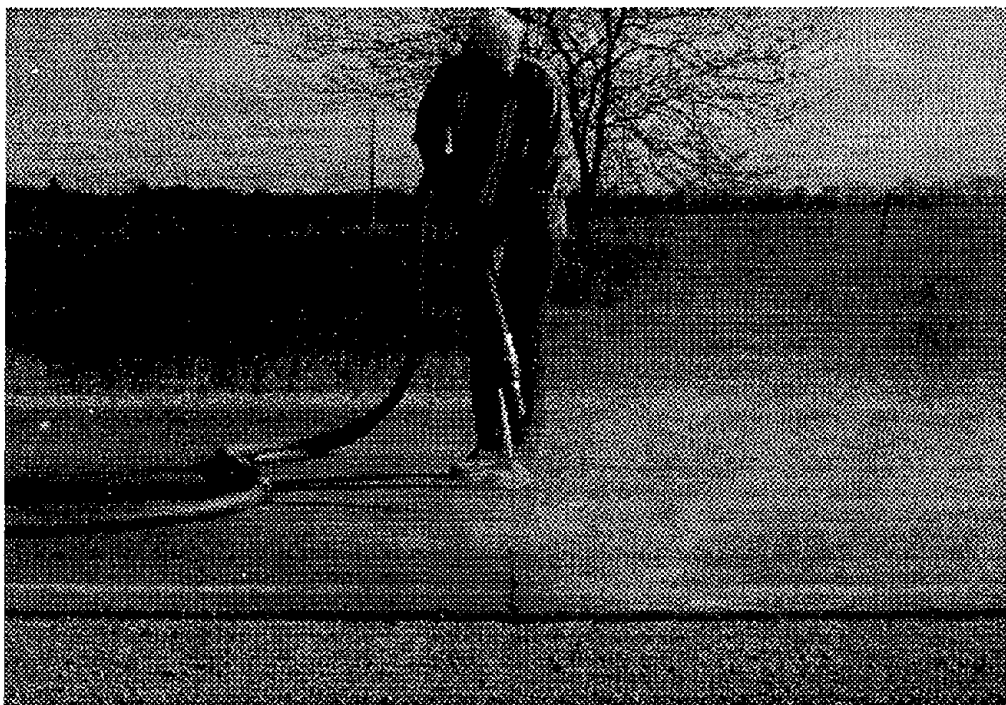
Figure 19. Light sandblasting using wand with attached wooden guide (crack preparation procedure 5).

Most sandblasting operations were conducted using Clemco blast machines connected to portable air compressors. Typically, one pass was made with the sandblaster along each side of a crack reservoir. A short time later, the reservoir and adjacent roadway were cleaned by airblasting. Sandblasting wands were held approximately 100 to 200 mm from the reservoir. At Wichita, a wooden rod was attached to the wand to help direct the blast against the crack sidewalls (figure 19).

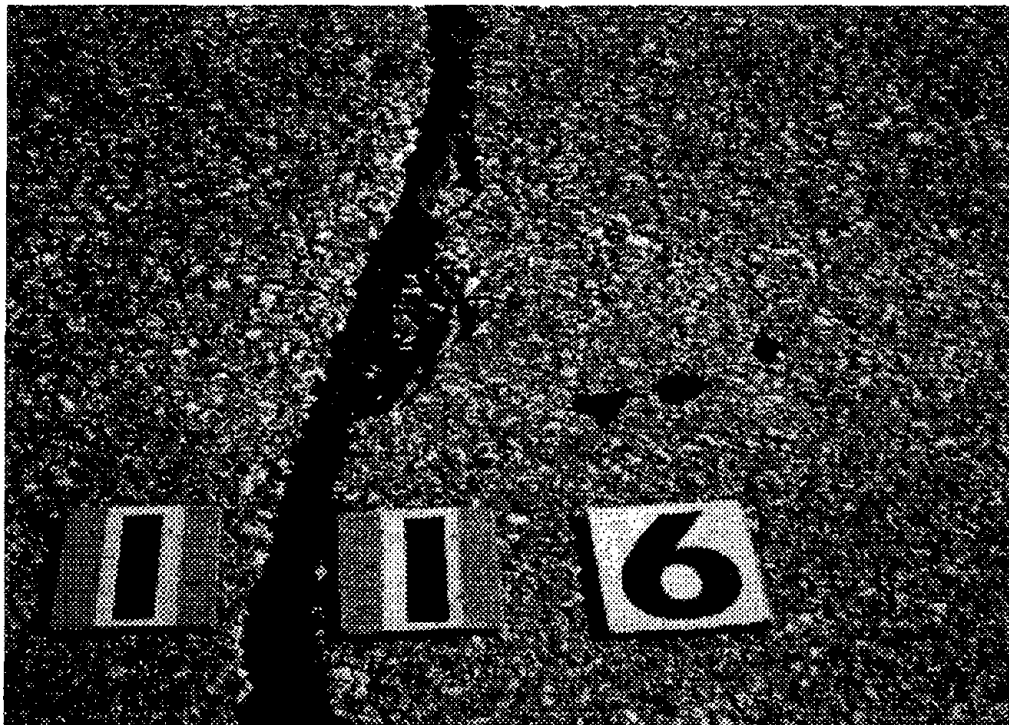
Figure 35. Typical spall and secondary crack adjacent to 890-SL silicone seal.
