LTPP Pavement Maintenance

Materials: SPS-4 Supplemental Joint Seal Experiment, Final Report

PUBLICATION NO. FHWA-RD-99-151

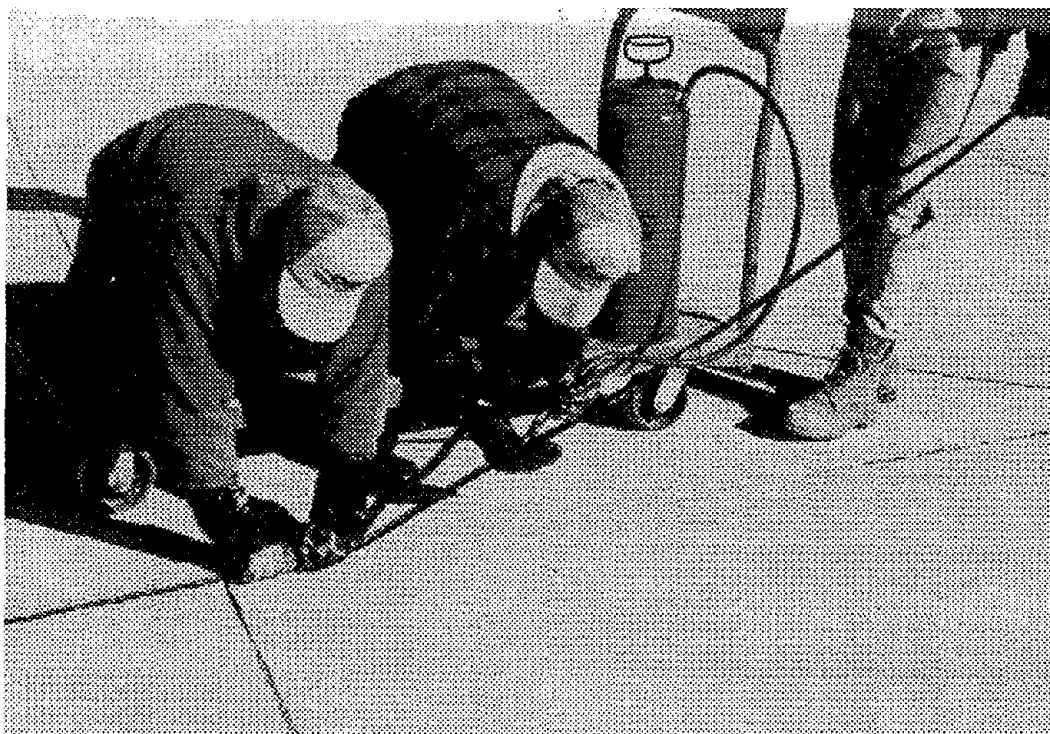
Figure 21. Manual installation of neoprene compression seal at Tremonton, Utah test site.

The Esco PV-687 seals at the Tremonton site were installed by hand, as shown in figure 21. In addition, because of an improperly functioning installation machine, the two compression seals selected for use at the Campo site were also installed by hand using putty knives. The result at the Campo site was several twisted and sunken seals, especially in the 6-mm-wide joints.
