**LTPP Seasonal Monitoring  
Program  
Site Installation and Initial Data  
Collection  
Section 040113  
Kingman, Arizona**

Site Installation and Initial Data Collection  
Section 040113, Kingman, Arizona

**Report No. FHWA-04-0114**

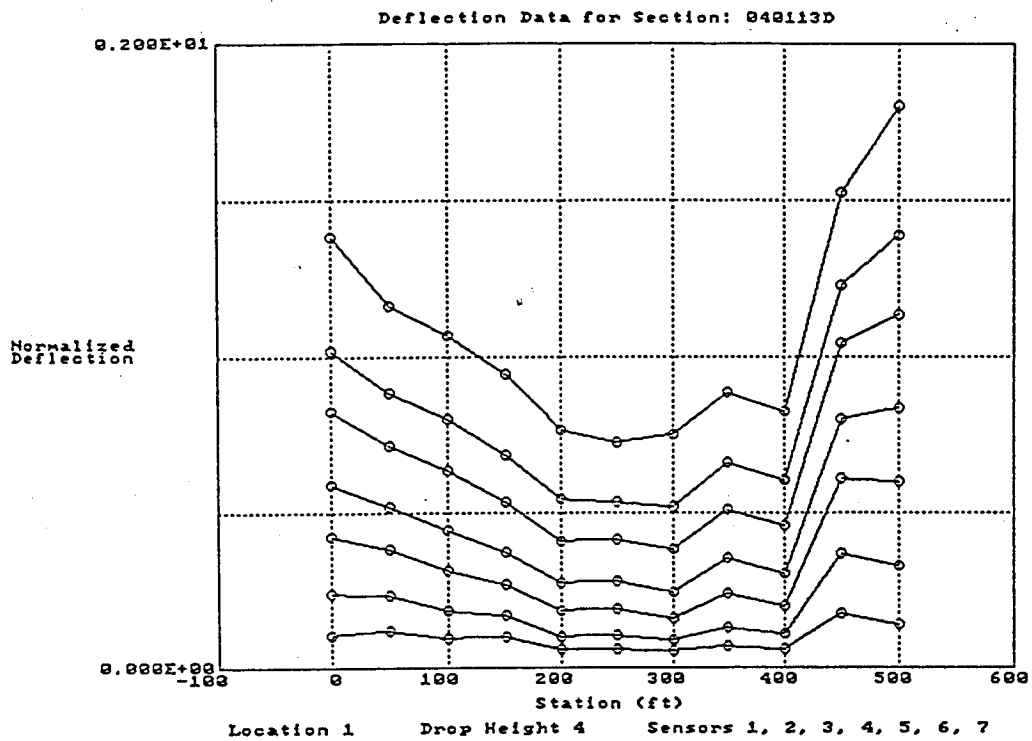
Figure A2. Normalized deflection profile from FWDCHECK.

Analysis of pre-installation FWD data indicated non-uniform deflection response at both ends of the section. Since both ends were non-uniform, construction data, drainage conditions at both ends, and other site information were carefully considered before the selection of the leave end for instrumentation. The equipment installation generally followed the schedule given below.

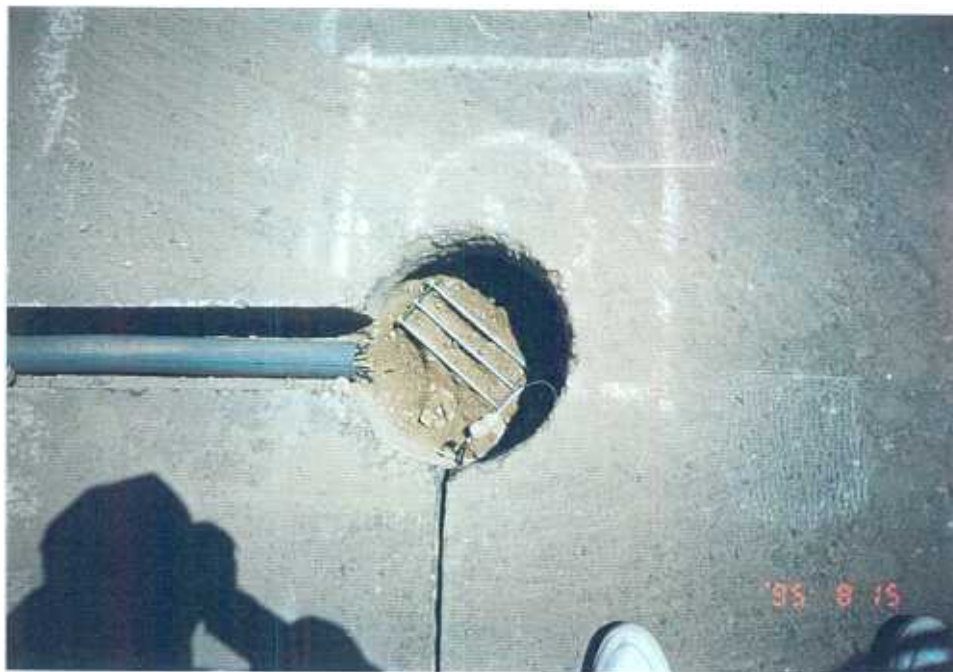
Figure C5. Instrument installation in progress.

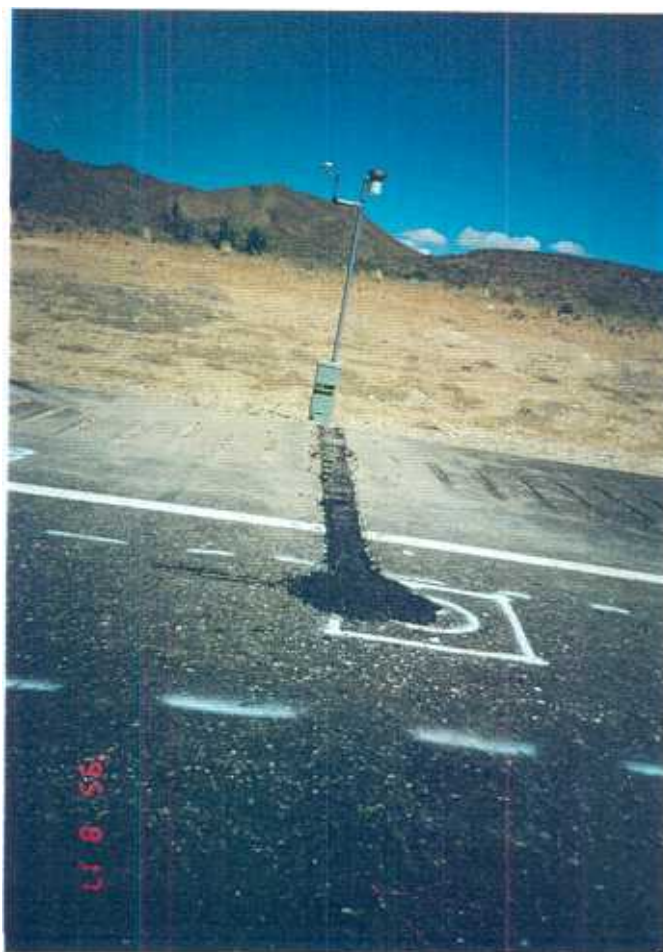
Figure C6. Weather station and instrument cabinet.

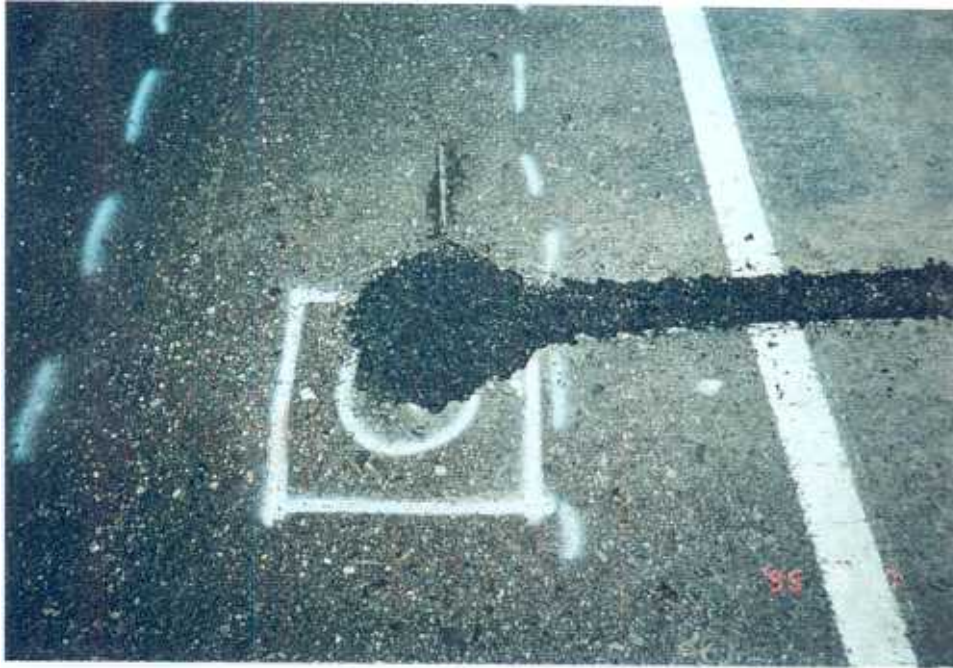
Figure C7. Instrumentation hole after repair.

The instrumentation hole and the conduit trench were patched by ADOT personnel with cold-mix asphalt concrete. Care was exercised to prevent damage to all of the equipment installed and the wires leading to the equipment cabinet. Subsequent tests confirmed that all installed equipment was functioning properly. The repair patch put on the instrument hole performed quite well throughout the monitoring period.

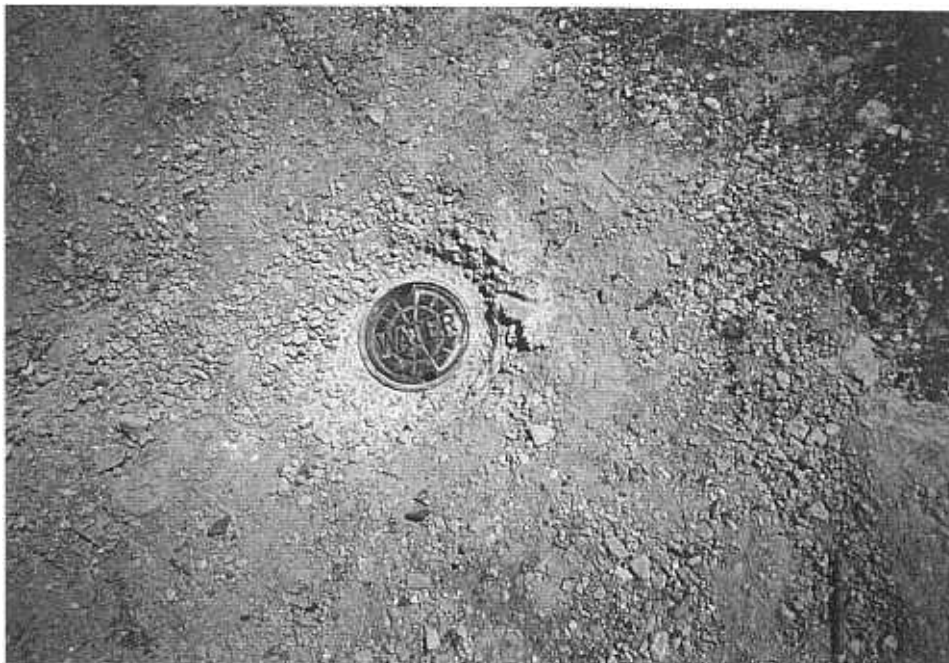
Figure C8. Observation well/piezometer.
