LTPP Seasonal Monitoring Program

Site Installation and Initial Data Collection Section 040114, Kingman, Arizona

Report No. FHWA-04-0114

SITE INSTALLATION AND INITIAL DATA COLLECTION ARIZONA SECTION 040114

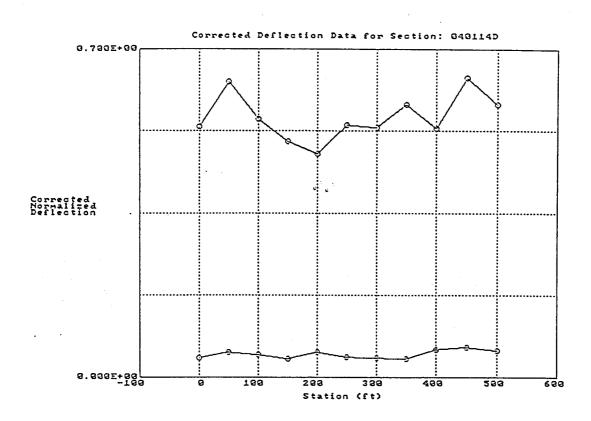
Figure A2. Corrected normalized deflection profile from FWDCheck.

Pre-installation FWD testing was carried out on the test section on February 17, 1995. FWD data was analyzed using the FWDCheck program. The results are presented in figures A2 through A5 in appendix A. The material properties of individual pavement layers are presented in table 2. Figures A6 and A7 in appendix A present the construction sampling and boring log of the instrumentation hole, respectively. Appendix A also contains the distress survey summary of the section.

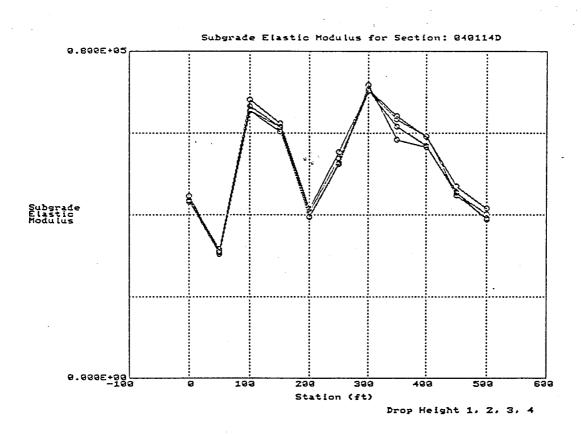
Figure A3. Elastic modulus of subgrade from FWDCheck.

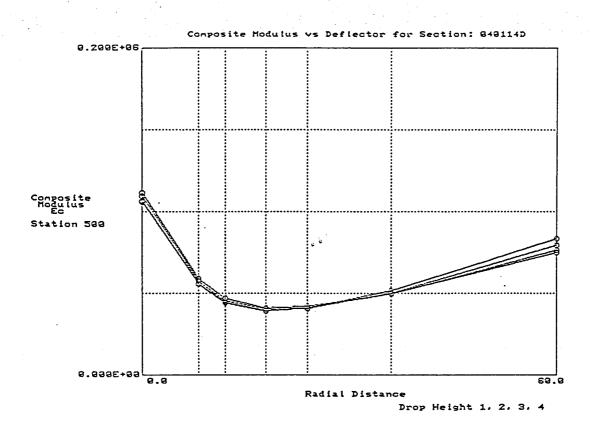
Figure A4. Composite modulus at station 5+00 from FWDCheck.

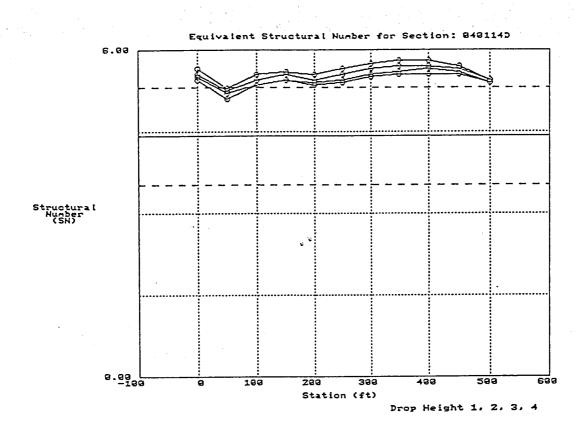
Figure A5. Equivalent structural number from FWDCheck.

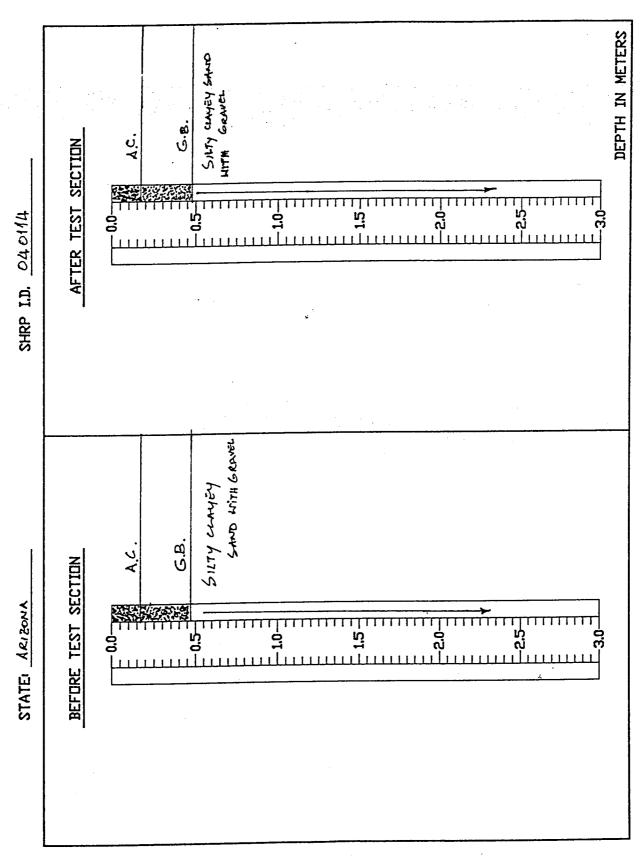
Figure A6. Sampling log of section during construction.

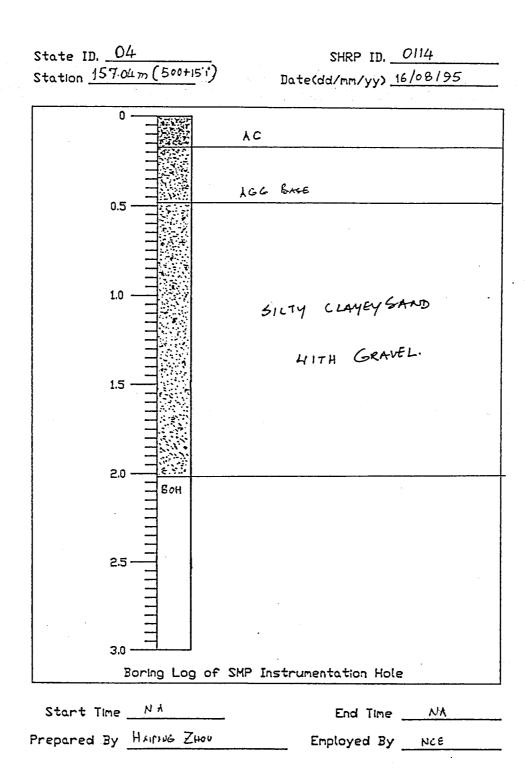
Figure A7. Boring log of instrument hole.

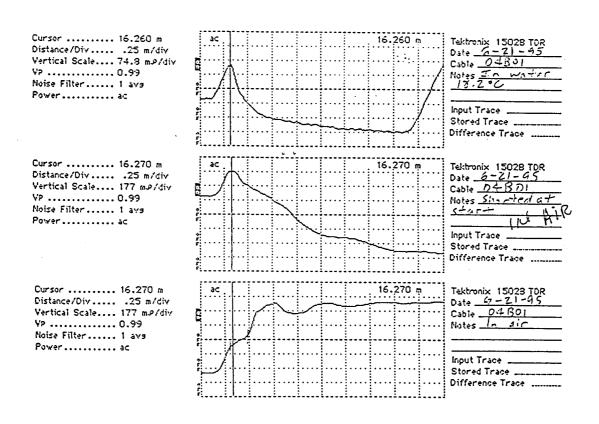
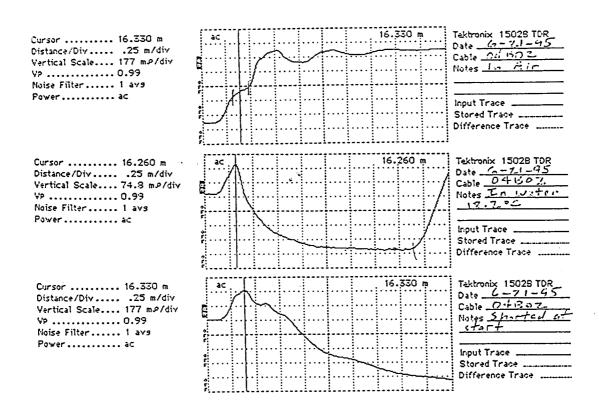
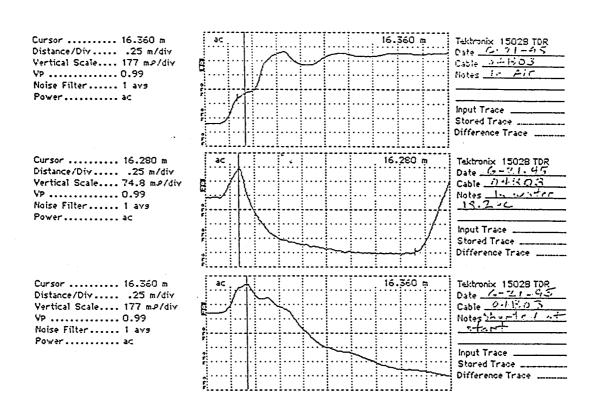
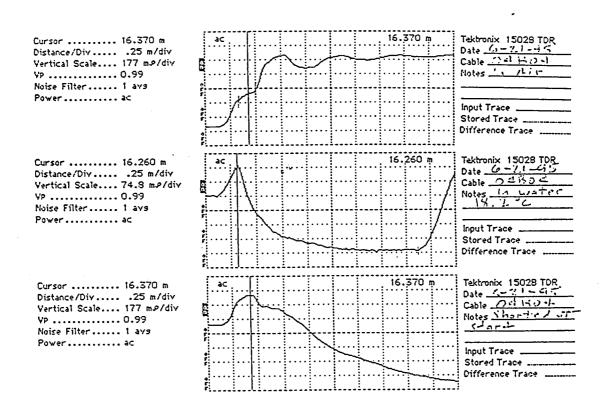
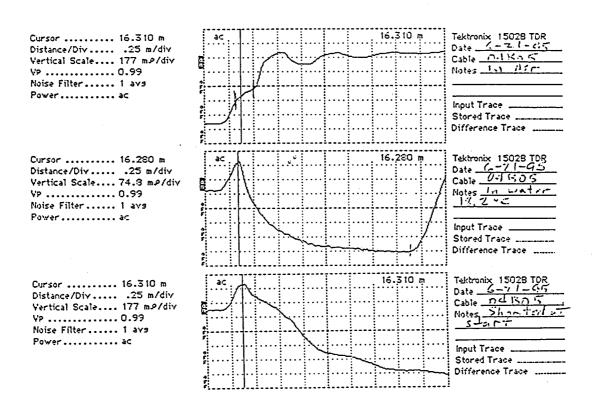
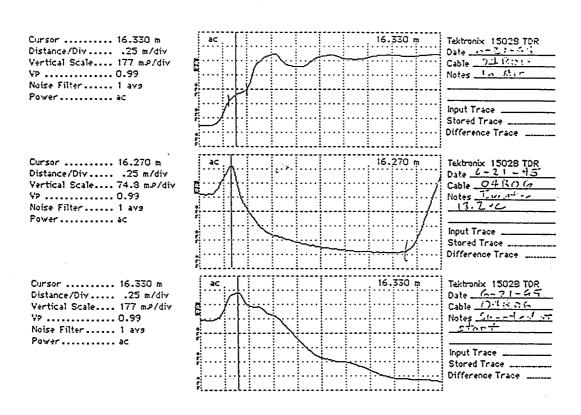
Figure B1. TDR trace obtained during calibration for sensor 04B01.

Figure B2. TDR trace obtained during calibration for sensor 04B02.

Figure B3. TDR trace obtained during calibration for sensor 04B03.

Figure B4. TDR trace obtained during calibration for sensor 04B04.

Figure B5. TDR trace obtained during calibration for sensor 04B05.

Figure B6. TDR trace obtained during calibration for sensor 04B06.

Calibration of TDR probes was completed by performing two measurements in air, one with the prongs shorted at the beginning of the sensor and the other not shorted. An additional measurement was made with the TDR sensor submerged in water. The TDR measured dielectric constants were within the specified limits, and the sensors produced the expected traces and were functioning properly. Individual TDR probe traces obtained during calibration are presented in figures B1 through B10 in appendix B. Serial numbers of equipment to be installed were noted, with the exception of radiation shield and air temperature sensor. The bench mark did not have a serial number and the battery pack serial number was not recorded because the batteries get frequently changed.

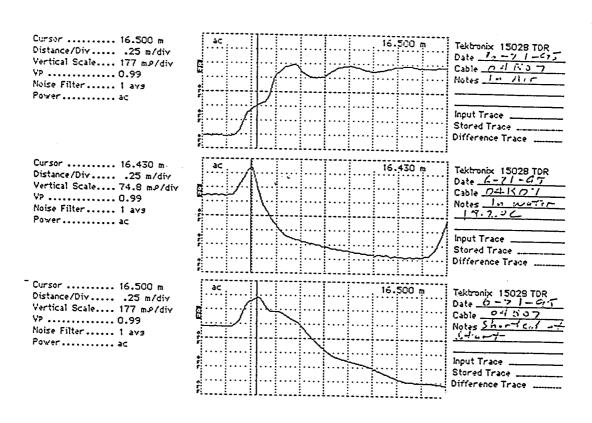
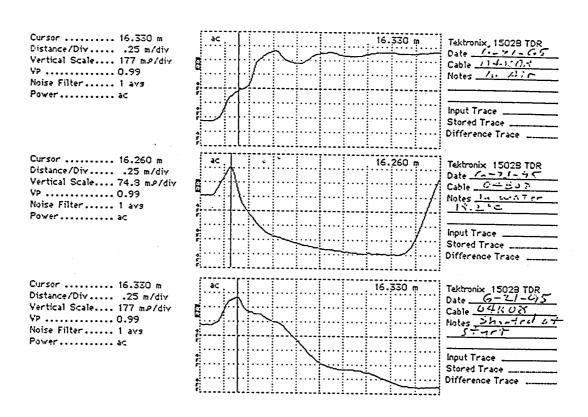
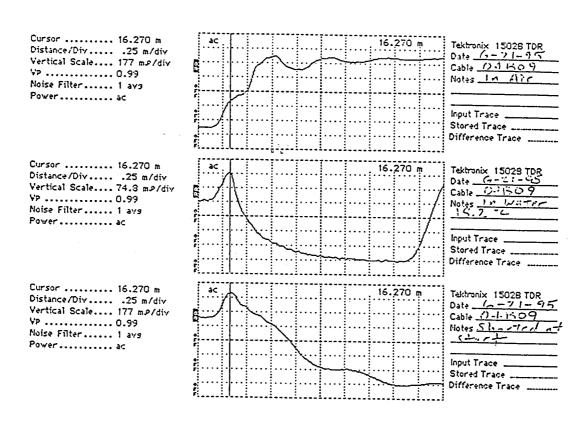
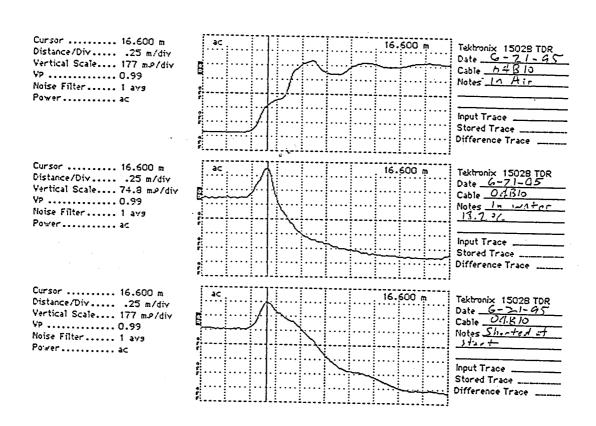
Figure B7. TDR trace obtained during calibration for sensor 04B07.

Figure B8. TDR trace obtained during calibration for sensor 04B08.

Figure B9. TDR trace obtained during calibration for sensor 04B09.

Figure B10. TDR trace obtained during calibration for sensor 04B010.

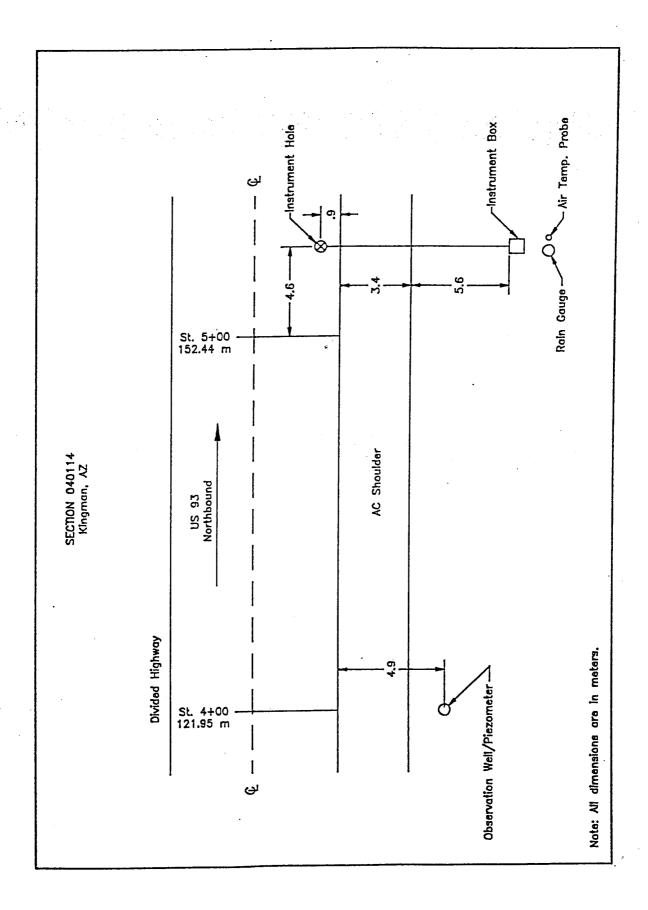
Figure C1. Instrumentation location within the section.

Pavement and subsurface instrumentation was installed at the leave end of the section at a distance of 157.04m (station 5+16) from the section beginning, in a 0.30m diameter hole bored using a 252mm diameter flight auger. The pavement temperature sensors (thermistors, unit #1) were installed in the AC layer as per LTPP guidelines. TDR moisture probes and subsurface temperature sensors (thermistors, unit #2) were installed in the base course and subgrade layers. The instrumentation hole was 2.07m deep. Figure C1 in appendix C presents the site layout and site location. The TDR probes were placed in an offset fan pattern such that the lead wires were on the side closest to the pavement edge. All the TDR probes were placed with an "S" shaped stress relief loop in their cables. Each TDR probe was connected to the 1502B cable tester while the soil around it was being compacted. Manual traces were generated to ensure that none of the TDR sensors were damaged during backfilling and compaction of instrumentation hole. TDR traces monitored during installation are presented in figures C2 and C3 in appendix C. TDR and thermistor probe lead wires were bundled and pulled through a 51mm diameter flexible electrical conduit buried in a 76mm wide trench, leading to the equipment cabinet. The equipment cabinet was located 9.00m away to the right of lane edge on almost level ground. Extension cables were used in all the sensors placed in the pavement. The installed depths of the TDR sensors are presented in table 5.

A 152mm diameter flight auger was used to bore the observation piezometer/benchmark at the edge of the pavement shoulder at a distance of 121.95m (section station 4+00), and 4.9m to the right of the lane edge. Upon completion of instrumentation installation, all wiring connections to the equipment cabinet were checked carefully for continuity and proper contacts. The "ONSITE" computer program was downloaded to the CR10 data logger located

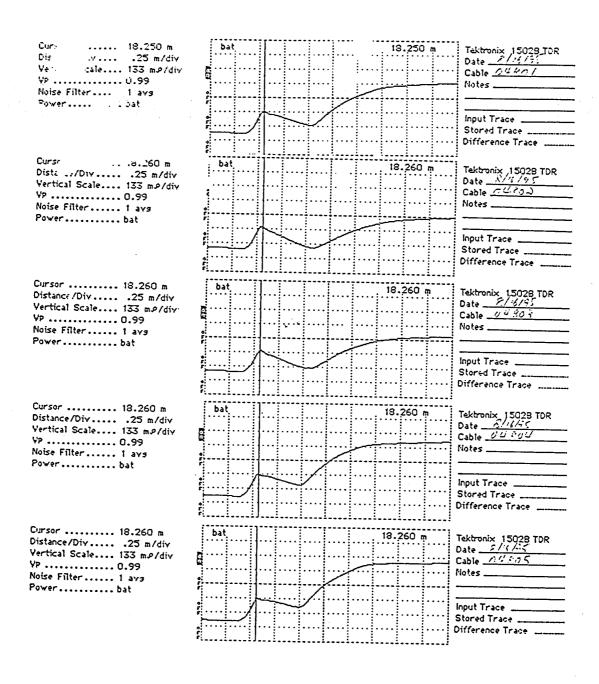
Figure C2. TDR traces measured during installation for sensors 04A01 thru 04A05.

Moisture samples were collected at each TDR probe location. A representative Proctor sample was taken at a depth of 1.07m from pavement surface. TDR traces obtained during installation were later used to determine in-situ moisture content at each TDR probe depth. From the individual trace, apparent probe length was determined and used in the moisture determination equations provided in the FHWA LTPP SMP Guidelines, April 1994.

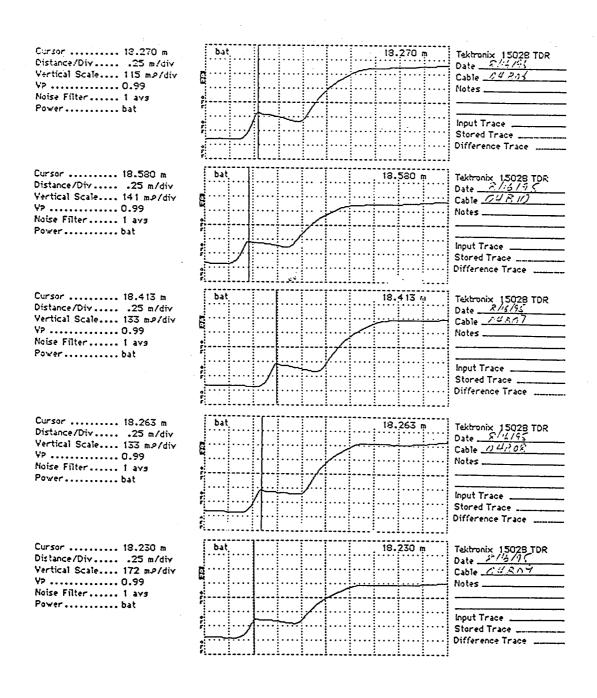
Figure C3. TDR traces measured during installation for sensors 04A06 thru 04A010.

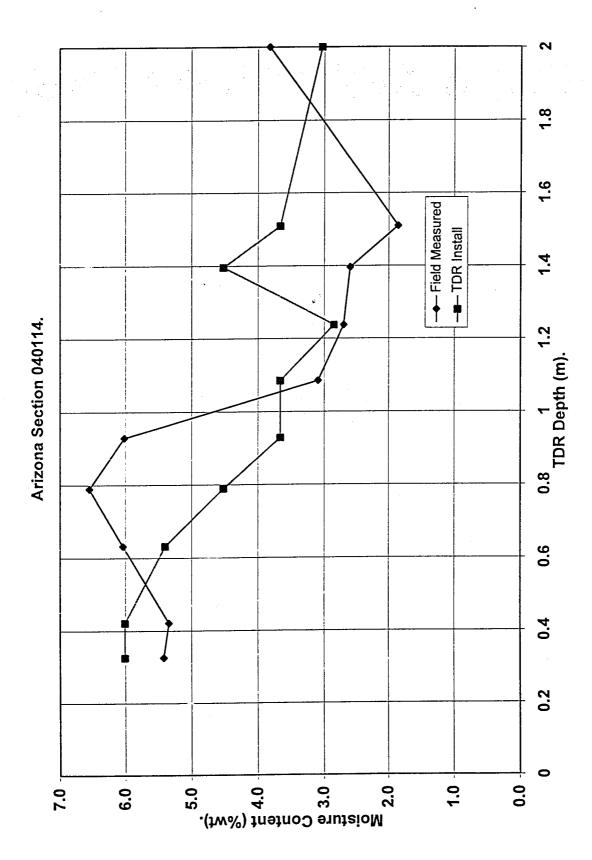
Figure C4. Measured field moisture contents and TDR moisture contents during installation.

It can be seen from the data in table 6, field measured moisture contents were generally close to the moisture contents determined from the TDR traces obtained during installation. Some difference in moisture contents at some sensor depths can be attributed to the field conditions and limitations of the moisture determination method used.

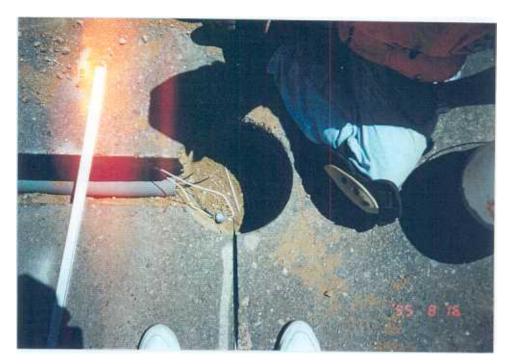
Figure C5. Instrument installation in progress.

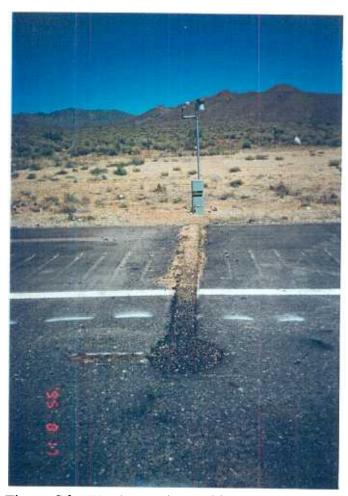
Figure C6. Weather station and instrument cabinet.

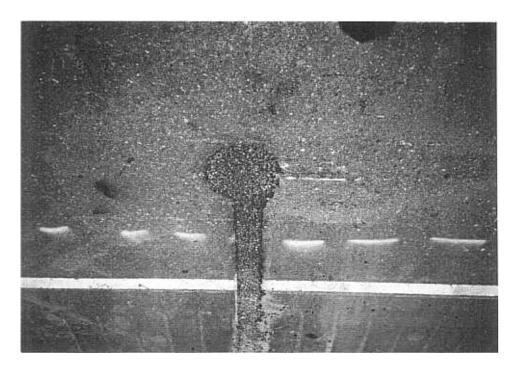
Figure C7. Instrument hole after repair.

The instrumentation hole and the conduit trench were patched by ADOT personnel with cold-mix asphalt concrete. Care was exercised to prevent damage to all of the equipment installed or the wires leading to the equipment cabinet. Subsequent tests confirmed that all the installed equipment was functioning properly. The repair patch of the instrument hole performed quite well throughout the monitoring period.

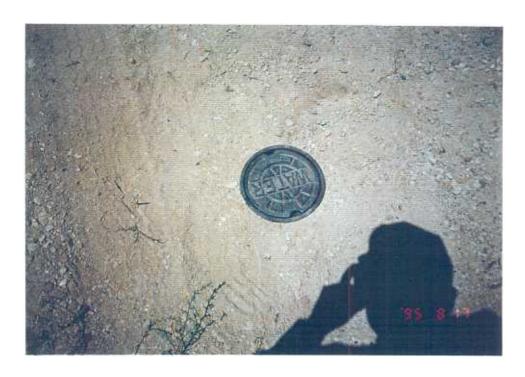
Figure C8. Observation well/piezometer.

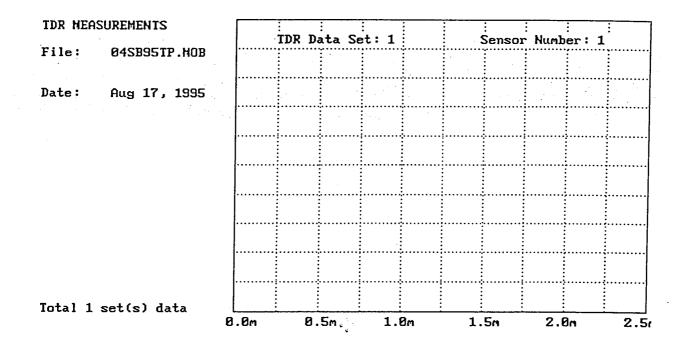
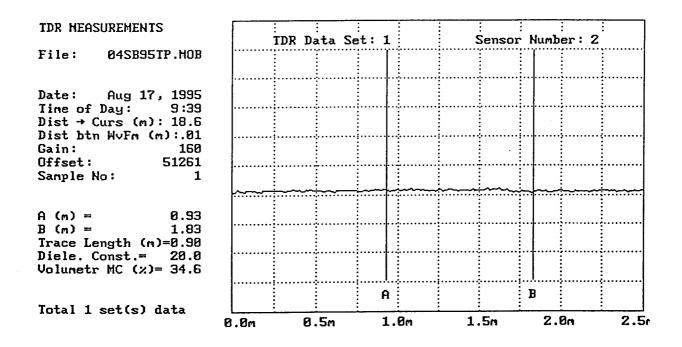
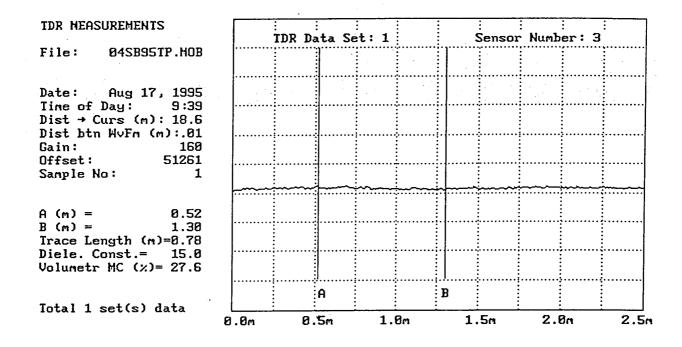
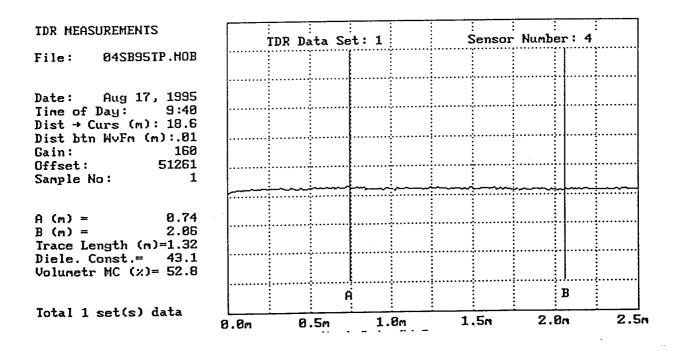
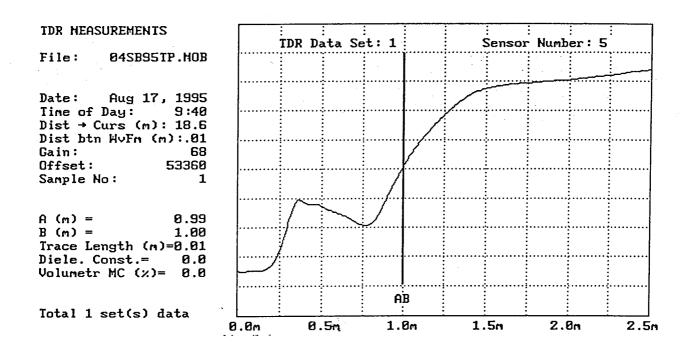
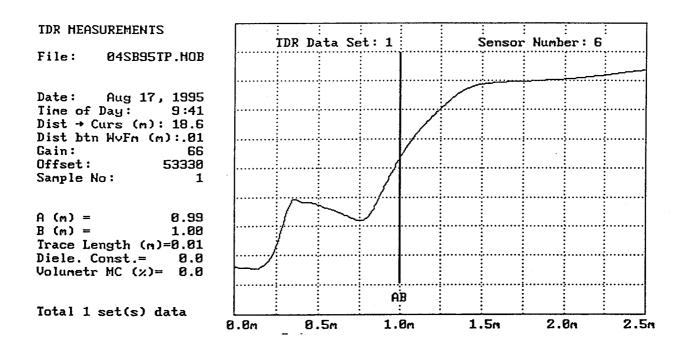
Figure D1. TDR trace recorded by the mobile system during initial data collection, sensor 04A01.

Figure D2. TDR trace recorded by the mobile system during initial data collection, sensor 04A02.

Figure D3. TDR trace recorded by the mobile system during initial data collection, sensor 04A03.

Figure D4. TDR trace recorded by the mobile system during initial data collection, sensor 04A04.

Figure D5. TDR trace recorded by the mobile system during initial data collection, sensor 04A05.

Figure D6. TDR trace recorded by the mobile system during initial data collection, sensor 04A06.

TDR data was collected using the mobile data acquisition system. The mobile system contains a CR10 data logger, a battery pack, two multiplexers, and a resistance multiplexer circuit board. Figures D1 through D10 in appendix D show the TDR waveform traces obtained with the mobile data acquisition system. TDR traces obtained by the mobile data aquisition system indicated some malfunctioning of the contact points. This explains flat traces recorded for some of the TDR sensors. This was noted for closer examination. Every single point of contact in the wiring was checked and the mobile box was thoroughly inspected. TDR trace data collected at the site during subsequent visits confirmed that the TDR sensors were functioning properly.

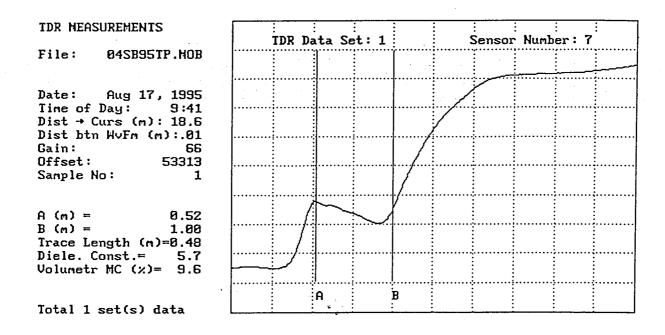
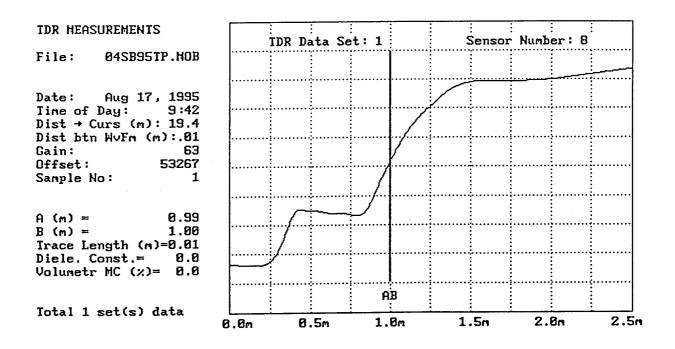
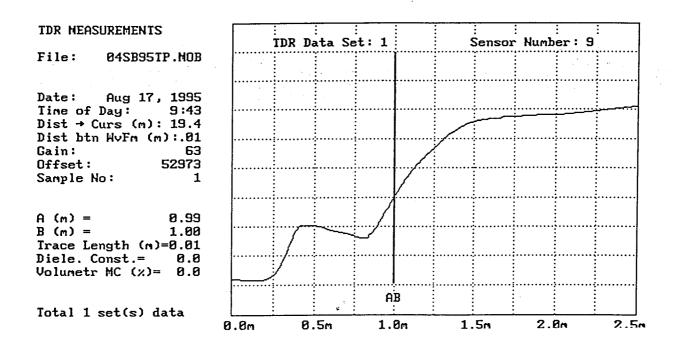
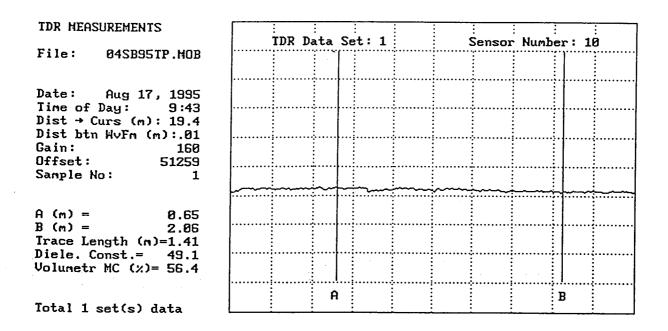
Figure D7. TDR trace recorded by the mobile system during initial data collection, sensor 04A071.

Figure D8. TDR trace recorded by the mobile system during initial data collection, sensor 04A08.

Figure D9. TDR trace recorded by the mobile system during initial data collection, sensor 04A09.

Figure D10. TDR trace recorded by the mobile system during initial data collection, sensor 04A010.

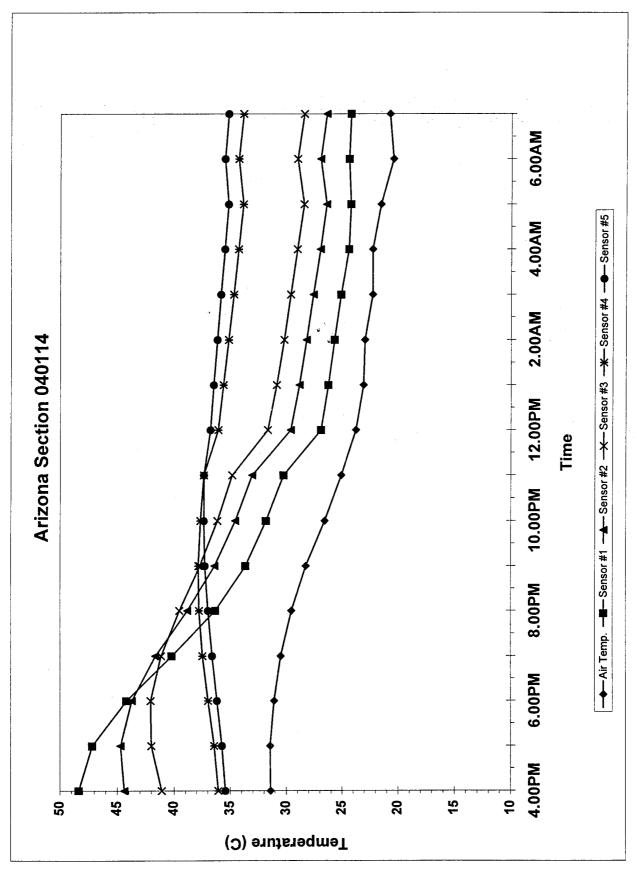
Figure D11. Hourly average air and top 5 sensor temperature recorded during initial data collection.
