**SEASONAL MONITORING PROGRAM  
DISMANTLE REPORT  
SITE 040114, KINGMAN, ARIZONA.**

**January 1997**

SUBJECT: **Suspension of SMP Site Monitoring Activities, Site 040114**

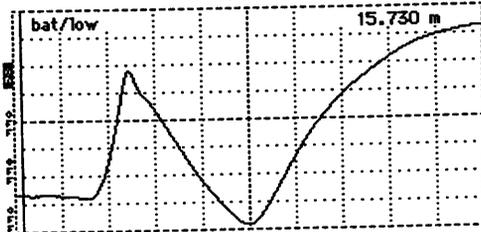
Cursor ..... 15.730 m  
Distance/Div ..... .25 m/div  
Vertical Scale..... 39.7 mP/div  
VP ..... 0.99  
Noise Filter..... 1 avs  
Power ..... bat/low

Tektronix 1502B TDR  
Date 8/13/96  
Cable # 6 040114  
Notes Looks Good  
Input Trace \_\_\_\_\_  
Stored Trace \_\_\_\_\_  
Difference Trace \_\_\_\_\_

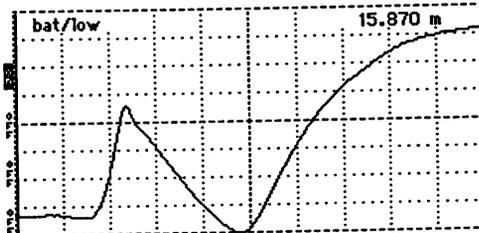
Cursor ..... 15.870 m  
Distance/Div ..... .25 m/div  
Vertical Scale..... 44.6 mP/div  
VP ..... 0.99  
Noise Filter..... 1 avs  
Power ..... bat/low

Tektronix 1502B TDR  
Date 8/13/96  
Cable # 7 040114  
Notes Looks Good  
Input Trace \_\_\_\_\_  
Stored Trace \_\_\_\_\_  
Difference Trace \_\_\_\_\_

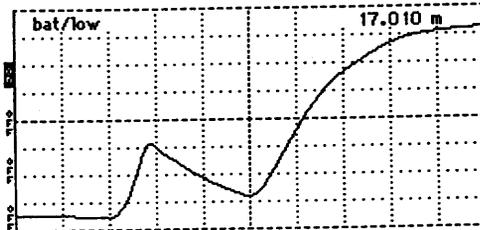
Cursor ..... 17.010 m  
Distance/Div ..... .25 m/div  
Vertical Scale..... 57.7 mP/div  
VP ..... 0.99  
Noise Filter..... 1 avs  
Power ..... bat/low

Tektronix 1502B TDR  
Date 8/13/96  
Cable # 8 040114  
Notes Looks Good  
Input Trace \_\_\_\_\_  
Stored Trace \_\_\_\_\_  
Difference Trace \_\_\_\_\_

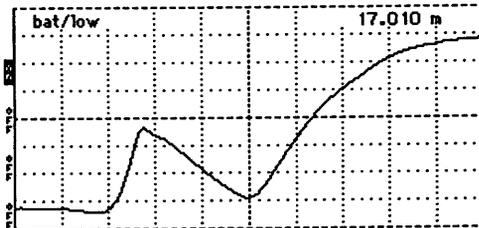
Cursor ..... 17.010 m  
Distance/Div ..... .25 m/div  
Vertical Scale..... 57.7 mP/div  
VP ..... 0.99  
Noise Filter..... 1 avs  
Power ..... bat/low

Tektronix 1502B TDR  
Date 8/13/96  
Cable # 9 040114  
Notes Looks Good  
Input Trace \_\_\_\_\_  
Stored Trace \_\_\_\_\_  
Difference Trace \_\_\_\_\_

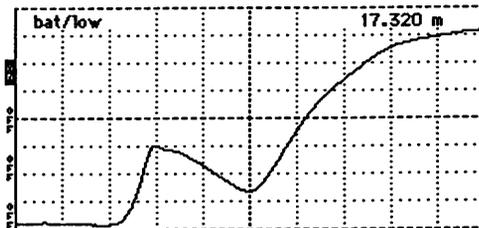
Cursor ..... 17.320 m  
Distance/Div ..... .25 m/div  
Vertical Scale..... 57.7 mP/div  
VP ..... 0.99  
Noise Filter..... 1 avs  
Power ..... bat/low

Tektronix 1502B TDR  
Date 8/13/96  
Cable # 10 040114  
Notes Looks Good  
Input Trace \_\_\_\_\_  
Stored Trace \_\_\_\_\_  
Difference Trace \_\_\_\_\_

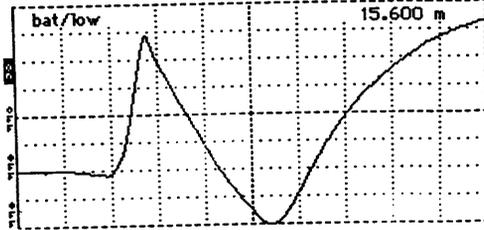
Cursor ..... 15.600 m  
Distance/Div ..... .25 m/div  
Vertical Scale..... 35.4 mP/div  
VP ..... 0.99  
Noise Filter ..... 1 avs  
Power ..... bat/low

Tektronix 1502B TDR  
Date 8/13/96  
Cable #1 040114  
Notes Looks Good

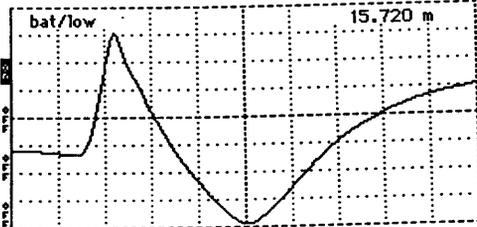
Cursor ..... 15.720 m  
Distance/Div ..... .25 m/div  
Vertical Scale..... 42.1 mP/div  
VP ..... 0.99  
Noise Filter ..... 1 avs  
Power ..... bat/low

Tektronix 1502B TDR  
Date 8/13/96  
Cable #2 040114  
Notes Looks Good

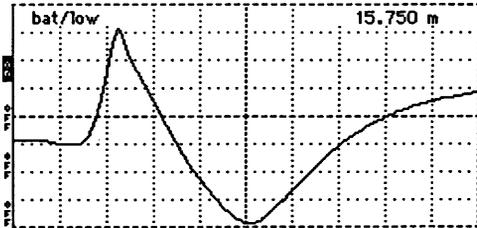
Cursor ..... 15.750 m  
Distance/Div ..... .25 m/div  
Vertical Scale..... 42.1 mP/div  
VP ..... 0.99  
Noise Filter ..... 1 avs  
Power ..... bat/low

Tektronix 1502B TDR  
Date 8/13/96  
Cable #3 040114  
Notes Looks Good

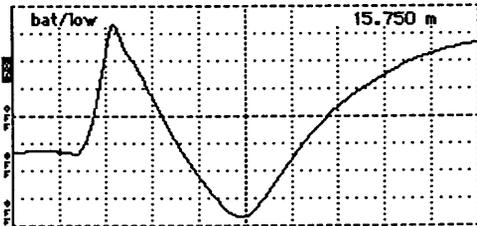
Cursor ..... 15.750 m  
Distance/Div ..... .25 m/div  
Vertical Scale..... 37.5 mP/div  
VP ..... 0.99  
Noise Filter ..... 1 avs  
Power ..... bat/low

Tektronix 1502B TDR  
Date 8/13/96  
Cable #4 040114  
Notes Looks Good

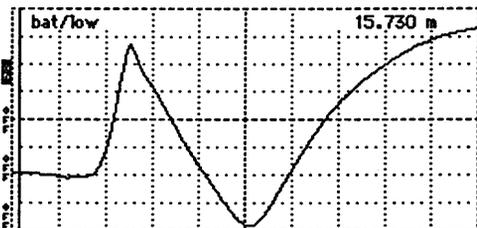
Cursor ..... 15.730 m  
Distance/Div ..... .25 m/div  
Vertical Scale..... 36.4 mP/div  
VP ..... 0.99  
Noise Filter ..... 1 avs  
Power ..... bat/low

Tektronix 1502B TDR  
Date 8/13/96  
Cable #5 040114  
Notes Looks Good

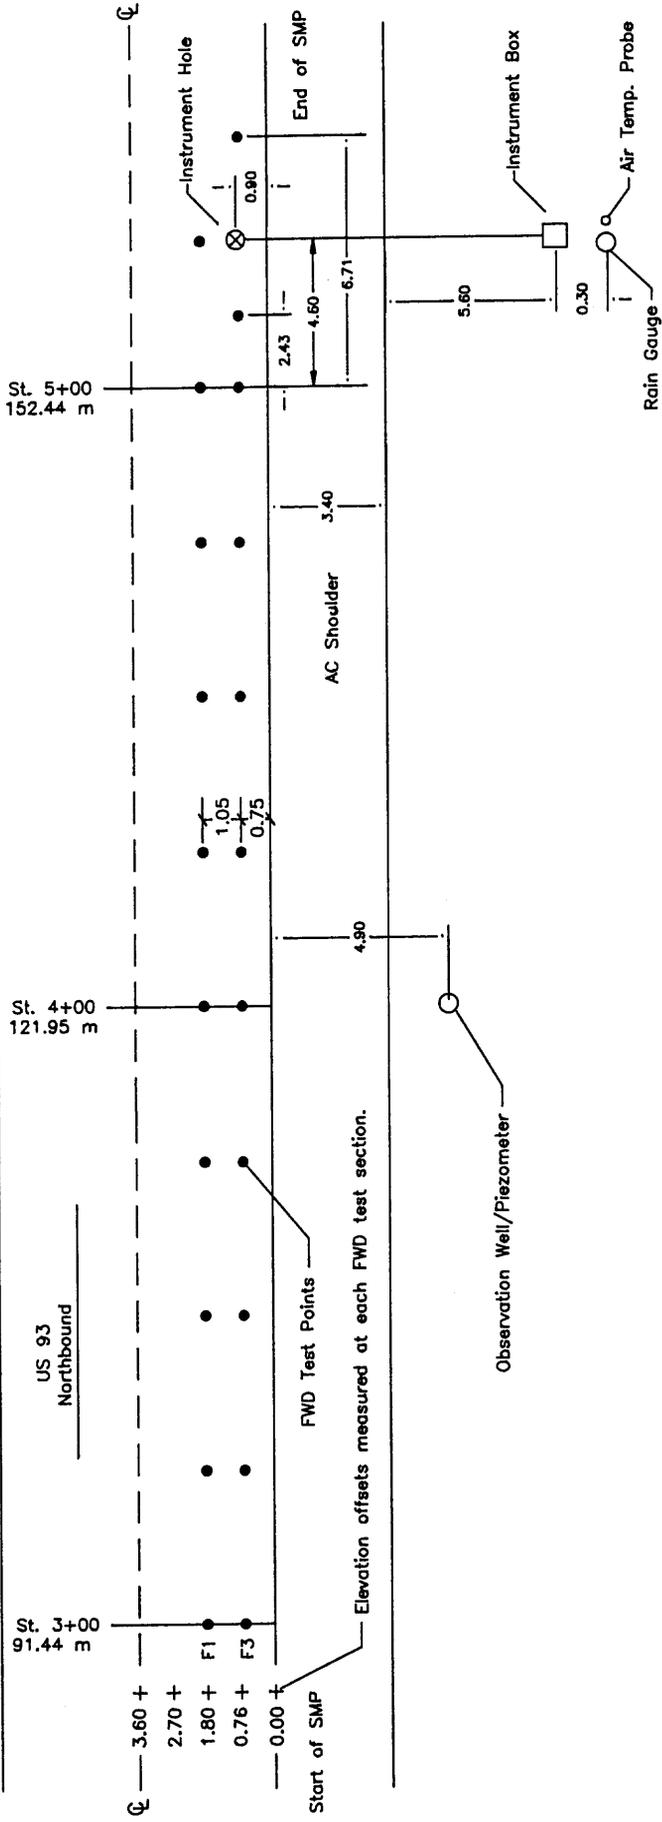
SECTION 040114  
Kingman, AZ

Divided Highway

Note: All dimensions are in meters.

- A layout sketch of the section indicating the location of the instrumentation hole, observation well, equipment cabinet, FWD test points and elevation measurement points was drawn so that, the site can be re-established easily upon return.

The instrumentation hole is located in the outside lane, at a distance of 157.04m (section station 5.00+15'), from the section beginning, in the outer wheel path. The equipment cabinet is located 9.00m to the right of the lane edge and the pole is 0.30m behind the equipment cabinet. The observation well/piezometer is located at a distance of 121.95m from the start of section, 4.90m away from the lane edge. Please refer to the site layout schematic for the testing and monitoring Mr.

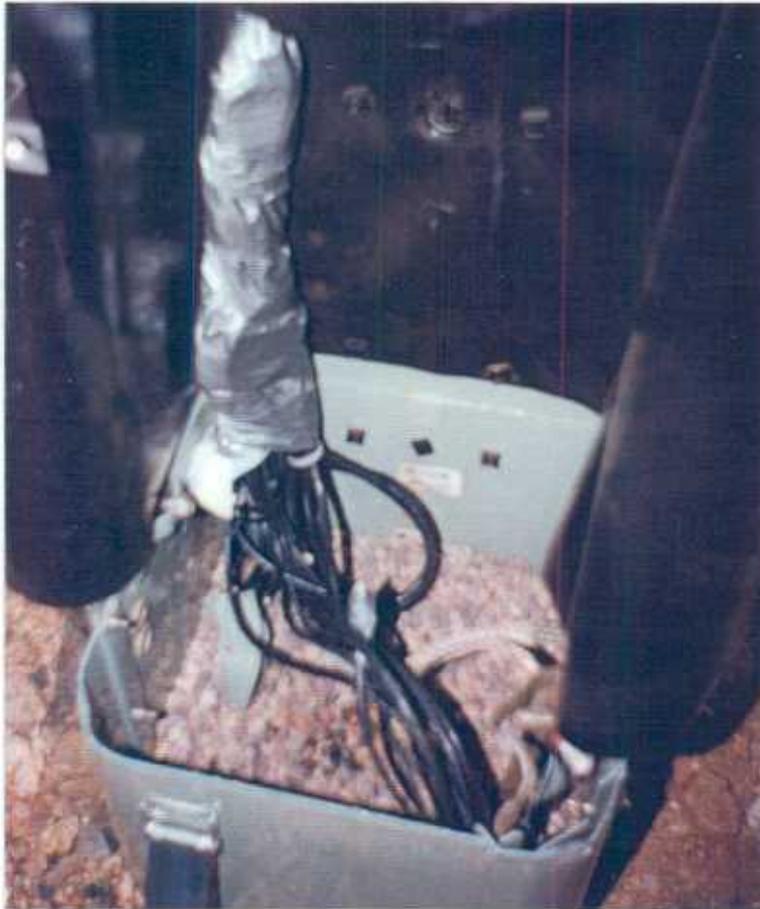
Taped Cable-ends.

- All TDR probes, thermistor temperature sensor unit cables and wiring were disconnected from the CR10 datalogger. These were carefully checked and labeled. Labels on each cable were scotch taped to ensure they would remain in place.

- A coat of electronics grade anti-corrosive compound was applied to all the cables and wiring connections to protect against corrosion of contact points. The cables were then put in a heavy duty plastic bag and were taped to keep out the elements and were then secured inside the equipment cabin.

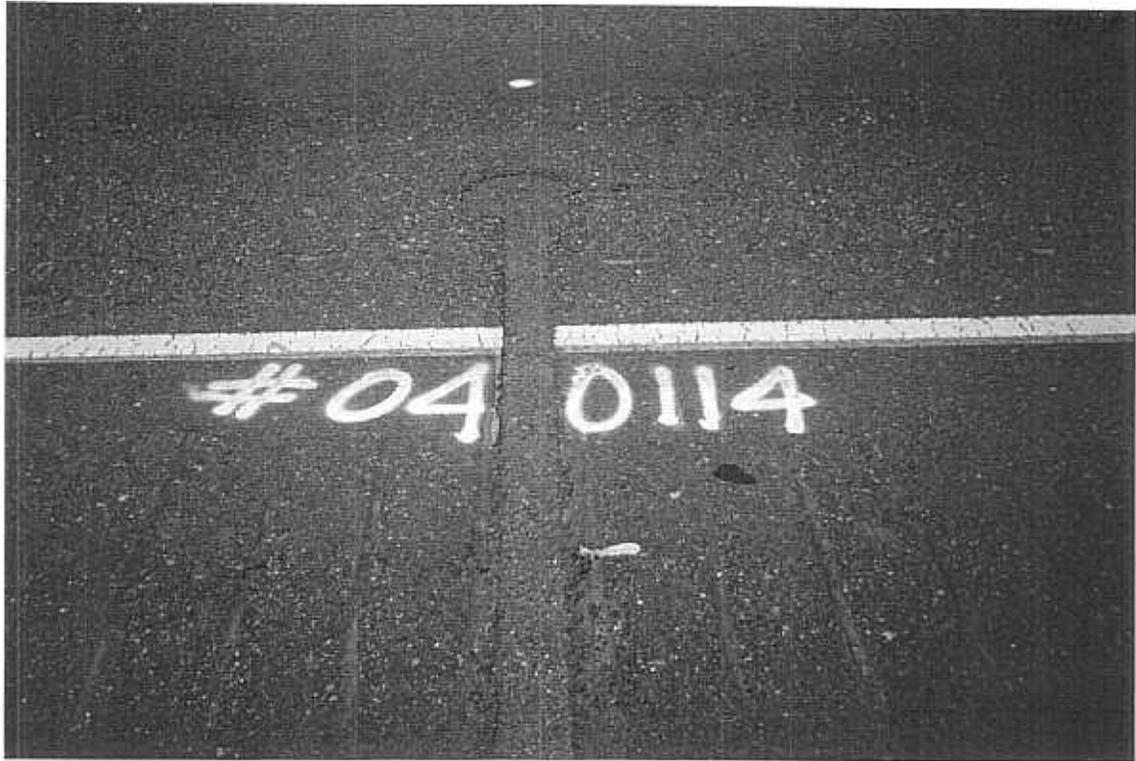
Instrumentation Hole.

- The instrumentation hole and access trench were both closely inspected and the joints were sealed with silicone sealant wherever necessary. No further patching was required.

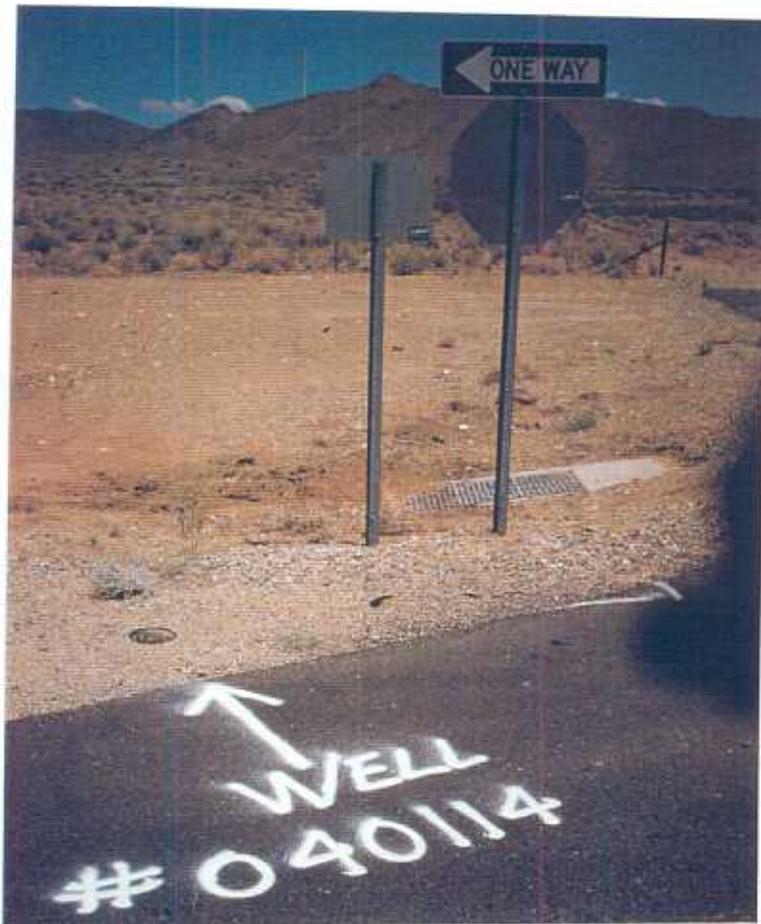
Observation Piezometer.

- The observation well and cap threads were thoroughly cleaned and lubricated (greased) before the well was sealed.
- The air temperature probe and rain gauge were disconnected from the steel pole and the pole was removed from the bottom joint. The pole stub, embedded in the ground, was cleaned and lubricated before capping.

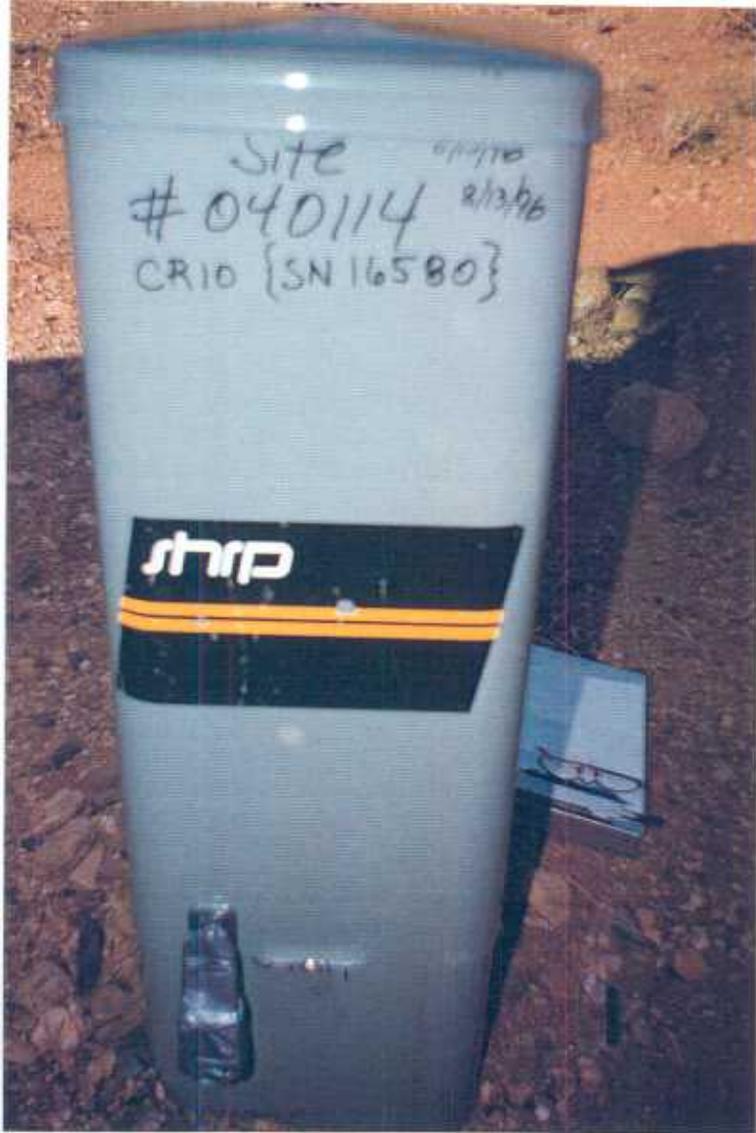
Equipment Cabinet.

- The instrument panel board containing the CR10 datalogger, the relay and the terminal strip was removed.
- The equipment cabinet was checked and adequate drainage was ensured in case of heavy precipitation.

- The equipment cabinet lock was lubricated with graphite lubricant, the lock was taped to keep out the natural elements.
- Nails were driven into the pavement at the elevation measurement and FWD test locations, the nailheads were spray painted white for easy identification
