**LTPP Seasonal Monitoring
Program
Site Installation and Initial Data
Collection
Section 040215
Phoenix, Arizona**

Site Installation and Initial Data Collection

Report No. FHWA-04-0215

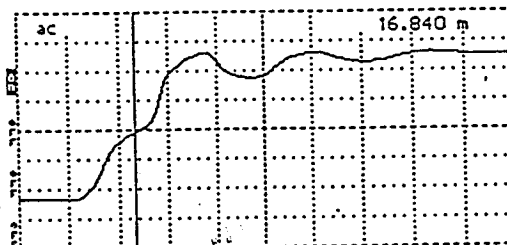
Figure B6. TDR traces obtained during calibration for sensor 04D06.

Tektronix 1502B TDR
 Date 6-22-95
 Cable 04D06
 Notes In Air
 Input Trace _____
 Stored Trace _____
 Difference Trace _____

Tektronix 1502B TDR
 Date 6-22-95
 Cable 04D06
 Notes In water
20.1°C
 Input Trace _____
 Stored Trace _____
 Difference Trace _____

Tektronix 1502B TDR
 Date 6-22-95
 Cable 04D06
 Notes Shorted at
start
 Input Trace _____
 Stored Trace _____
 Difference Trace _____

Calibration of TDR probes was completed by performing two measurements in air, one with the prongs shortened at the beginning of the sensor and the other not shortened. An additional measurement was made with the TDR sensor submerged in water. The TDR measured dielectric constants were within the specified limits, and the sensors produced the expected traces and were functioning properly. Individual TDR probe traces obtained during calibration are presented in figures B1 through B10 in appendix B. Serial numbers of equipment to be installed were noted, with the exception of radiation shield and air temperature sensor. The bench mark did not have a serial number and the battery pack serial number was not recorded because the batteries get frequently changed.

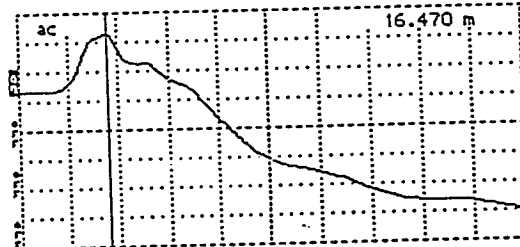
Figure B7. TDR traces obtained during calibration for sensor 04D07.

Tektronix 1502B TDR
 Date 6-17-95
 Cable 04D07
 Notes In Air
 Input Trace _____
 Stored Trace _____
 Difference Trace _____

Tektronix 1502B TDR
 Date 6-22-95
 Cable 04D07
 Notes In Water
20.1 °C
 Input Trace _____
 Stored Trace _____
 Difference Trace _____

Tektronix 1502B TDR
 Date 6-22-95
 Cable 04D07
 Notes Shaded at
Start
 Input Trace _____
 Stored Trace _____
 Difference Trace _____
