**SEASONAL MONITORING PROGRAM
DISMANTLE REPORT
SITE 040215, PHOENIX, ARIZONA.**

January 1997

SUBJECT: **Suspension of SMP Site Monitoring Activities, Site 040215**

This memo will serve as the SMP Site Monitoring Suspension Status Report for Site 040215 (04SD) near Phoenix, Arizona. This report narrates the activities associated with the suspension of SMP site monitoring.

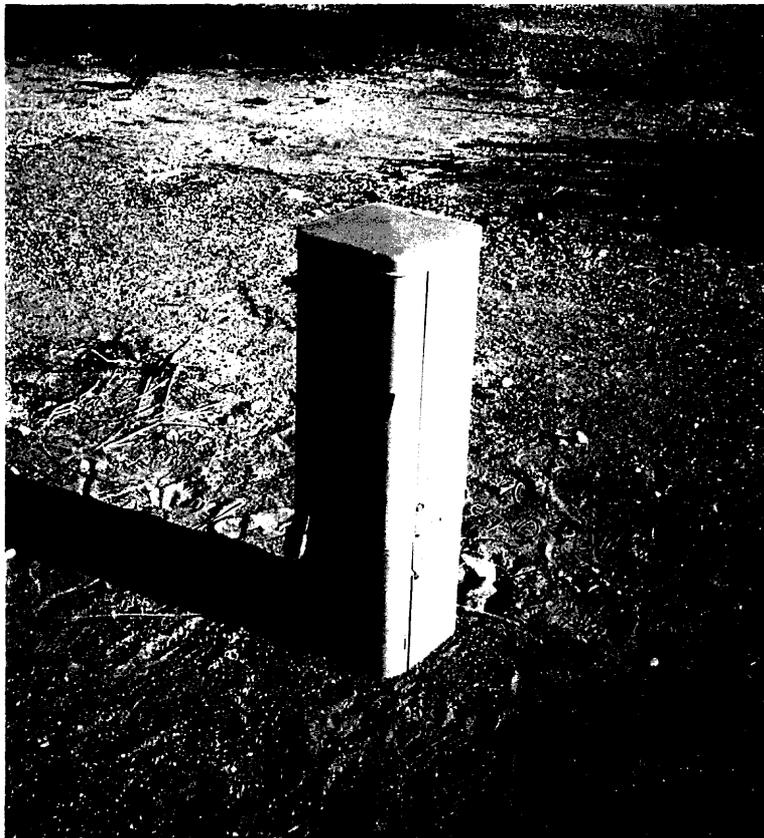
Equipment Cabinet.

- The instrument panel board containing the CR10 datalogger, the relay and the terminal strip was removed.
- The equipment cabinet was checked and adequate drainage was ensured in case of heavy precipitation.

- The equipment cabinet lock was lubricated with graphite lubricant, the lock was taped to keep out the natural elements.
- The deflection and elevation measurement locations were marked with white paint for easy identification.
