**LTPP Seasonal Monitoring  
Program  
Site Installation and Initial Data  
Collection  
Section 041024  
Flagstaff, Arizona**

Site Installation and Initial Data Collection  
Section 041-24, Flagstaff, Arizona

**Report No. FHWA-04-1-1024**

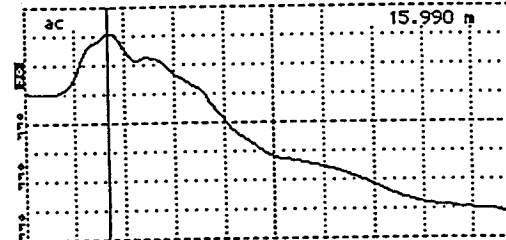
Figure B8. TDR traces obtained for sensor 04C08 during calibration.

Tektronix 1502B TDR  
 Date 6-22-95  
 Cable 04C08  
 Notes In water  
19.3°C  
 Input Trace \_\_\_\_\_  
 Stored Trace \_\_\_\_\_  
 Difference Trace \_\_\_\_\_

Cursor ..... 15.990 m  
 Distance/Div..... .25 m/div  
 Vertical Scale.... 177 m $\rho$ /div  
 VP ..... 0.99  
 Noise Filter..... 1 avs  
 Power..... ac

Tektronix 1502B TDR  
 Date 6-22-95  
 Cable 04C08  
 Notes Started at  
start  
 Input Trace \_\_\_\_\_  
 Stored Trace \_\_\_\_\_  
 Difference Trace \_\_\_\_\_

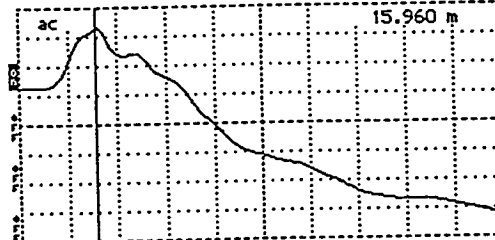
Figure B9. TDR traces obtained for sensor 04C09 during calibration.

Tektronix 1502B TDR  
 Date 6-27-95  
 Cable 04C09  
 Notes In Water  
19.3°C  
 Input Trace \_\_\_\_\_  
 Stored Trace \_\_\_\_\_  
 Difference Trace \_\_\_\_\_

Cursor ..... 15.960 m  
 Distance/Div..... .25 m/div  
 Vertical Scale..... 177 mV/div  
 VP ..... 0.99  
 Noise Filter..... 1 avs  
 Power..... ac

Tektronix 1502B TDR  
 Date 6-27-95  
 Cable 04C09  
 Notes Shut-off at  
Start  
 Input Trace \_\_\_\_\_  
 Stored Trace \_\_\_\_\_  
 Difference Trace \_\_\_\_\_
