**LTPP Seasonal Monitoring  
Program  
Site Installation and Initial Data  
Collection  
Section 063042  
Lodi, California**

Site Installation and Initial Data Collection  
Section 063042, Lodi, California

**Report No. FHWA-06-3042**

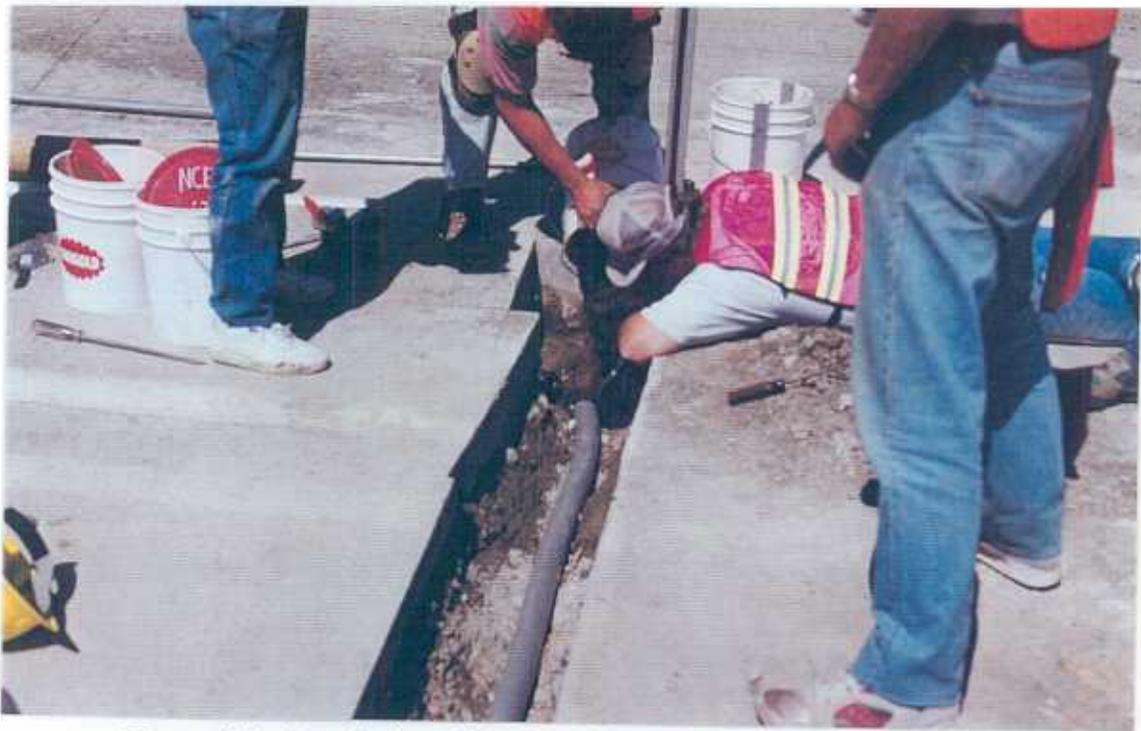
Figure C5. Installation of TDR and thermistor sensors in progress.

TDR probes were placed in an offset fan pattern such that the lead wires were on the hole side closest to the pavement edge. All the TDR probe lead wires had the "S" shaped stress relief loop made in them. Each TDR probe was connected to the function generator while the soil around it was being compacted and manual traces were generated. This was done to ensure that none of the TDR sensors were damaged during the backfilling and compaction of the instrumentation hole. TDR and thermistor probe lead wires were bundled and put through a 51mm diameter flexible electrical conduit buried in a 76mm wide trench, leading to the equipment cabinet. The equipment cabinet was located 8.20m away from the instrumentation hole on gently sloping ground. The installed depths of TDR are presented in table 5.

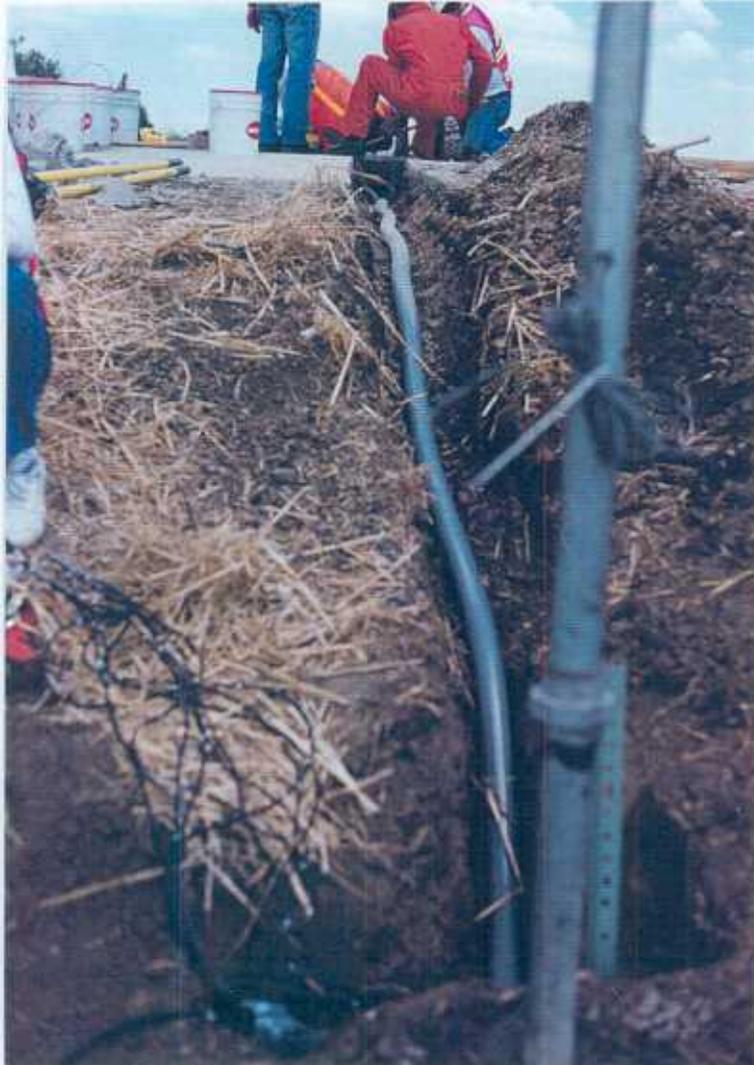
Figure C6. Cable trench and the climatic equipment pole.

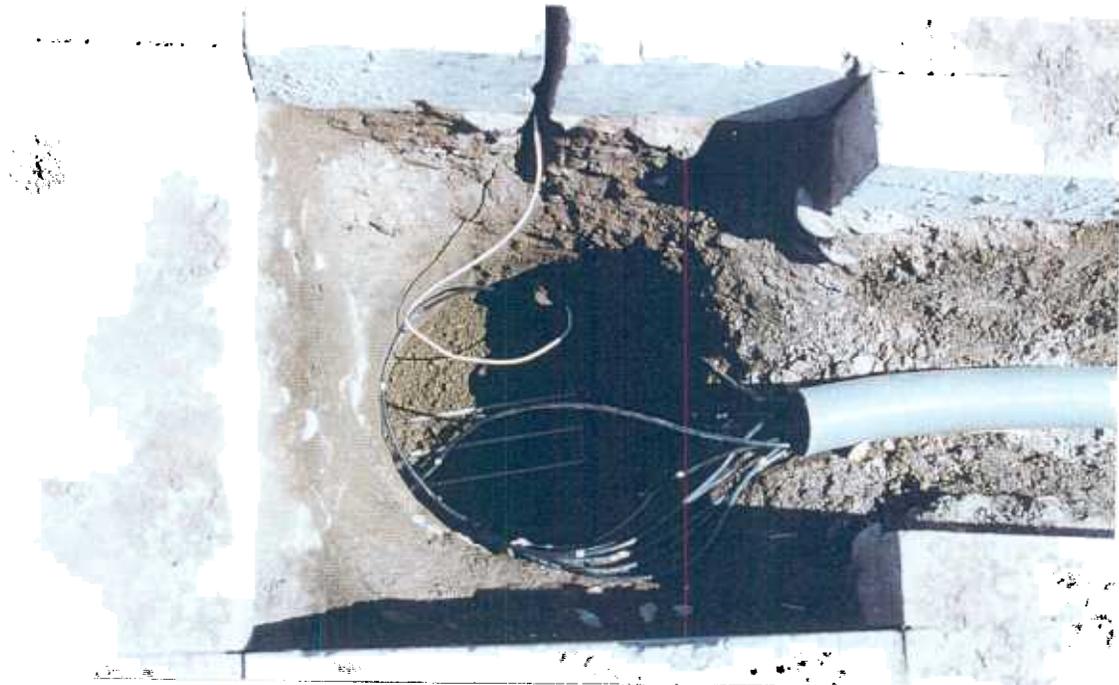
Figure C7. Instrumentation hole with the TDR and temperature sensors.

Pavement and subsurface instrumentation was installed at the leave end of the section at a distance of 160.14m (station 5+25'3") from section beginning, in a 0.30m diameter hole bored using a 252mm diameter stem auger after sawing a 0.50m square hole in the PCC layer. The pavement temperature sensors (thermistor unit #1) were installed in the PCC layer as per LTPP guidelines. TDR moisture probes and subsurface temperature sensors (thermistor unit #2) were installed in the instrumentation hole. The instrumentation hole was 2.38m deep.

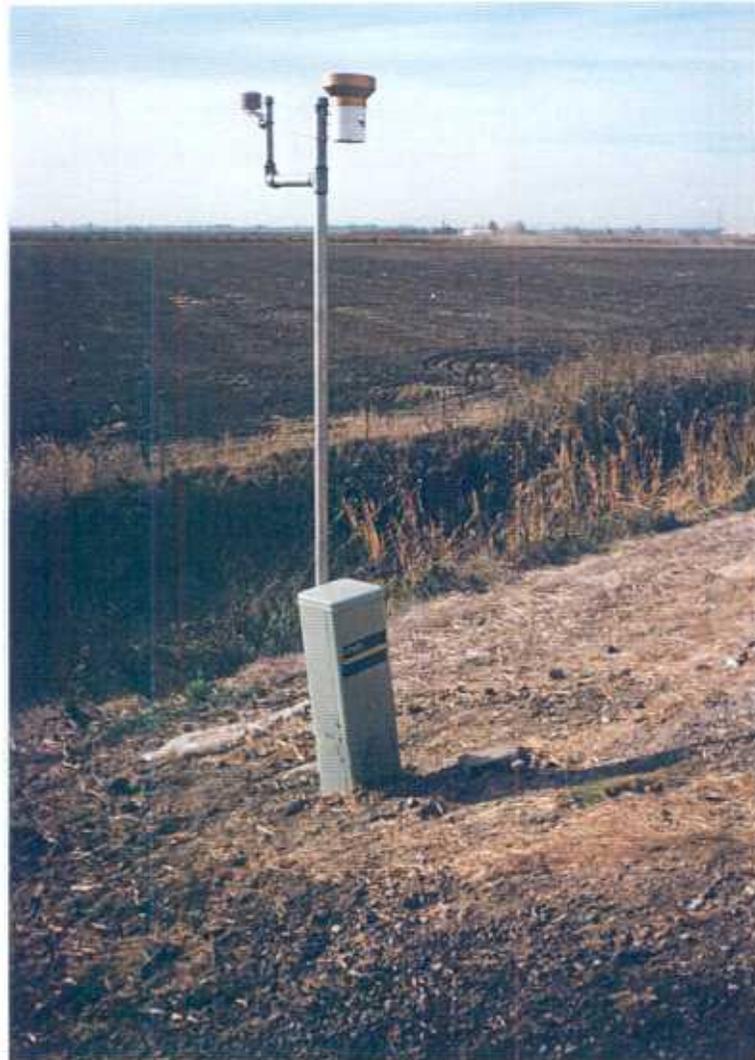
Figure C8. Equipment cabinet and climatic sensors.
