## **LTPP Seasonal Monitoring Program**

Site Installation and Initial  
Data Collection  
Section 091803, Groton  
Connecticut

**Report No. FHWA-TS-95-09-01**

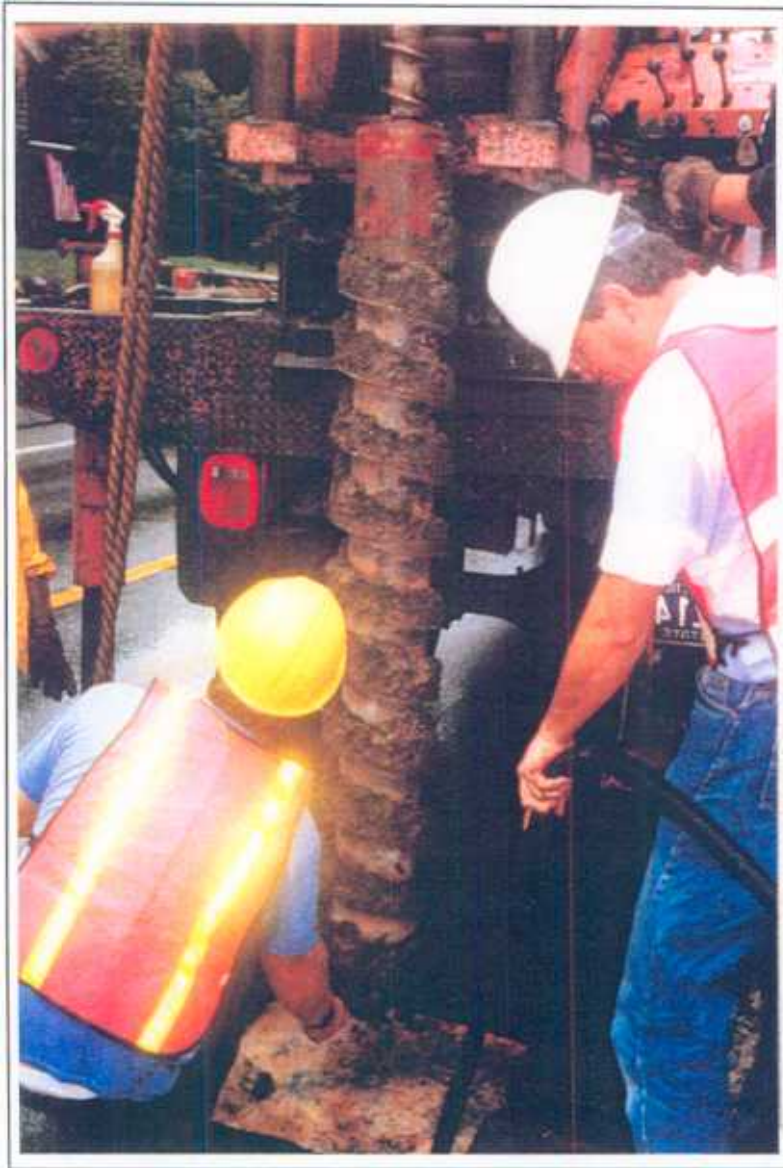
Figure E-2. Instrumentation Hole

A 610 mm square hole was cut into the AC surface, located in the outside wheel path, 0.66 m from the edge of the travel lane at station 5+21, using a heavy duty portable paving saw. A 20 mm notch was cut in the center of the south side of the instrumentation hole to accommodate the stainless steel thermistor probe for measuring the gradient temperature in the AC layer. A 102 mm wide saw cut was made between the instrumentation hole and the edge of the paved shoulder to accommodate the instrumentation cabling. A pick and shovel was used to remove the aggregate material from the pavement area. A backhoe was used to excavate a trench from the edge of pavement to the location of the equipment cabinet. A concrete base was installed to support the aluminum cabinet supplied by CTDOT for retaining the cabling, data logger and batter assembly.

A 250 mm hollow stem auger, with the plug removed, was used to excavate the instrumentation hole. Due to the extensive amount of rocks in the base material it was necessary to loosen the rocks with the auger and remove them either by hand or with a small scoop.

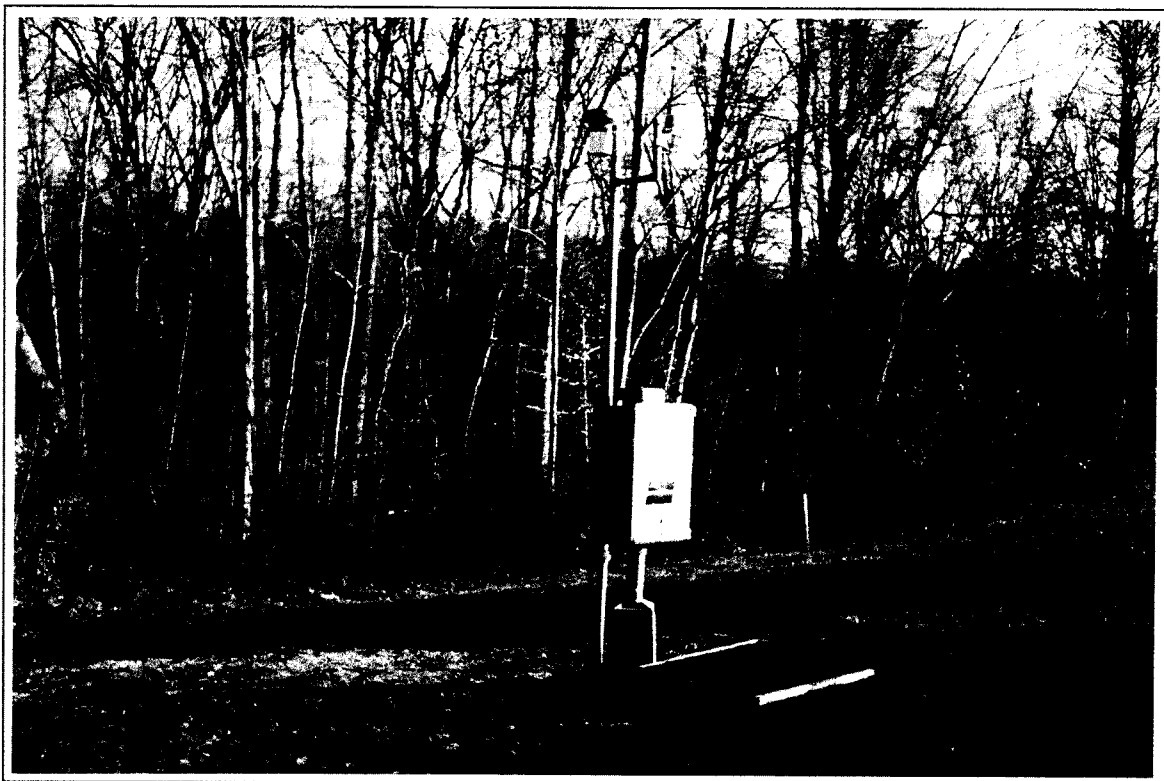
Figure E-7. Equipment Cabinet, Air Temperature Probe, and Rain Gage

- Height of Air Temperature Probe (center): 3.58m
- Height of Tipping Bucket Rain Gage (center): 3.66m
- Total Depth of Piezometer: 3.06m
- Distance of Piezometer Below Ground Level: 51mm

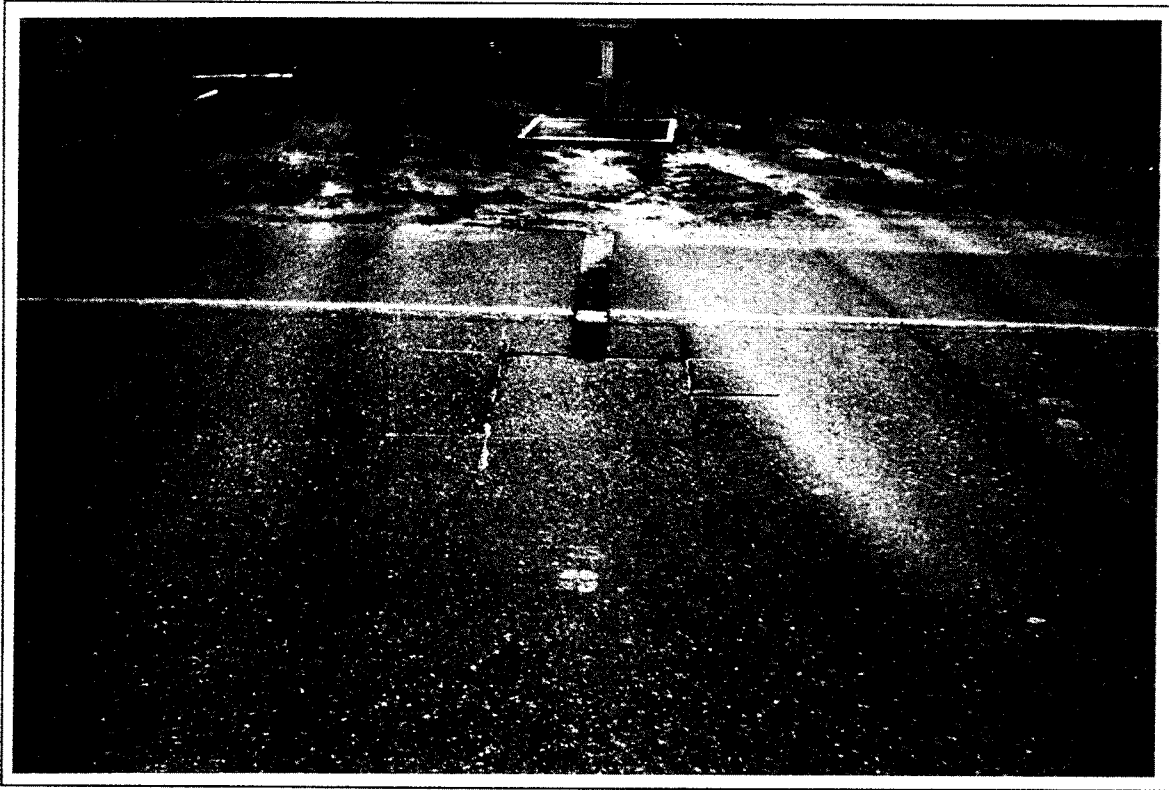
Figure E-10. Instrumentation Hole, a Few Months After Installation

When the site was visited on November 15, 1993 three months after installation, the instrumentation hole patch was checked and photos were taken as shown in Appendix E. There was minor settlement in the patched areas and the sealant did not hold properly. There were also some cracks propagating off of the corner cuts for the block. A Corning self leveling 888 crack sealing compound was used to seal the joints at the perimeter of the block.
