LTPP Seasonal Monitoring Program

**Site Installation and Initial
Data Collection**

Section 161010

Idaho Falls, Idaho

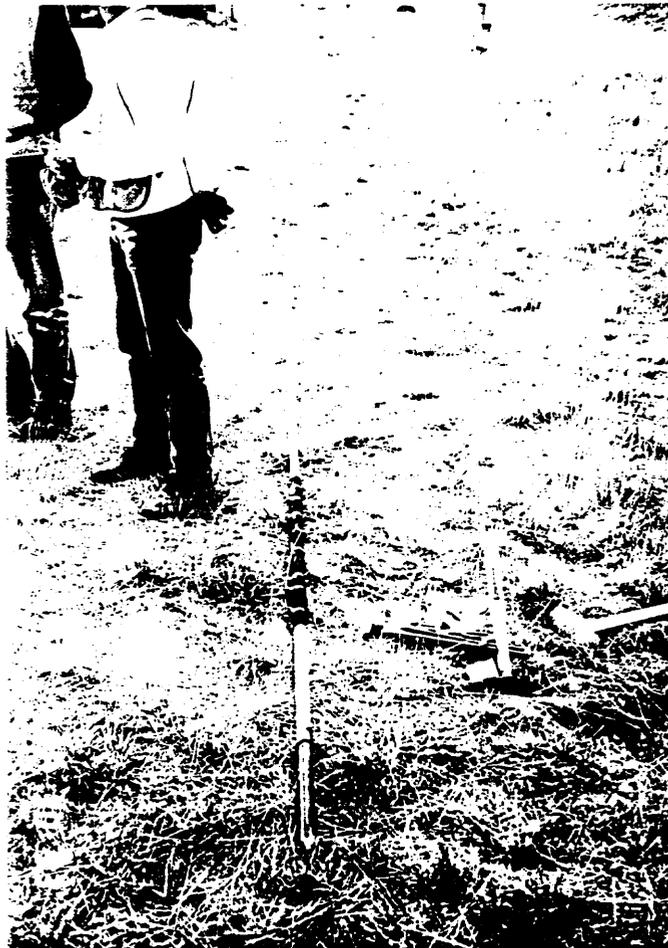
Figure E-2. Piezometer/bench mark assembly with geonor anchor point installed.

- A geonor anchor point was used on the end of the piezometer/bench mark assembly. This device proved easy to install and promises to provide better anchoring than the floor flange. This type of anchor point is recommended for fine grain and active soil applications and in situations where the water table is likely to be encountered during installation.

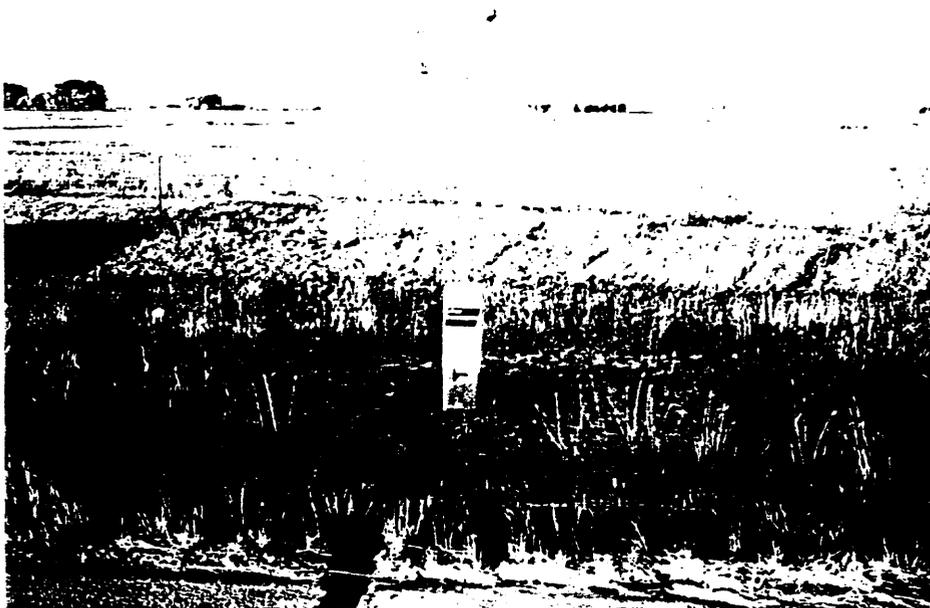
Figure E-4. Equipment cabinet and climatic sensors.
