LTPP Seasonal Monitoring Program

Site Installation and Initial
Data Collection
Section 241634, Ocean City
Maryland

Report No. FHWA-TS-96-24-01

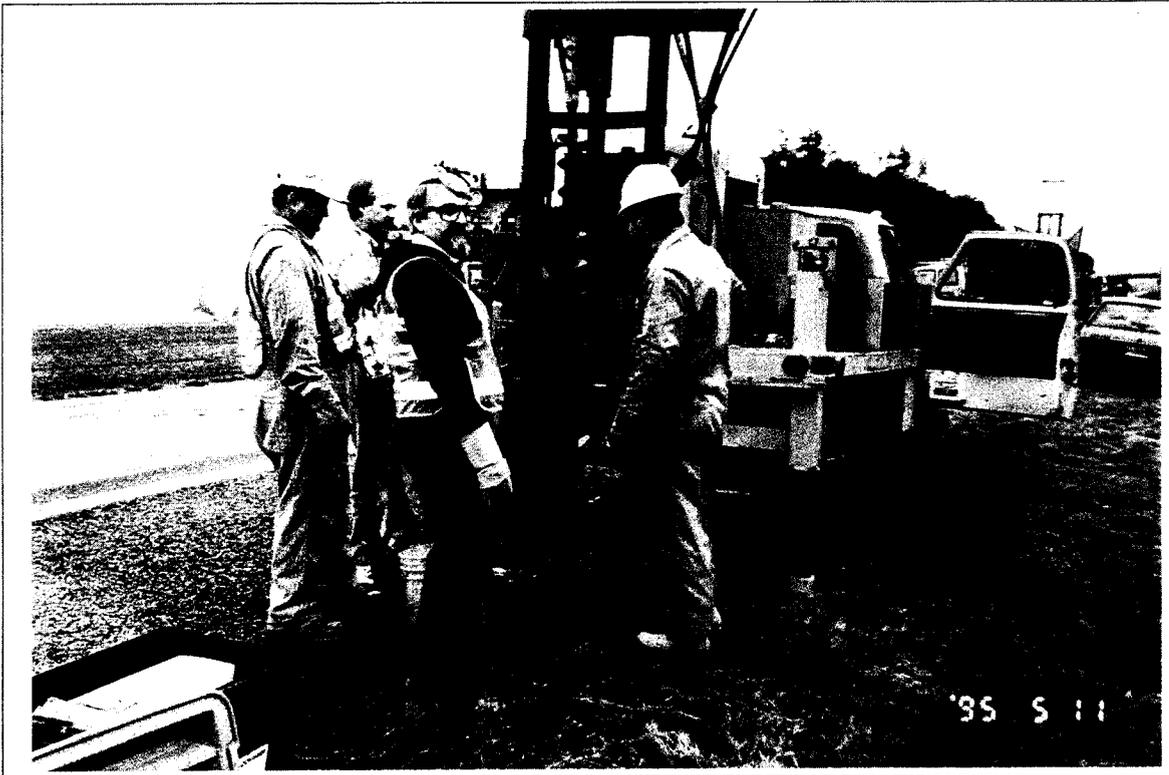
Figure E-1. Augering the Piezometer Hole

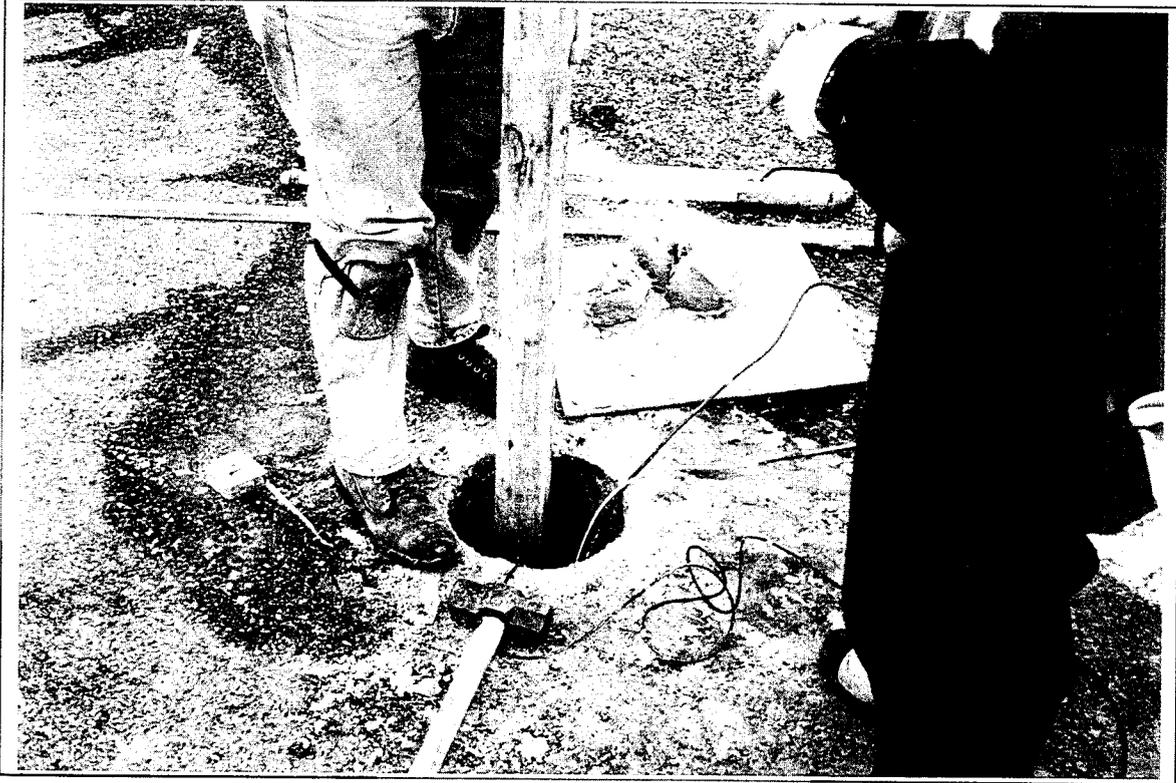
Figure E-3. Compacting the Instrumentation Hole

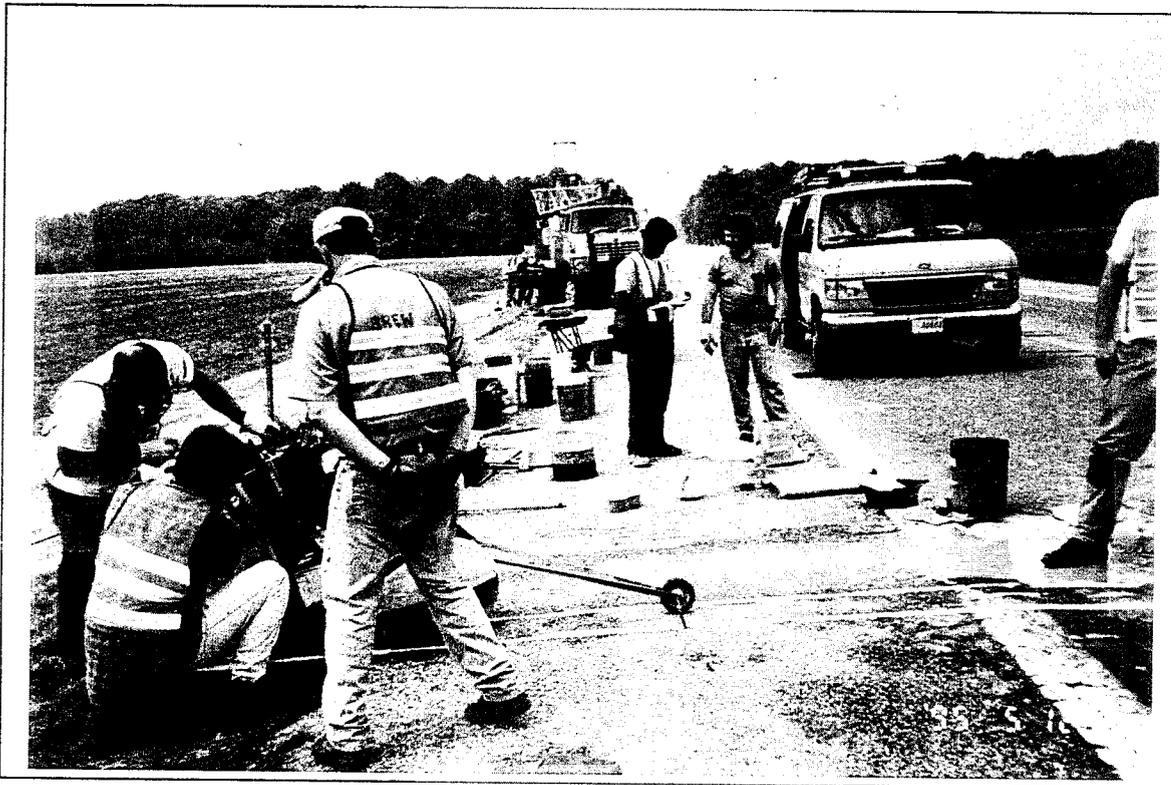
Figure E-4. Sawcutting Trench
