# LTPP Seasonal Monitoring Program

## Site Monitoring Suspension Status Draft Final Report for GPS Section 313018 (31B) Kearney, Nebraska

September 1996

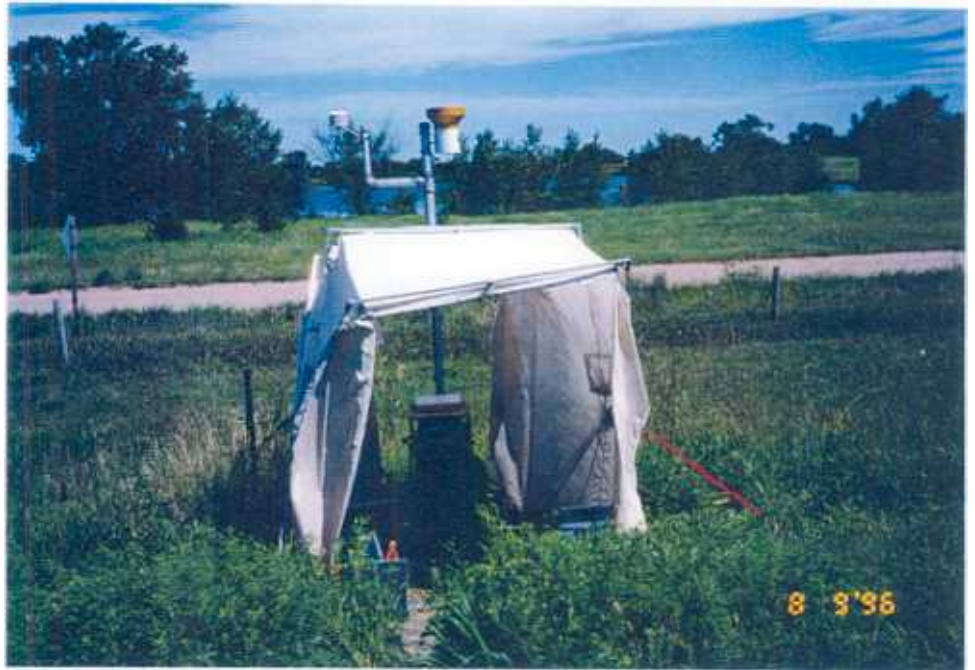
Photograph #1 ⇒

As shown in photograph 1 in appendix E, the collector unit (funnel) of the rain gauge is intact and no obvious problems were noted from the data recorded from June 10, 1996 through August 9, 1996.

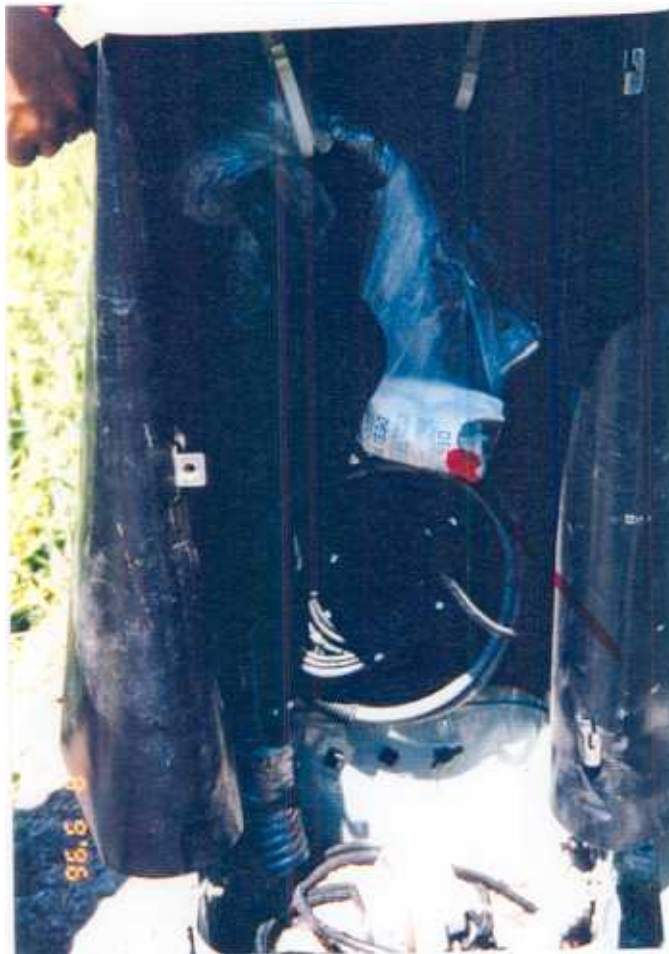
⇐ Photograph # 2

- Disconnection and removal of the panel board containing the Onsite CR10, power supply, terminal strip, and relay. A desiccant pouch with all wires and connectors was sealed in a plastic bag as shown in photograph 2 in appendix E.
- After completion of the final water table depth measurement, the end of the piezometer was sealed and marked for easy identification.
- As shown in photograph 3 the vegetation growing around the benchmark installed by the Nebraska DOT was cleared. Photograph 4 shows how the benchmark is marked by the DOT for easy identification.
- The three temperature holes in the pavement were sealed with silicone after the final temperature readings.
- Locked cabinet as shown in photograph number 5 in appendix E. Photograph 6, also in appendix E shows the remaining pipe at the back of the cabinet.
