# **LTPP Seasonal Monitoring Program**

Site Installation and Initial Data Collection  
Section 320101, Battle Mountain, Nevada

**Report No. FHWA-32-0101**

June 1997

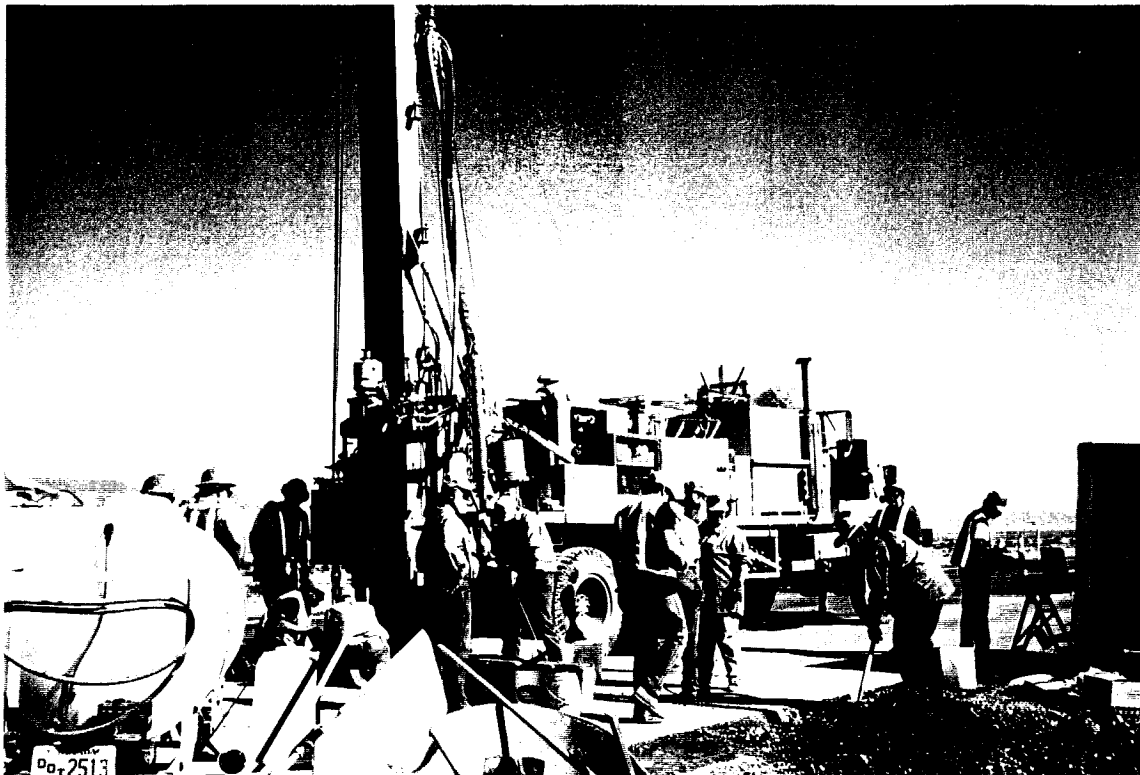
Figure C3. General activities during installation at the site.

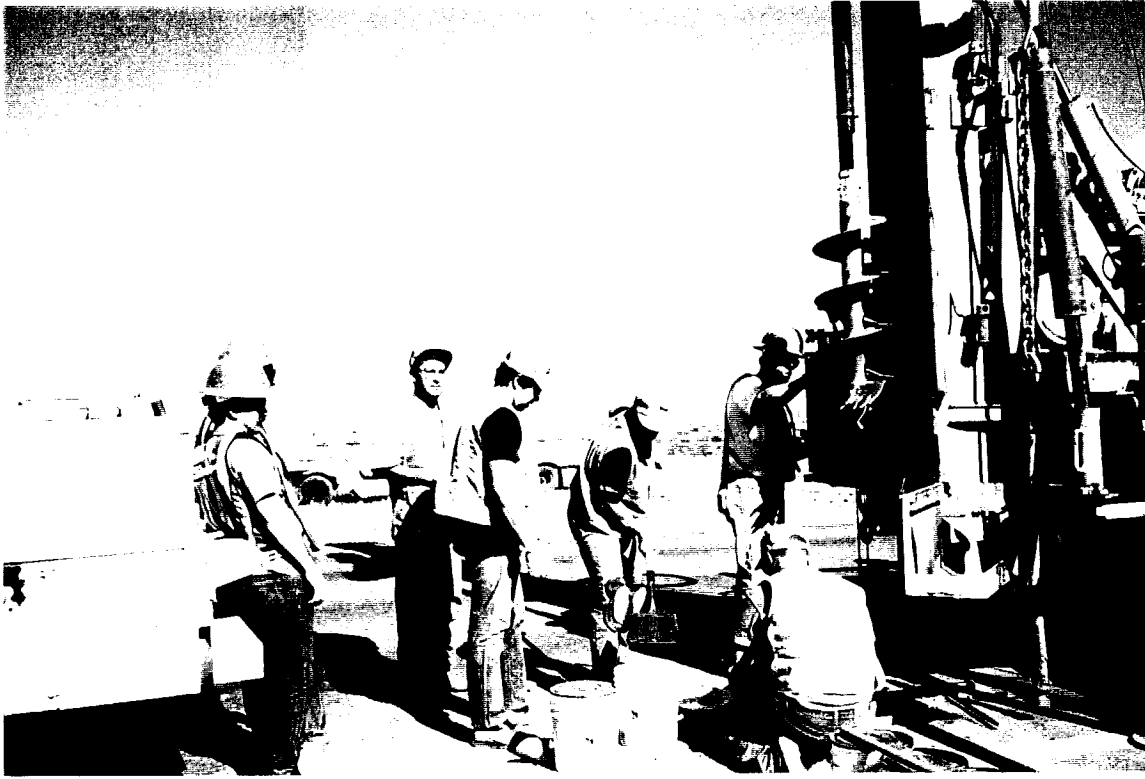
Figure C5. Instrumentation hole drilling in progress.

Pavement and subsurface instrumentation was installed at the leave end of the section at a distance of 157.15m (station 5+15.45') from the section beginning, in a 0.30m diameter hole bored using a 252mm diameter flight auger after sawing out a 0.5m square block from the surface AC layer. The pavement temperature sensors (thermistors, unit number 1) were installed in the AC layer as per LTPP guidelines. TDR moisture probes and subsurface temperature sensors (thermistors, unit number 2) were installed in the base course and subgrade layers. The instrumentation hole was 2.10m deep. Figure C1 in appendix C presents the site layout and instrument location. All the TDR probes were placed with an "S" shaped stress relief loop in their cables. The TDR probes were placed in an offset fan pattern such that the lead wires were on the side closest to the pavement edge. TDR, resistivity, and thermistor probe lead wires were bundled and pulled through a 51mm diameter flexible electrical conduit buried in a 76mm wide trench, leading to the equipment cabinet. The equipment cabinet was located 9.75m away, to the right of lane edge on almost level ground. The installed depths of the TDR sensors are presented in table 6. All instruments at this site were installed in adherence with FHWA LTPP SMP Guidelines, April 1994.
