LTPP Seasonal Monitoring Program

Site Installation and Initial
Data Collection
Section 331001, Concord
New Hampshire

Report No. FHWA-TS-94-33-01

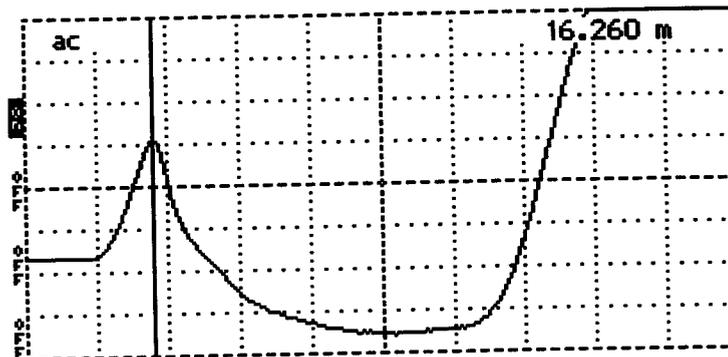
Trace Number 4 - Probe in Alcohol

Cursor 16.260 m
 Distance/Div25 m/div
 Vertical Scale.... 64.8 mP/div
 VP 0.99
 Noise Filter..... 1 avs
 Power ac

Tektronix 1502B TDR
 Date 10/9/93
 Cable 1
 Notes Alcohol
 Input Trace _____
 Stored Trace _____
 Difference Trace _____

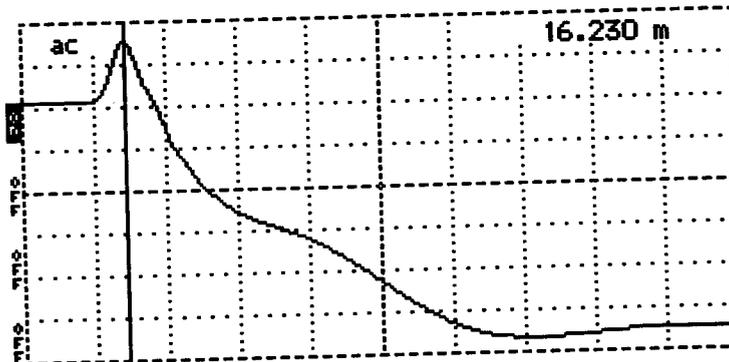
TDR Trace 1 - Beginning Probe Shorted

Cursor 16.230 m
Distance/Div25 m/div
Vertical Scale.... 145 m ρ /div
VP 0.99
Noise Filter 1 avg
Power ac

Tektronix 1502B TDR
Date 10/9/93
Cable 2
Notes Short CB
Input Trace _____
Stored Trace _____
Difference Trace _____

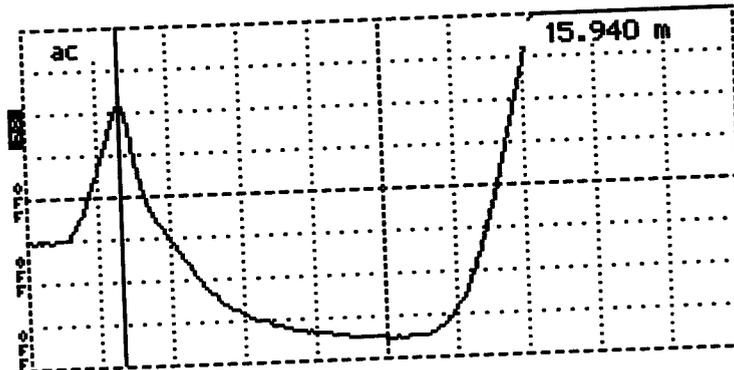
Trace Number 4 - Probe in Alcohol

Cursor 15.940 m
 Distance/Div25 m/div
 Vertical Scale.... 53.0 mP/div
 0.99
 Base Filter 1 avg
 Power ac

Tektronix 1502B TDR
 Date 10/19/93
 Cable 9
 Notes Alcohol

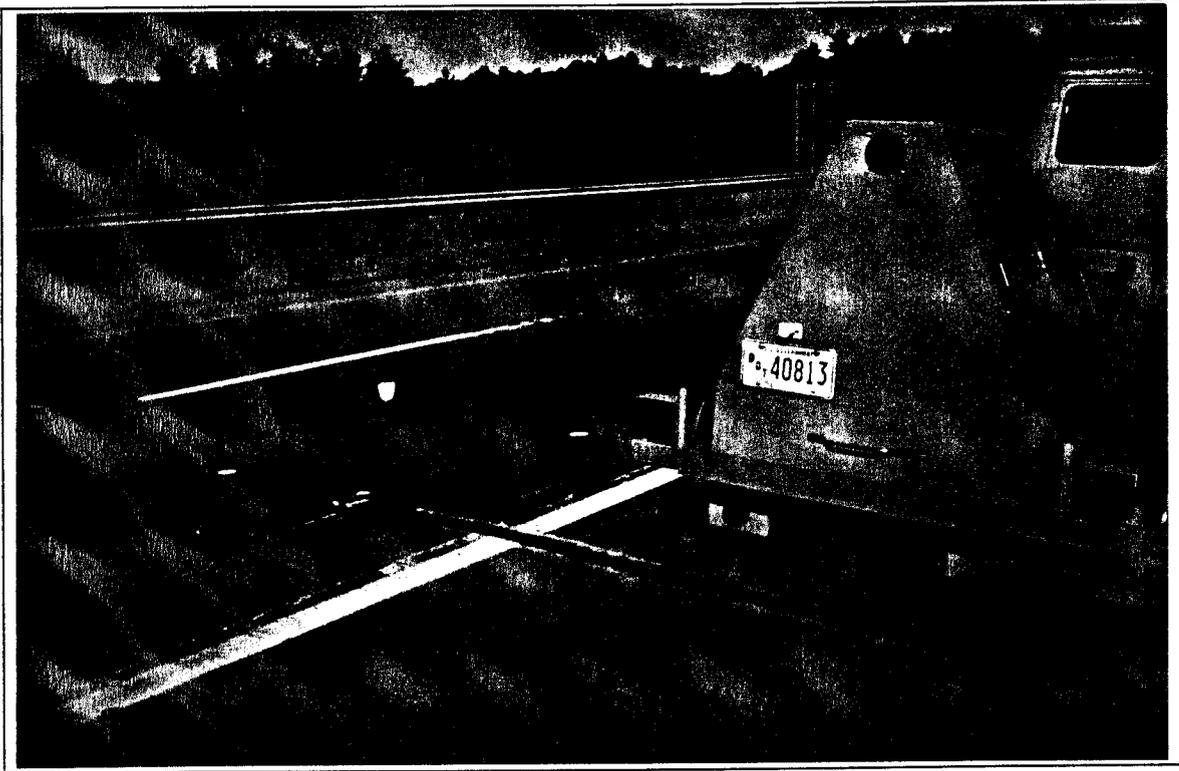
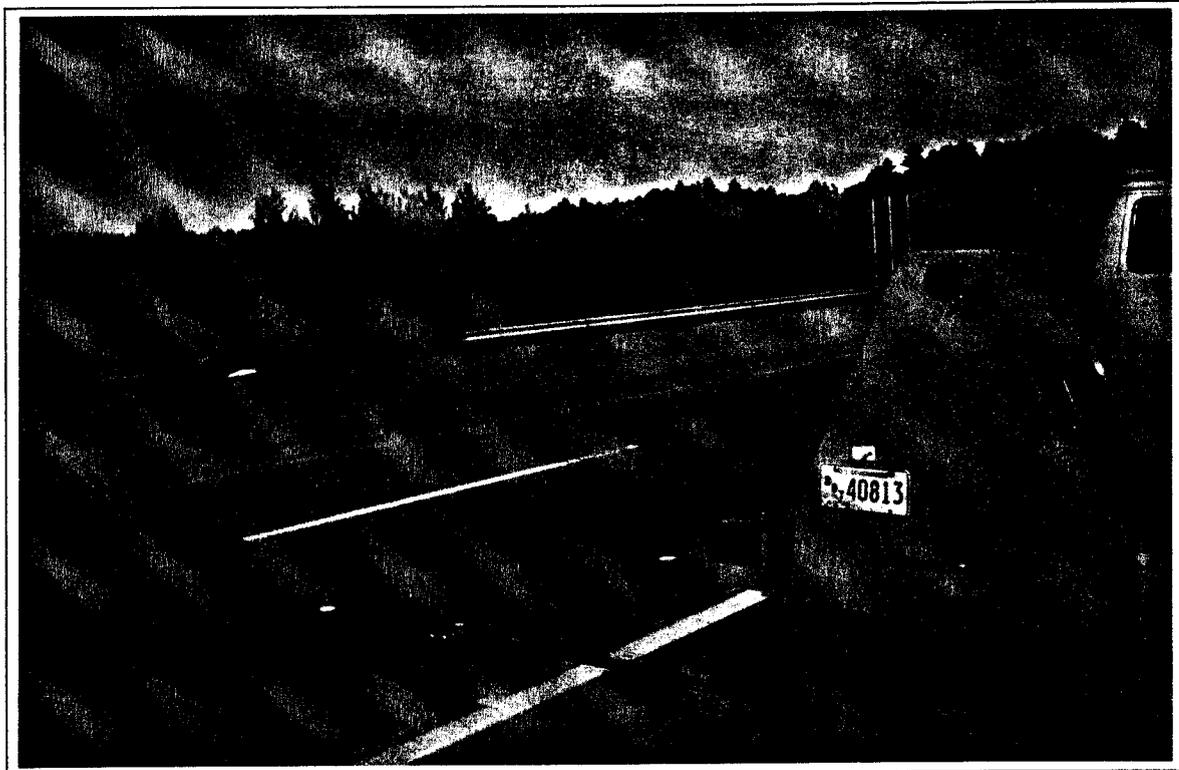
Figure E-6. Patch Area, the Day After Installation

Figure E-7. Patch Area, the Day After Installation

The instrumentation hole was repaired by reinstalling the 305mm asphalt core. Some juggling was required to get the core level with the existing pavement surface. Once the core was leveled it was removed from the hole and the bottom 100mm was heavily covered with a two part epoxy (PC-7) and reset into the hole forcing the epoxy against the side and up along the wall of the core hole. The weight of the state dump truck, which slowly moved back and forth over the core, was used to firmly seat the core into the hole.

The trench for the cabling from the instrumentation hole to the edge of pavement was leveled with crushed gravel to the existing bottom of the paved layer and a cold mix was compacted to the level of the existing surface. The remainder of the trench was filled with native material and compacted, followed by a cleanup of loose material from the paved area. The guardrails were reinstalled by the state district personnel. Traffic control was removed at 6:00 p.m. and the lane reopened to traffic. During the next day the instrument hole and edge of the trench were sealed using Corning self-leveling 888 crack sealing compound. Removal of the asphalt trench material and other disposable items were handled by the NHDOT district personnel.
