LTPP Seasonal Monitoring Program

Site Installation and Initial
Data Collection
Section 364018, Oneonta
New York

Report No. FHWA-TS-95-36-01

September 1995

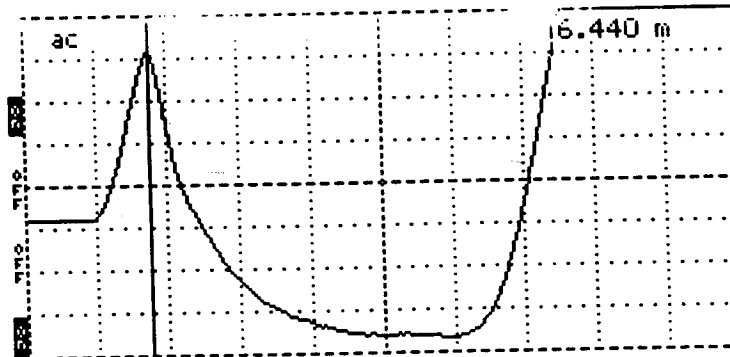
Figure B-1(cont.). TDR Traces Obtained During Calibration

Trace Number 4 - Probe in Alcohol

Trace Number 5 - Probe in Water

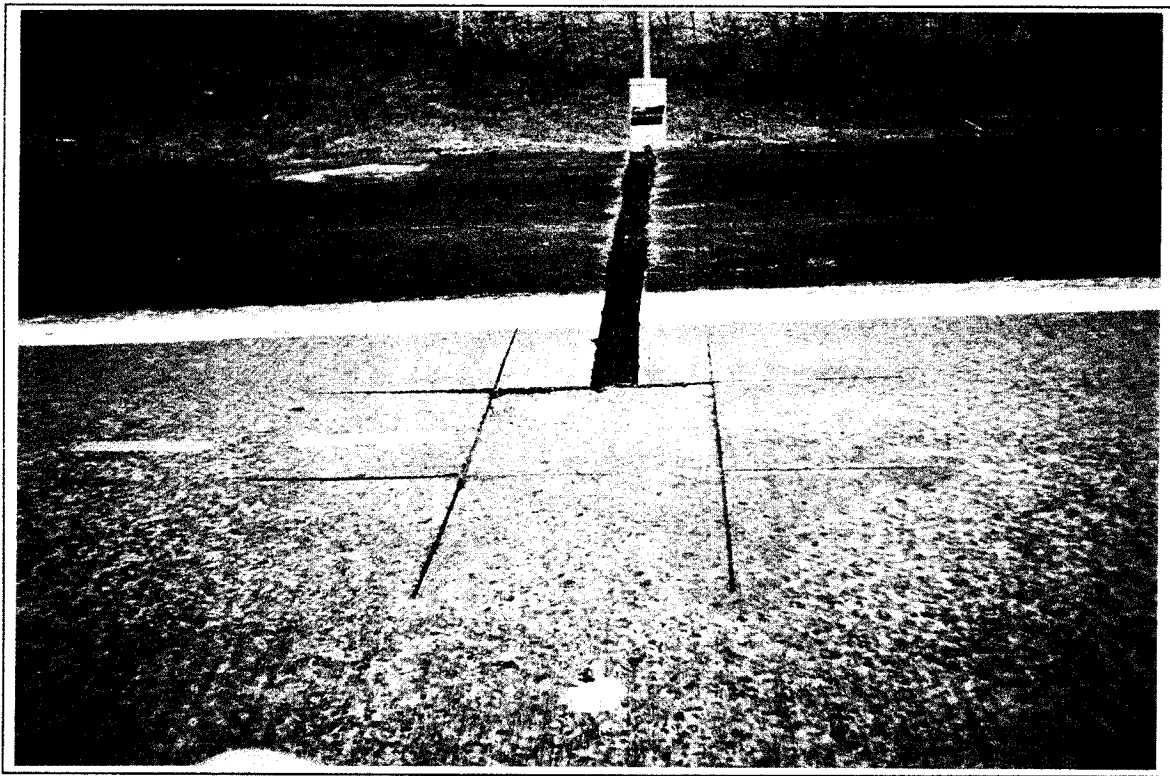
Figure E-4. Instrument Hole, Trench, and Equipment Cabinet
