# **LTPP Seasonal Monitoring Program**

## **Site Monitoring Suspension Status Draft Final Report for GPS Section 469187 (46B) Faith, South Dakota**

FHWA CONTRACT No. DTFH61-96-C-00013

October 1997

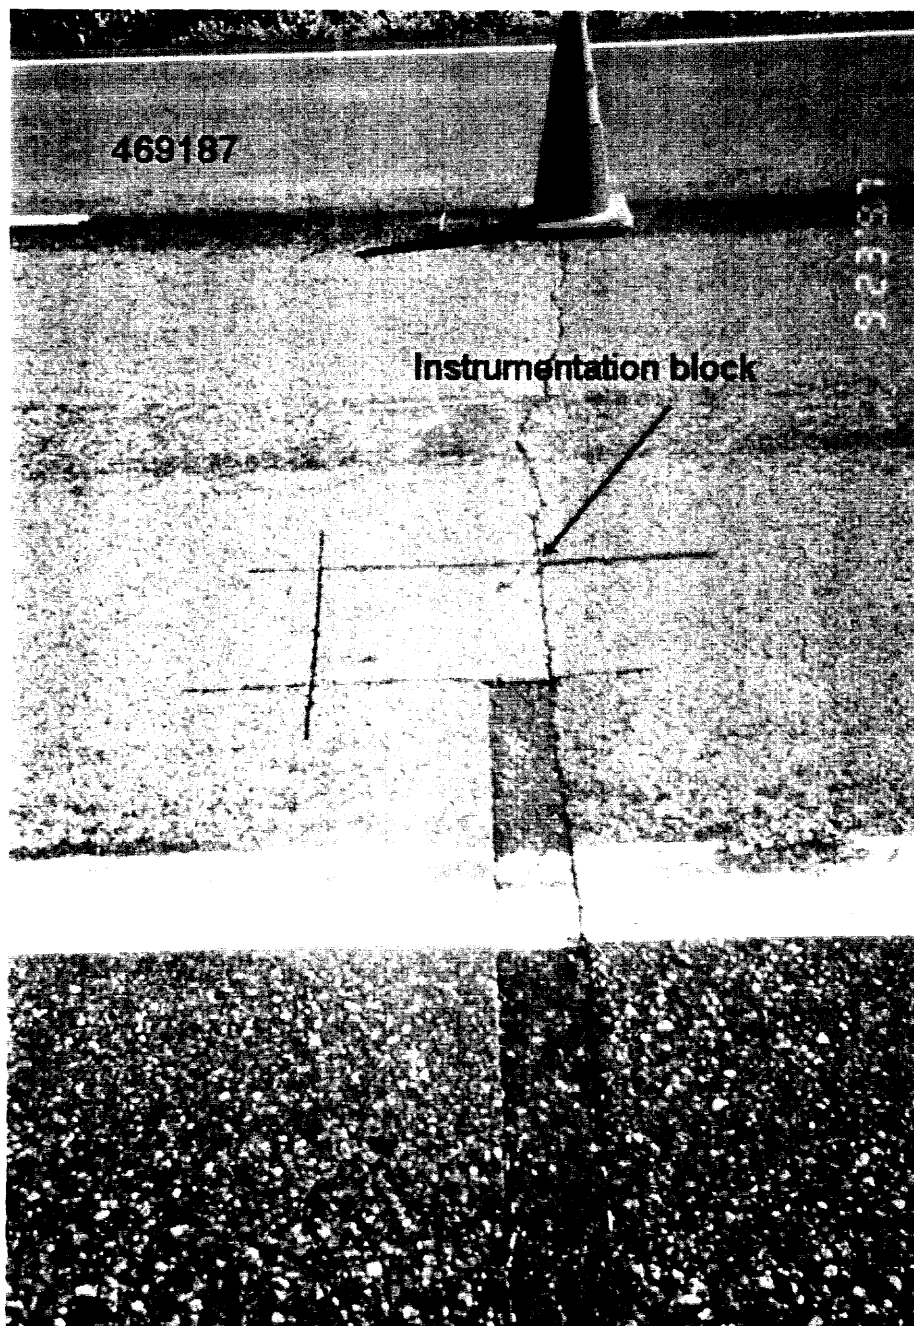
Photograph # 3

- Application of an electronics quality, anti-corrosion compound to the TDR and BNC connectors, electrical resistivity connector, and MRC temperature lead wires.
- Disconnection and removal of the panel board containing the Onsite CR10, power supply, terminal strip, and relay. A desiccant pouch with all wires and connectors was sealed in a plastic bag. The wires were secured as high as possible in the cabinet, as shown in photograph 1 in appendix D.
- Locked and taped cabinet as shown in photograph 2 in appendix D.
- Painted the units used to protect South Dakota DOT benchmark red for easy identification.
- The edges of the instrumentation block were in excellent condition, and no resealing was needed, as shown in photograph 3 in appendix D.
