# LTPP Seasonal Monitoring Program

Site Installation and Initial Data Collection Section 510113, Danville Virginia

Report No. FHWA-TS-96-51-03

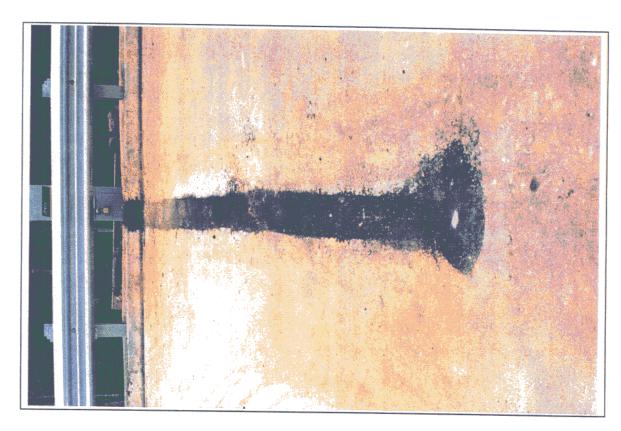
Figure E-3. Instrument Hole and Trench Area After Completion - Facing West

All indications until the site visit on January 24, 1996, were that the instrument hole and trench were in very good condition. Pictures of the instrument hole are presented in Appendix E.

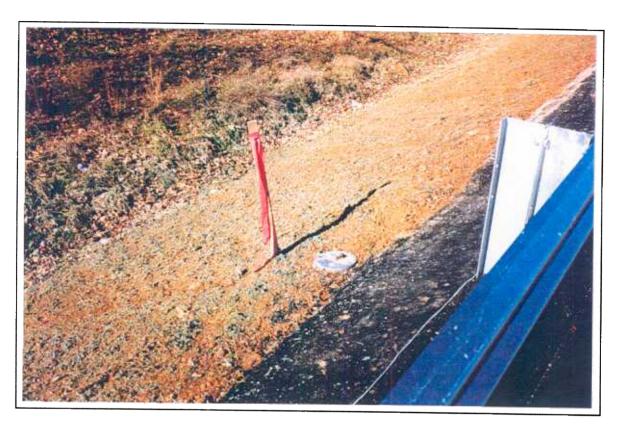
Figure E-5. Piezometer Access Location

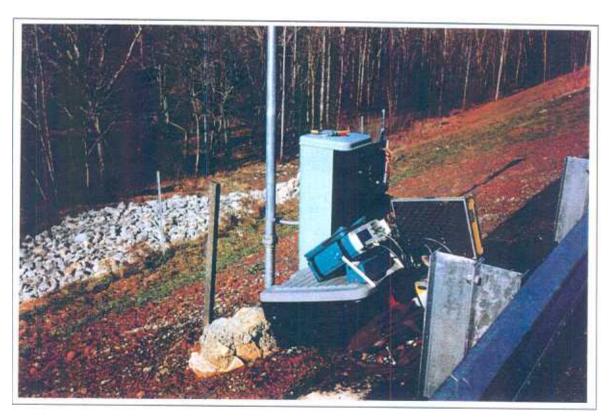
Figure E-6. Mobile Data Collection Set-Up

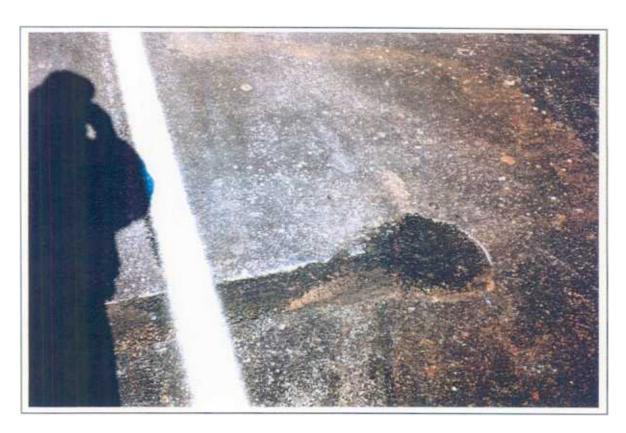
Figure E-7. Close-up of Instrument Hole After Paint Striping - December 20, 1995
