# **LTPP Seasonal Monitoring Program**

**Site Installation and Initial  
Data Collection**

**Section 561007  
Cody Wyoming**

**Report No. FHWA-56-1007**

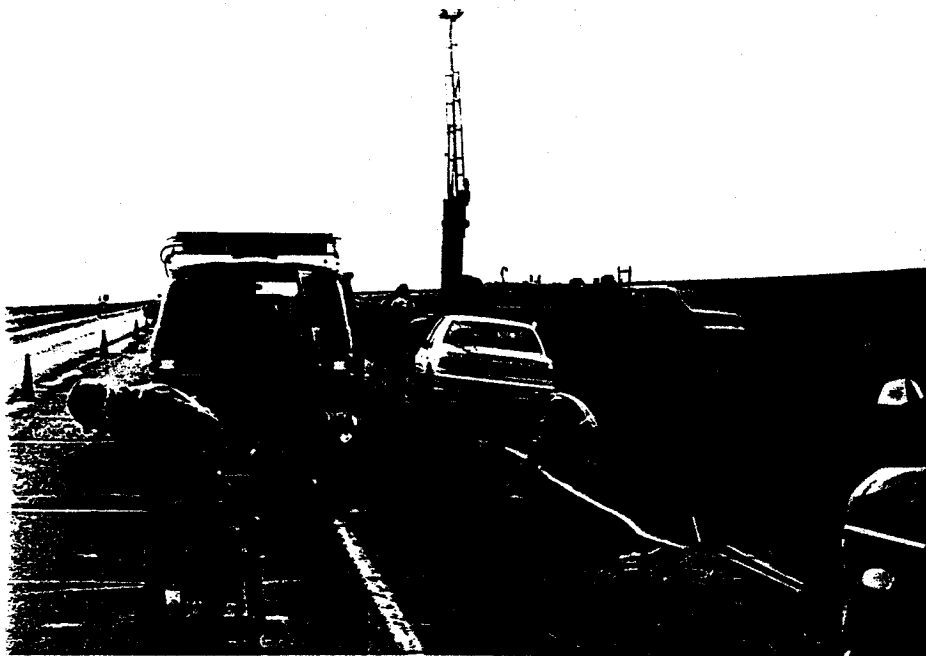
Figure E-3. Installation operations.
