## **LTPP Seasonal Monitoring Program**

Site Installation and Initial  
Data Collection  
Section 871622 Bracebridge,  
Ontario

**Report No. FHWA-TS-94-87-01**

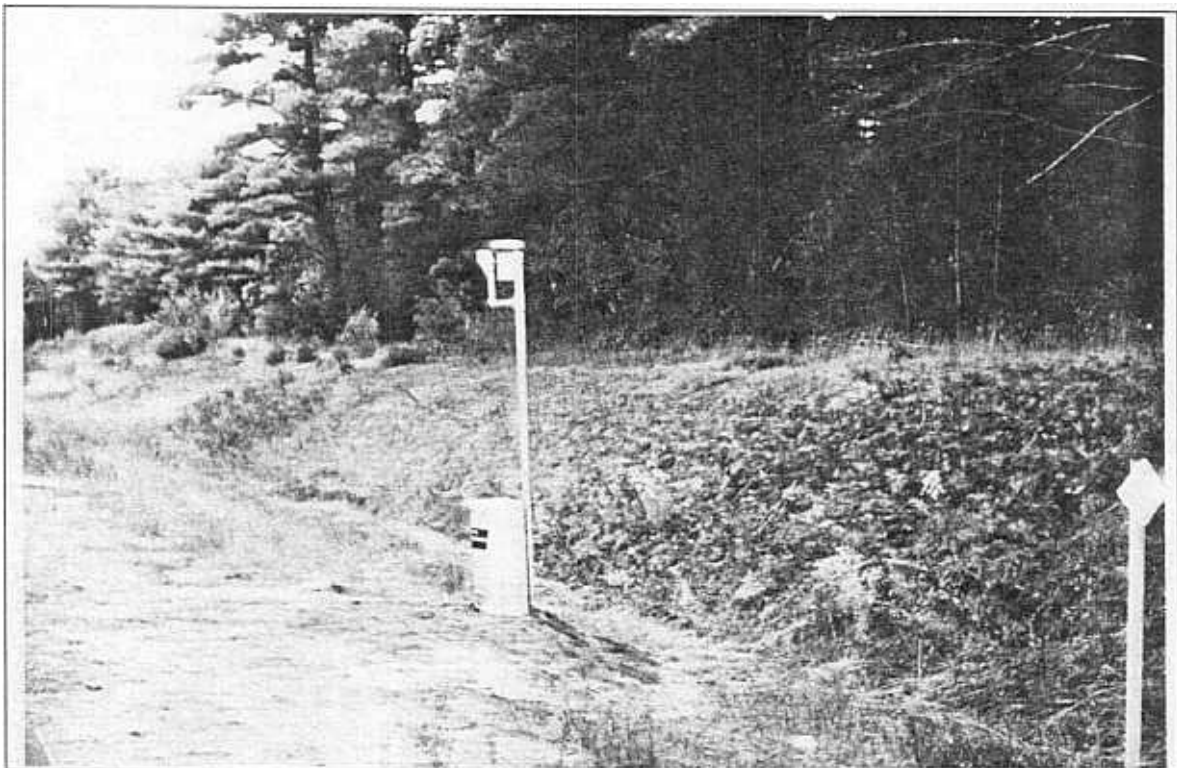
Figure E-3. Equipment Cabinet, Air Temperature Probe, and Rain Gage
