INTERNATIONAL ROAD DYNAMICS INC.

LTPP SPS PHASE II

WEIGH-IN-MOTION SITE ACCEPTABILITY ASSESSMENT REPORT

ARIZONA SPS-1
LTPP ID 040100
JULY 29, 2005
CLIN 1001 TASK ORDER 3

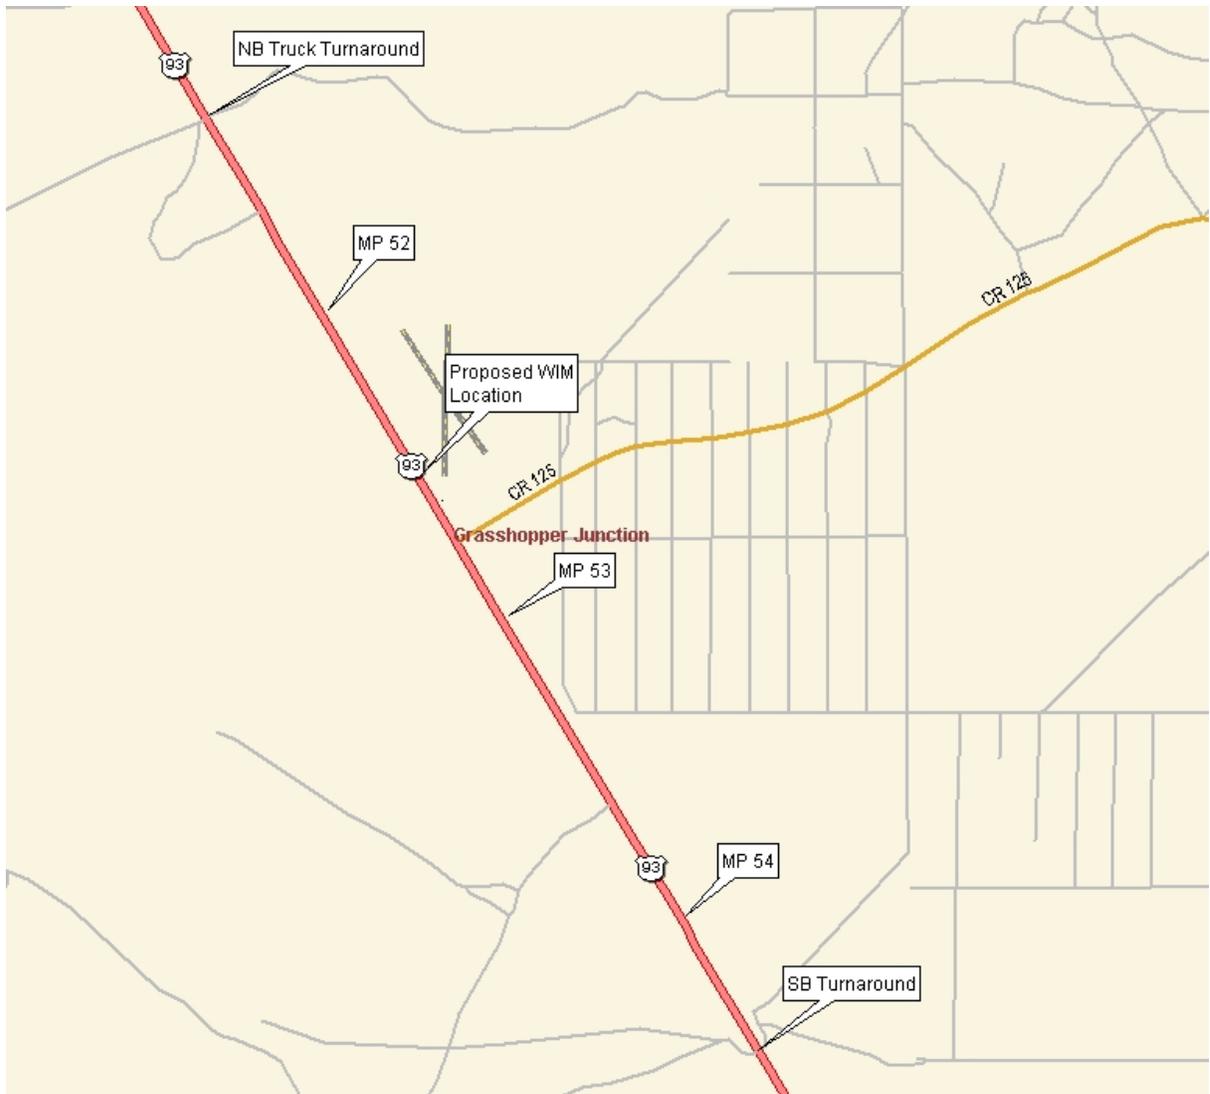
Figure 1: Truck Circuit Map

The nearest usable Northbound truck turnaround is a median crossover which is located 1.2 miles downstream of the WIM site.

The nearest useable Southbound truck turnaround is a median crossover which is located 1.9 miles upstream of the WIM site.

The test truck round trip circuit route is 6.2 miles. There are no foreseen potential restrictions. Both of the turnaround locations are well signed and easily maneuvered due to the median crossovers' having left turn pockets off of the traveled way. The estimated lap time is 15 minutes.

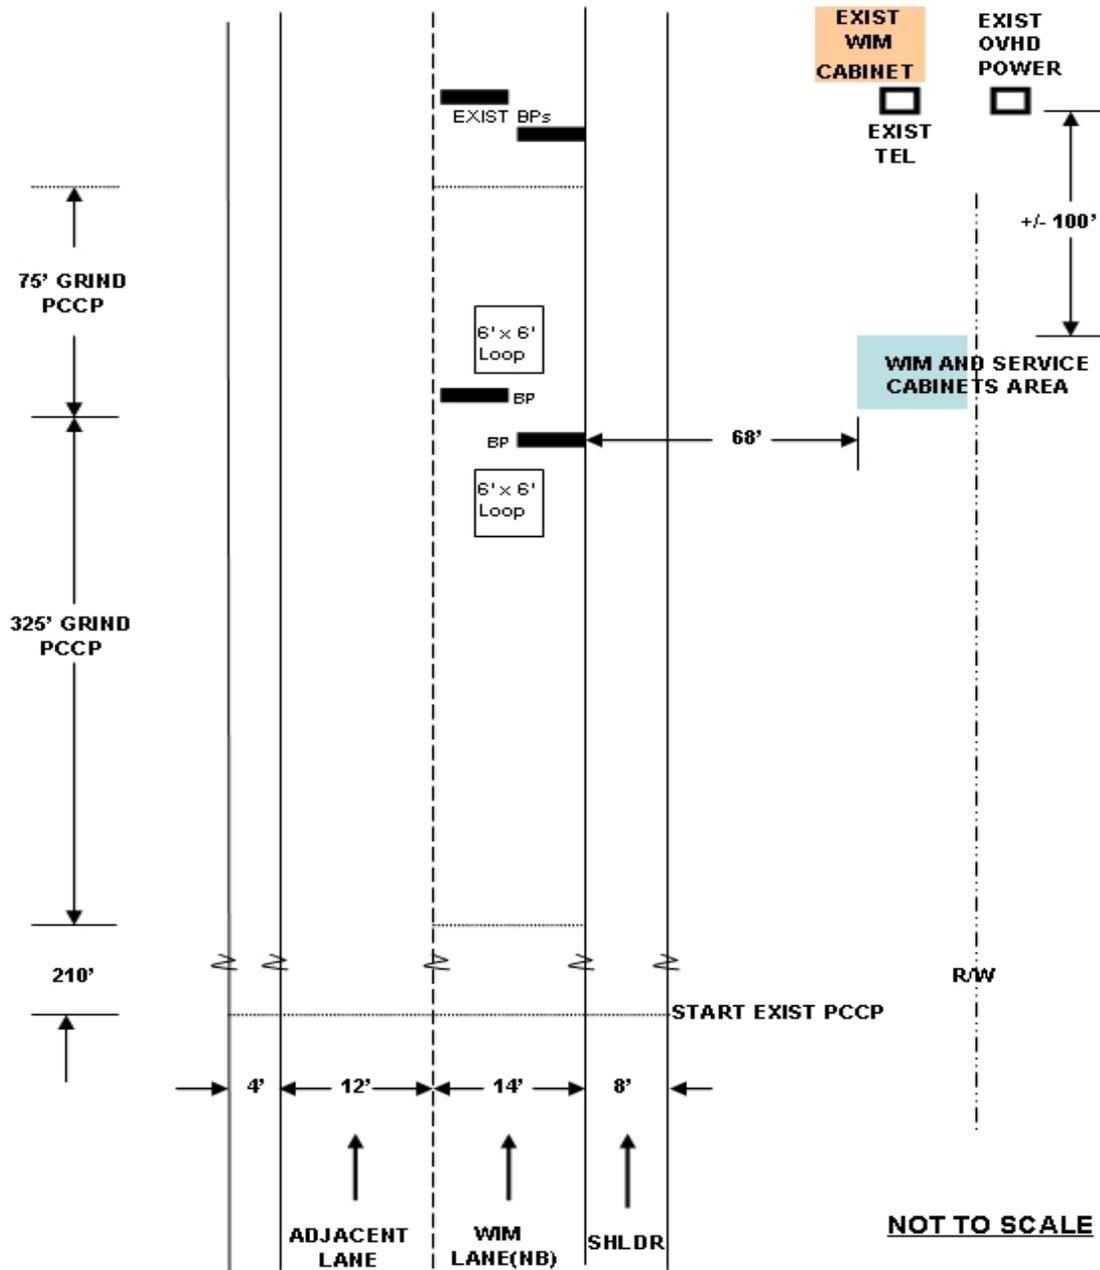
Figure 4: Proposed WIM Site Layout

The centerline of the bending plate weigh pads should be installed approximately 108 feet upstream of the centerline of the existing staggered bending plates. This location has been marked with a "WIM" in white paint on the outside shoulder. During the CLIN 2 design stage, the layout of the existing transverse weakened plane joints will be analyzed to best fit the in-road sensors among the joints to optimize constructability and structural stability.

Proposed WIM Scales Location

N35° 23.99' W114° 15.67'

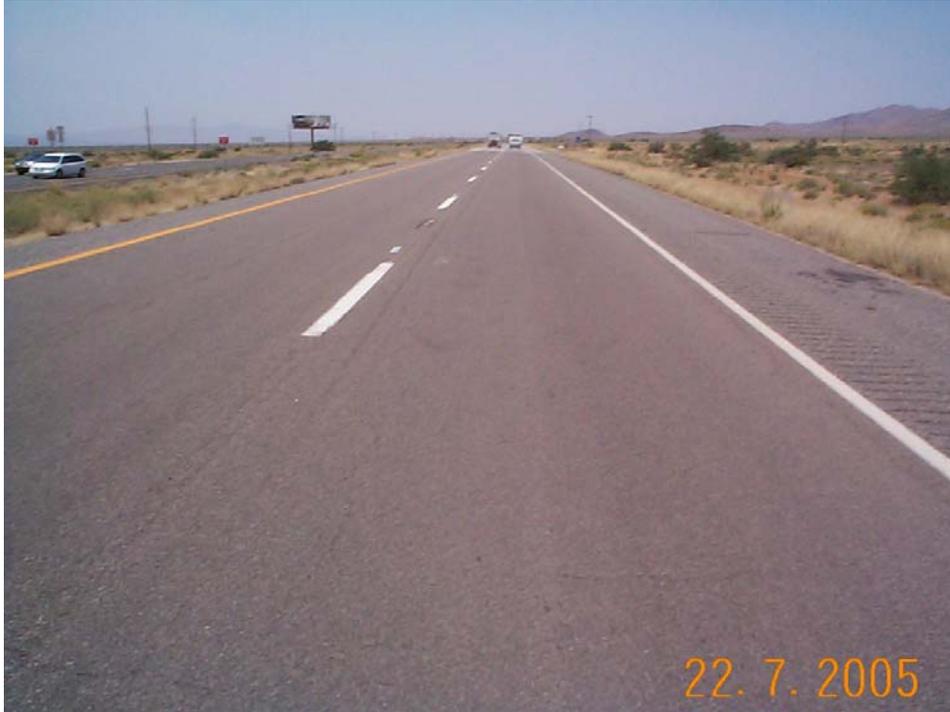
E.1.1 ROADWAY APPROACHING PCC SLAB

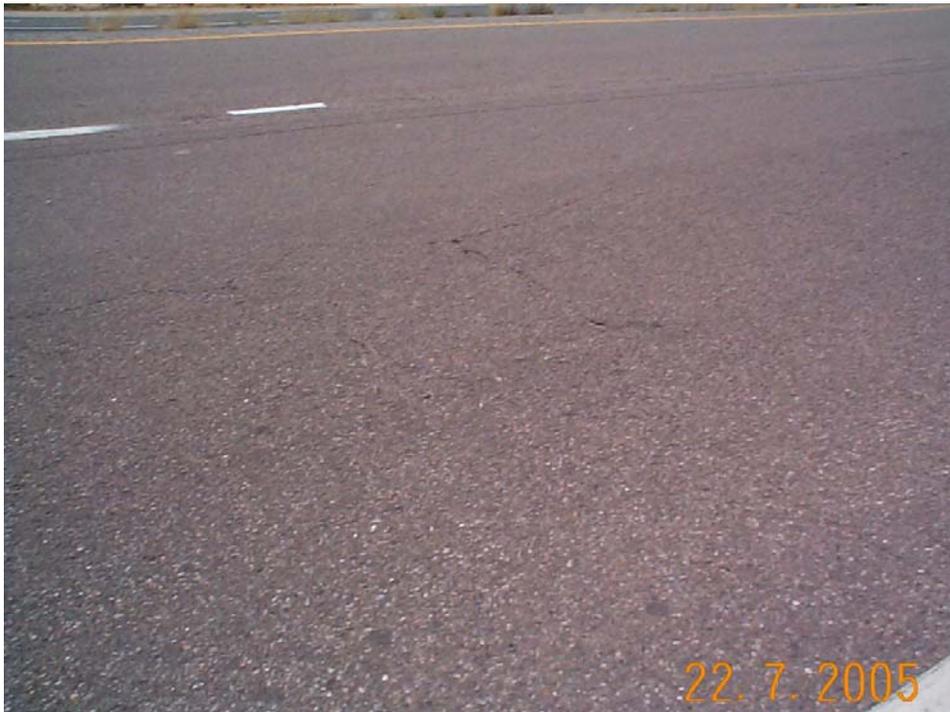
The existing AC pavement in advance of the 854 foot PCC slab appears to be in stable condition, although there is much longitudinal and transverse cracking evident. Although extensive hairline surface cracking was noted throughout the existing PCC slab, the slab appears to be in good condition. A couple transverse random cracks across the lane were also noted, but the pavement at these locations appear to be stable. Although some spalling of the transverse weakened plane joints was noted, such spalling should not pose a structural problem. However, several of these joints need cleaning and resealing. The AC/PCC cold joints at each end of the PCC slab also need cleaning and sealing.

The upstream pavement included in the surface evaluation included 65 feet of AC pavement and 365 feet of PCC pavement. The AC portion has quite a bit of both transverse and longitudinal cracking in the wearing course but the pavement appears to be structurally stable. The upstream AC/PCC cold joint appears to be structurally stable but needs some sealant work. The upstream PCC pavement, like the “WIM Pavement” section, has random hairline surface cracking throughout the section which would not appear to be cause for concern. The transverse joints have some spalling and need sealant replacement.

E.1.2 LONGITUDINAL AND TRANSVERSE CRACKING IN AC APPROACH PAVEMENT

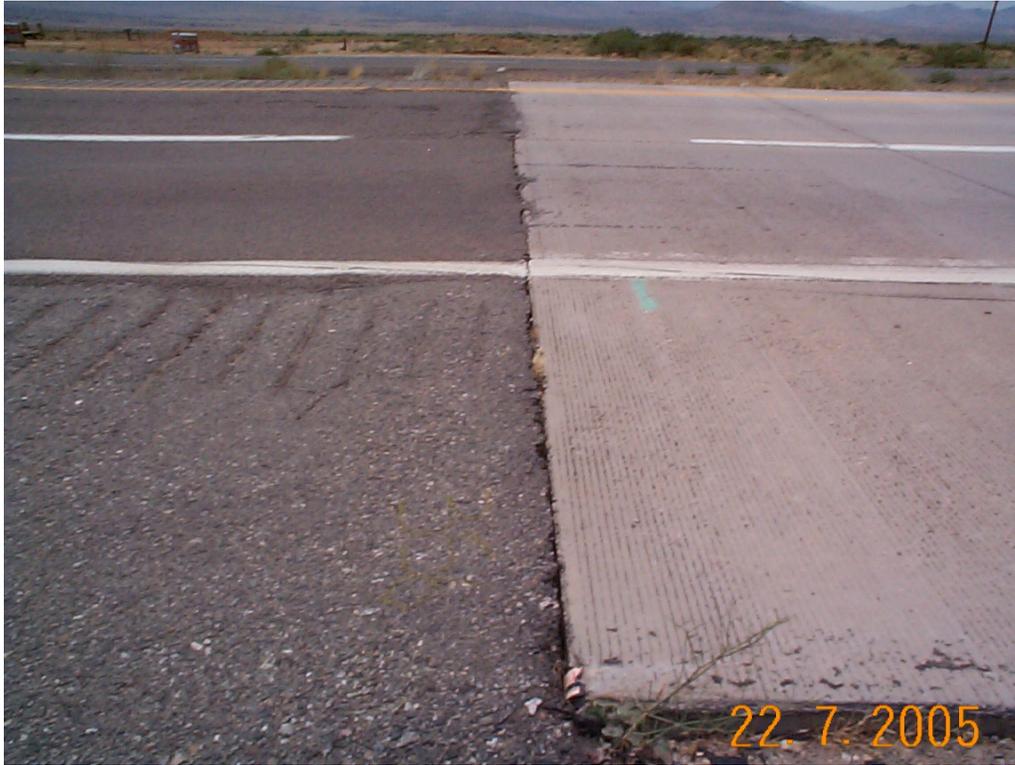
of these joints need to be performed. The AC/PCC joint leading and trailing the PCC slab is in rough condition and requires sealing and maintenance as well. Grinding should be performed at the leading edge of the slab to try and smooth out a dip located at this point. Transverse joints are cut in a 17'-15'-13'-15' pattern on perpendicular. Based on previous profiling the roadway does not currently meet required smoothness specifications.

E.1.5 PCC/AC COLD JOINT AT LEADING EDGE OF PCC SLAB

Based upon the CLIN 1 team's on-site observations, it is recommended that the State perform joint sealant repairs throughout the PCC slab as well as at the AC/PCC transverse cold joints at each end of the slab. Additionally, based upon the team's on-site observations and review of the Phase I contractor's analysis of profiler data, it is recommended that the PCC slab be blanket ground from 325 feet upstream to 75 feet downstream of the new scale location prior to the installation of the new WIM system. The smoothness of the existing PCC WIM slab is questionable and as a result WIM accuracy may or may not be met. Upon completion of these corrective actions, a follow-up evaluation of the pavement should be made. Such evaluation should include visual observation of the PCC WIM slab's structural stability and visual observation of trucks passing through the site. In addition to these visual observations, an analysis of new profile data should be made by the team. Upon confirmation that corrective actions have brought the pavement up to acceptable condition in terms of structural

Notwithstanding FHWA's recommendation and preference, it is also highly recommended that the AC pavement profile problem immediately preceding the PCC slab's transverse PCC/AC cold joint in advance of the WIM scales be corrected and that following pavement rehabilitation the PCC/AC cold joint be ground smooth.

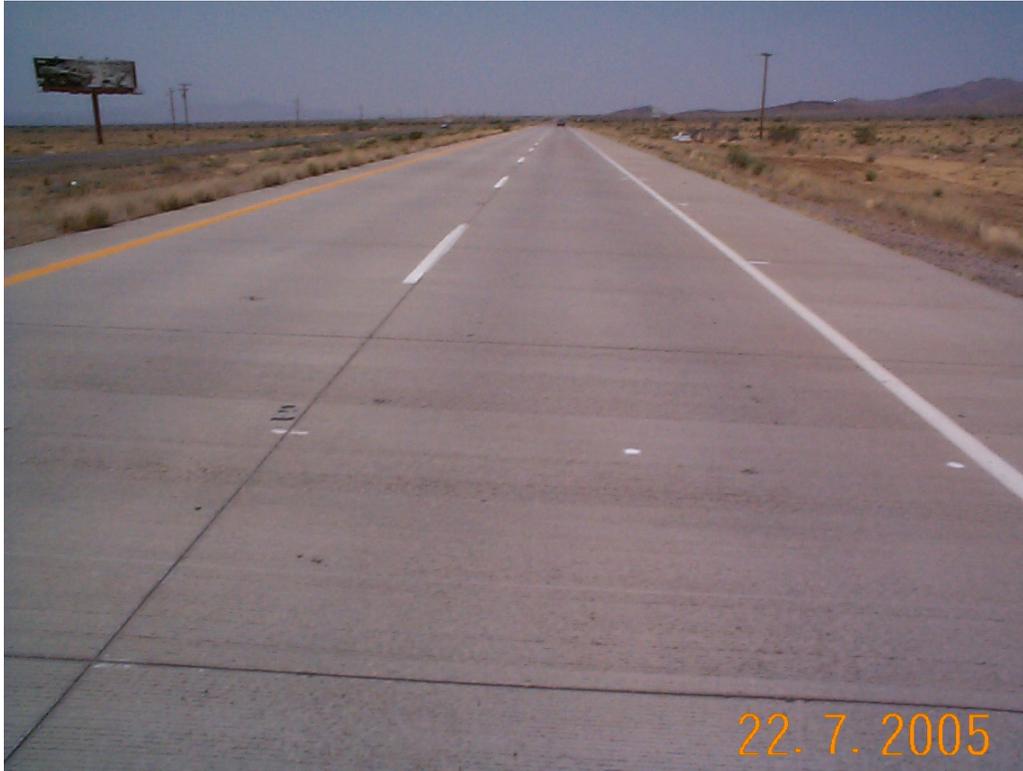
The “WIM Pavement” portion of this slab was determined by marking a point immediately in advance of the existing WIM system's lead loop as the end of the blanket grind to be performed and backing the new WIM system in from that point. This resulted in having 544 feet of structurally sound PCC pavement in advance of the new scale location, 325 feet of which is included in the “WIM Pavement” section. There is random hairline surface cracking throughout the 400 foot “WIM Pavement” section which would not appear to be cause for concern. There is a random transverse crack going across the lane 103 feet in advance of the new scale location but the pavement at this point appears to be stable. There is another random transverse crack across the lane right at the end of the “WIM Pavement” section (75 feet past the new scale location) but the pavement at this point also appears to be stable. These cracks may look uglier in cold weather if they open up a bit (it was well over 100° F during the assessment), but do not appear to be a cause for concern.

E.1.7 START 400 FOOT "WIM PAVEMENT" SECTION

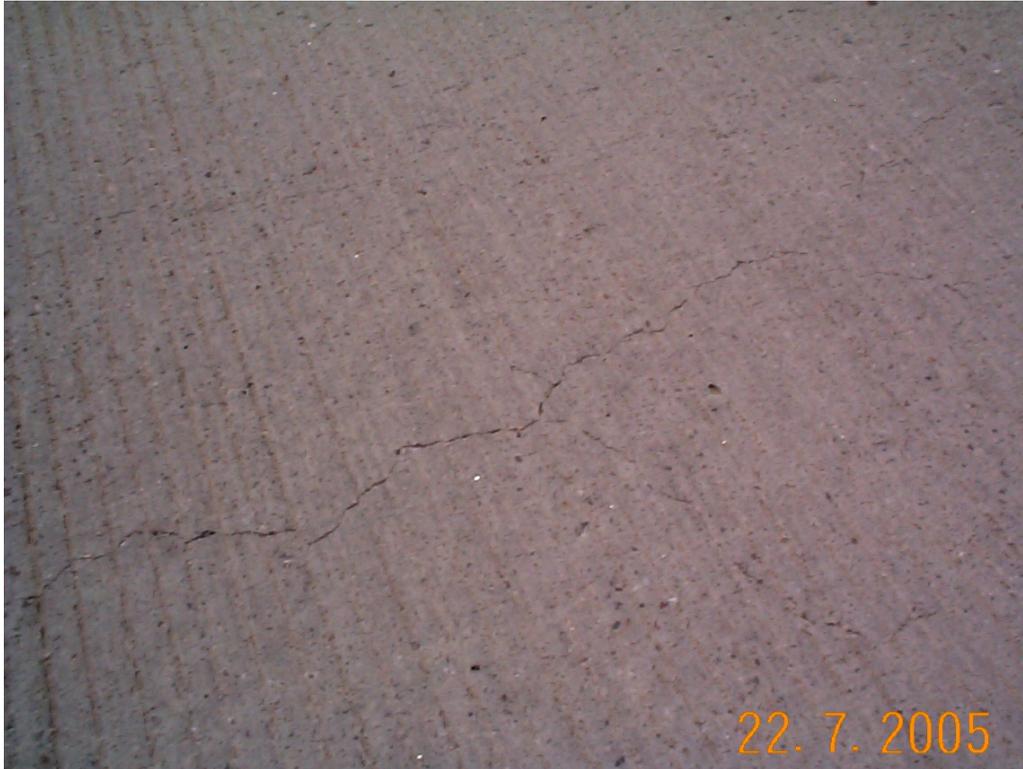
E.1.9 RANDOM HAIRLINE SURFACE CRACKING IN WIM PAVEMENT, TYP.

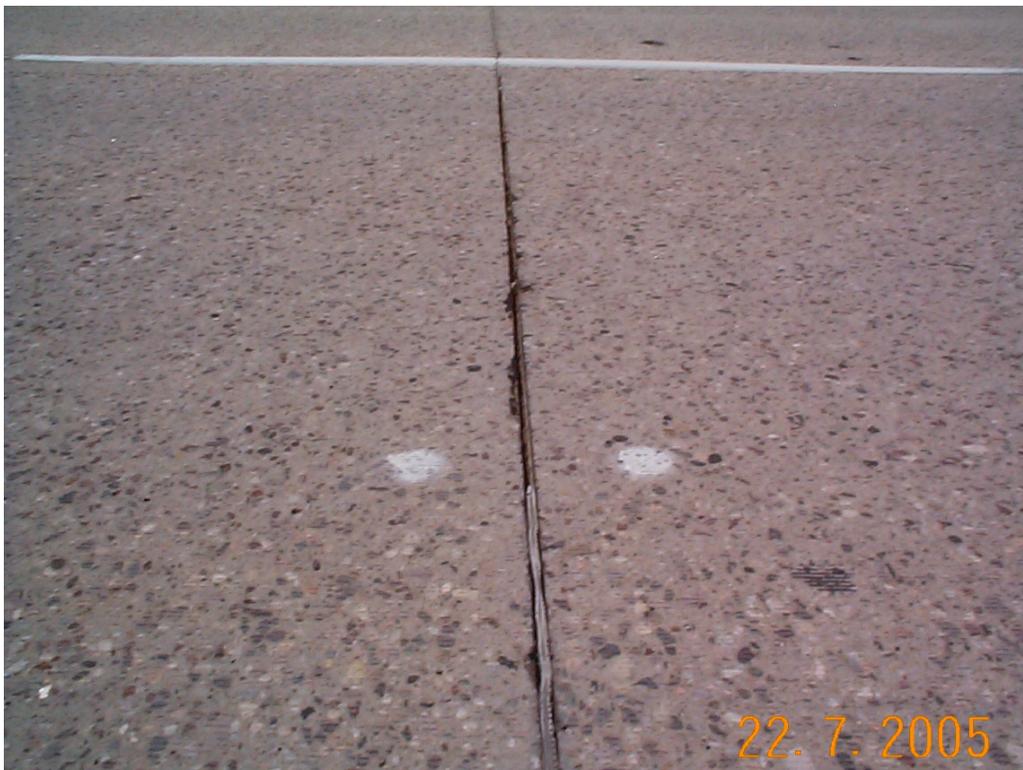
The entire PCC slab, including the “WIM Pavement”, has perpendicular transverse weakened plane joints with a spacing pattern of 15'-13'-15'-17'. Some

of these joints exhibit spalling, but not to a point of concern. Although these joints are sealed, several are in need of cleaning and sealant replacement.

E.1.10 JOINT NEEDING CLEANING AND RESEALING IN WIM PAVEMENT, TYP.

Based upon both on-site visual observations and an analysis of pavement profiling data, there is indication that the lack of adequate surface smoothness of the existing PCC slab may cause suspension dynamics in the trucks traversing the site sufficiently large enough to cause inaccurate weight estimate measurements by the WIM system. Due to this, corrective action to the smoothness of the 400 foot "WIM Pavement" portion of the existing PCC slab prior to the installation of the WIM system's scales should be performed. Such corrective action should be a blanket grinding of the PCC slab from 325 feet in advance of to 75 feet following the new scale location. Additionally, the PCC slab's transverse joints should be cleaned and resealed.

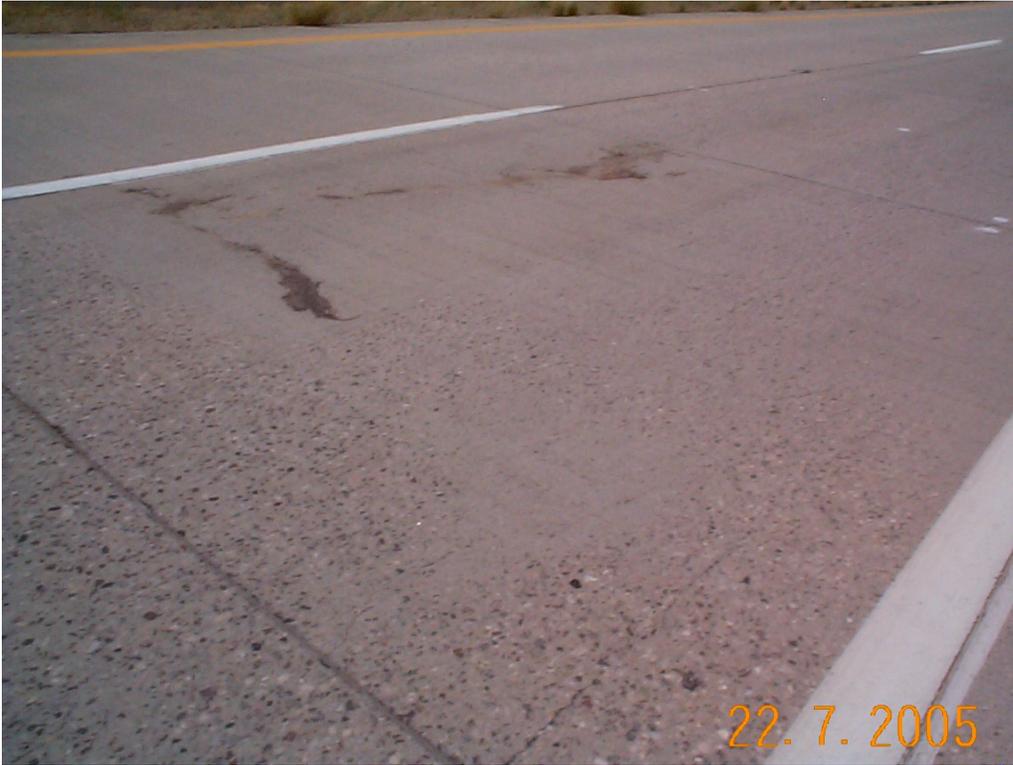
Spot grinding of the existing 854 foot PCC slab has been performed over the first 485 feet of the slab and blanket grinding has been performed from the 485 foot point to +/- 100 feet beyond the existing WIM scales. Observations of trucks and other vehicle types approaching and passing through the selected new WIM scale location (535 feet from the start of the slab) indicated some body motion through the portion of pavement from 170 feet to 90 feet in advance of the new scale location. This portion of pavement is within the area of spot grinding and it would appear, based upon the grinding marks on the pavement, that a full blanket grind would eliminate the minor pavement profile “holes” effecting the noted body motion in crossing vehicles. Major body motion was observed in the AC pavement immediately in advance of the start of the PCC slab. Although this “long wavelength” profile problem is +/- 540 feet in advance of the planned scale location and, in theory, should not be detrimental to WIM scale accuracy, it is somewhat of a concern for the CLIN 1 team. Several automobile “drive throughs” by the CLIN 1 team members appeared to confirm the above noted observations. Some vehicle body motion could be felt as well as some suspension “chatter”. The most recent Profile data was collected by the RSC on 2/11/2004. Based upon the profile evaluation performed by the Phase I contractor, (Assessment

E.1.11 "HOLE" LEFT DURING GRINDING OF PCC SLAB, TYP.

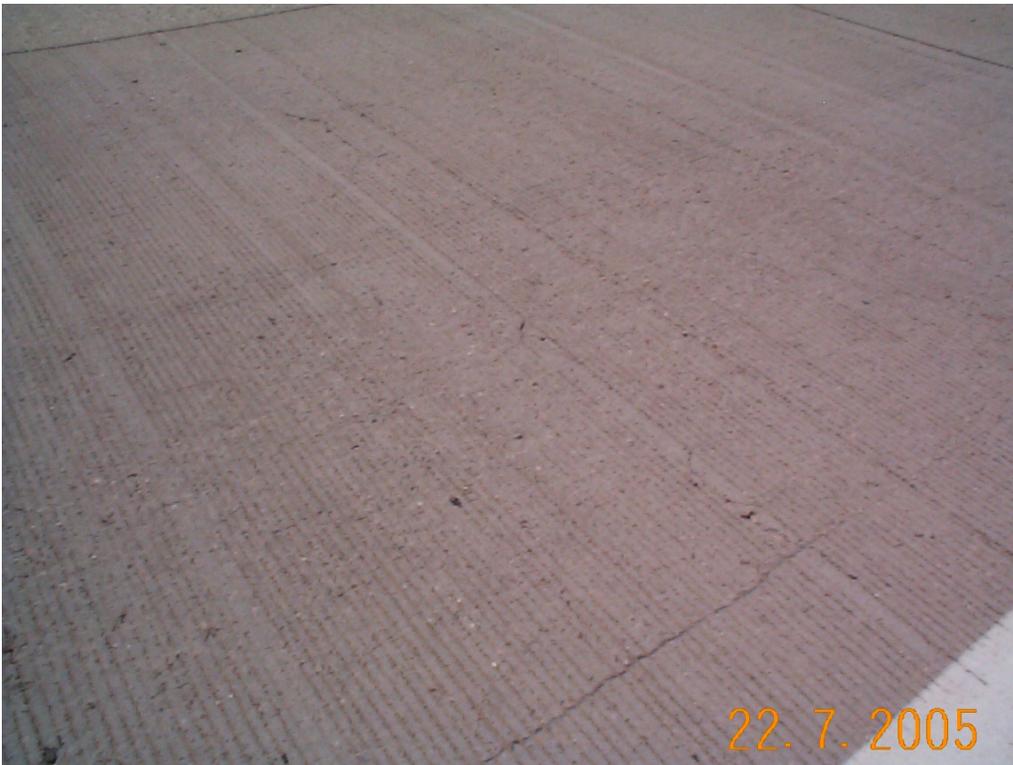
The 25 foot PCC downstream pavement is also similar to the upstream and “WIM pavement” sections and, as previously noted, contains a random transverse crack crossing the lane at the start of the section.

E.1.12 RANDOM TRANSVERSE CRACK ACROSS LANE 103' IN ADVANCE NEW SCALES

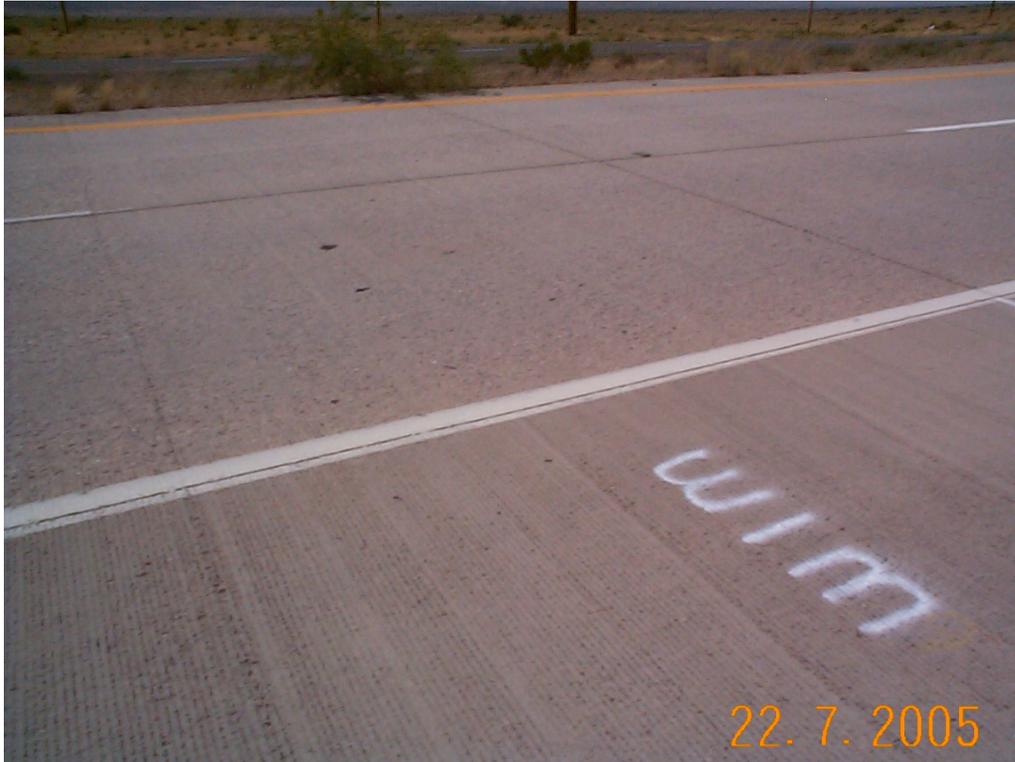
E.1.13 RECOMMENDED LOCATION FOR CENTERLINE NEW SCALES

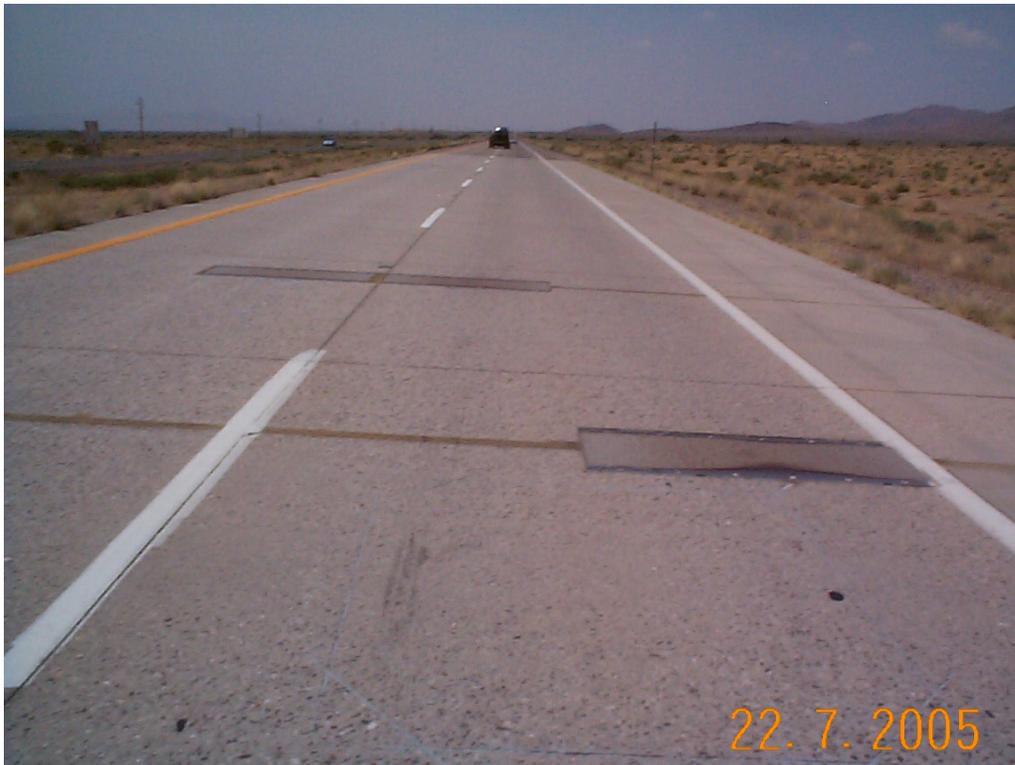
E.1.16 EXIST BENDING PLATES JUST DOWNSTREAM FROM WIM PAVEMENT SECTION

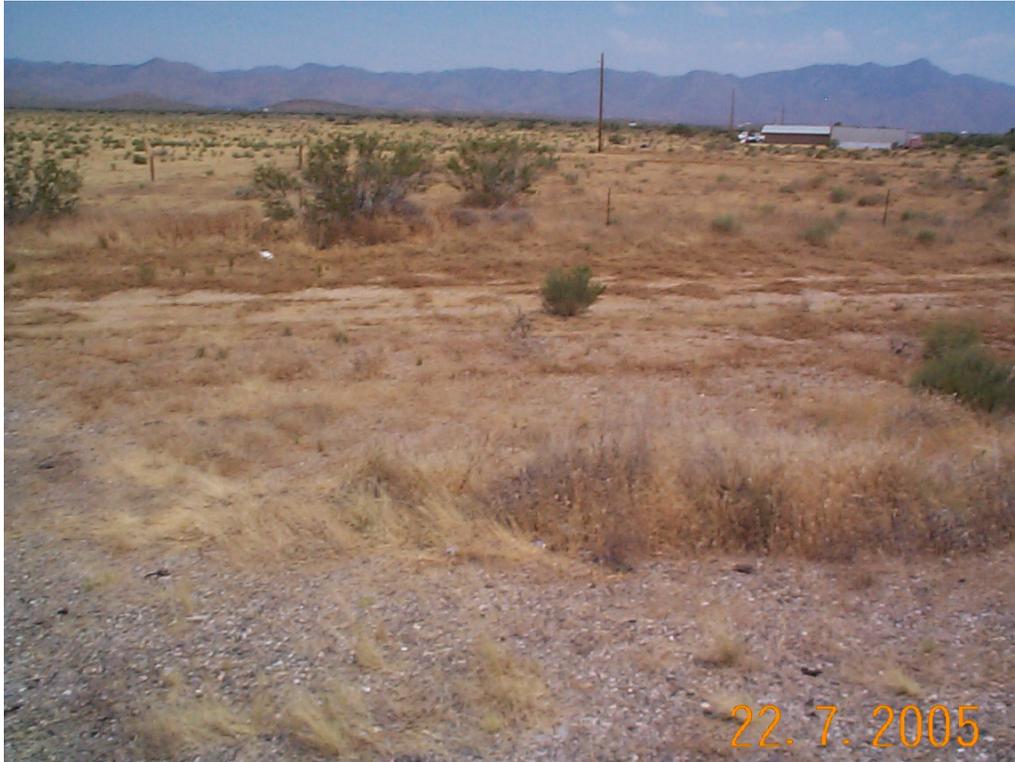
There is an adequate location for the WIM controller cabinet at the site adjacent to the highway right-of-way fence. This location would provide over 65 feet clearance from the roadway. There is good visibility from the cabinet location of the sensors and approaching vehicles. There is adequate room adjacent to the cabinet location for service facilities. Roadway drainage is very good. The existence of culverts and topography of the site area indicate a potential for ponding or movement of water adjacent to the base of the roadway embankment. The selected location for the cabinet is on higher ground and any chance of ponding water at the cabinet would appear to be minimal. There is adequate topography for scale pit drainage. The width and structural stability of the adjacent lane and its shoulder allow a lane closure and traffic shift which will provide safe clearance in the work zone from live traffic during installation of the WIM system.

E.1.17 RECOMMENDED LOCATION FOR NEW CABINET

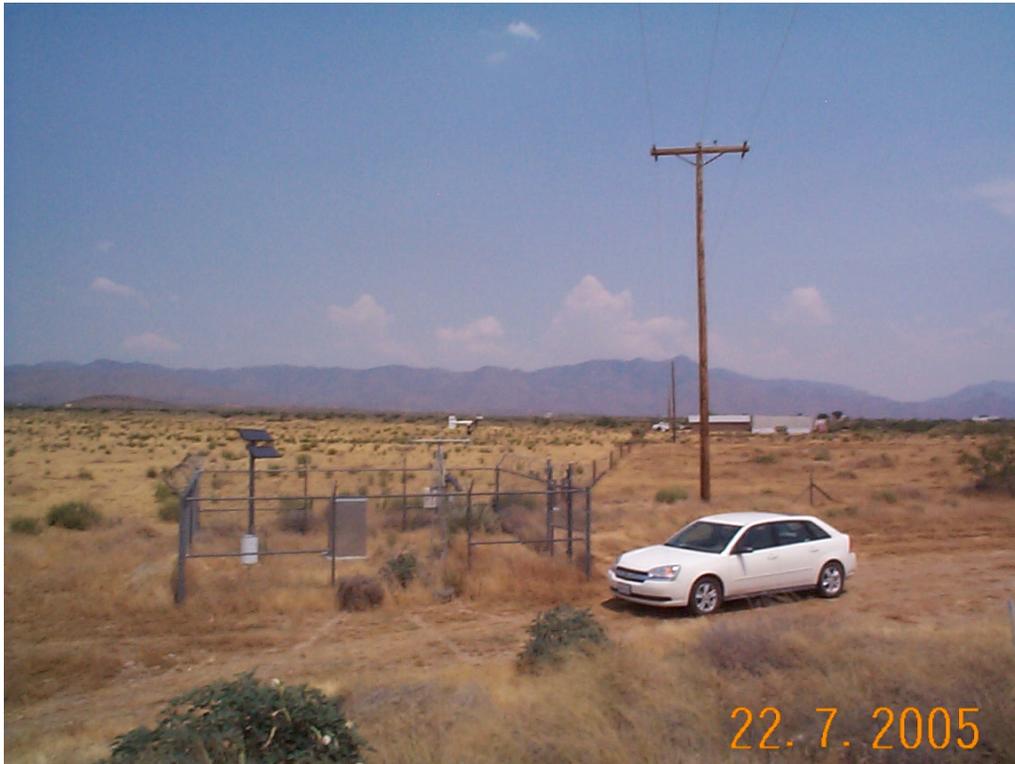
Overhead power lines cross the roadway 100 feet North of the proposed WIM system location. These are the standard "service" lines and will not interfere with system performance.

E.1.19 POTENTIAL POWER SOURCE

The State will need to extend existing power and phone services to service points within 25 feet of the proposed WIM cabinet location.

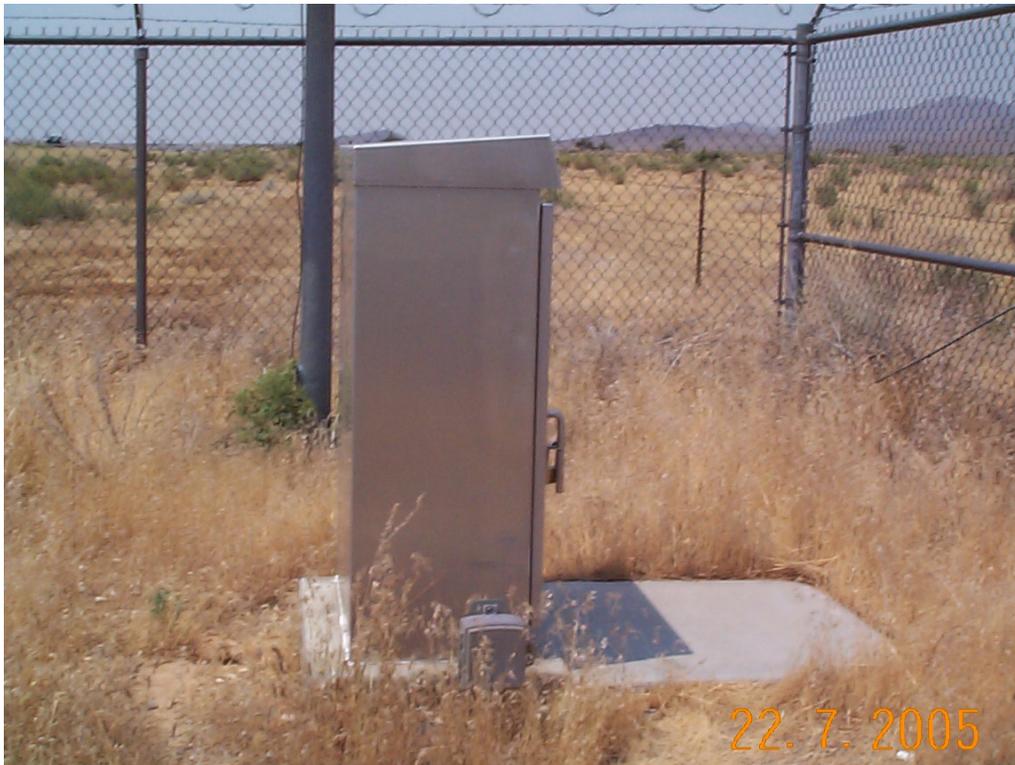
E.1.20 EXISTING TELEPHONE SERVICE ADJACENT EXIST WIM CABINET
