Assessment Report for  
Arizona, SPS 1

Visit date: March 3, 2004

A visit was made to the Arizona SPS-1 site on March 3, 2004 for the purpose of conducting an assessment of the WIM system located on US route 93 at milepost 52.62, 0.25 miles north of County Road 125.

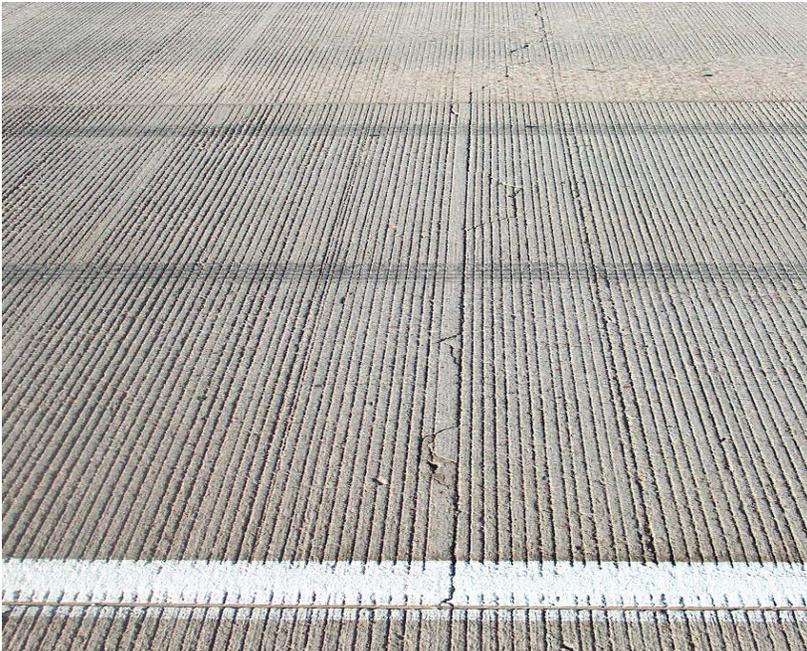
The pavement appears to be in good condition with little distress. There was transverse cracking approximately 86 feet and 203 feet prior to the WIM scale area as shown in Figure 13-1 and Figure 13-2 respectively. These distresses do not appear to significantly affect the dynamics of the trucks as they pass over the WIM scales. Figure 13-3 shows the condition of the pavement in the downstream direction and Figure 13-4 shows in the condition of the pavement in the upstream direction.

**Figure 13-2 Transverse Cracking 203 feet prior to WIM Scale (Distress Photo 2)**

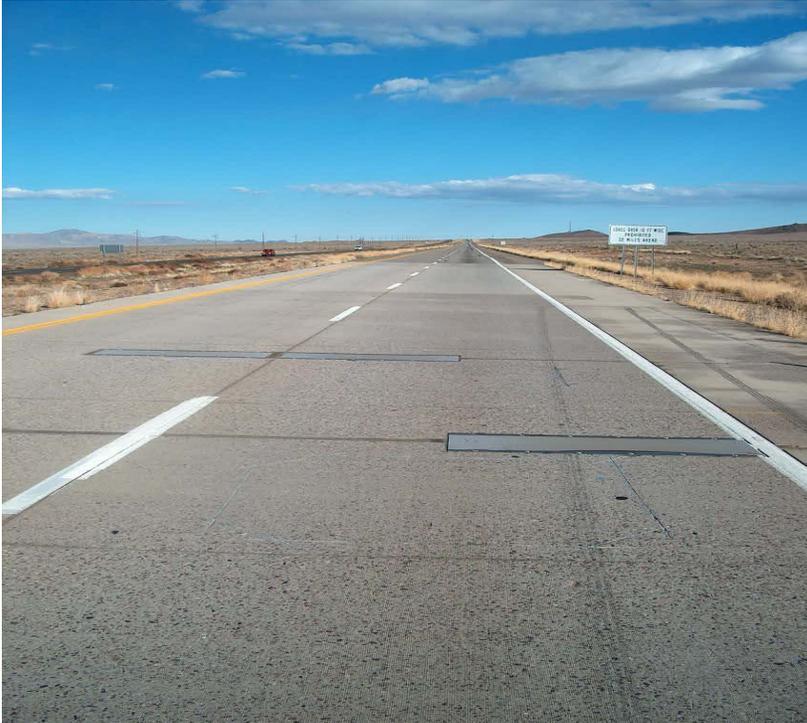
**Figure 13-3 Pavement Condition in Downstream Direction (Distress Photo 3)**

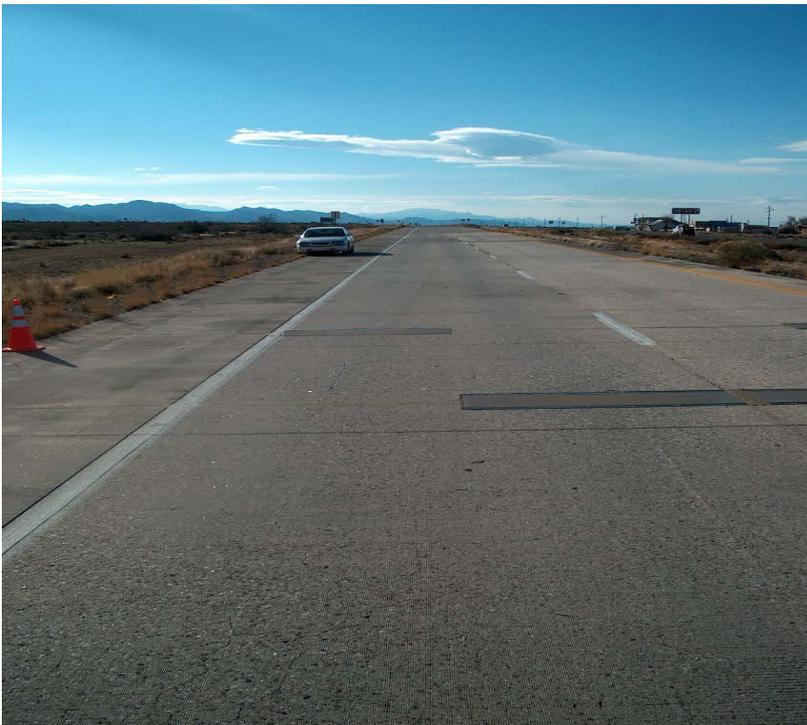
**Figure 13-4 Pavement Condition in Upstream Direction (Distress Photo 4)**

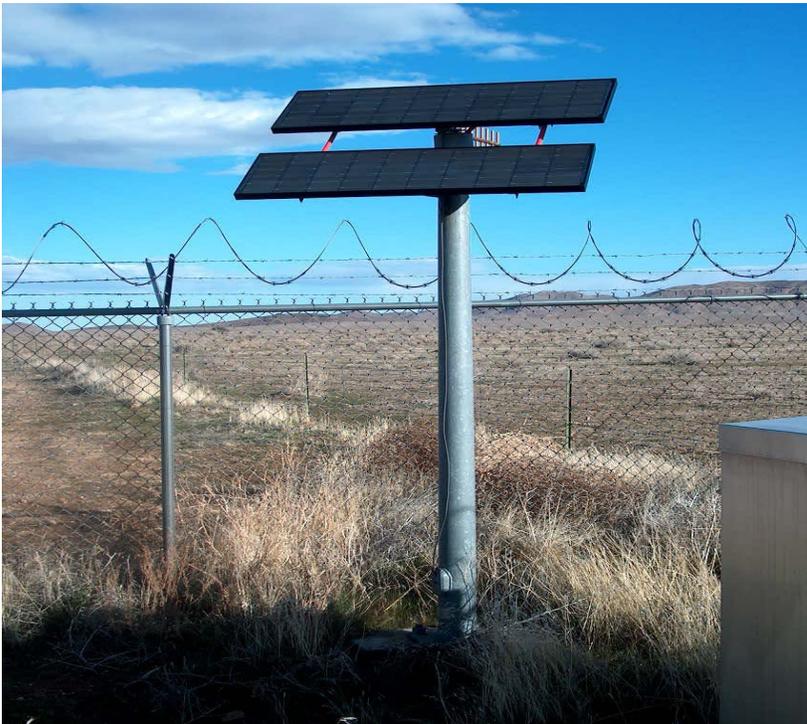
Solar\_Panel\_TO\_4\_04\_24A\_0100\_03\_03\_04.JPG

A visual inspection of all system components, including in-road sensors, cabinet, pull boxes, service mast, solar panels and conduit as well as the telephone service components was conducted. All components are in excellent physical condition.
