Assessment Report for  
California, SPS 5

Visit date: March 4, 2004

A visit was made to the California SPS-5 on March 4, 2004, for the purpose of conducting an assessment of the WIM system located on Interstate 40 at milepost 28.892, 5.24 miles east of the Fort Cady Road Interchange (Exit 23 on I-40). The LTPP lane is the driving lane in the eastern direction and is identified by the controller as lane number 1.

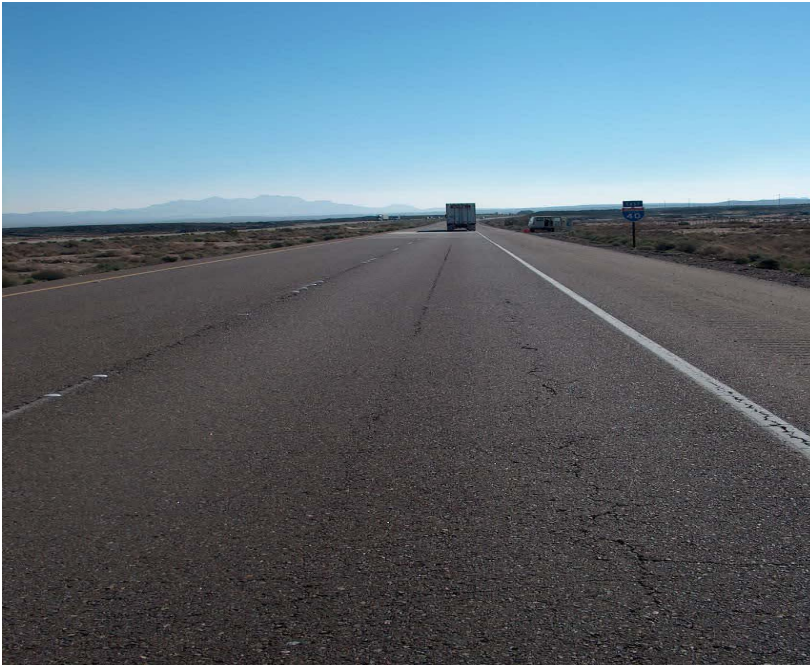
- Longitudinal cracking through the entire length of the WIM section as shown in Figure 13-1.
- Alligator cracking along right wheel path in several locations throughout the WIM section as shown in Figure 13-2.
- Block cracking throughout the asphalt pavement area prior to the WIM scale area as shown in Figure 13-3.
- Map cracking across the PCC pavement that comprises the WIM scale area as shown in Figure 13-4.
- Grinding begins 150 feet prior to the WIM scales
- Asphalt to PCC transition with a 1 inch fault 50 feet prior to the WIM scales as shown in Figure 13-5
- PCC to asphalt transition 25 feet following the WIM scales as shown in Figure 13-6.

**Figure 13-1 Longitudinal Cracking at 060500**

It is recommended that the pavement at least 325 feet prior to and 75 feet following the WIM scales be replaced. The pavement replacement recommendation is based on the following factors:

- Longitudinal cracking at the lane centerline and alligator cracking in the right wheel path throughout the WIM scale approach, weighing and exiting areas
- Significant map cracking throughout the WIM scale approach, weighing and exiting areas
- Significant faulting at the asphalt transitions at each end of the WIM concrete section
- The PCC section installed specifically for the WIM installation is 75 feet in length, which is less than the recommended length of 400 feet.

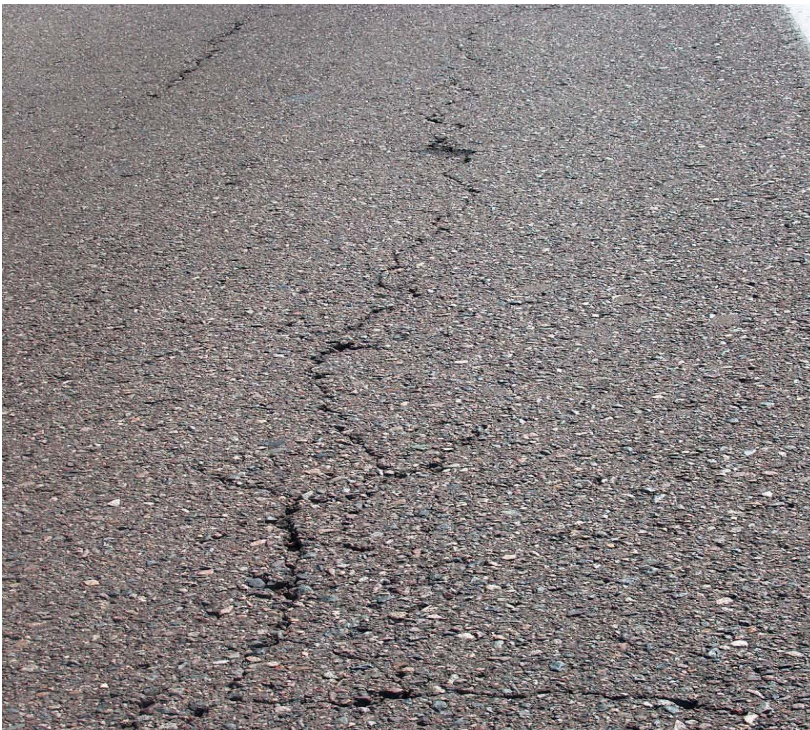
**Figure 13-2 Alligator Cracking of Asphalt Pavement at 060500**

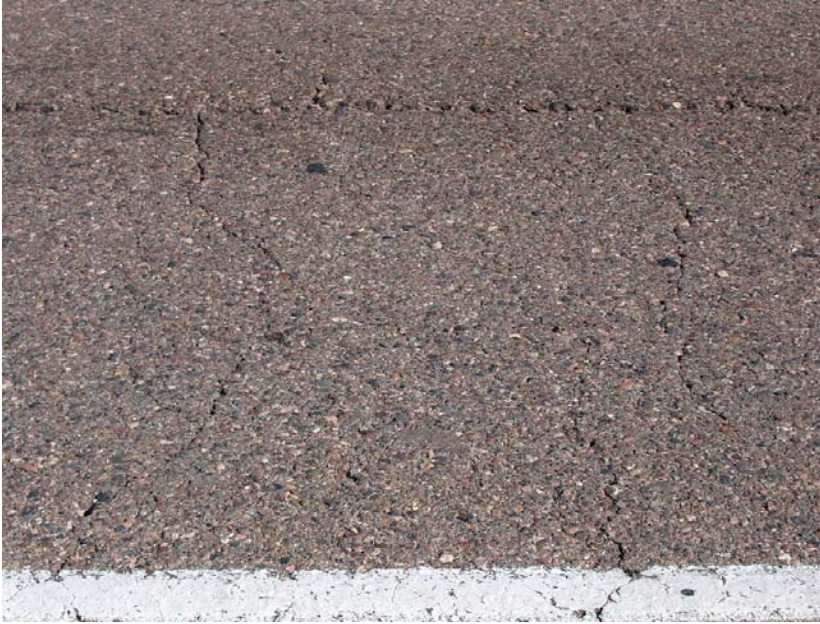
**Figure 13-3 Block Cracking of Asphalt Pavement at 060500**

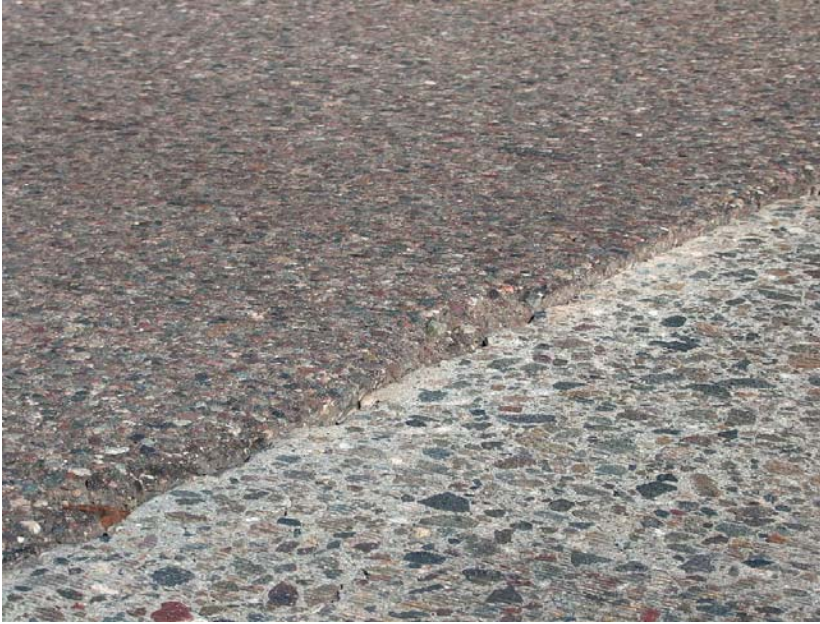
**Figure 13-5 Faulting at Asphalt to PCC Pavement Transition at 060500**

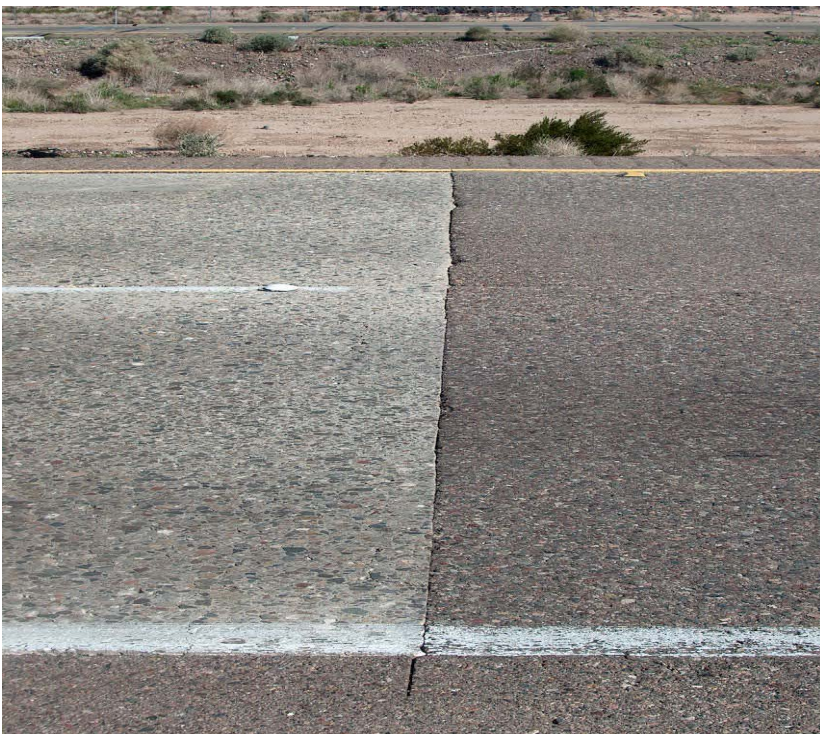
**Figure 13-6 Faulting at PCC to Asphalt Pavement Transition at 060500**

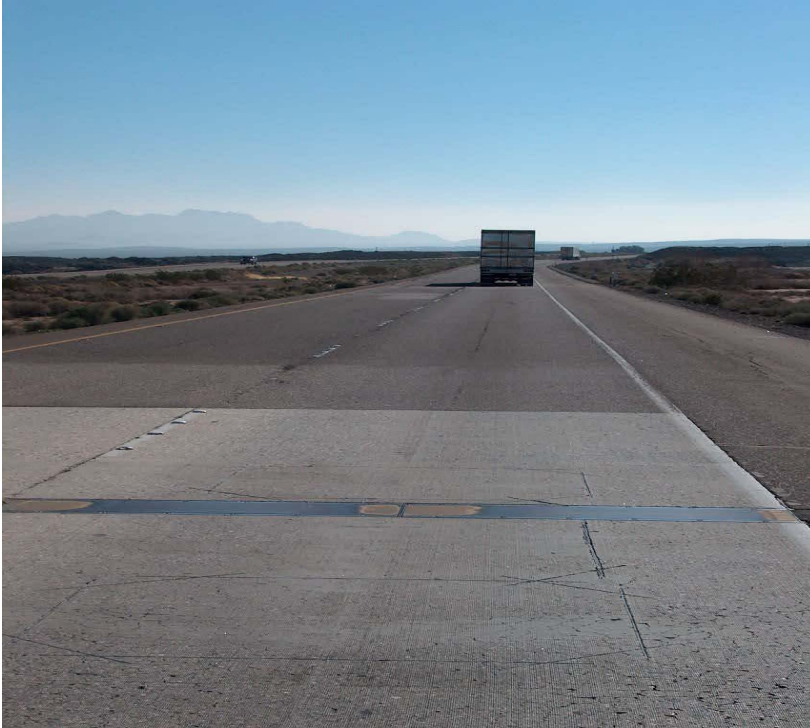
Figure 13-7 shows the condition of the pavement in the downstream direction and Figure 13-8 shows in the condition of the pavement in the upstream direction.

**Figure 13-7 Pavement Condition in Downstream direction at 060500**

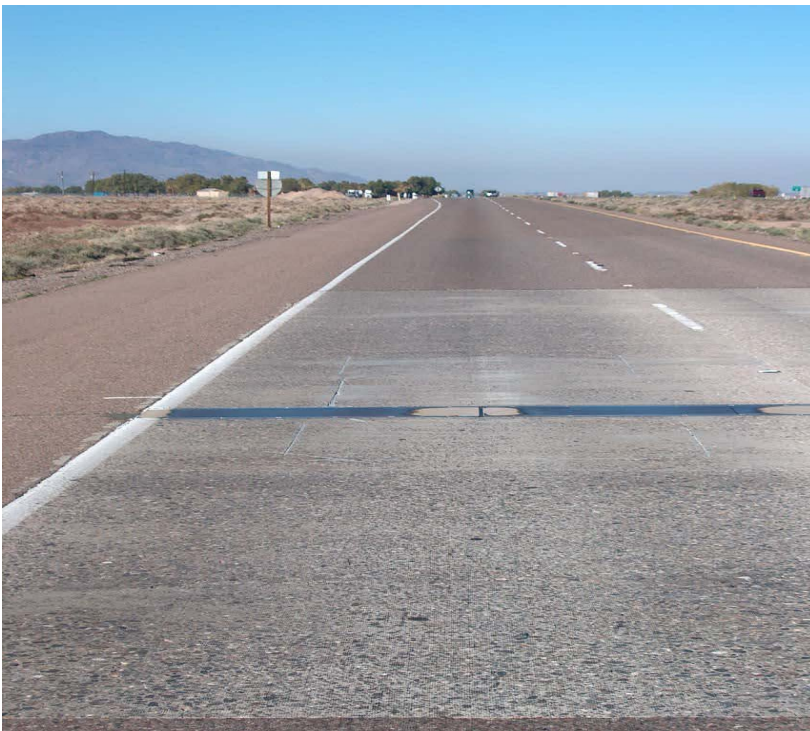
**Figure 13-8 Pavement Condition in Upstream direction at 060500**

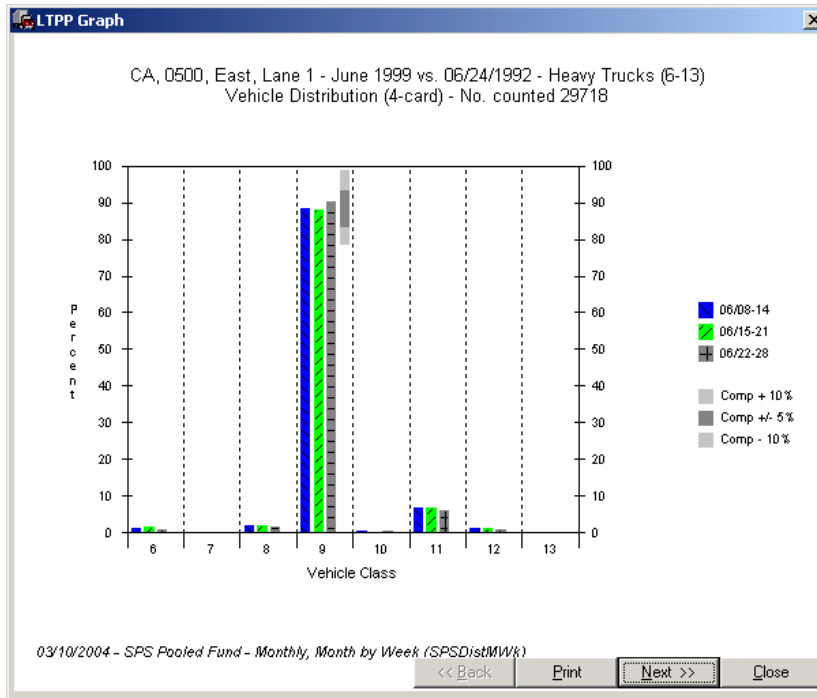
Figure 14-1 shows a typical by week pattern for heavy truck classification data. The individual weeks show essentially the same heavy truck mix. Every vehicle in Classes 6 through 13 that constitutes at least 10 percent of the population is expected to stay within plus or minus 5 percent of the value observed during the two weeks following validation. This range is shown by the darker band inside the lighter band to the right of the weekly data. Weeks that go outside more than plus or minus 10 percent of the expected value will fall above or below the light gray areas of the band. These are weeks that should have been subjected to additional scrutiny prior to accepting the data as reasonable.

For this site, the fleet mix is essentially the same albeit the classification data is for only one year. A typical graph for this period is shown in Figure 14-1. There was no significant difference in the mix stability graphed for the weight data as shown in Figure 14-2.

Figure 14-1 Heavy Truck Distribution Pattern for Classification Data for 060500

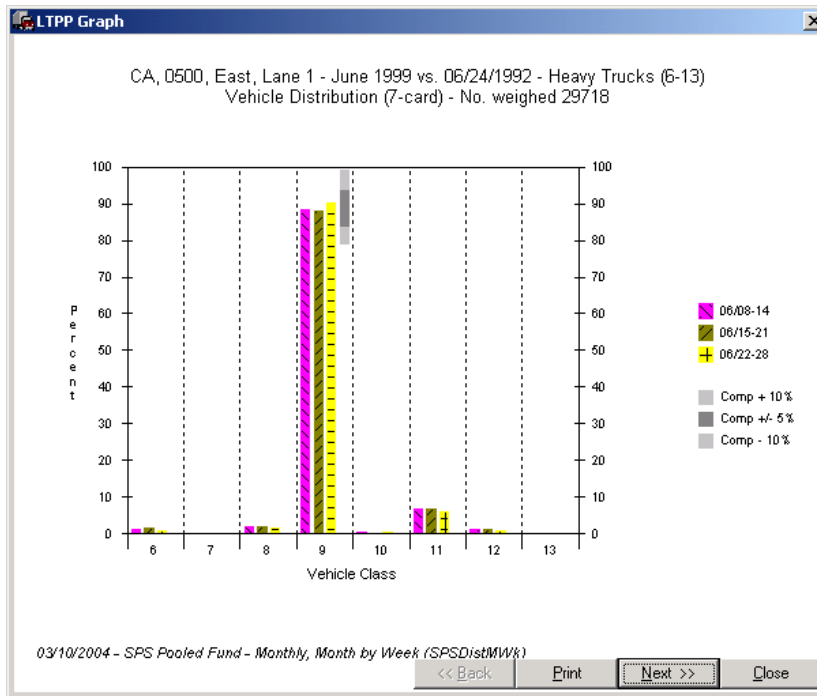
Figure 14-2 Typical Heavy Truck Distribution Pattern for Weight Data for 060500

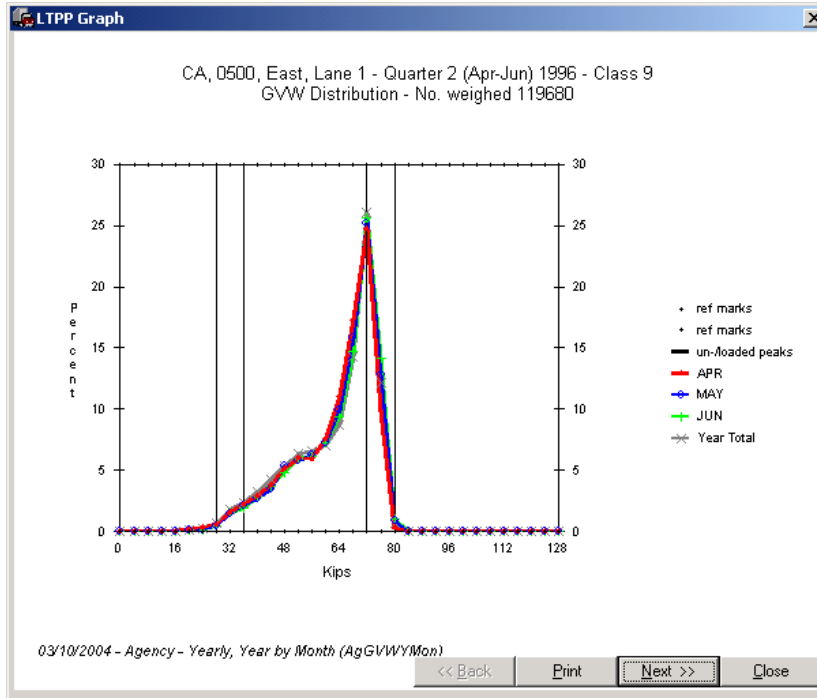
To investigate any seasonal variations the Class 9 GVW distributions are graphed by month by year. As shown in Figure 14-5 there is no significant seasonal variation in the peak loads for this site.

Figure 14-5 Class 9 GVW Distribution - April to June 1996 for 060500

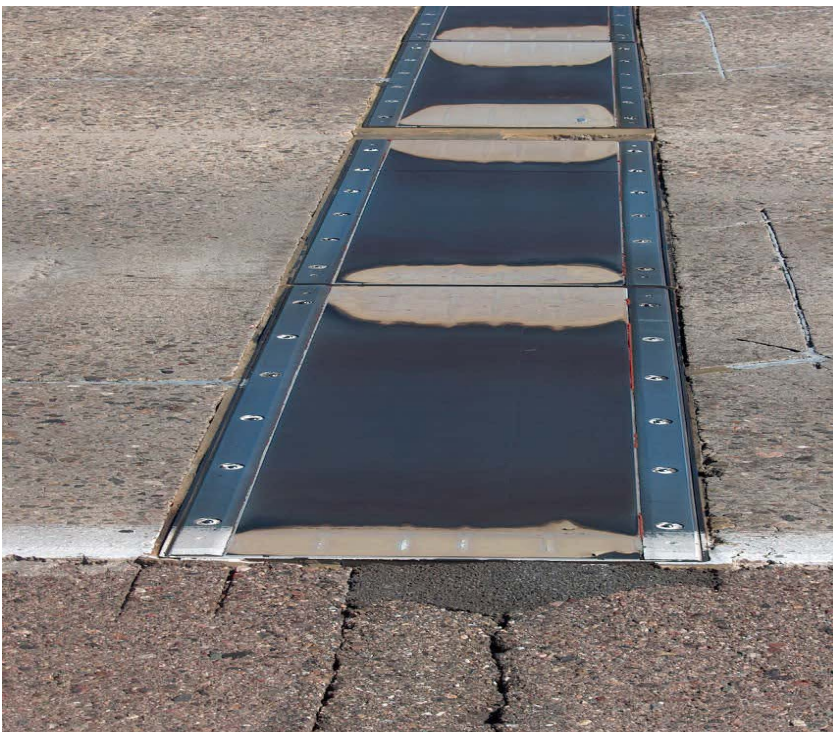
Weighing\_Sensor\_TO\_4\_06\_31A\_0500\_03\_04\_04.JPG

The site is instrumented with PAT America bending plate weight sensors and a PAT America DAW-200 WIM controller.

The equipment is in working order.
