Assessment Report for  
Florida, SPS Experiment 1

Visit date: December 3, 2003

SITE ID: 120100

LOCATION: US 27 South, 13.8 miles south of SR 80, South Bay

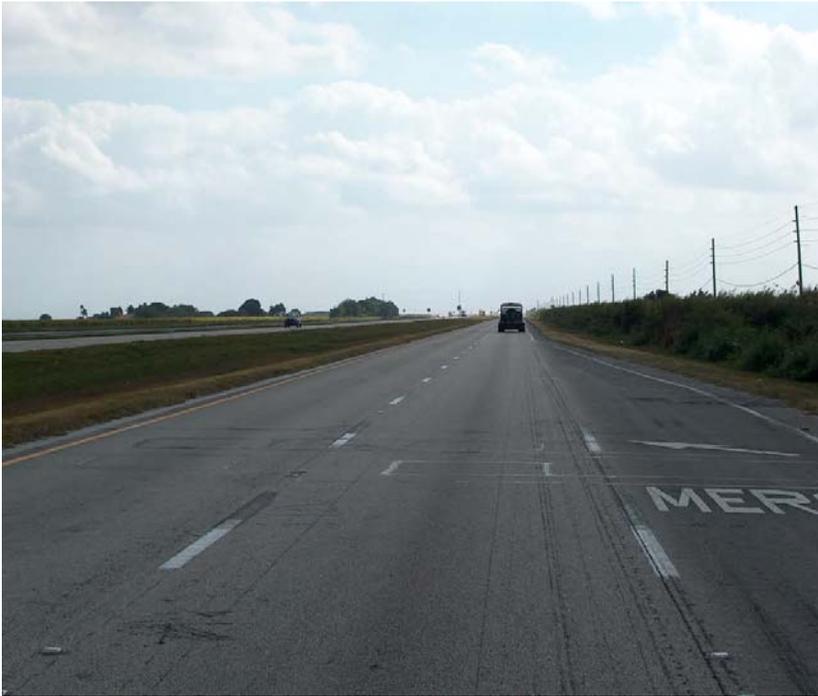
**Figure 13-1 Pavement Condition of 120100 in Downstream Direction**

The pavement appears to be in good condition with little or no distress. Figure 13-1 shows the condition of the pavement in the downstream direction and Figure 13-2 shows in the condition of the pavement in the upstream direction.

A visual inspection of the pavement 425 feet in advance of the WIM area and 75 feet following the WIM area was conducted. No significant pavement distress that would affect the performance of the WIM scales was detected.

Since all the WIM Smoothness Index LRI and SRI values for the right shift exceed the threshold, grinding is recommended in the extreme right side of the travel lane as a corrective action.

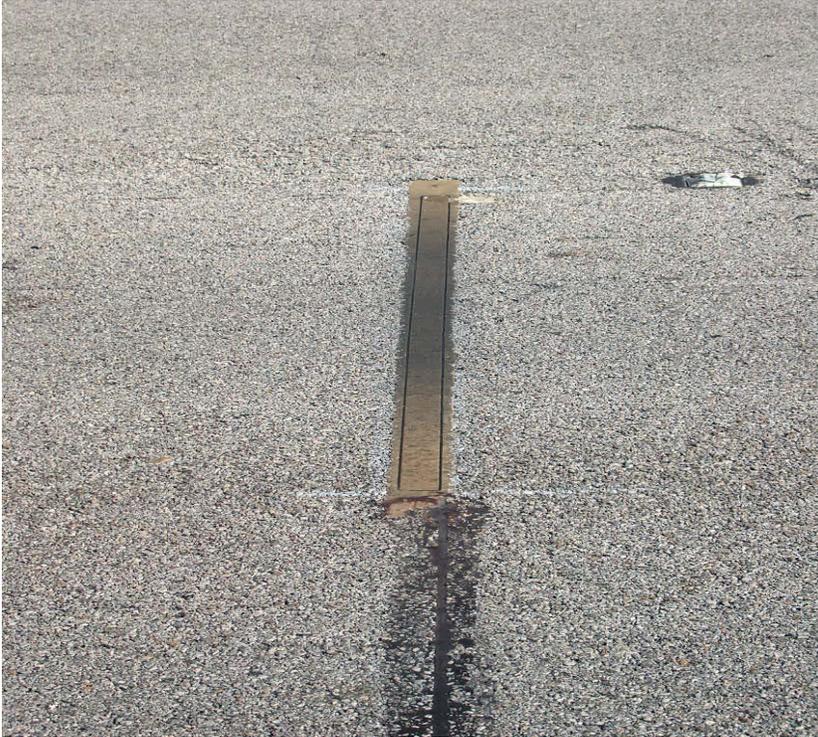
Leading\_Quartz\_Sensor\_TO\_2\_12\_12A\_0100\_12\_03\_03.JPG

An electronic check of all WIM components was performed. All in-road sensors and WIM controller components are working properly. The left side component of the leading quartz sensor indicated a lower than normal insulation resistance, but not below acceptable tolerances for proper performance. Other performance values for this sensor were normal.
