Assessment Report for  
Florida, SPS Experiment 5

Visit date: December 4, 2003

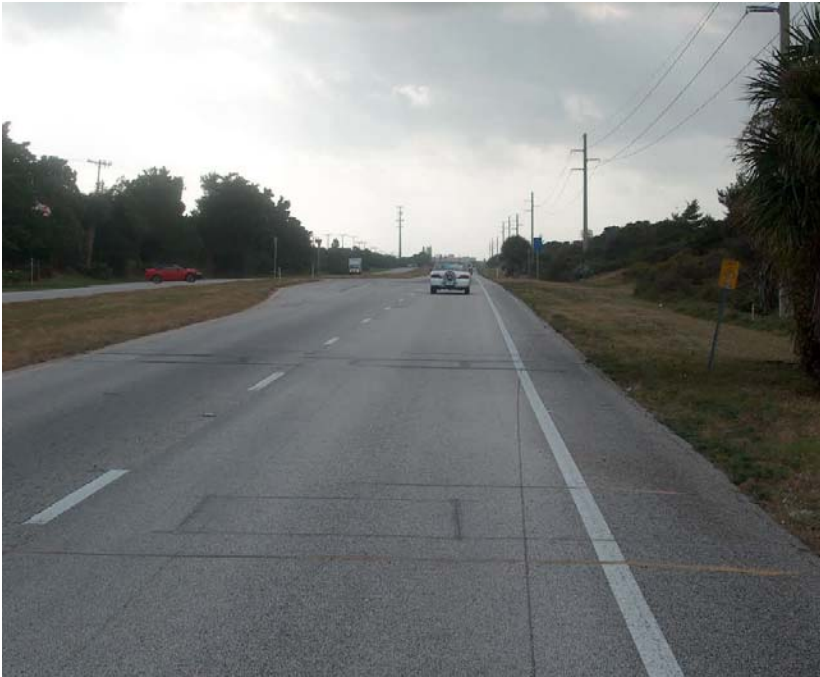
**Figure 13-1 Pavement Condition of 120500 in Downstream Direction**

A visual inspection of the pavement 425 feet in advance of the WIM area and 75 feet following the WIM area was conducted. A prior installation of WIM components was found immediately following the present sensor installation. The distress to the pavement resulting from this has been repaired. No significant pavement distress that would affect the performance of the WIM scales was detected.

The pavement is in good condition with little or no distress. Figure 13-1 shows the condition of the pavement in the downstream direction and Figure 13-2 shows the condition of the pavement in the upstream direction.
