Assessment Report for  
Kansas, SPS 2

Visit date: March 31, 2004

A visit was made to the Kansas SPS-2 site on March 31, 2004 for the purposes of conducting an assessment of the WIM system located on US Interstate 70, at milepost 287.48, 1.1 miles east of the Chapman interchange, exit 286 on I-70. The LTPP lane is the driving lane in the western direction.

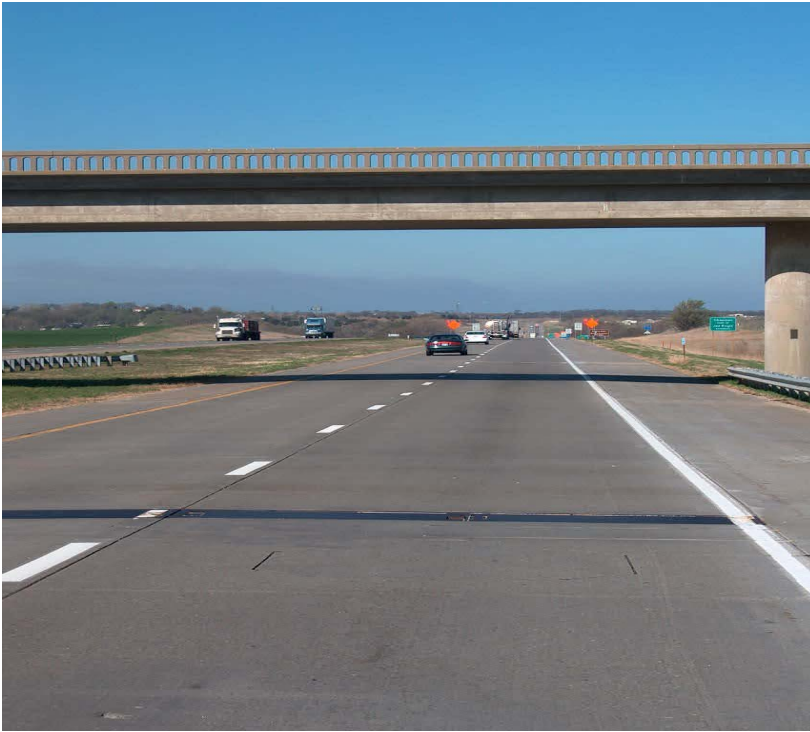
There are however dips 175 feet and 85 feet prior to the WIM Scales. Figure 13-1 and Figure 13-2 show the condition of the pavement in the downstream and upstream direction respectively.

**Figure 13-1 Pavement Condition in Downstream Direction at 200200**

Should pavement replacement not be a viable option, grinding of the entire section of the pavement should be performed to reduce the roughness. Also, grinding should be performed 175 and 85 feet prior to the WIM scale to eliminate the dips.

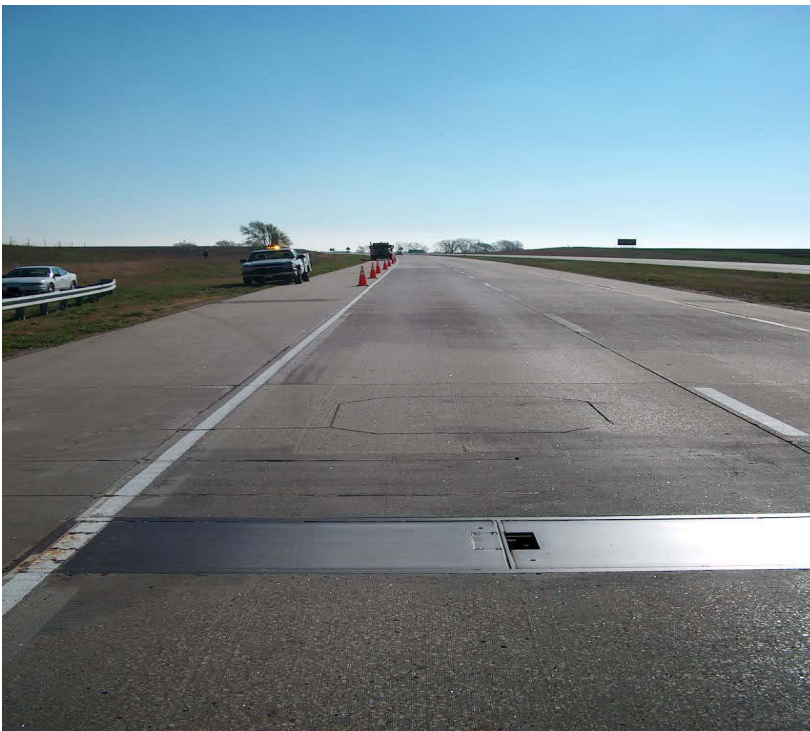
**Figure 13-2 Pavement Condition in Upstream Direction at 200200**

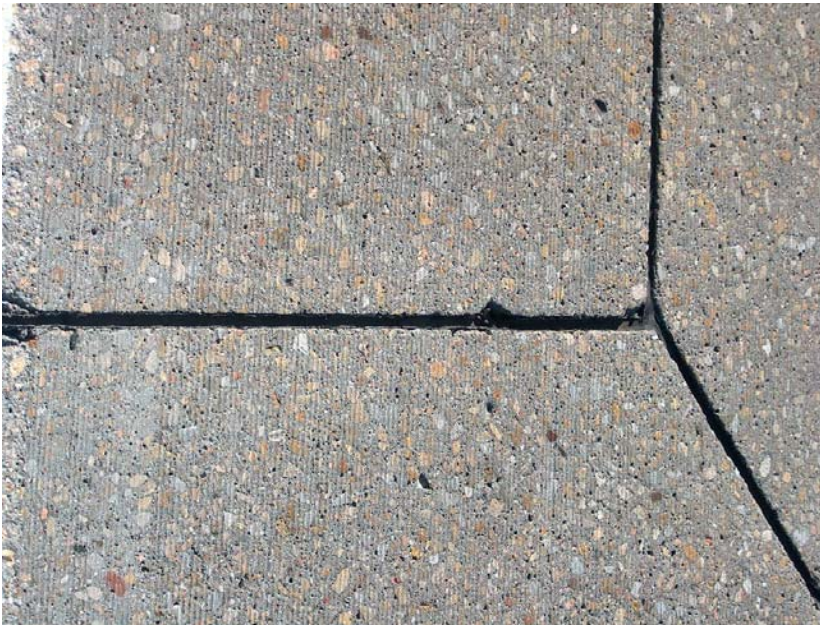
- Loop sealant is insufficient as seen in Figure 15-1 and needs to be filled in to prevent water and debris intrusion.
- Parts of the first piezo and the epoxy have broken free from the pavement as seen in Figure 15-2.

**Figure 15-1 Insufficient Loop Sealant at 200200**

The WIM controller needs to be reinstalled. The loop sensor sealant needs to be filled in until it is flush with the pavement to prevent water and debris intrusion. The broken piezo needs to be removed and the channel filled with epoxy. Bolts on the weighing platforms and the access panel on the right weighing sensor need to be replaced. Since both platforms appear to be loose in their frames, the brackets that hold the weighing platforms need to be repaired or replaced.

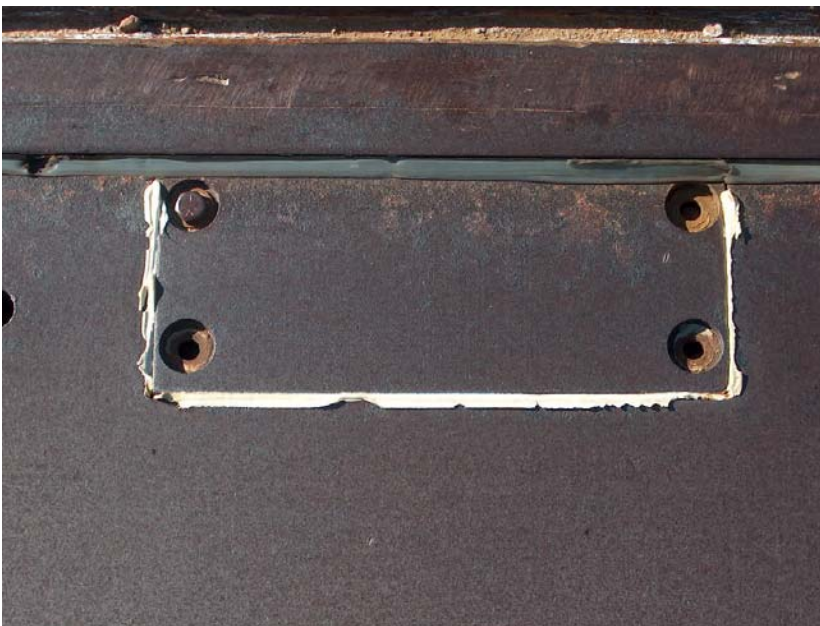
- An access panel for the right platform is missing and needs to be replaced as seen in Figure 15-3.
- Both load cell platforms are missing bolts as seen in Figure 15-4 and the missing bolts need to be replaced.
- Both load cell platforms appear to be loose in their frames. The holding brackets located under the platform need to be repaired or replaced.

**Figure 15-4 Missing Bolts in Weight Sensors at 200200**

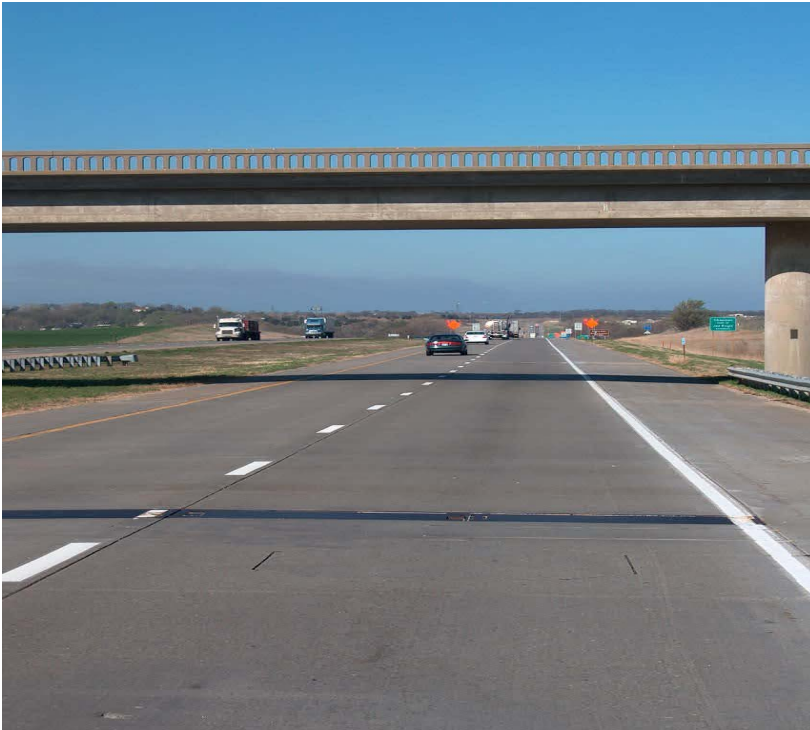
Downstream\_TO\_4\_20\_30A\_0200\_3\_31\_04.JPG (Distress photo 1)

A visual inspection of the pavement 425 feet in advance of the WIM area and 75 feet following the WIM area was conducted. The pavement appears to be in good condition.
