# WIM System Field Calibration and Validation Summary Report

Maine SPS-5  
SHRP ID – 230500

Validation Date: November 30, 2010  
Submitted: 12/17/2010

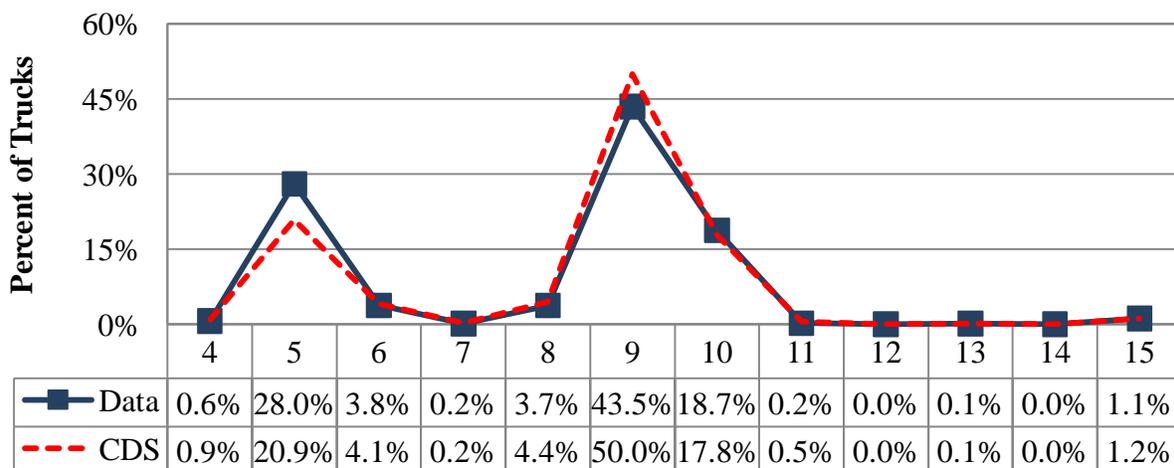
**Figure 2-1 – Comparison of Truck Distribution**

The traffic data was analyzed to determine the expected truck distributions. This analysis provides a basis for the classification distribution study that was conducted on site. Figure 2-1 provides a comparison of the truck type distributions for the two datasets. The figure indicates an increase in the number of Class 5 trucks and a decrease in the number of Class 9 trucks between the October 2008 and October 2010 data sets.

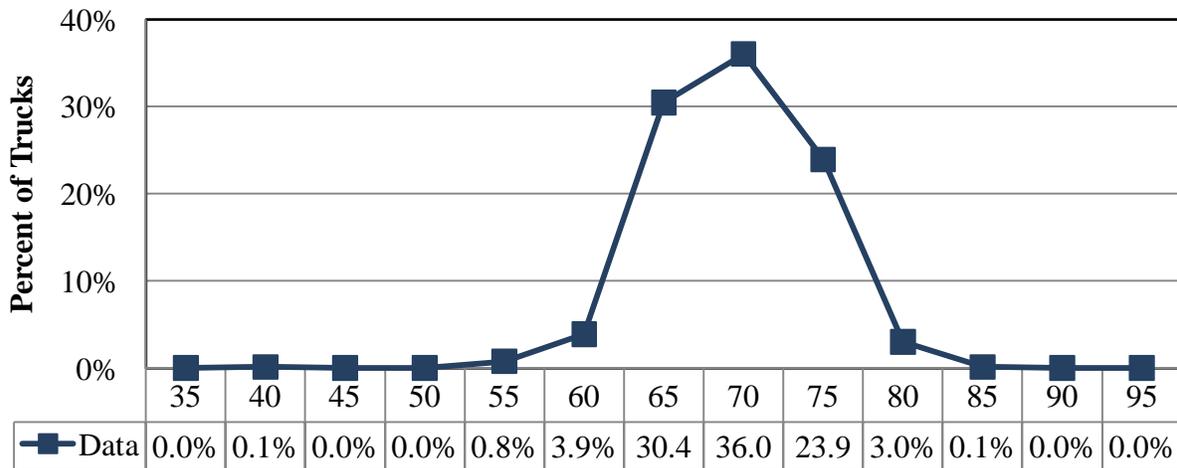
**Figure 2-2 – Truck Speed Distribution – 25-Oct-10**

As shown in Figure 2-2, the majority of the trucks at this site are traveling between 65 and 75 mph. The posted speed limit at this site is 65 and the 85<sup>th</sup> percentile speed for trucks at this site is 72 mph. The coverage of truck speeds for the validation will be 55 and 65 mph. Since the 85<sup>th</sup> percentile speeds for trucks is above the posted speed limit, the post-visit applied calibration will be used to develop compensation factors for speed points from 65 to 70 mph.

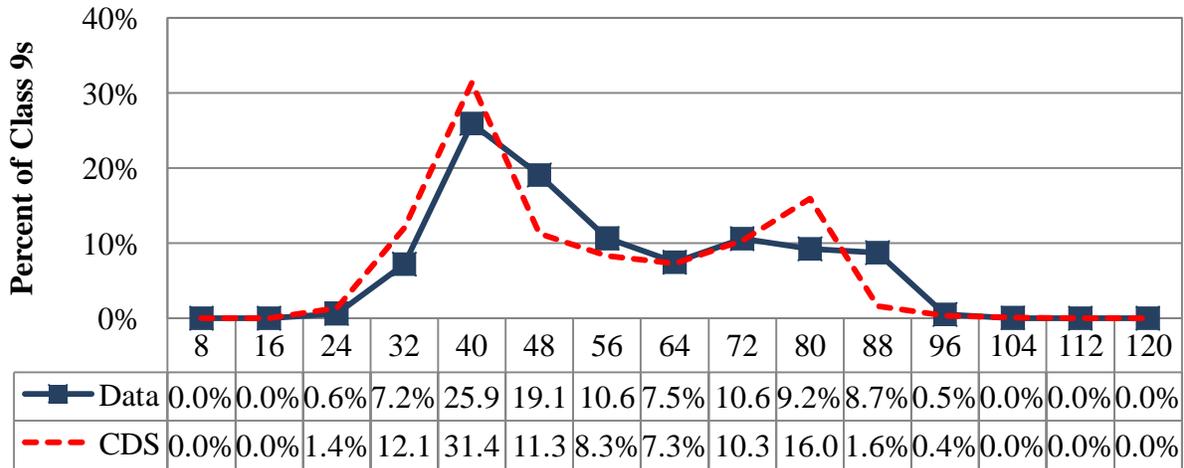
**Figure 2-3 – Comparison of Class 9 GVW Distribution**

As shown in Figure 2-3, there is a shift to the left for the loaded peak between the October 2008 Comparison Data Set (CDS) and the October 2010 two-week sample W-card dataset (Data). The

new loaded peak is also not well-defined. The results indicate that there may have been a change in the pavement condition or sensor deterioration.

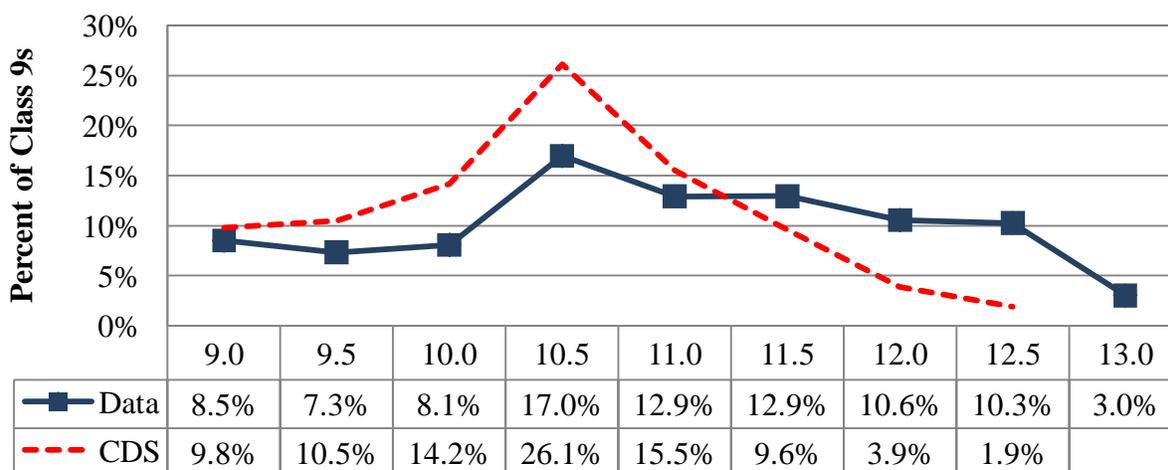
**Figure 2-4 – Distribution of Class 9 Front Axle Weights**

It can be seen in the figure that although the greatest percentage of trucks having front axle weights averaging 10.5 kips has remained consistent, the percentage of trucks at this weight have decreased between the October 2008 Comparison Data Set (CDS) and the October 2010 dataset (Data). The number of trucks with front axle weights greater than 10.5 kips has increased and the number of trucks with front axle weights less than 10.5 kips has decreased.

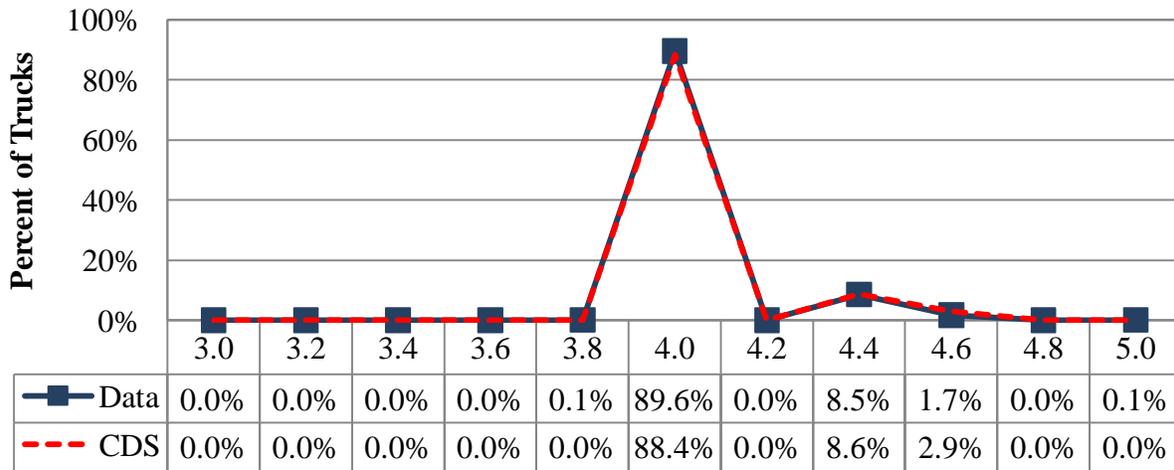
**Figure 2-5 – Comparison of Class 9 Tractor Tandem Spacing**

As seen in the figure, the Class 9 tractor tandem spacing for the October 2008 Comparison Data Set and the October 2010 Data are nearly identical.

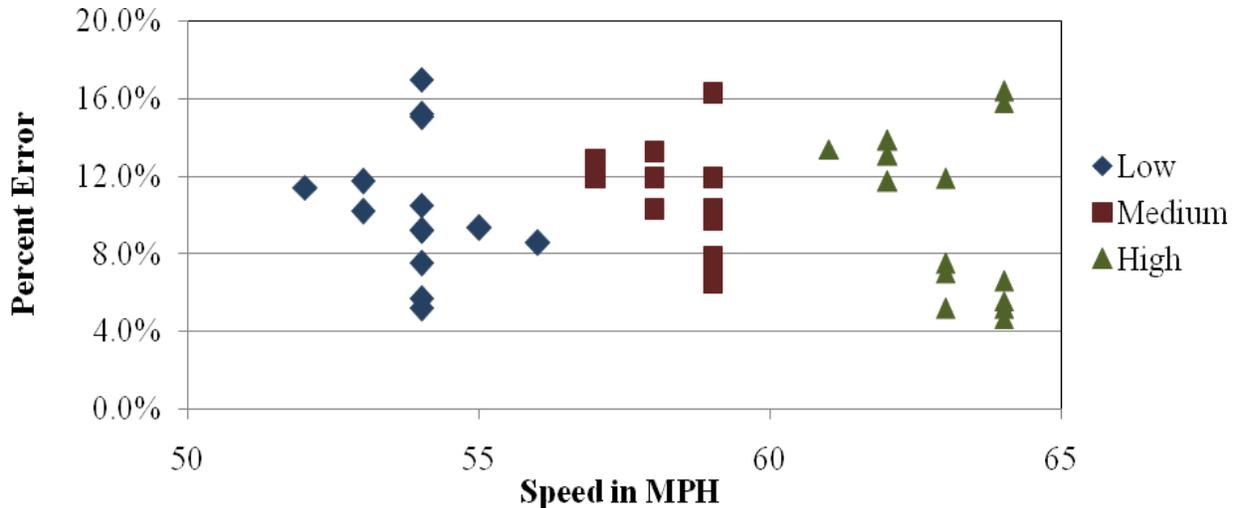
**Figure 5-1 – Pre-Validation GVW Error by Speed – 30-Nov-10**

As shown in Figure 5-1, the equipment overestimated GVW at all speeds. The range in error is slightly greater at the lower and higher speeds when compared with the medium speeds.

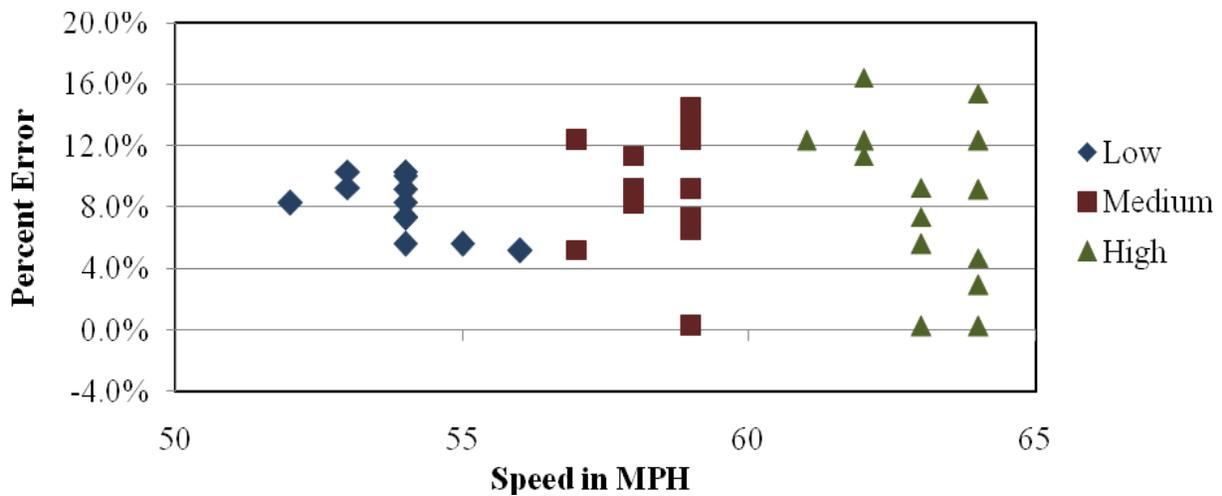
**Figure 5-2 – Pre-Validation Steering Axle Weight Errors by Speed – 30-Nov-10**

As shown in Figure 5-2, the equipment overestimates steering axle weights at all speeds. The range in error appears to be increase as speed increases.

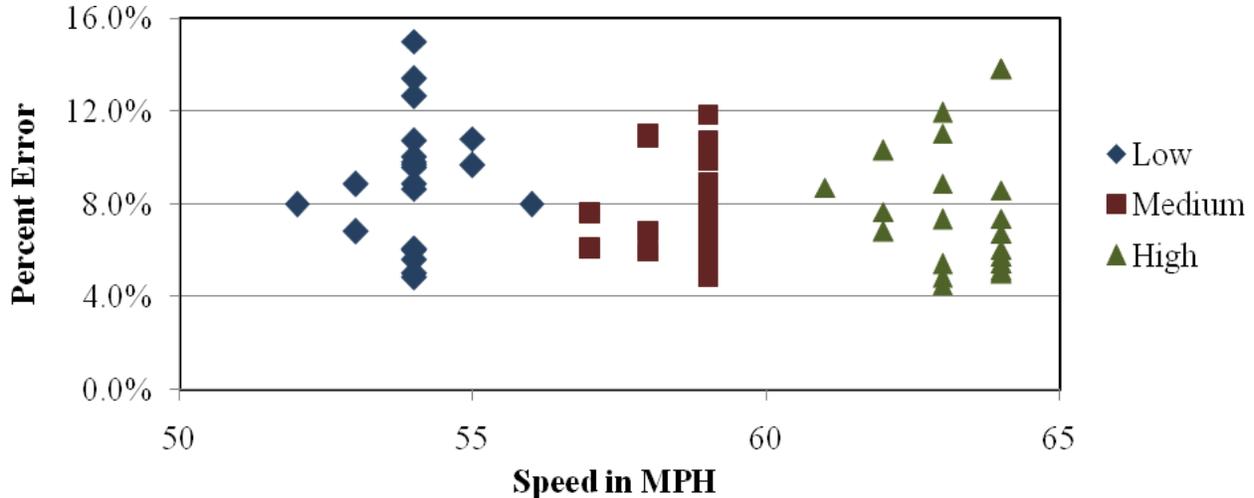
Figure 5-3 – Pre-Validation Tandem Axle Weight Errors by Speed – 30-Nov-10

As shown in Figure 5-3, the equipment overestimates tandem axle weights at all speeds. The range in error is greater at the lower and higher speeds when compared with the medium speeds.

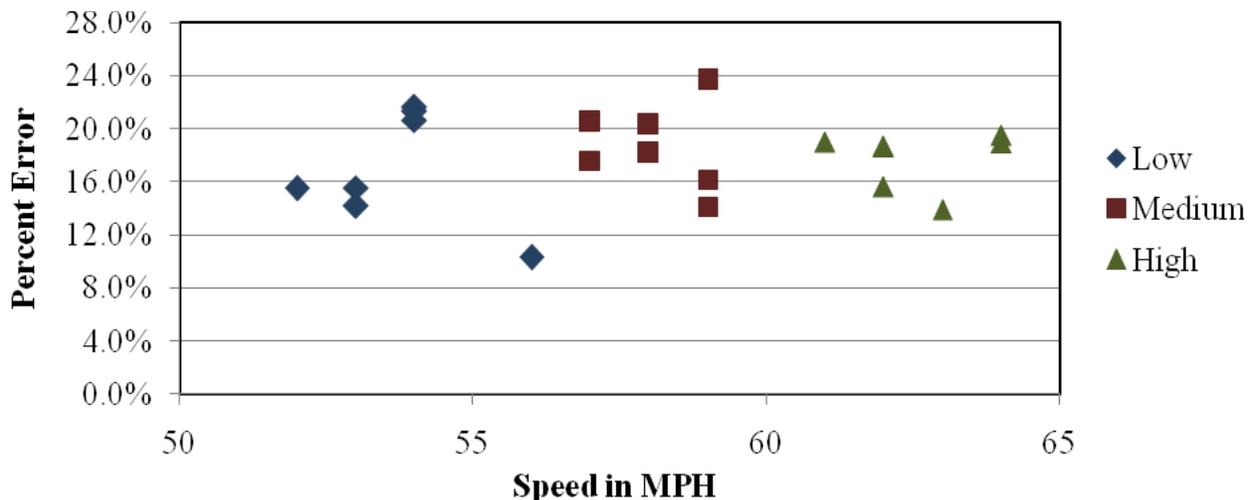
Figure 5-4 – Pre-Validation Tridem Axle Weight Errors by Speed – 30-Nov-10

As shown in Figure 5-4, the equipment overestimates tridem axle weights with similar accuracy at all speeds. Note that this overestimation is much greater than the overestimations of steering or tandem axle weights. The range in error appears to be consistent throughout the entire speed range.

It is recommended that the problems associated with the inconsistent weight measurements of tandem and tridem axle group weights and the failure of the equipment to detect inputs from the #2 WIM sensor be further investigated to determine if the problem is with the controller or with the sensor.

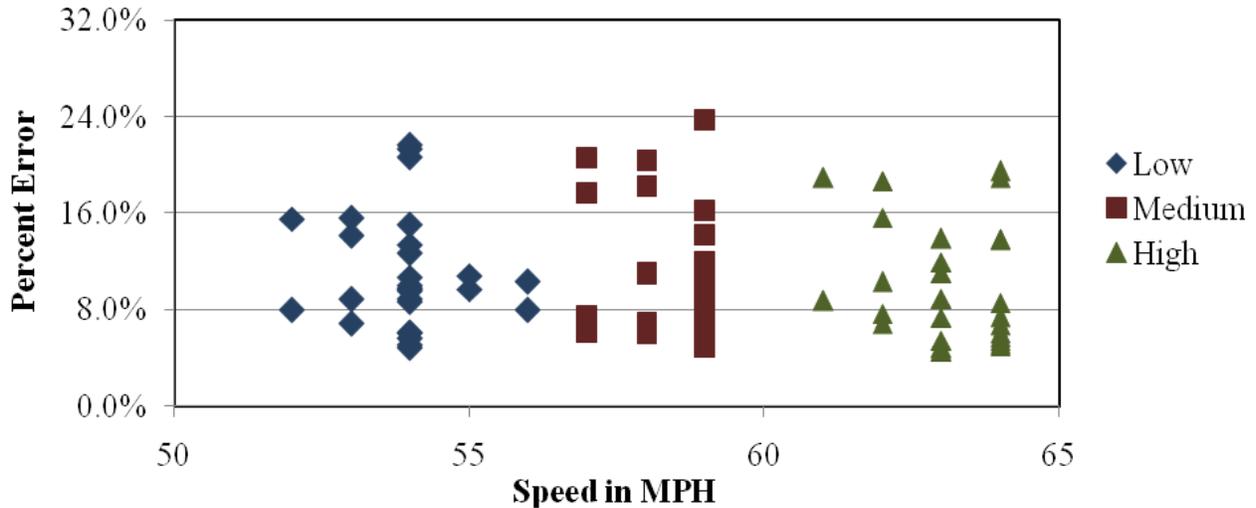
**Figure 5-5 – Pre-Validation Axle Group Weight Errors by Speed – 30-Nov-10**

As shown in Figure 5-5, the difference in the overestimation of tandem and tridem axle weights creates a significant range in axle group weight measurements error when observed collectively, although the range in error appears to be consistent throughout the entire speed range.

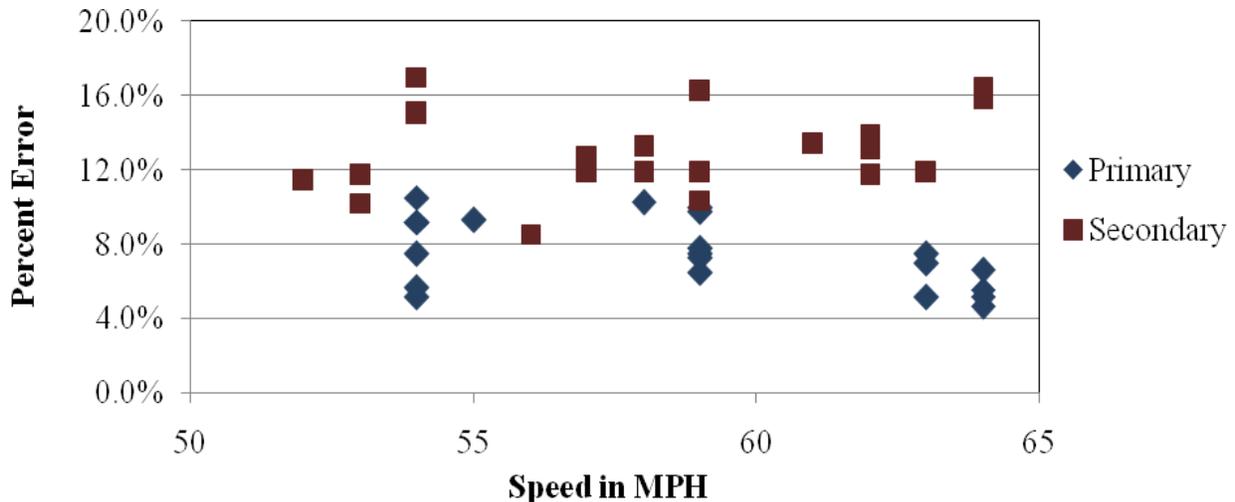
**Figure 5-6 – Pre-Validation GVW Errors by Truck and Speed – 30-Nov-10**

When the GVW error for each truck type is analyzed as a function of speed, it can be seen that the WIM equipment overestimates the GVW of the Secondary truck by a greater degree due to the addition of the tridem axle group. Distribution of errors is shown graphically in Figure 5-6.

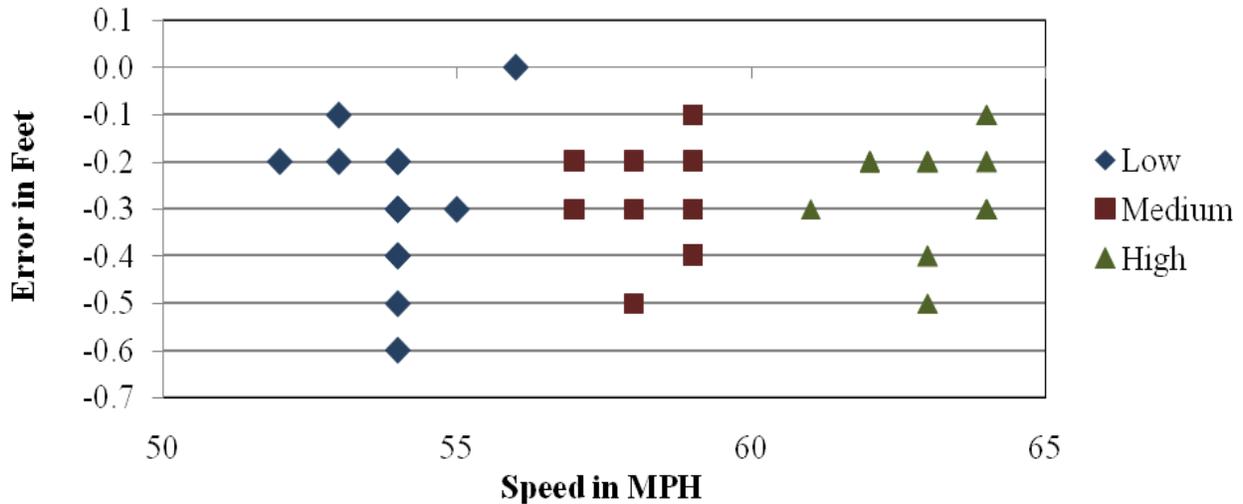
**Figure 5-7 – Pre-Validation Axle Length Errors by Speed – 30-Nov-10**

For this site, the error in axle length measurement was consistent at all speeds. The range in axle length measurement error ranged from -0.6 feet to 0.0 feet. Distribution of errors is shown graphically in Figure 5-7.

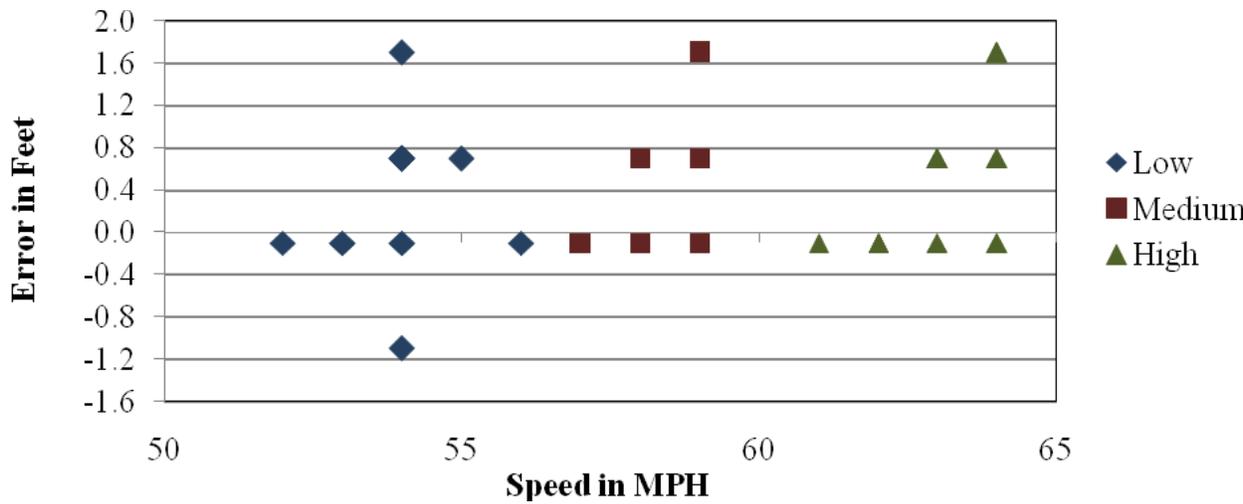
**Figure 5-8 – Pre-Validation Overall Length Error by Speed – 30-Nov-10**

For this system, the WIM equipment measured overall vehicle length with reasonable accuracy at all speeds, with an error range of -1.1 to 1.7 feet. Distribution of errors is shown graphically in Figure 5-8.

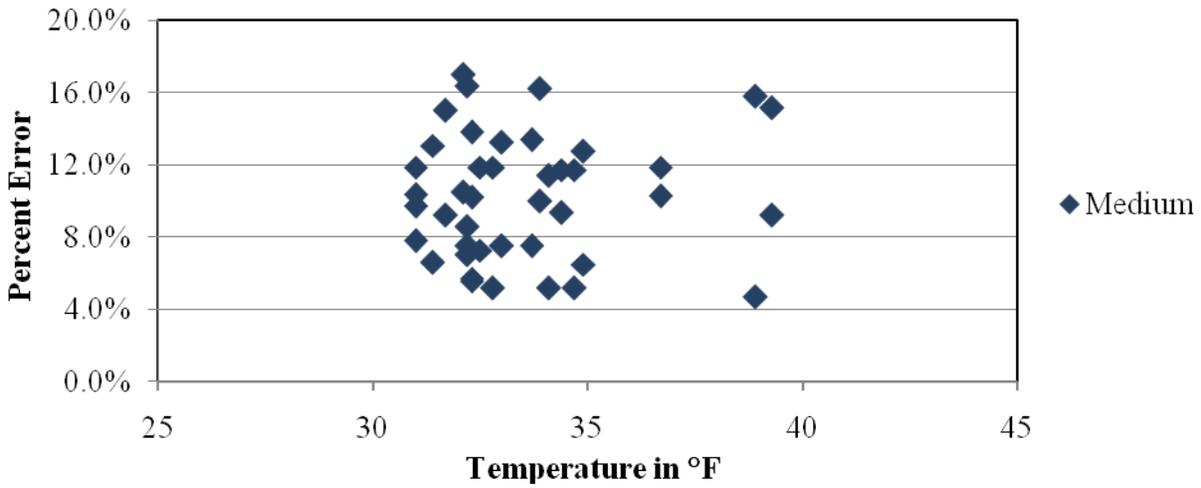
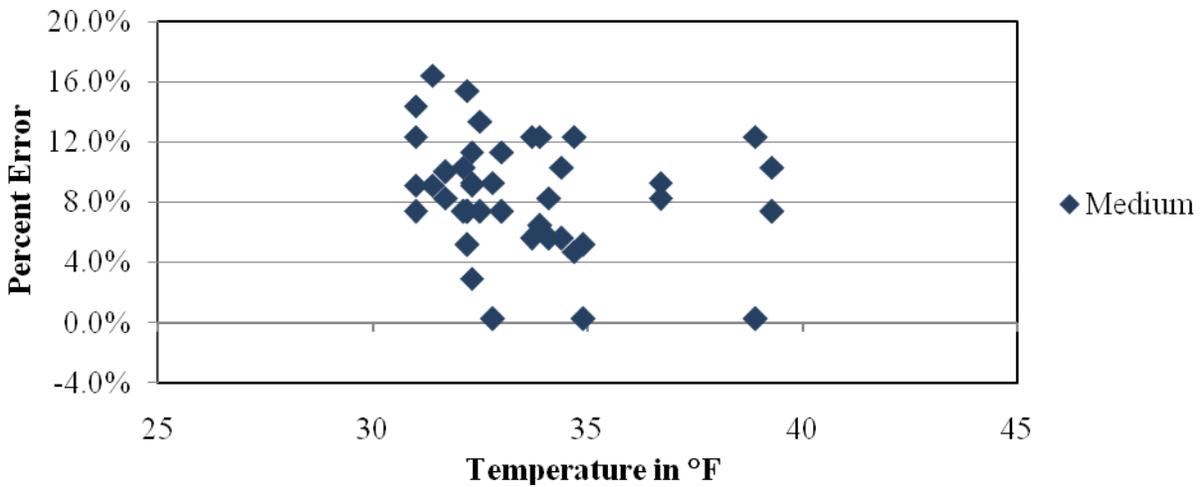
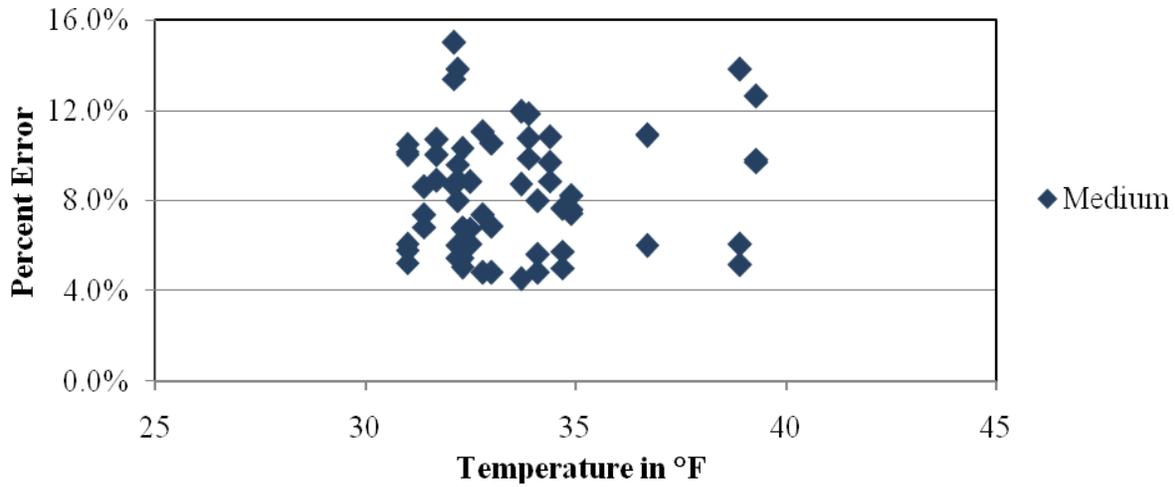
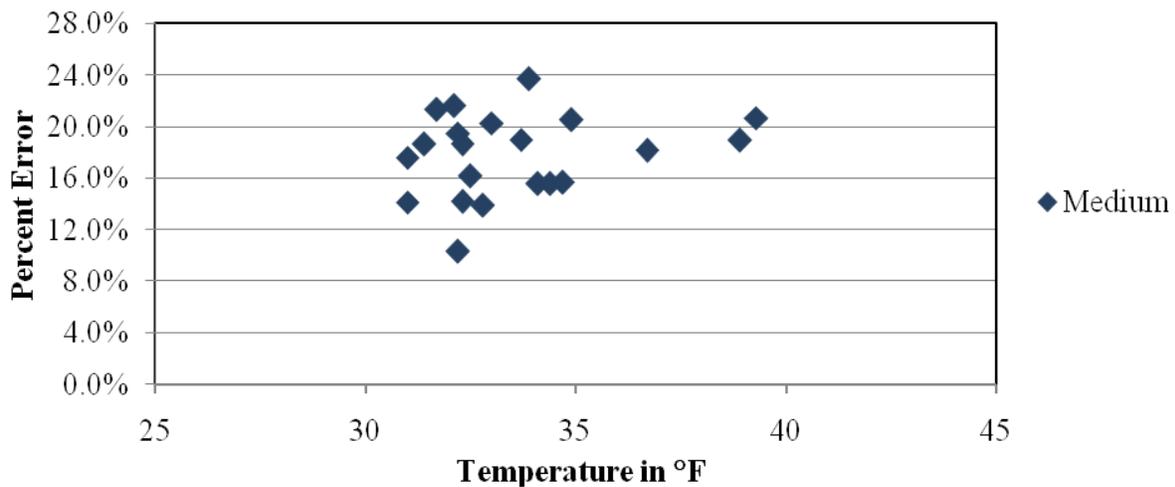
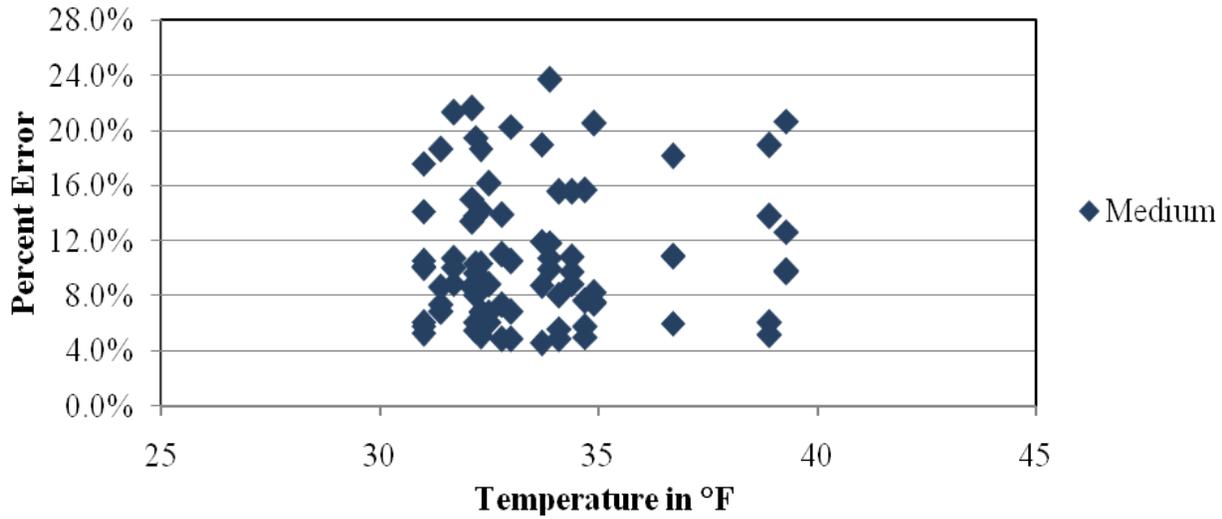
From Figure 5-9 through Figure 5-13, it can be seen that the equipment overestimates all weights across the range of temperatures observed in the field. Tridem axle weights were overestimated by a much greater degree. Due to the limited temperatures range, a correlation between temperature and weight estimates could not be investigated.

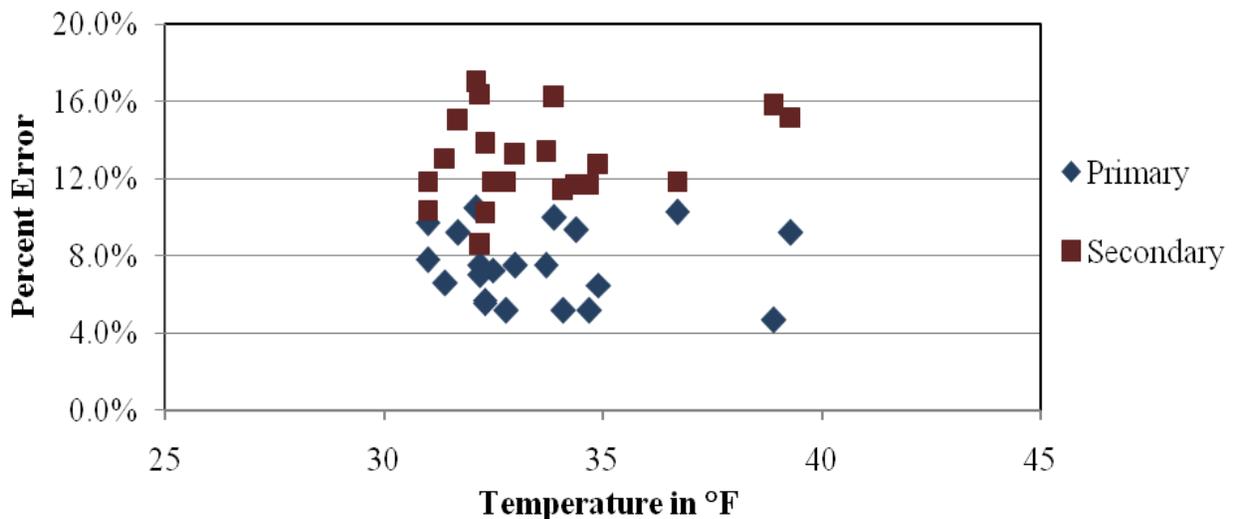
Figure 5-14 – Pre-Validation GVW Error by Truck and Temperature – 30-Nov-10

Similar to the speed analysis, when the GVW error for each truck is analyzed as a function of temperature, it can be seen that the WIM equipment overestimates the GVW of the Secondary truck by a greater degree due to the addition of the tridem axle group measurement errors. Distribution of errors is shown graphically in Figure 5-14.
