INTERNATIONAL ROAD DYNAMICS INC.

LTPP SPS PHASE II

WEIGH-IN-MOTION SITE ACCEPTABILITY ASSESSMENT REPORT

MARYLAND SPS-5
LTPP ID 240500
MARCH 9, 2005
CLIN 1001 TASK ORDER 1

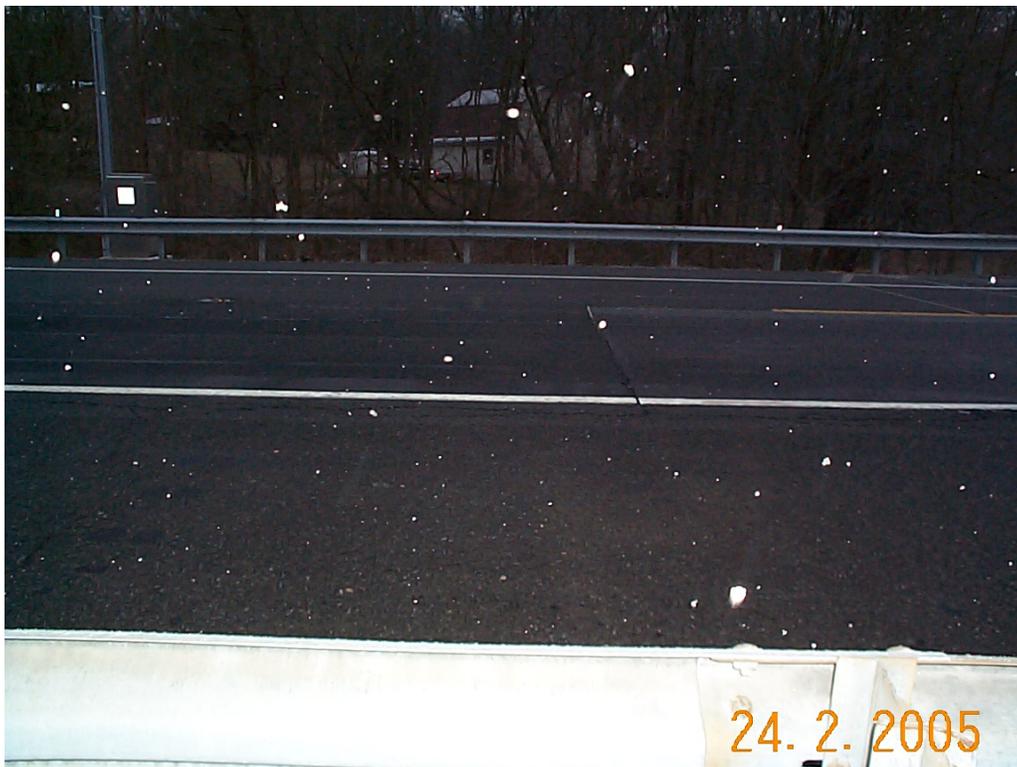
E.1.5 UPSTREAM VIEW OF ROADWAY AND LEADING EDGE OF SLAB

The upstream PCC and AC joint is in poor condition. Sealant is no longer adhering to pavement edges and the AC pavement is deteriorating (i.e., fraying along the edge with a mean width between 6-19 mm).

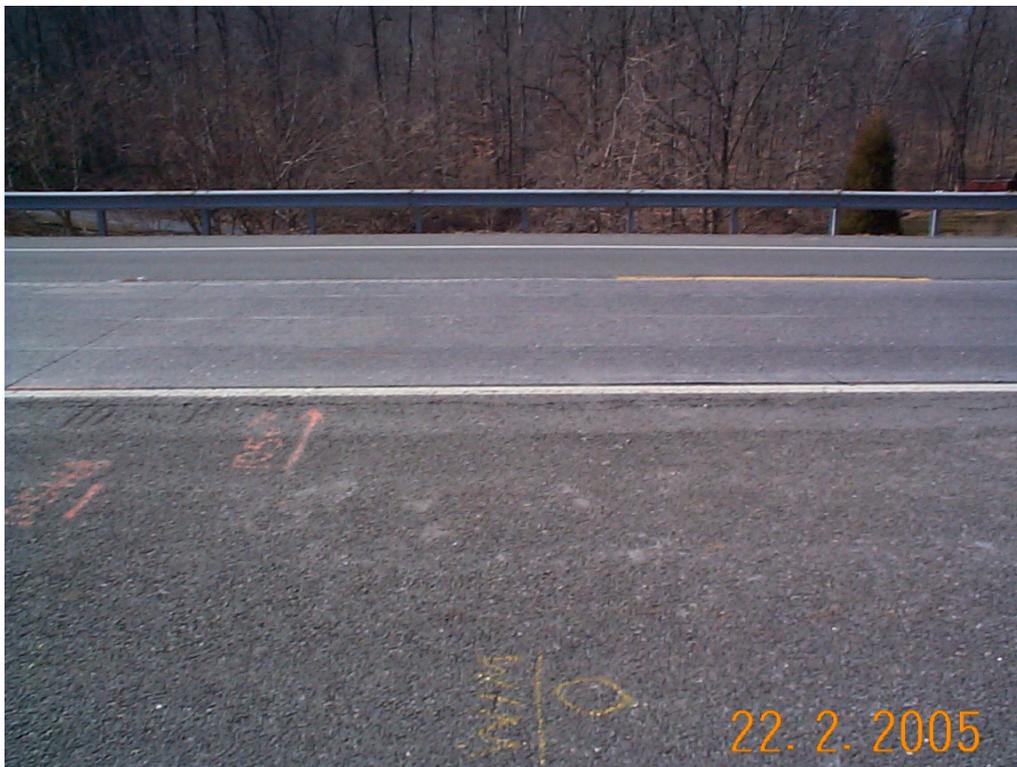
E.1.7 RECOMMENDED SCALE LOCATION

The 400 foot PCC slab installed in October 2004 specifically for the WIM system sensors appears to be structurally sound with no evidence of distress conditions. It is recommended that the WIM system scales be installed approximately 75 feet from the end of the PCC slab.

The Bending Plate Weigh Pads should be installed halfway between 2 transverse weakened plane joints, approximately 75 feet from the end of the 400 foot PCC slab. This would put the sensors almost directly across and within 20 feet from the proposed WIM cabinet.

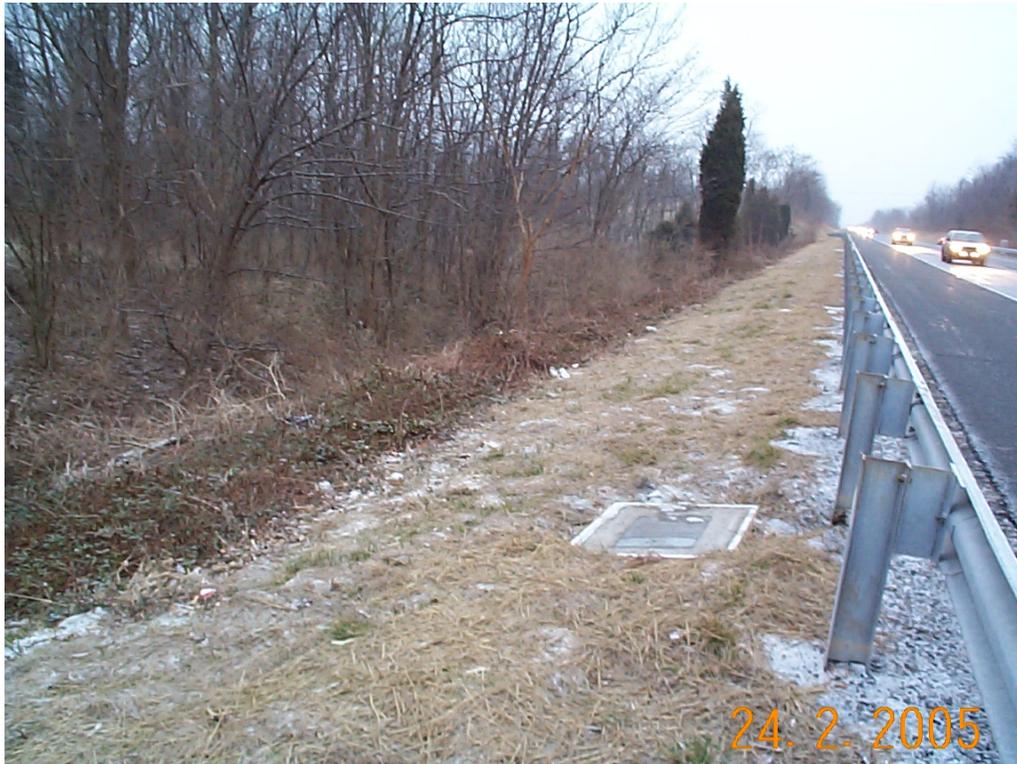
E.1.8 RECOMMENDED CABINET LOCATION

There is an adequate location for the WIM controller cabinet behind the guard rail by the existing junction box that will be used by the State for supply of AC power and telephone services. There is good visibility from this location of the sensors and approaching vehicles. There is adequate room adjacent to the cabinet location for service facilities. Roadway and overall site drainage is adequate. There is no foreseen potential for ponding or flooding at the cabinet and pullboxes and there is adequate topography for scale pit drainage. There is the ability to provide safe clearance in the work zone from live traffic during installation of the WIM system.

The State will run AC power and telephone service to the proposed WIM controller cabinet location from the existing ATR # 68 controller cabinet. (Appendix D.1.8 Recommended Cabinet Location)

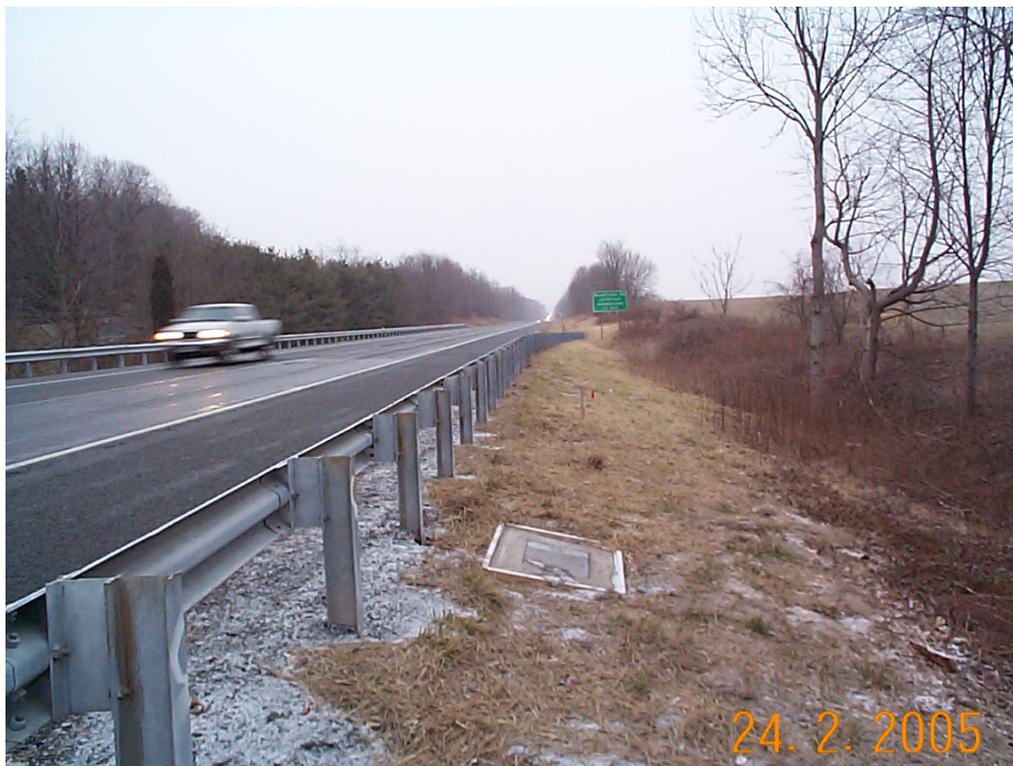
E.1.12 ROADWAY DRAINAGE

The cross slope was reported to be 1.6% by the State. The drainage was reported to be adequate.

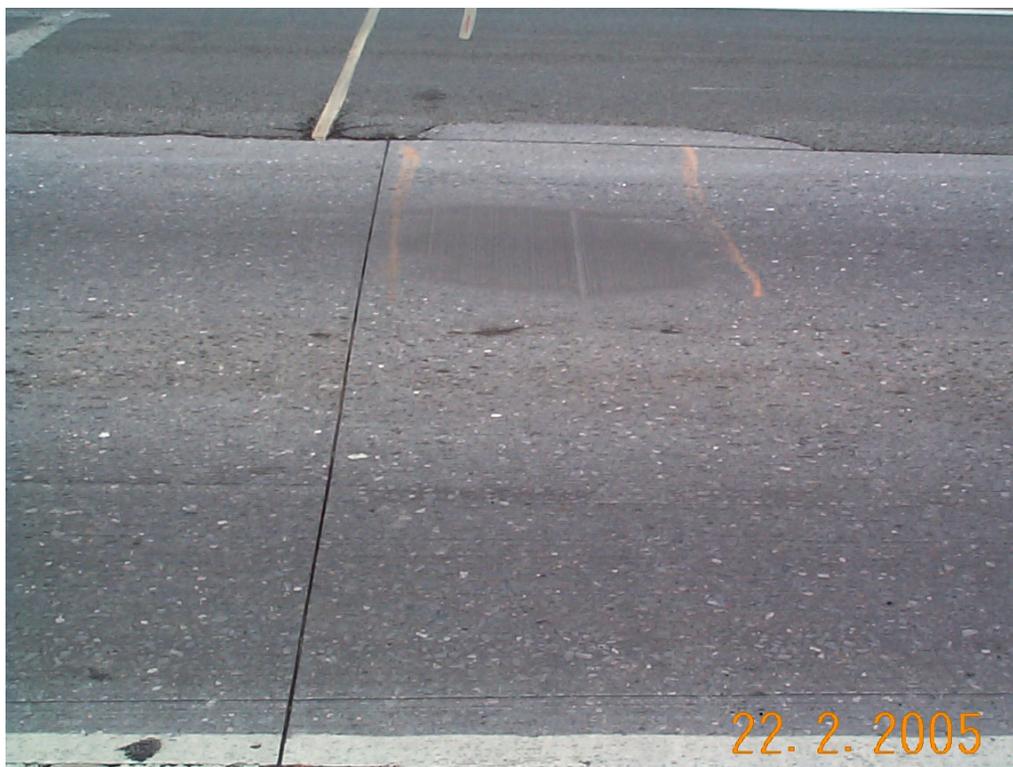
E.1.13 SLAB ANOMOLY (LOW SPOT)

The PCC pavement was constructed October, 2004. It was reported by the State that grinding was performed on the PCC using a 36 in wide blanket grinder. Some anomalies are located within the PCC were not entirely removed (i.e., several low spots approximately 1-2 ft in size).

In addition, based on analysis of the pavement profiling data there is indication that the lack of adequate pavement smoothness may cause body and/or suspension dynamics in the trucks traversing the site sufficiently large enough to cause inaccurate weight estimate measurements. Due to this, corrective action is necessary prior to the installation of the WIM system to ensure the system will meet the specified accuracy requirements.
