LTPP SPS PHASE II

WEIGH-IN-MOTION SITE ACCEPTABILITY ASSESSMENT REPORT

NEW MEXICO SPS-1
LTPP ID 350100
FEBRUARY 06, 2008
CLIN 2001 TASK ORDER 15

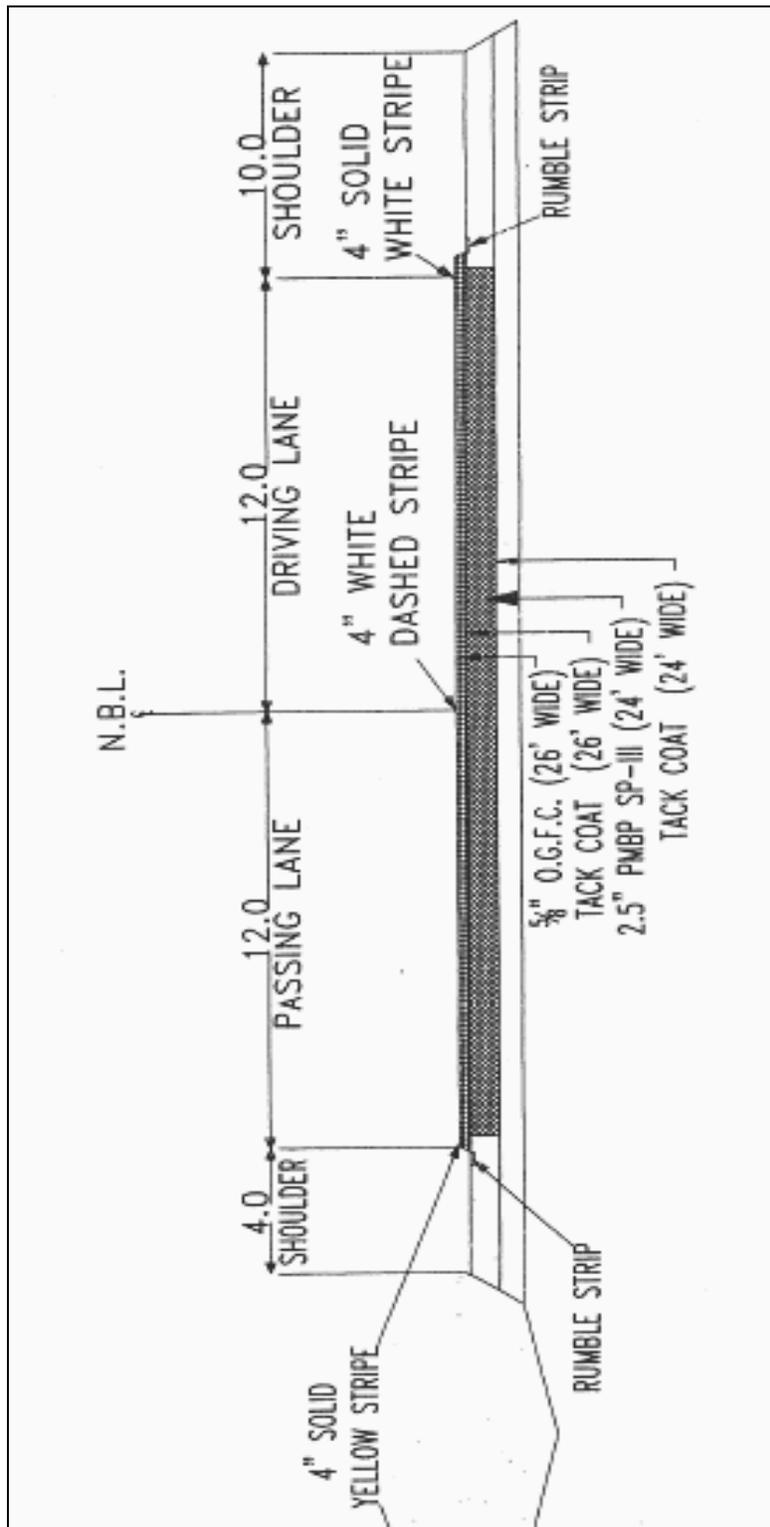
Figure 1: AC Rehabilitation Structural Section

The SPS-1 is a flexible pavement study. The I-25 roadway at the study location consists of 4 lanes, 2 northbound and 2 southbound. The pavement test sections are located in the outside northbound lane. The travelled way AC pavement approaching, through, and departing the selected location for the new WIM system as well as through the pavement test sections was recently rehabilitated by the state. This pavement consists of a 5/8 inch OGFC wearing course over new and old PMBP coarses. The state provided the plan for the new sections which is displayed in Figure 1.

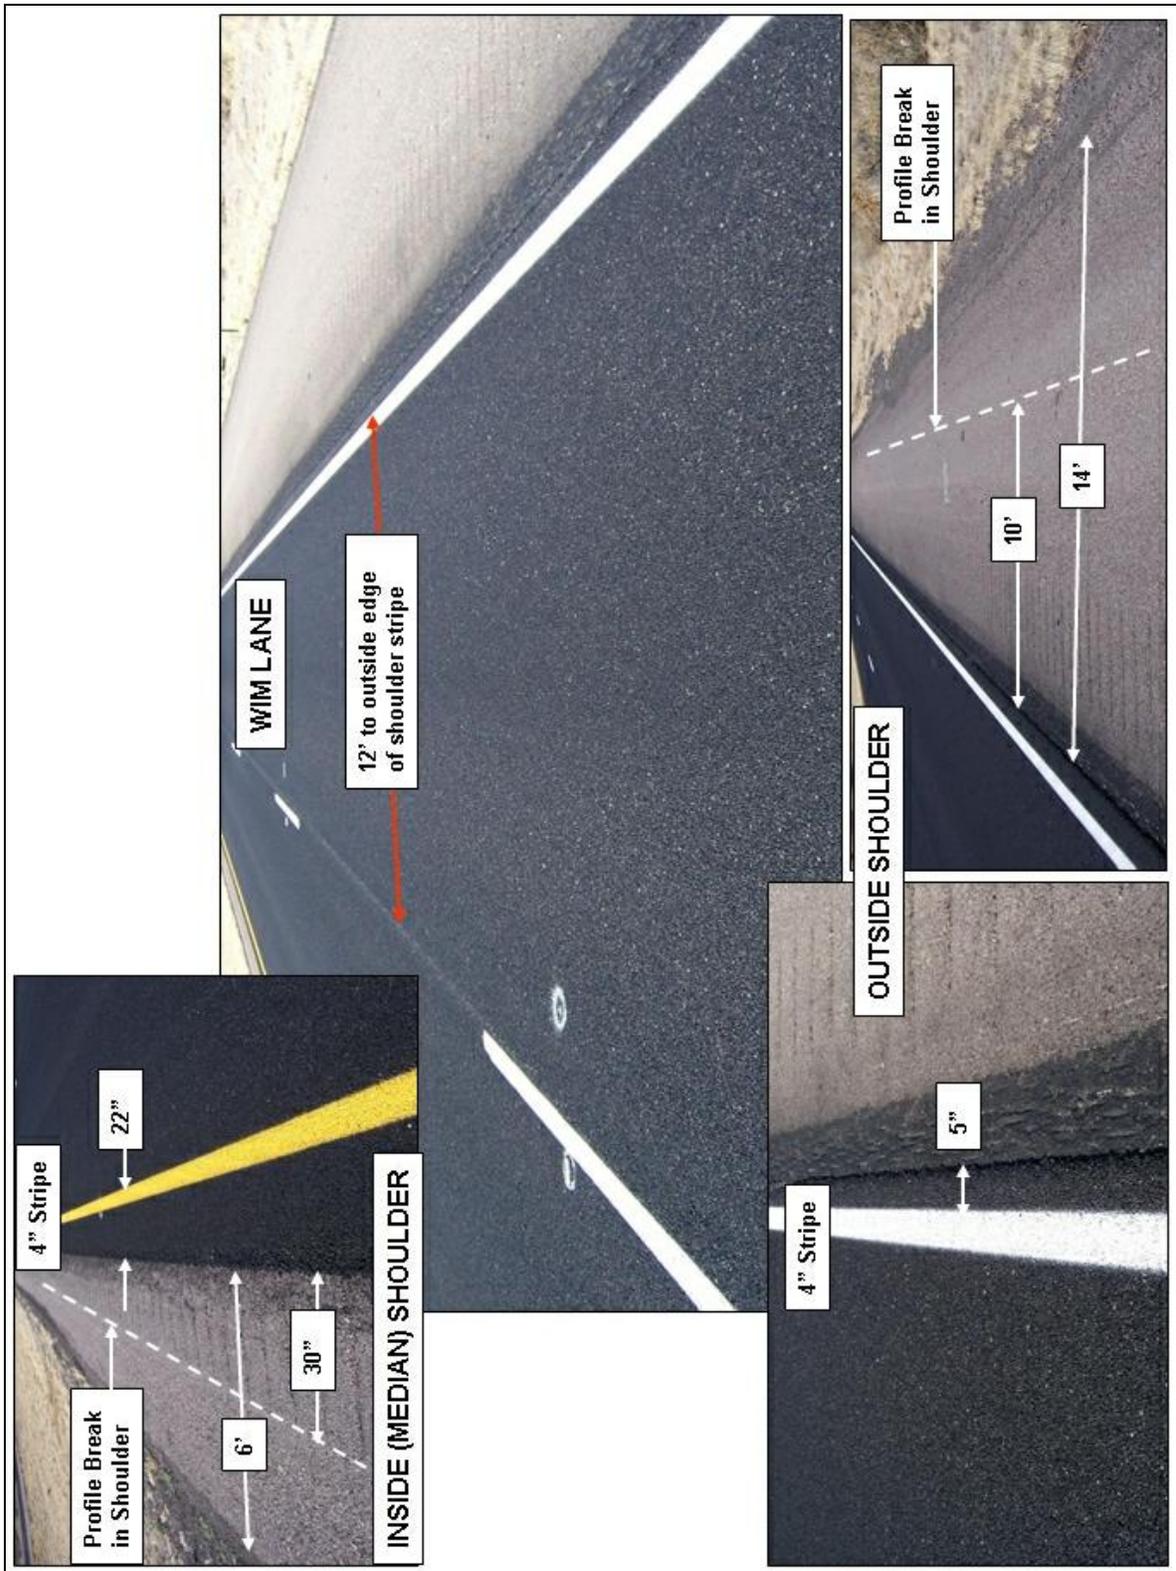
Figure 2: Pavement Measurements Taken at WIM Sensor Location

The outside and inside (median) shoulders are dense grade AC and were not included in the pavement rehabilitation project. The two northbound lanes are each striped at 12 feet wide. Although the state furnished plan displays the outside shoulder width at 10 feet and the inside (median) shoulder width at 4 feet, actual measurements taken at the new WIM location varied from these. The actual measurements are displayed in Figure 2.

Striping: NB outside lane: 4" solid white stripe delineates 12' lane. The 5/8" thick OG wearing course extends 5" beyond the outer edge of the stripe. The 14' shldr has a profile grade break at +/- 10' from the edge of the OG course. NB inside lane: 4" solid yellow stripe delineates 12' lane. The OG wearing course extends 18" beyond the outer edge of the stripe. The 6' shoulder has a profile break at 30" from the edge of the OG course.

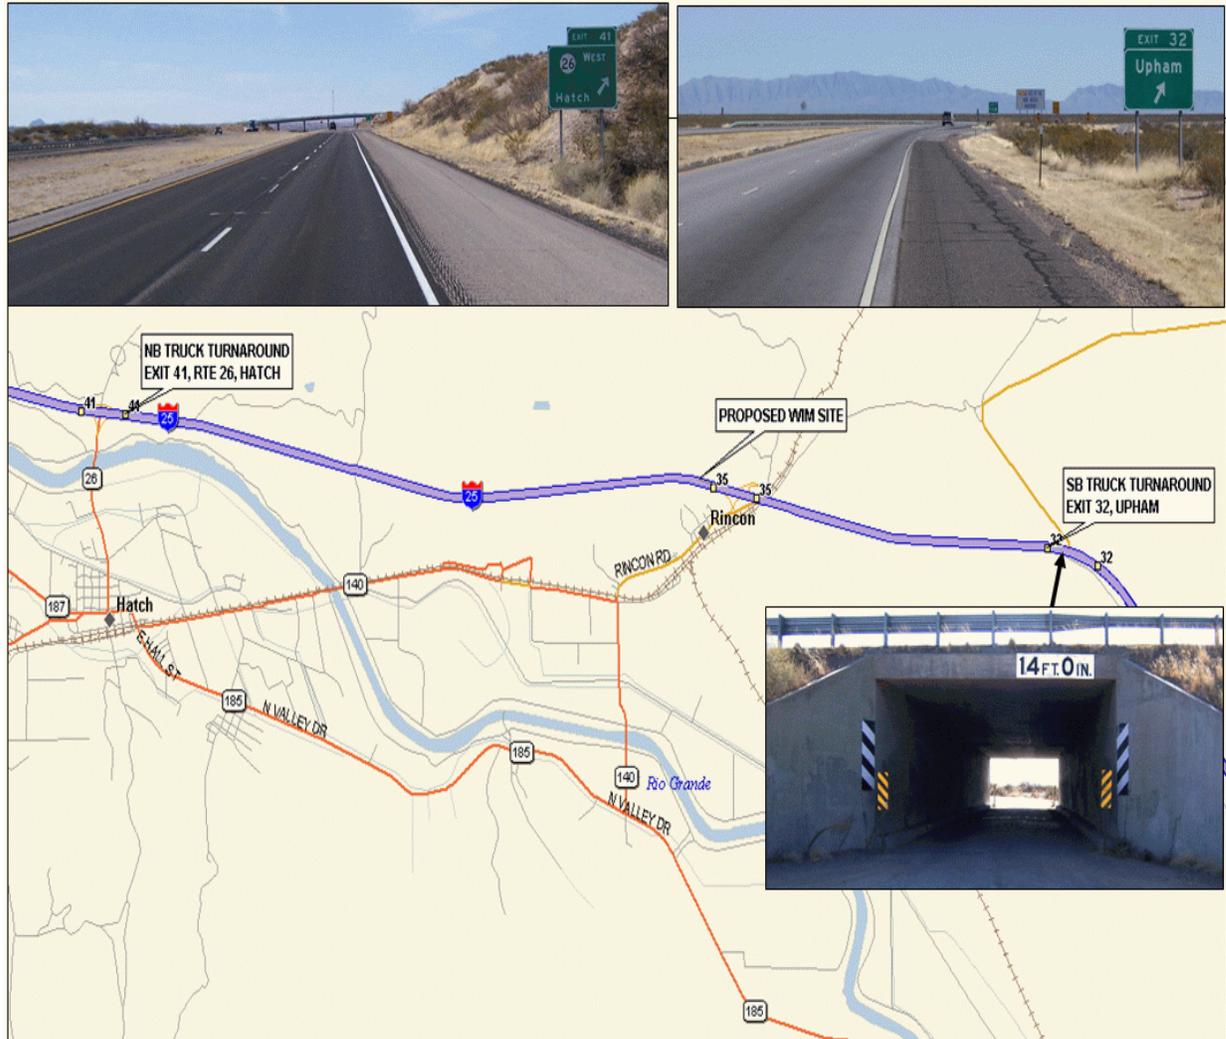
Figure 3: Truck Circuit Map

The nearest northbound truck turnaround for use by calibration and validation test trucks is I-25 Exit 41 (Hatch, SR 26), which is located 5.0 miles downstream (north) of the WIM site. The nearest useable southbound test truck turnaround is I-25 Exit 32 (Upham), which is located 3.0 miles upstream (south) of the WIM site. The test truck round trip circuit route is 17 miles. In utilizing the northbound Exit 41 off ramp, the drivers will have to determine the best way to get turned around for the southbound return. The interchange itself does not provide for an easily maneuvered turnaround and it may be necessary to travel toward or into the community of Hatch to find a suitable turnaround location. The southbound Exit 25 interchange should pose no maneuvering problem in returning northbound, but it is noted that the vertical clearance is posted at 14.0 feet for the road passing under the main line. The estimated lap time is 15 to 20 minutes. For the lower speed test truck runs, it might be possible for the test trucks to use the southbound I-25 Exit 35 (Rincon Road), immediately south of the proposed WIM site.

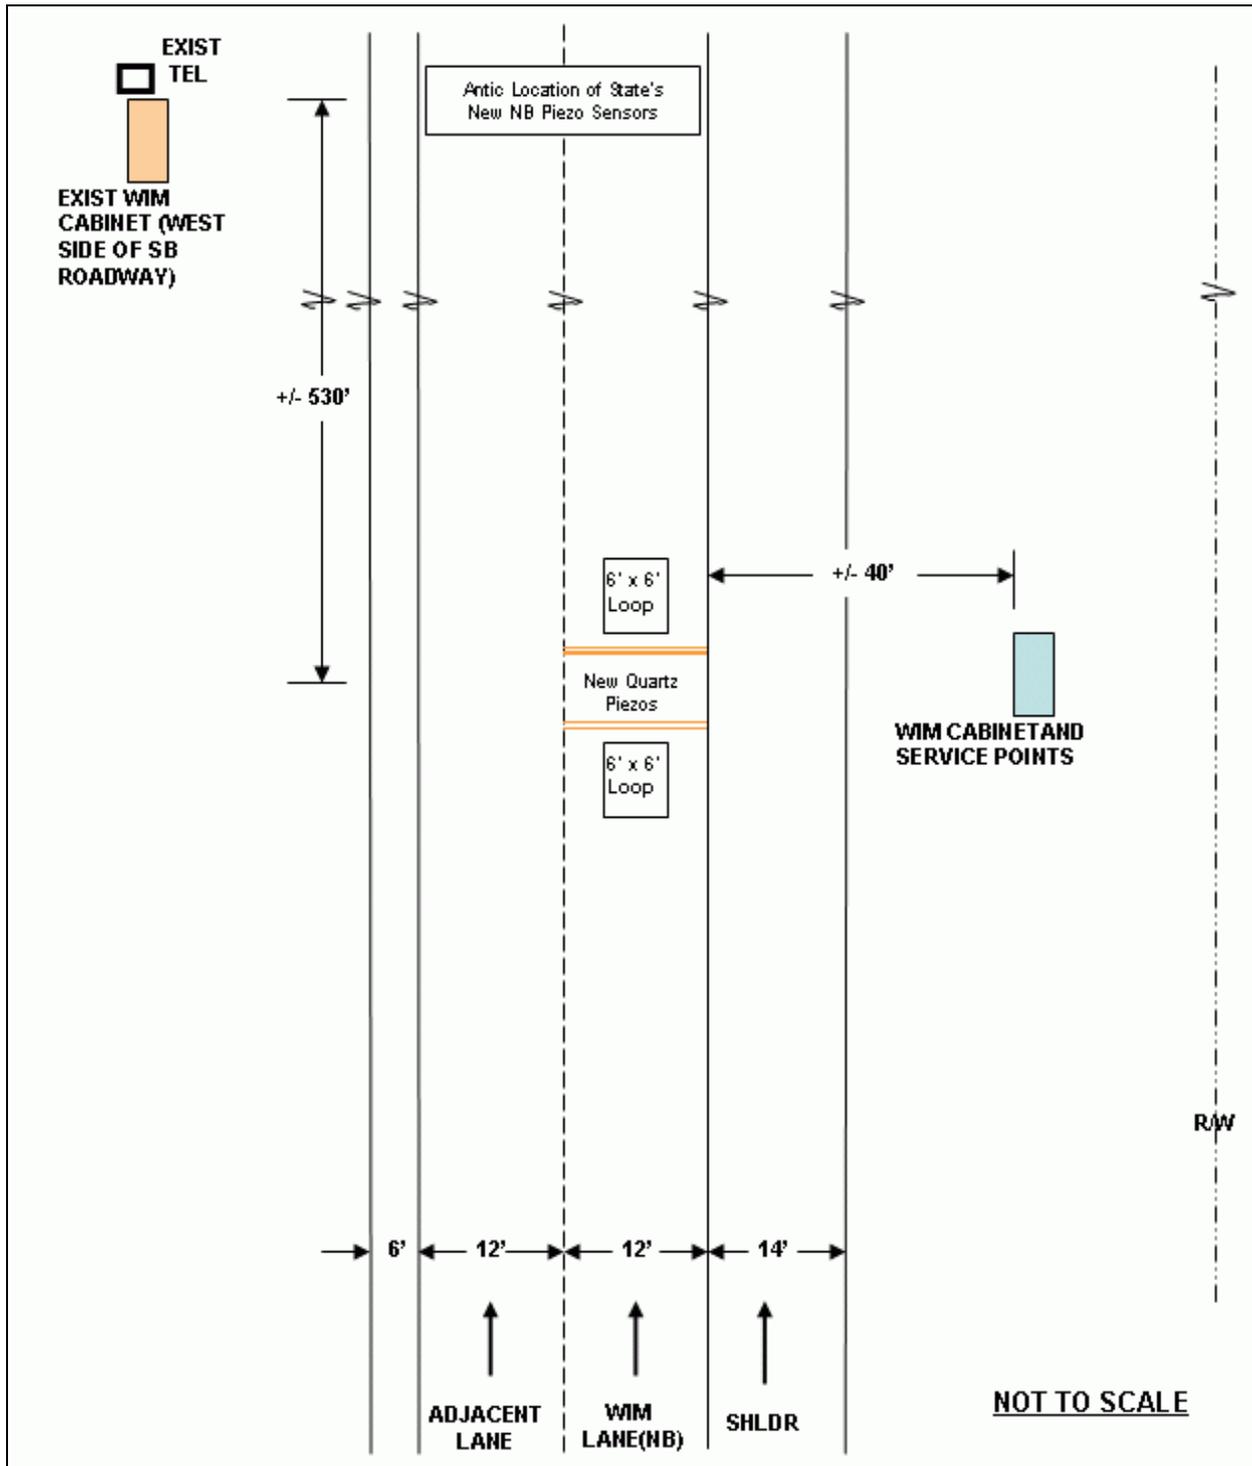
Figure 6: Proposed WIM Site Layout

The centerline of the double threshold quartz piezo sensors should be installed approximately 530 feet upstream of the state's existing WIM cabinet (at the time of the site assessment, the state had not yet re-installed the WIM's northbound in-road sensors). This location has been marked with a "900 WIM" in orange paint on the outside shoulder.

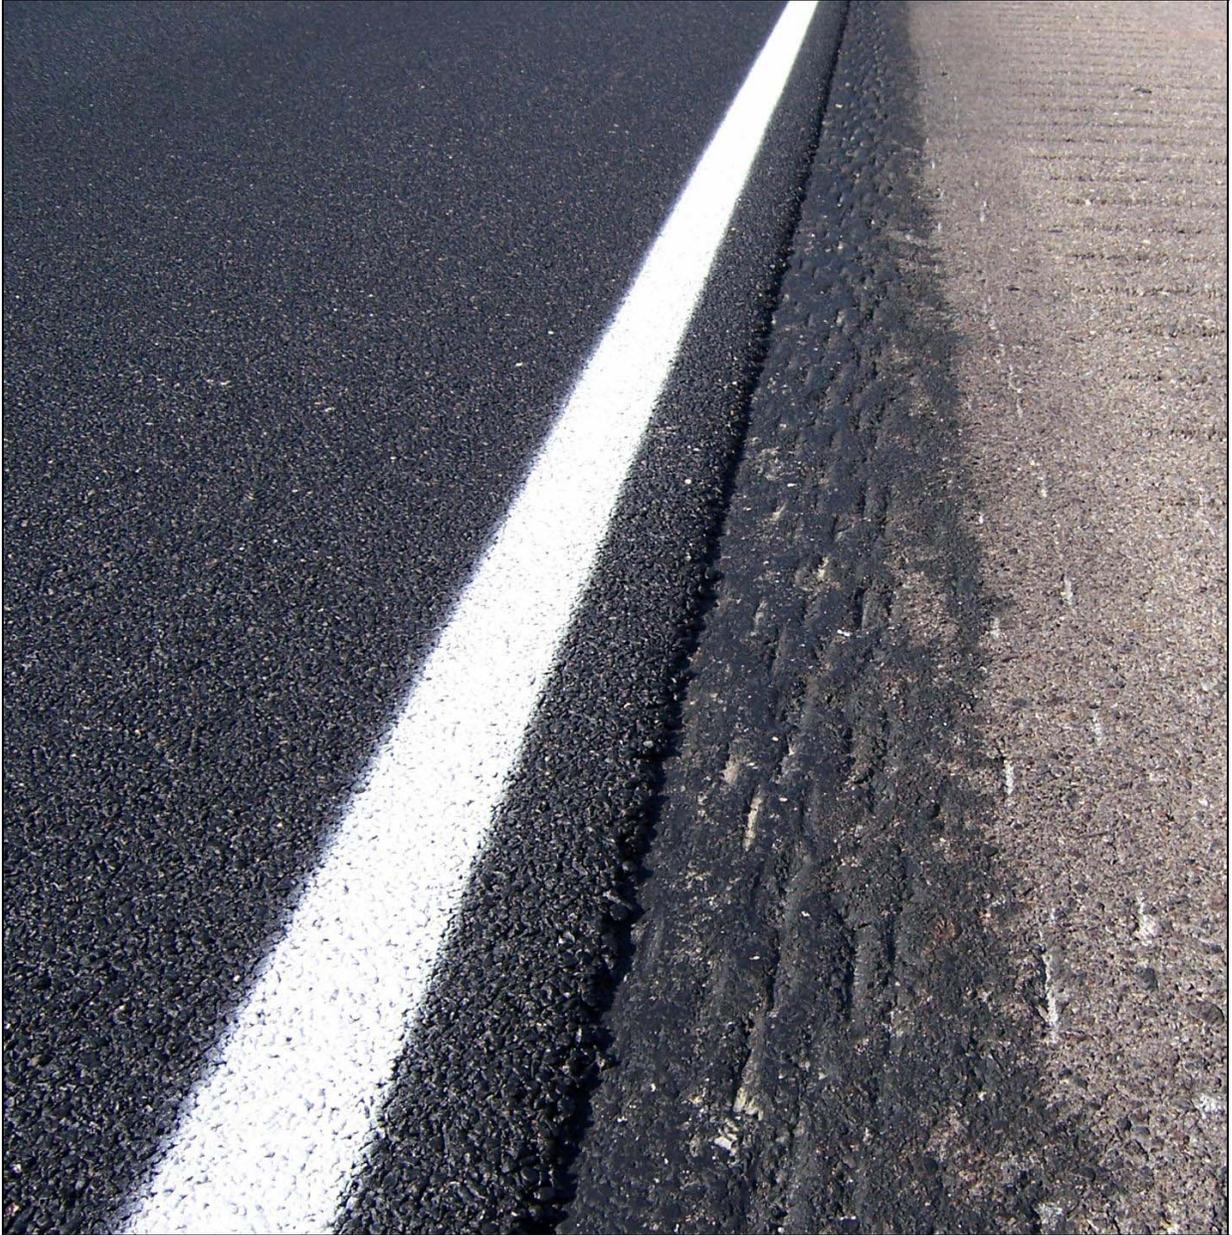
E.1.5 EDGE OF 5/8" THICK OPEN GRADE WEARING COARSE AT SHOULDER

Based upon on-site observations, it would appear that the newly rehabilitated AC pavement is structurally sound and reasonably smooth. However, it is the opinion of the CLIN 1 Team that in terms of weigh sensor longevity there is some risk in installing a sensor in a 5/8 inch Open Grade wearing course.

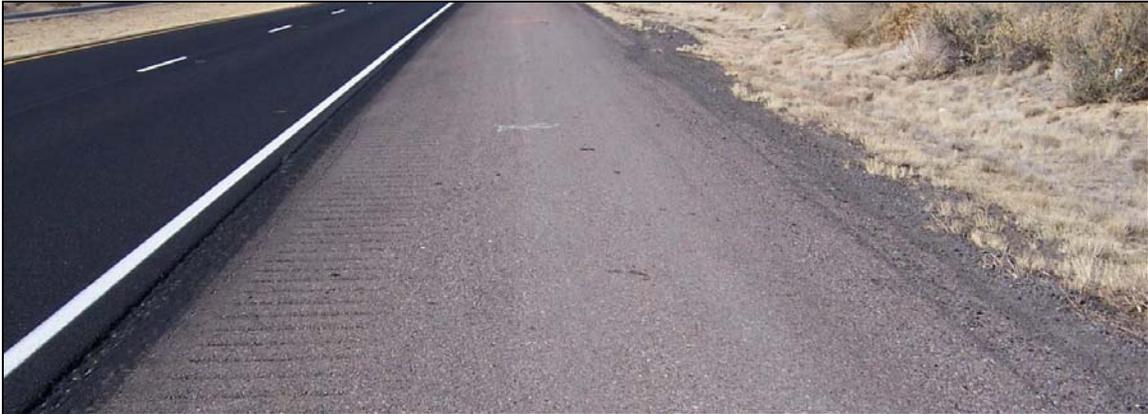
E.1.6 RIGHT SHOULDER, TYPICAL

Although the roadway’s AC shoulders throughout the study area were not included in the recent pavement rehabilitation, they appear to be in fair to good condition. The shoulders display only some minor longitudinal cracking.

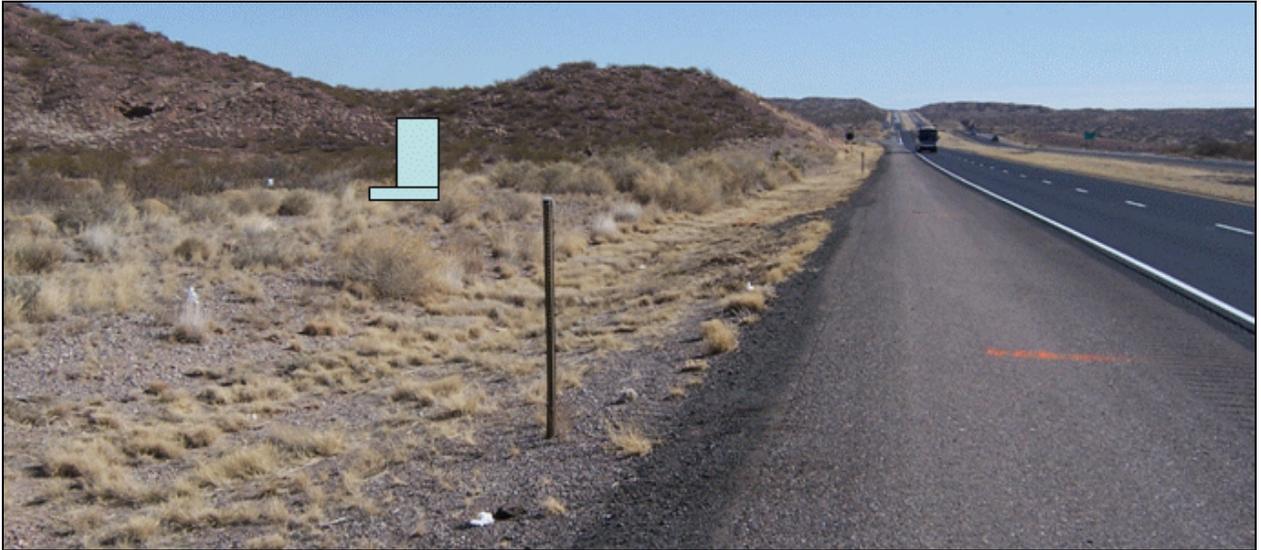
E.1.10 RECOMMENDED CABINET LOCATION

There is an adequate location for the WIM controller cabinet at the site adjacent to the roadway with over 40 feet clearance from the traveled way. There is good visibility of the sensors and approaching vehicles from the cabinet location. There is adequate room adjacent to the cabinet location for service facilities. Roadway and overall site drainage is good. There is no foreseen potential for ponding or flooding at the cabinet or pullbox locations. There is adequate topography for scale pit drainage. The width and structural stability of the adjacent lane and median shoulder allow a lane closure and traffic shift which will provide safe clearance in the work zone from live traffic during installation of the WIM system.

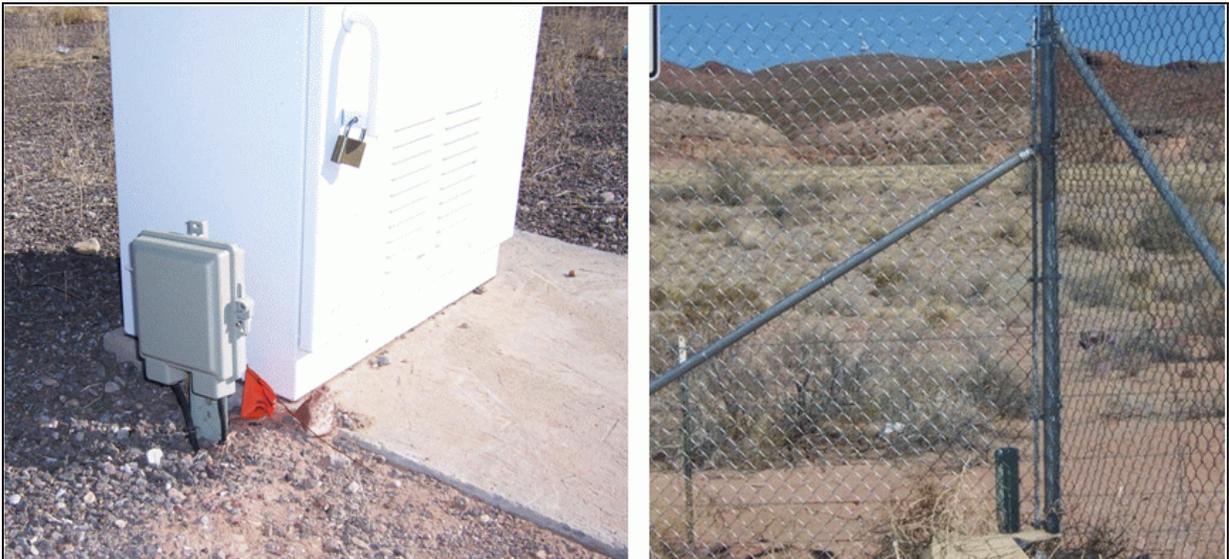
E.1.11 EXISTING TELEPHONE SERVICE AT EXISTING WIM CABINET AND R/W

Potential source(s) for telephone: Telephone service is available at the existing WIM cabinet (adjacent to SB lanes) which is located 685 feet from the proposed new WIM cabinet location (adjacent to NB lanes). A telephone service point was also found adjacent to the SB roadway's R/W fence. To extend service from either of these service points to the new WIM cabinet location would require a lengthy bore and trenching. The state rep advised he would discuss the feasibility of extending the service with the telephone service provider.
