Assessment Report for
New Mexico, SPS 1

Visit date: February 18 and 19, 2004

A visit was made to the New Mexico SPS-1 site on February 18 and 19, 2004 for the purpose of conducting an assessment of the WIM system located on Interstate 25, at milepost 36.245, approximately 0.8 miles north of the Rincon Interchange. The LTPP lane is in the northern direction and is identified as lane number 1 in the WIM controller. **This site is currently not a candidate for evaluation and calibration.**

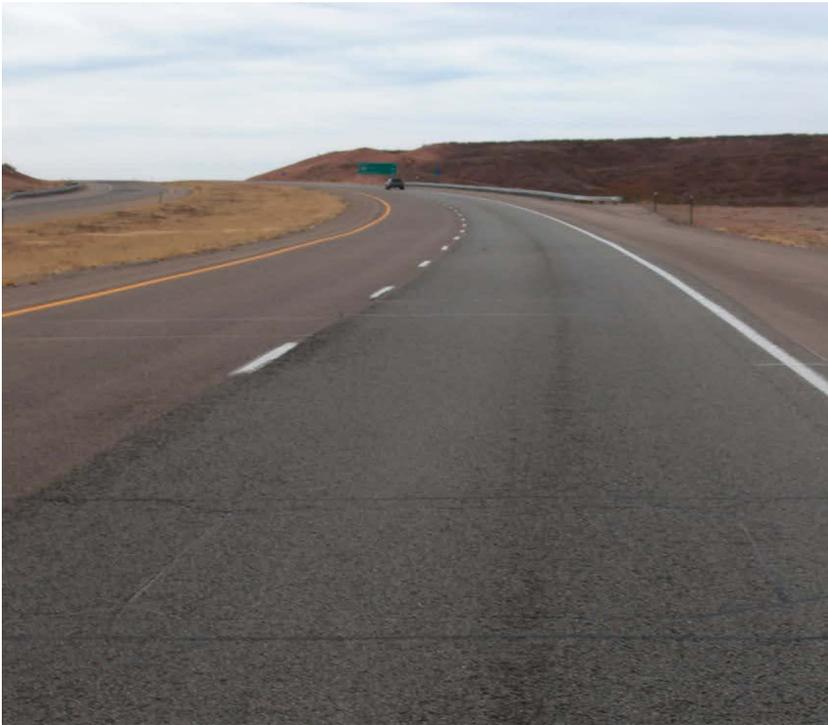
Figure 13-1 Pavement Condition of 350100 in Downstream Direction (Distress Photo 1)

A visual inspection of the pavement 425 feet in advance of the WIM area and 75 feet following the WIM area was conducted. No pavement distress that would affect the performance of the WIM scales was discovered.

Figure 13-1 and Figure 13-2 show the condition of the pavement in the downstream and upstream directions respectively. Figure 13-3 shows the abandoned WIM site.

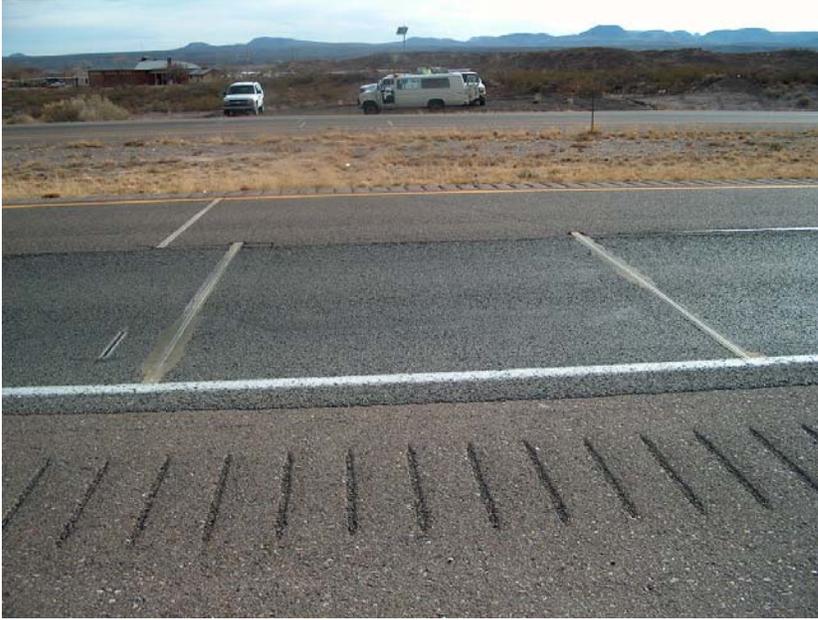
Figure 13-3 Abandoned WIM Sensor Locations at 350100

A visual inspection of the abandoned WIM installation noted cracking of the epoxy and pavement around the edge of the WIM sensors near the road centerline.

There is an abandoned WIM installation approximately 50 feet following the present location. This does not appear to influence truck dynamics as they pass over the present WIM scale location.

- b) The abandoned WIM sensor installations located 50 feet downstream sensors should be completely removed and the sensor channels filled in.
 - c) Rehabilitation to meet the smoothness criteria for the proposed sites based on profile data and a smoothness index evaluation.

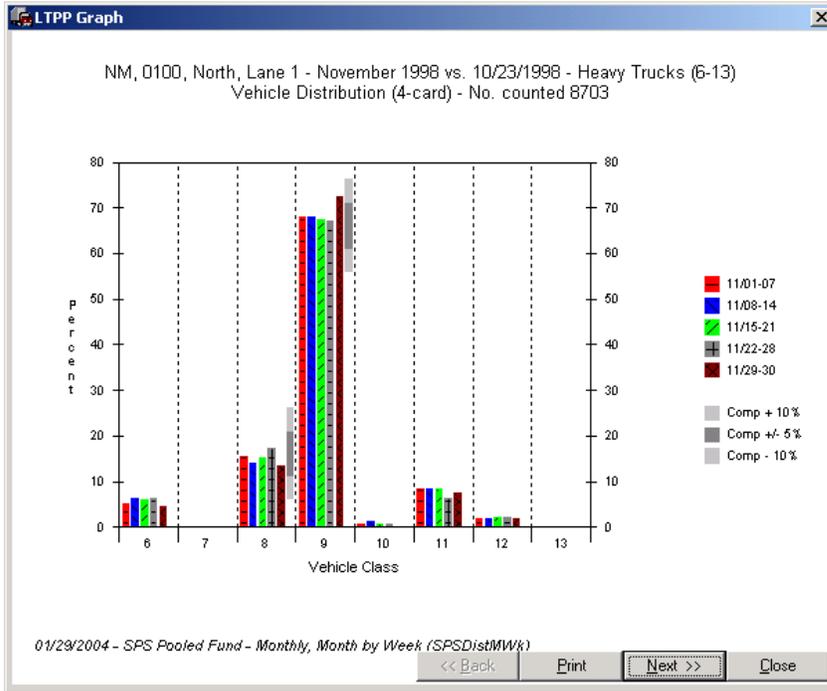
Figure 14-1 Heavy Truck Distribution Pattern for Classification Data in November 1998 for 350100

Figure 14-1 shows a by week pattern for heavy truck classification data. The individual weeks show essentially the same heavy truck mix. Every vehicle in Classes 6 through 13 that constitutes at least 10 percent of the population is expected to stay within plus or minus 5 percent of the value observed during the two weeks following validation. This range is shown by the darker band inside the lighter band to the right of the weekly data. Weeks that go outside more than plus or minus 10 percent of the expected value will fall above or below the light gray areas of the band. These are weeks that should have been subjected to additional scrutiny prior to accepting the data as reasonable.

For this site, the fleet mix is essentially the same during November 1998. A typical graph for this period is shown in Figure 14-1 there was no significant difference in the mix graphed for the weight data as shown in Figure 14-2. However, there was a significant increase in Class 8s in 2002 as compared to 1998 as seen in Figure 14-3 for classification data. At the same time the number of Class 6s and Class 11s became negligible. The reason for this change is unknown.

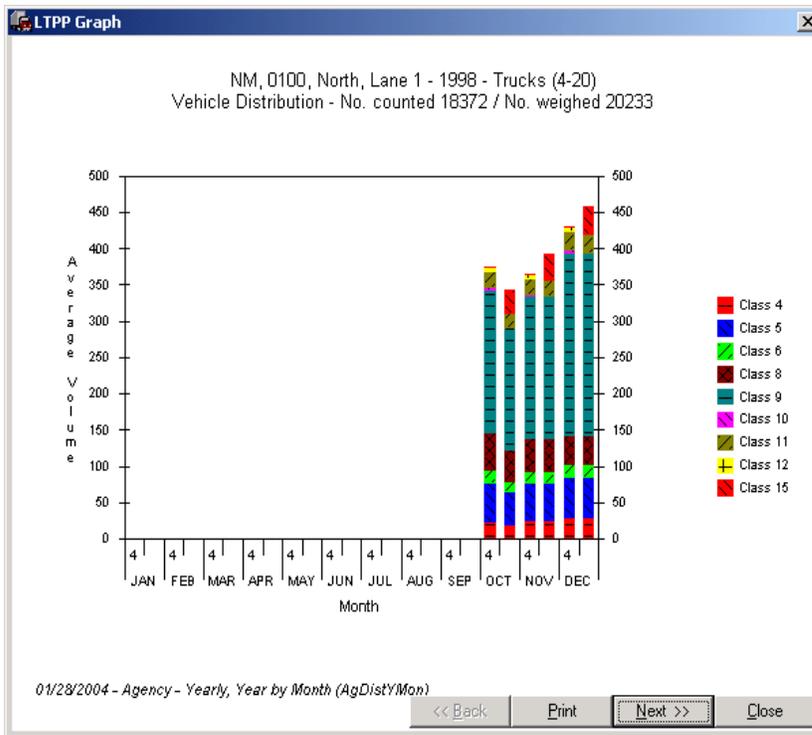
Figure 14-4 Vehicle Distribution by Month for the Year 1998 for 350100

Figure 14-4 shows a pattern for vehicle distribution by month by year for the data collected from the classifier versus the data collected by the WIM equipment. As seen from the graph there is limited data from which to draw conclusions. However, from the available data it appears that the data collected by the classifier and the WIM equipment are generally similar. The data comparison in 2001 cannot be done since in the month the data was collected by the WIM equipment the classifier did not collect any data. There is no WIM equipment data for 2000 and 2002 for the LTPP lane.

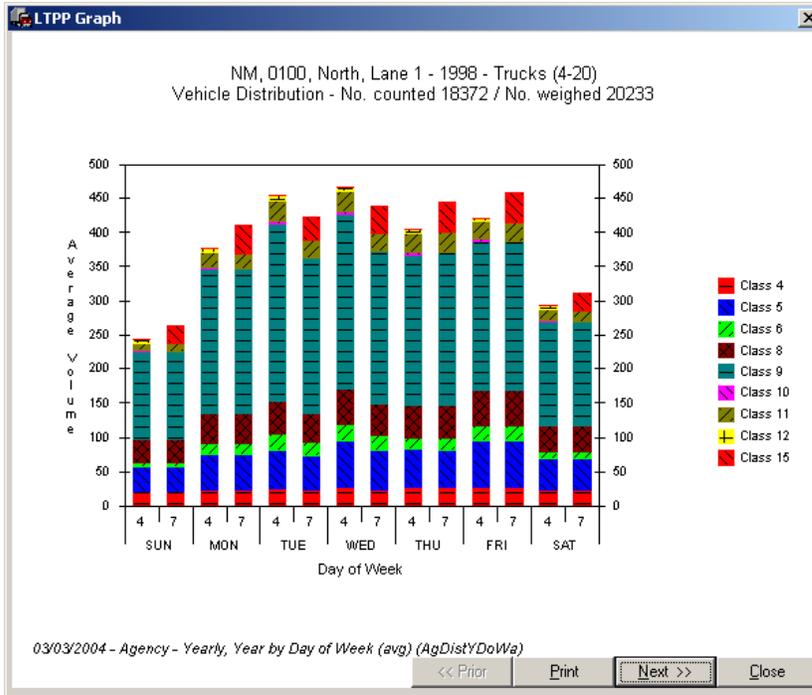
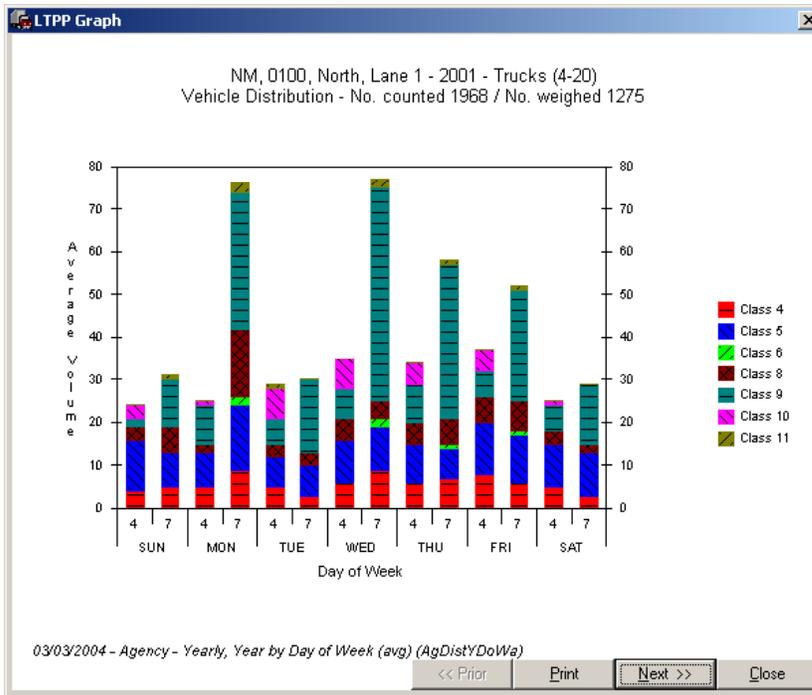
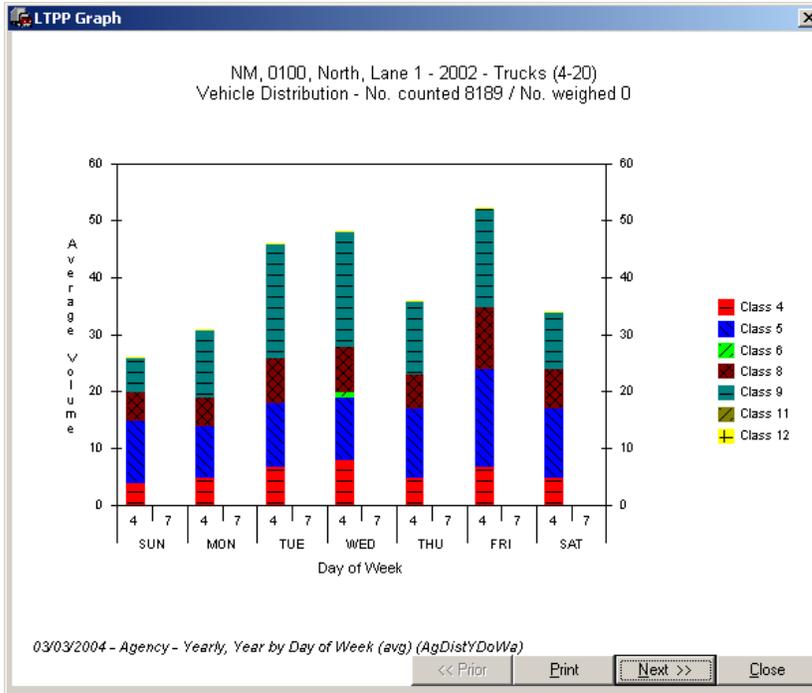
To illustrate the reason that review of volumes is suggested Figure 14-5 through Figure 14-7 have been included. They show the large drop in volumes and the variation in the mix between data sources.

Based on this review it is recommended that further investigation be done to determine the reason for the drastic shift in the percentage of Class 9 vehicles between 1998 and

2000. The change in percentage is also reflected in the change in the average number of Class 9 vehicles weighed between 1998 and 2001. One or both sets of data may need to be omitted from further use in the traffic database depending on the findings of that investigation. It may be, however, that one set of data is site-related and the other is site-specific. In that case a determination will have to be made on whether the site-related data should be retained or replaced with Traffic Data Sheet 10 estimates.

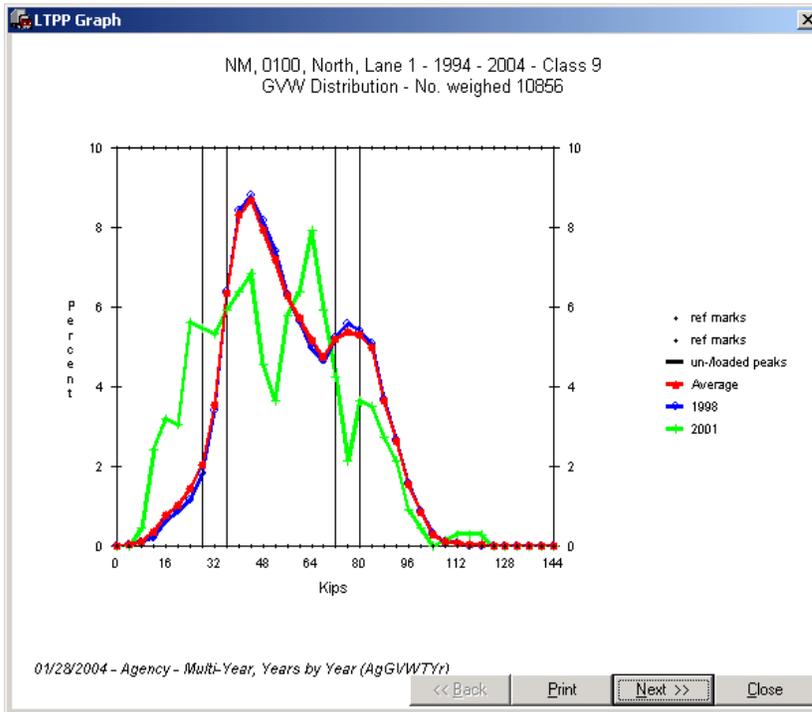
Figure 14-8 Class 9 GVW Distribution - 1998 and 2001 for 350100

The overall assessment of loading patterns is done using a Class 9 GVW graph by year over the available years. In Figure 14-8 the unloaded peak shifted away from the range in 1998 whereas the loaded peak was within the range. However, in 2001 the data did not show the same trend as in 1998. The peaks were not in the typical locations for this vehicle class.

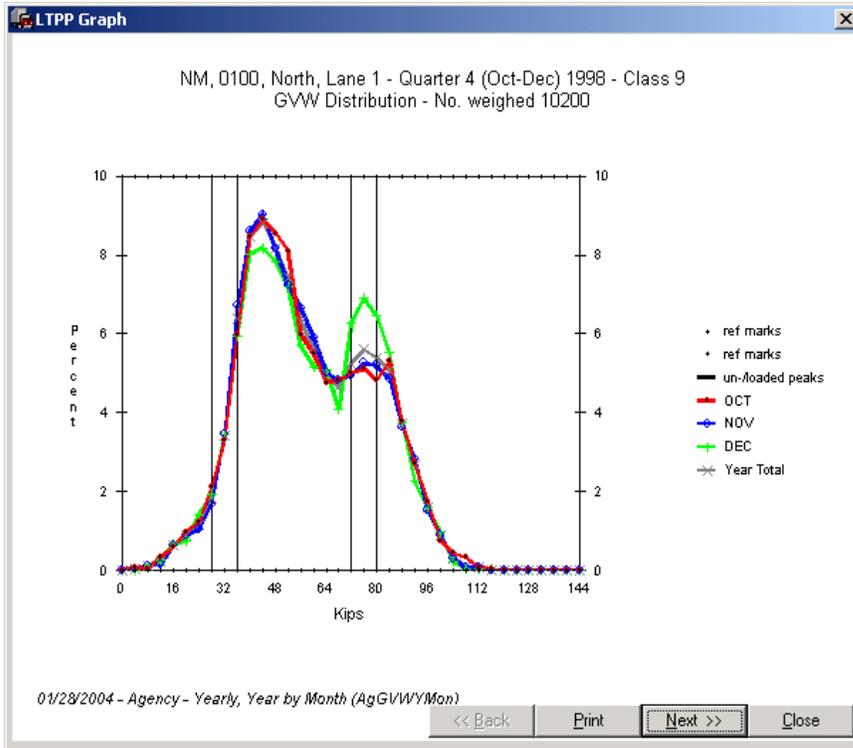
Figure 14-9 Class 9 GVW Distribution - Oct 1998 to Dec 1998 for 350100

To investigate any seasonal variations the Class 9 GVW distributions are graphed by month by year. As shown in Figure 14-9 in October and November the trend was similar whereas in December the peak unloaded percentage was slightly less and the peak loaded percentage was significantly higher compared to the two months. The reason for this variation is unknown at present.

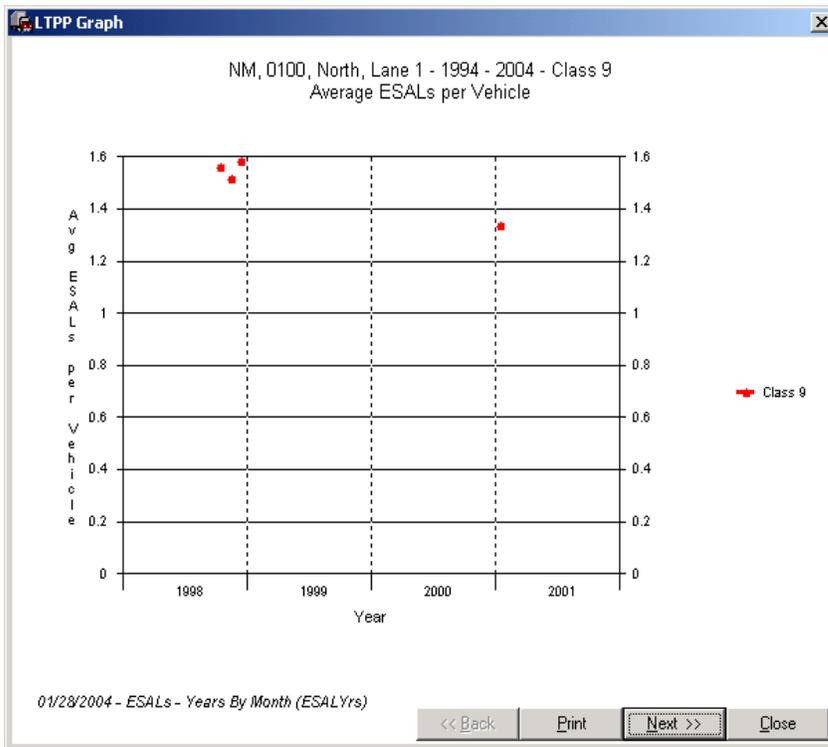
Figure 14-10 Average Class 9 ESALs for 1998 and 2001 for 350100

Average ESALs for Class 9 vehicles are a very crude method of identifying loading shifts. Figure 14-10 shows the average Class 9 ESALs per month for this location. To remove the influence of changing pavement structure all ESAL values have been computed with and SN = 5 and a p_t of 2.5. Average ESALs per Class 9 are not used as an indicator of research quality data. As seen from the graph there is not sufficient data to suggest any conclusions.

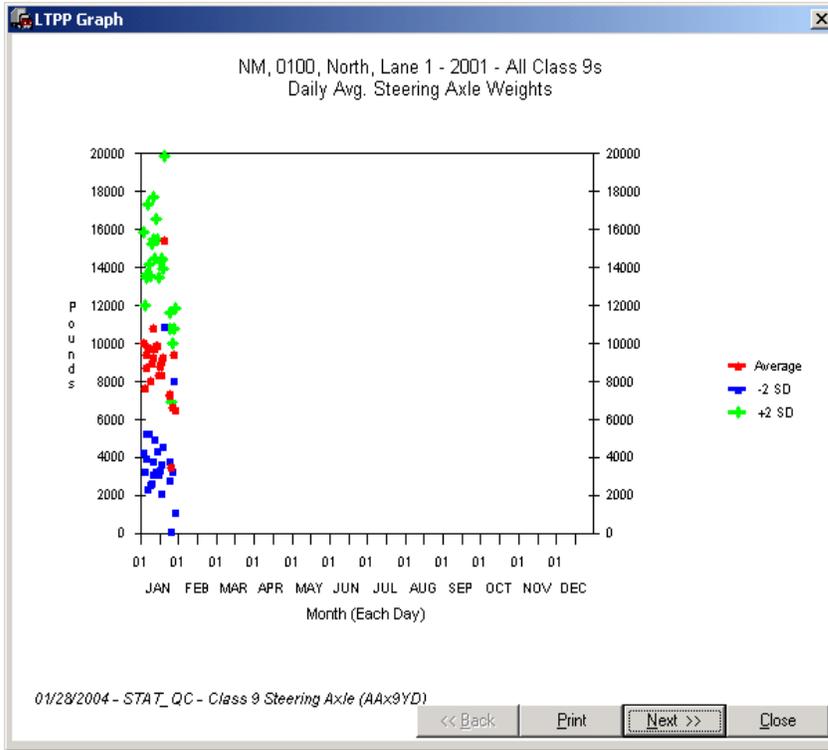
Figure 14-11 Average Daily Class 9 Steering Axle Weight - 2001 for 350100

A frequently used statistic for checking scale calibration and doing auto-calibration of WIM equipment is the weight of the front axle. This value is site specific and should be relatively constant particularly for loaded Class 9s (vehicles in excess of 60,000 lbs.). Typically when auto calibration is used this value either cycles repeatedly or with very large truck volumes results in an essentially straight line for the mean. As shown in Figure 14-11 there is not sufficient data to provide any conclusions.

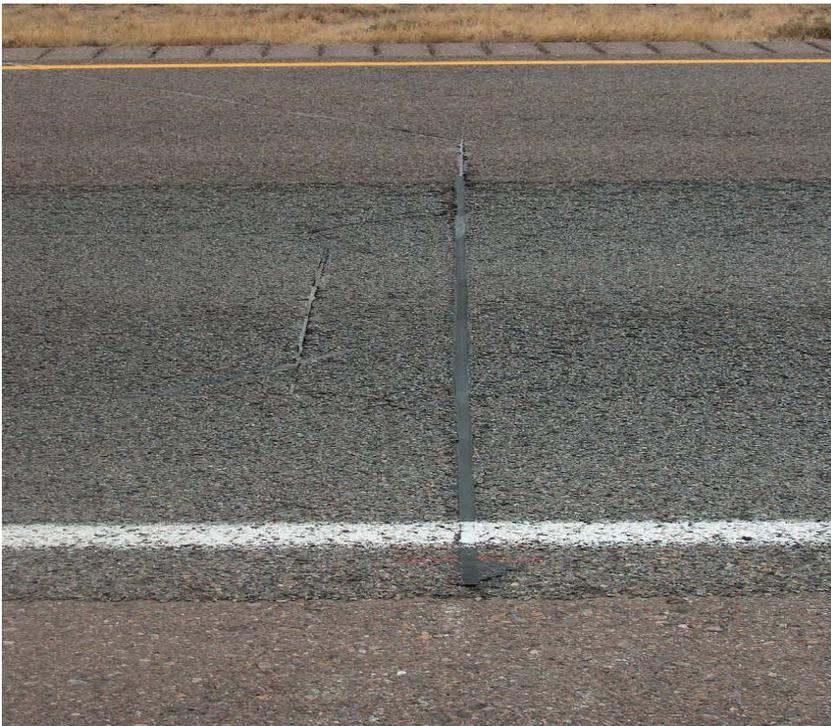
Trailing_Sensor_TO_4_35_21A_0100_02_18_04.JPG

An electronic check of all WIM components was performed. The trailing sensor measured no output signal. All other in-road sensors and the WIM controller are working properly.

The trailing piezo weighing sensor is providing no output signal to the controller. At a minimum, this sensor will need to be replaced to return the WIM system to a fully functional condition. Since piezo sensors function as a matched set, the leading sensor should be replaced in conjunction with the trailing sensor.
