LTPP SPS PHASE II

WEIGH-IN-MOTION SITE ACCEPTABILITY ASSESSMENT REPORT

NEW MEXICO SPS-5
LTPP ID 350500
JANUARY 21, 2008
CLIN 2001 TASK ORDER 15

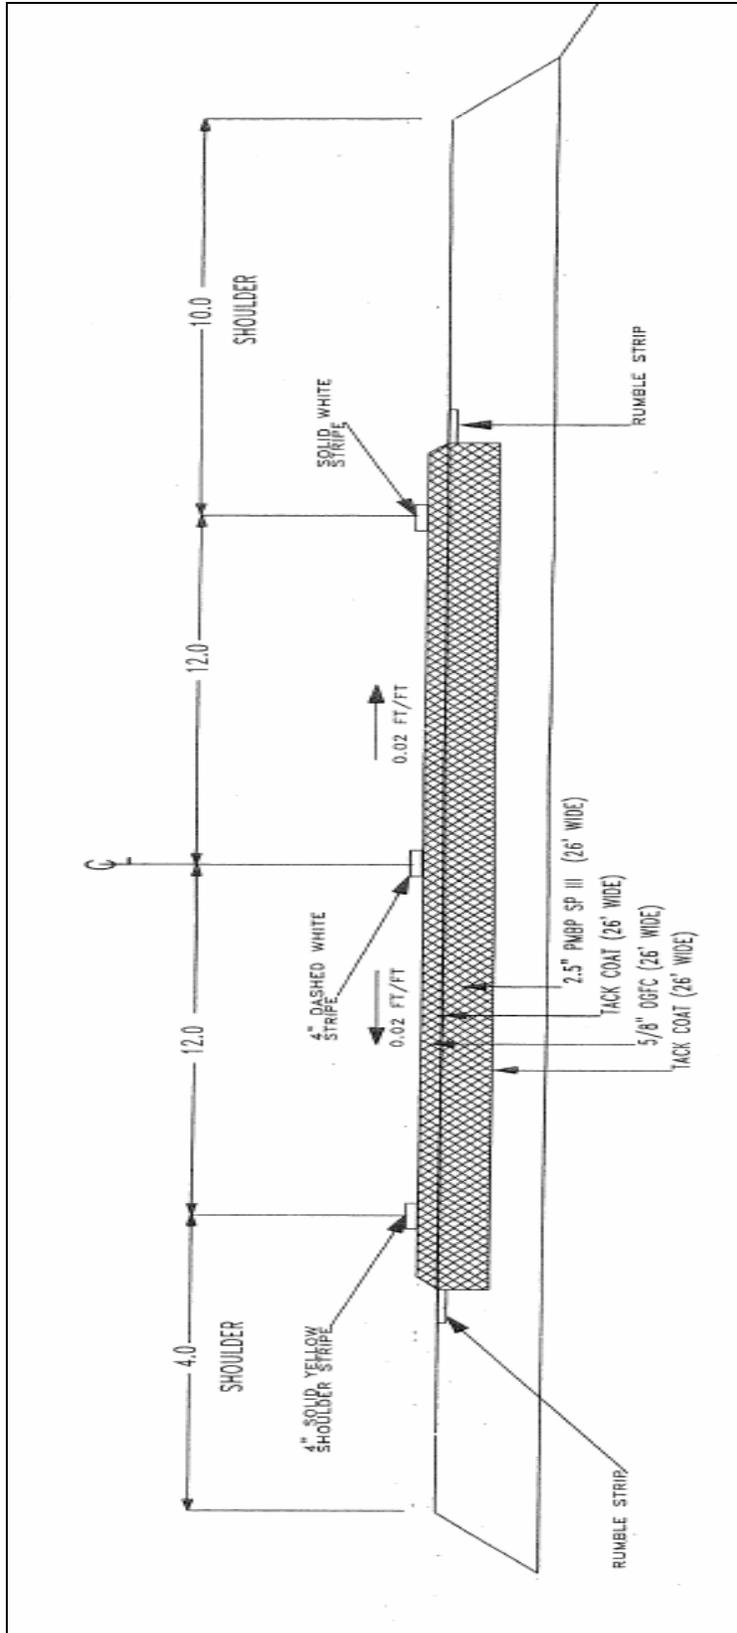
Figure 1: AC Rehabilitation Structural Section

The SPS-5 is a study on the rehabilitation of flexible pavements. The existing I-10 roadway at the study location consists of 4 lanes, 2 eastbound and 2 westbound. The pavement test sections are located in the outside eastbound lane. The travelled way AC pavement approaching, through, and departing the selected location for the new WIM system as well as through the pavement test sections was recently rehabilitated by the state. This pavement consists of a 5/8 inch OGFC wearing course over +/- 8 inches of new and old PMBP coarses. The state provided the plan for the new sections which is displayed in Figure 1.

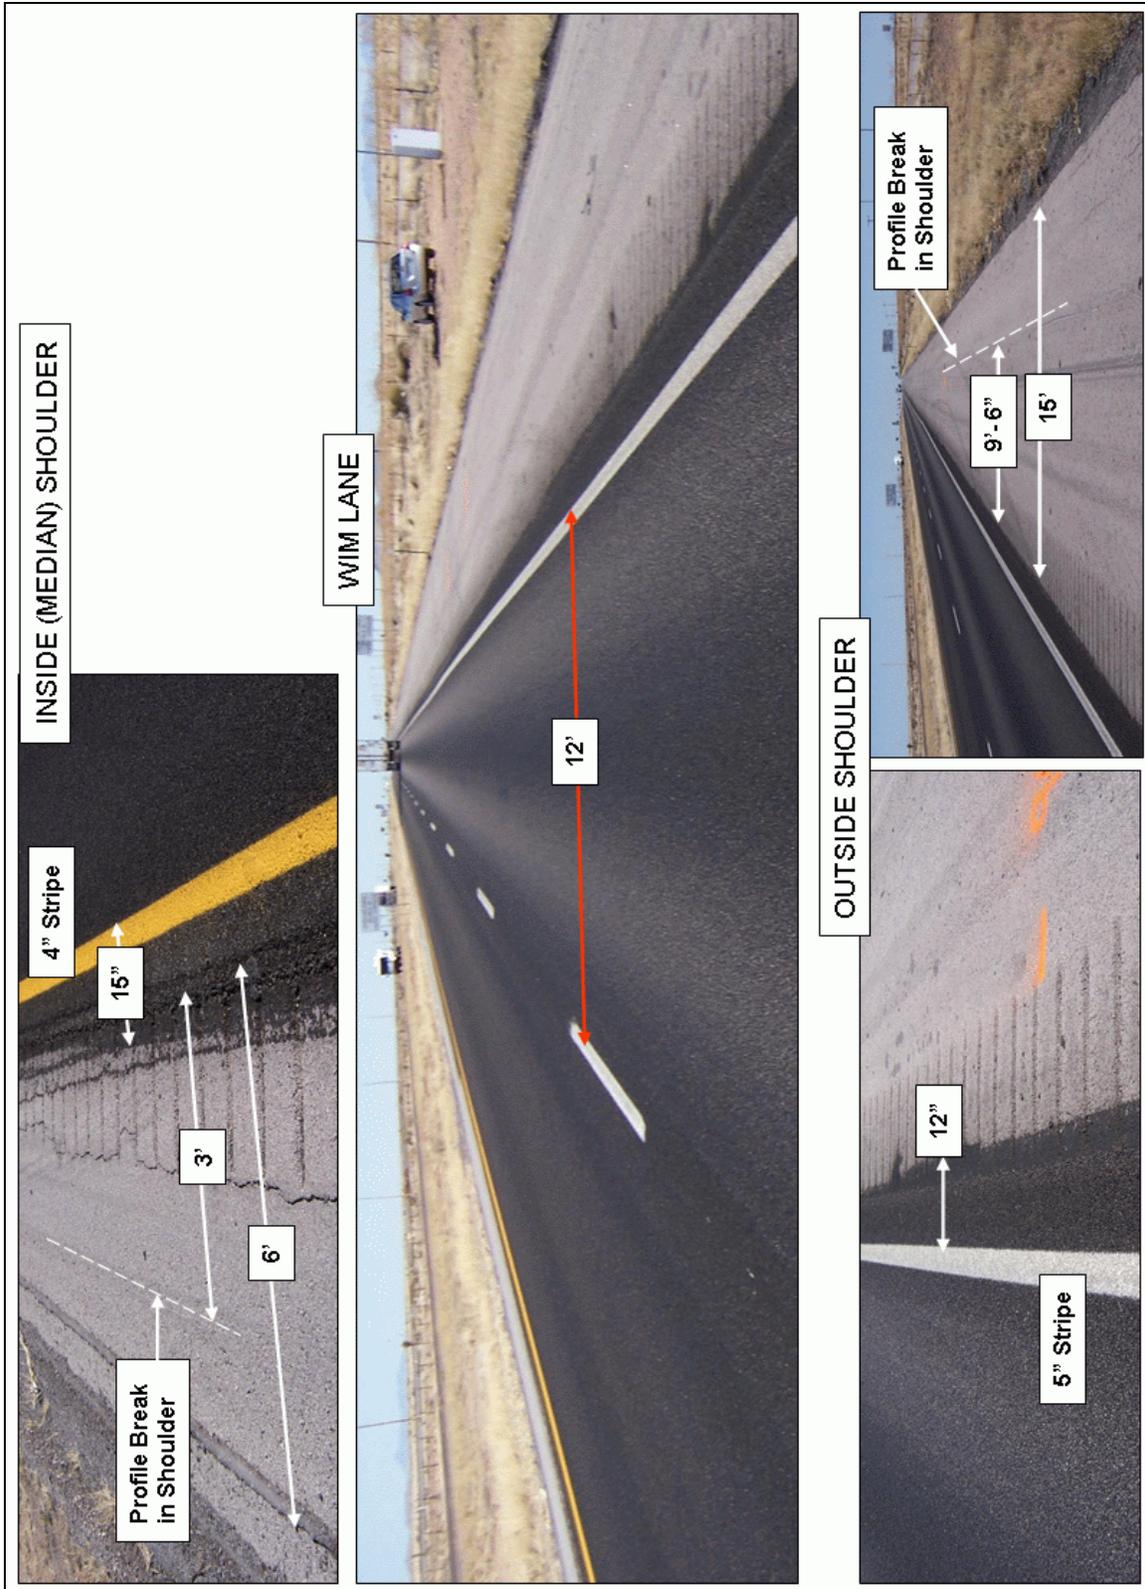
Figure 2: Pavement Measurements Taken at WIM Sensor Location

The outside and inside (median) shoulders are dense grade AC and were not included in the pavement rehabilitation project. The two eastbound lanes are each 12 feet wide. Although the state furnished plan displays the outside shoulder width at 10 feet and the inside (median) shoulder width at 4 feet, actual measurements taken at the new WIM location varied from these. The actual measurements are displayed in Figure 2.

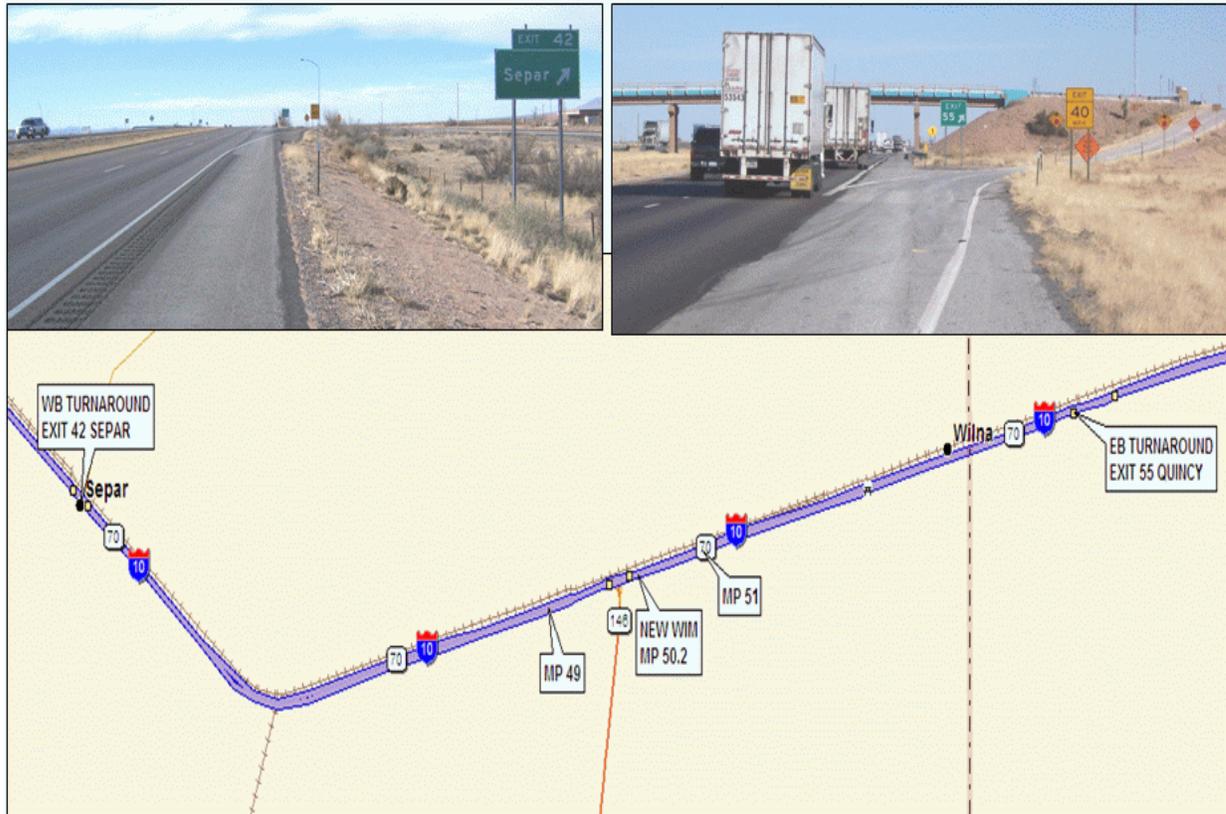
Figure 3: Truck Circuit Map

The nearest usable eastbound truck turnaround is I-10 Exit 55, which is located 5.6 miles downstream of the WIM site.

The nearest useable westbound truck turnaround is I-10 Exit 42, which is located 7.6 miles upstream of the WIM site.

The test truck round trip circuit route is 27 miles. There are no foreseen potential restrictions and the turnaround locations are easily accessed and maneuvered. The estimated lap time is 25 minutes. It is noted that the state offered to consider providing traffic control safety services if a suitable median crossover location could be found for the test trucks, but no such crossover could be located.

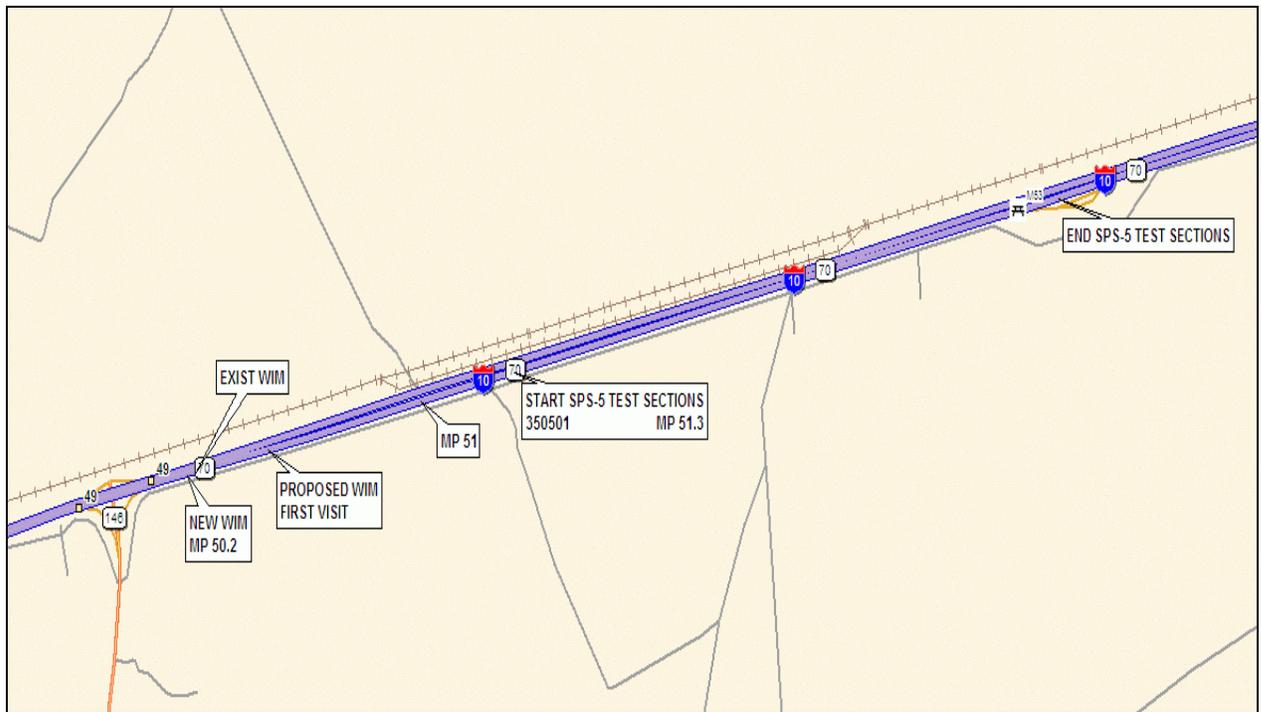
Figure 5: Map of the I-10 WIM Site at Milepost 50.2

The LTPP SPS-5 test sections are located approximately 85 miles west of Las Cruces in the eastbound outside lane of Interstate 10 between Exit No.'s 49 and 55.

The location selected for the proposed WIM system installation is the eastbound outside lane at milepost 50.2 which is 1.1 miles in advance of the first test section (350501) and 140 feet in advance of the state's existing WIM scale location. The proposed WIM controller cabinet can be located near the Right-of-Way fence approximately 48 feet from the edge of traveled way.

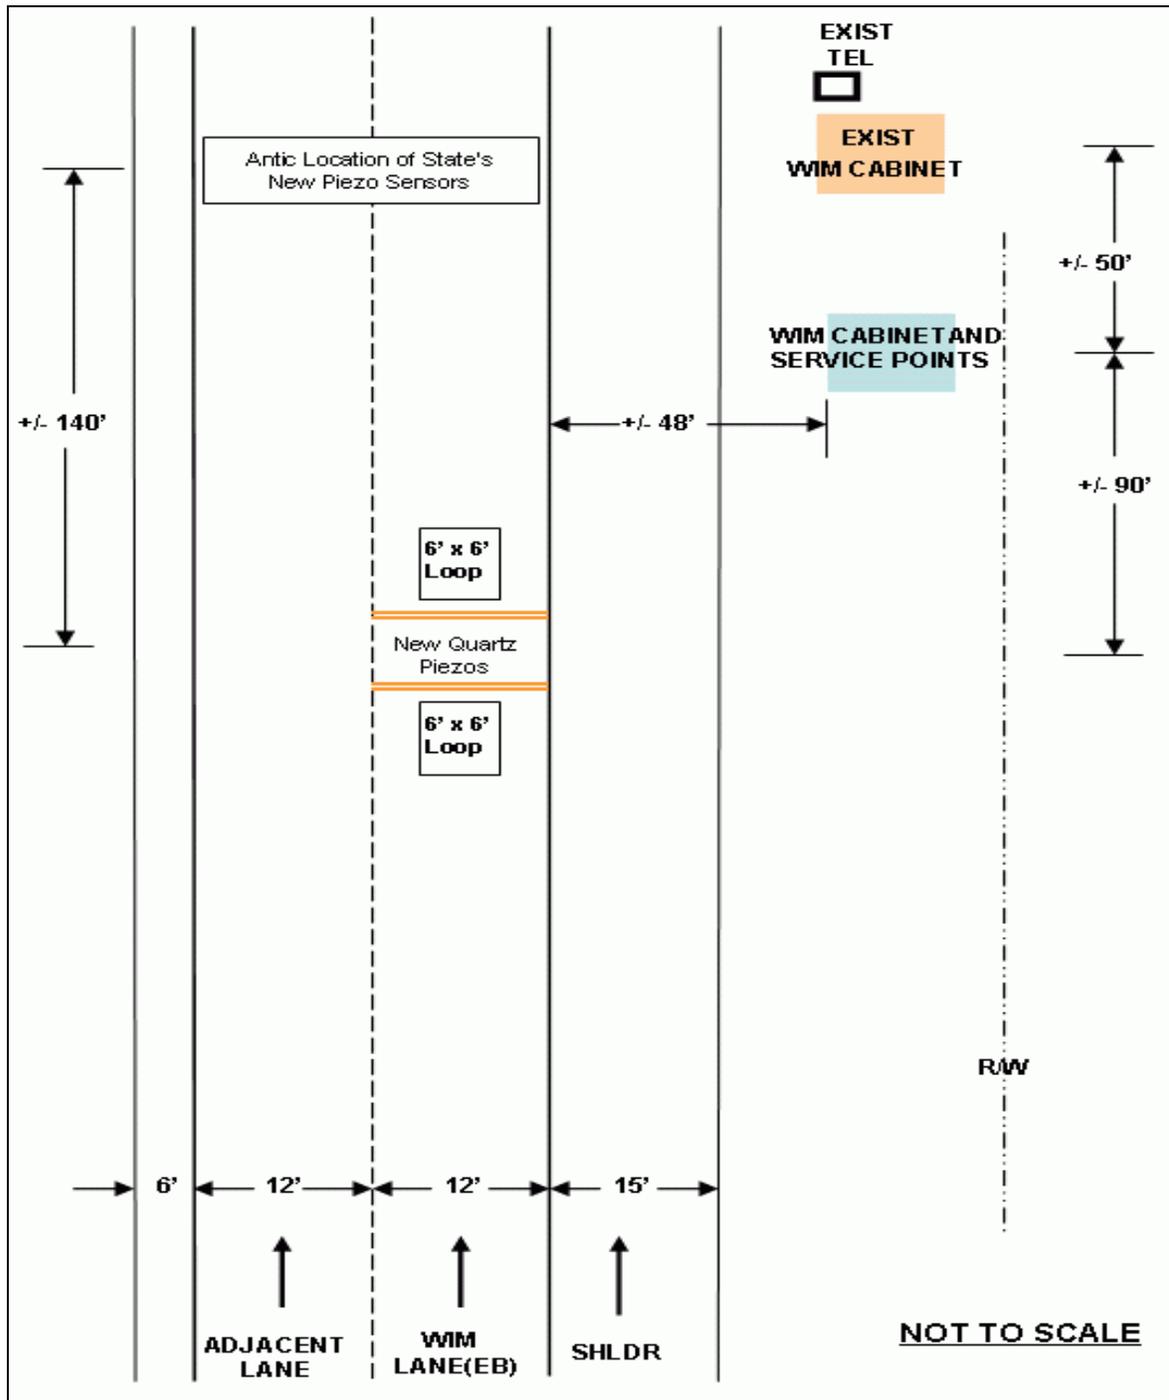
Figure 6: Proposed WIM Site Layout

The centerline of the double threshold quartz piezo sensors should be installed approximately 140 feet upstream of the state's existing WIM cabinet (at the time of the site assessment, the state had not yet re-installed the WIM's in-road sensors). This location has been marked with a "WIM" in orange paint on the outside shoulder.

GPS Coordinates for Scales: N32° 11.595', W108° 18.093'

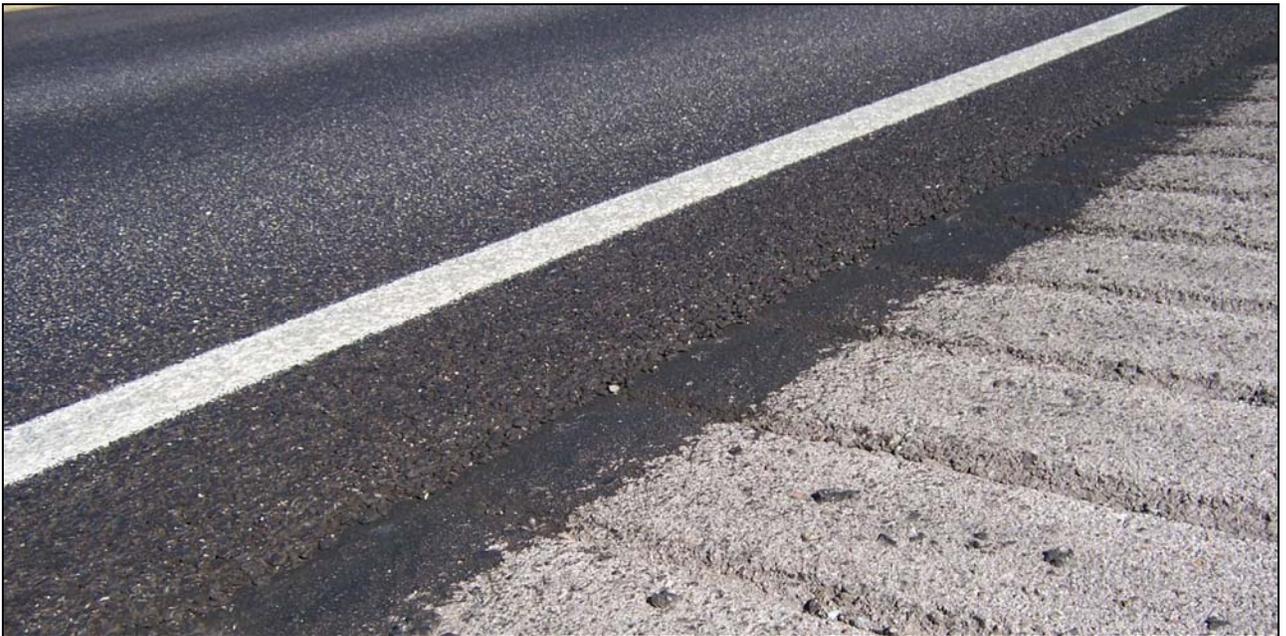
E.1.6 OG WEARING COURSE EDGE AT SHOULDER

Striping: EB outside lane: 5" solid white stripe delineates 12' lane. The OG wearing course extends 12" beyond the outer edge of the stripe. The 15' shldr has a profile grade break at 9'-6" from the edge of the OG course. EB inside lane: 4" solid yellow stripe delineates 12'-8" lane. The OG wearing course extends 11" beyond the outer edge of the stripe. The 6' shoulder has a profile break at 3' from the edge of the OG course.

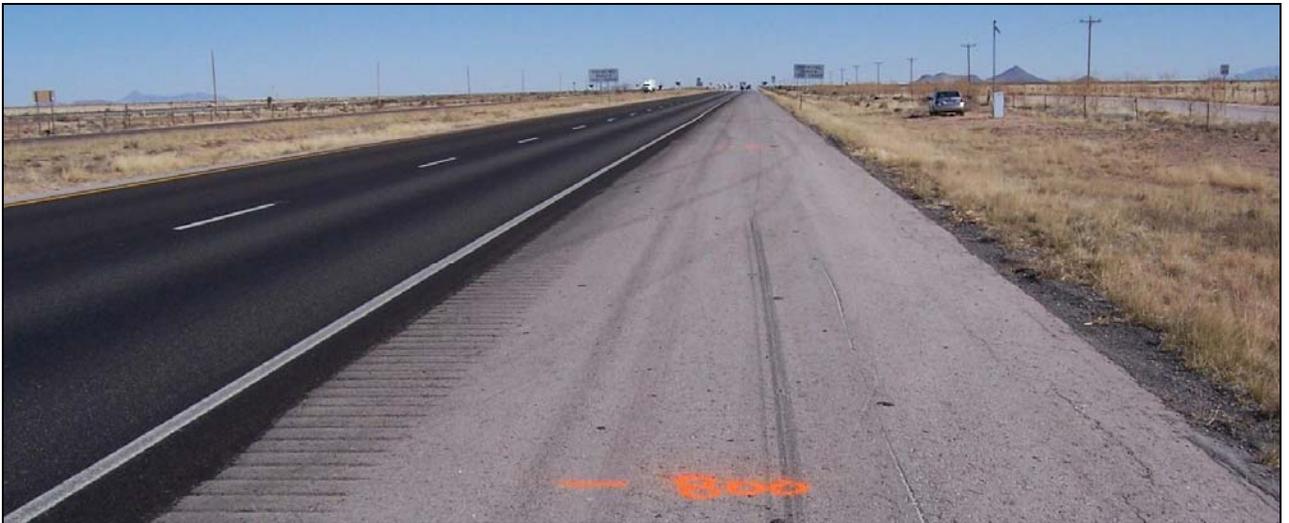
E.1.8 DOWNSTREAM VIEW OF SHOULDER 100' IN ADVANCE OF WIM SCALE LOCATION

Although the roadway’s AC shoulders throughout the study area were not included in the recent pavement rehabilitation, they appear to be in fair to good condition. The outside shoulder displays only some minor longitudinal cracking along its extreme right edge. The inside shoulder does display some significant longitudinal cracking immediately adjacent to the rumble strip, but should not prevent moving the left wheels of traffic onto the shoulder to facilitate closure of the WIM lane during installation.

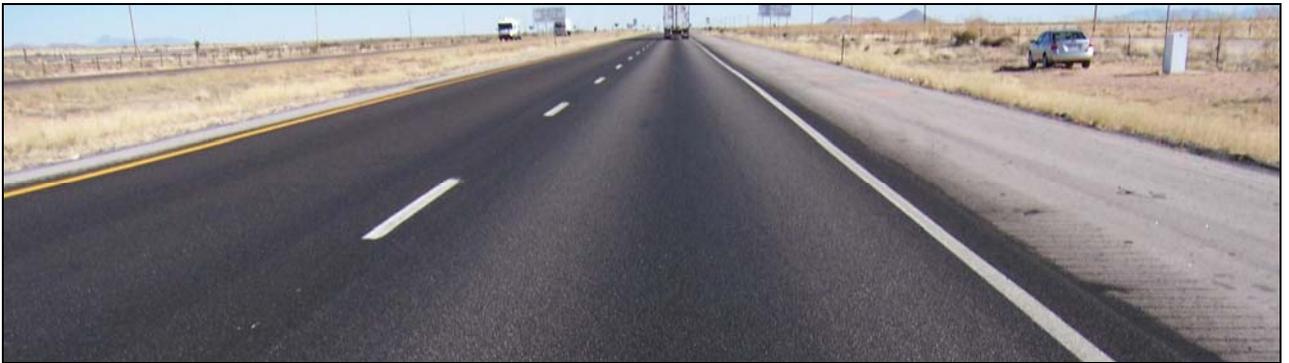
E.1.10 DOWNSTREAM PAVEMENT AT RECOMMENDED SCALE LOCATION

The traveled way AC pavement was rehabilitated in 2007. The structural condition of the AC pavement appears to be excellent. There is no evidence of cracking, rutting, or raveling in the wearing course.

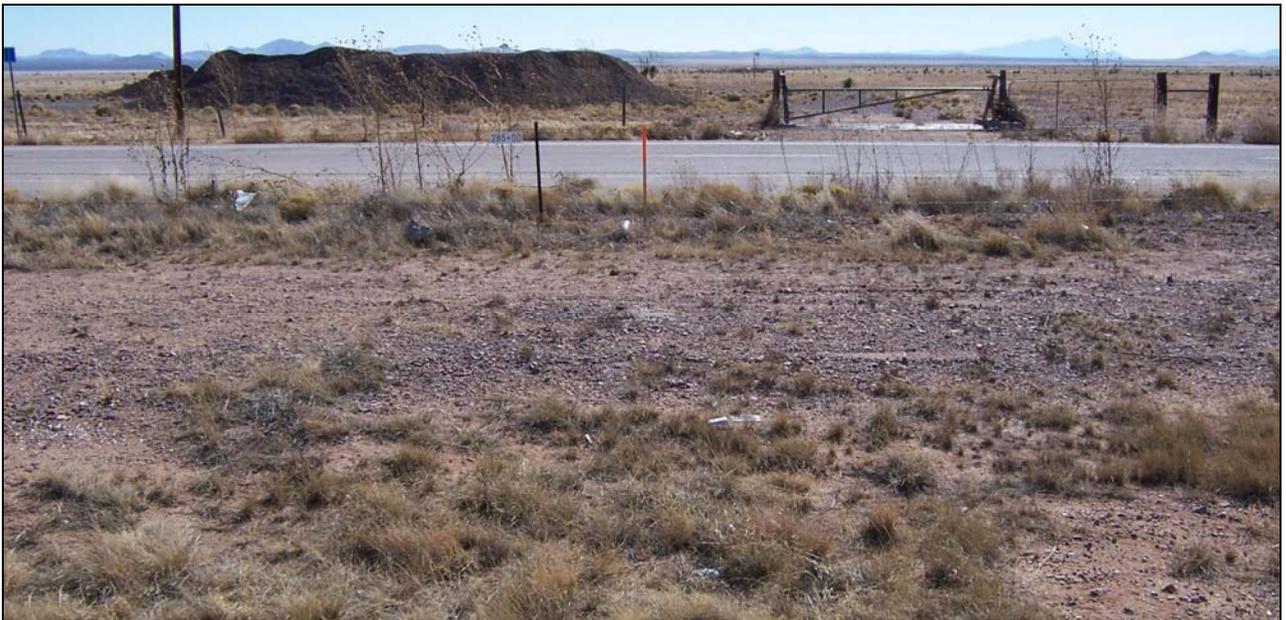
E.1.13 RECOMMENDED CABINET LOCATION

There is an adequate location for the WIM controller cabinet at the site near the highway right-of-way fence. This location, in line with the state's existing WIM cabinet, would provide +/- 48 feet clearance from the traveled way. There is good visibility of the sensors and approaching vehicles from the cabinet location. There is adequate room adjacent to the cabinet location for service facilities. Roadway and overall site drainage is good. There is no foreseen potential for ponding or flooding at the cabinet or pullbox locations. There is adequate topography for scale pit drainage. The width and structural stability of the adjacent lane and median shoulder allow a lane closure and traffic shift which will provide safe clearance in the work zone from live traffic during installation of the WIM system.

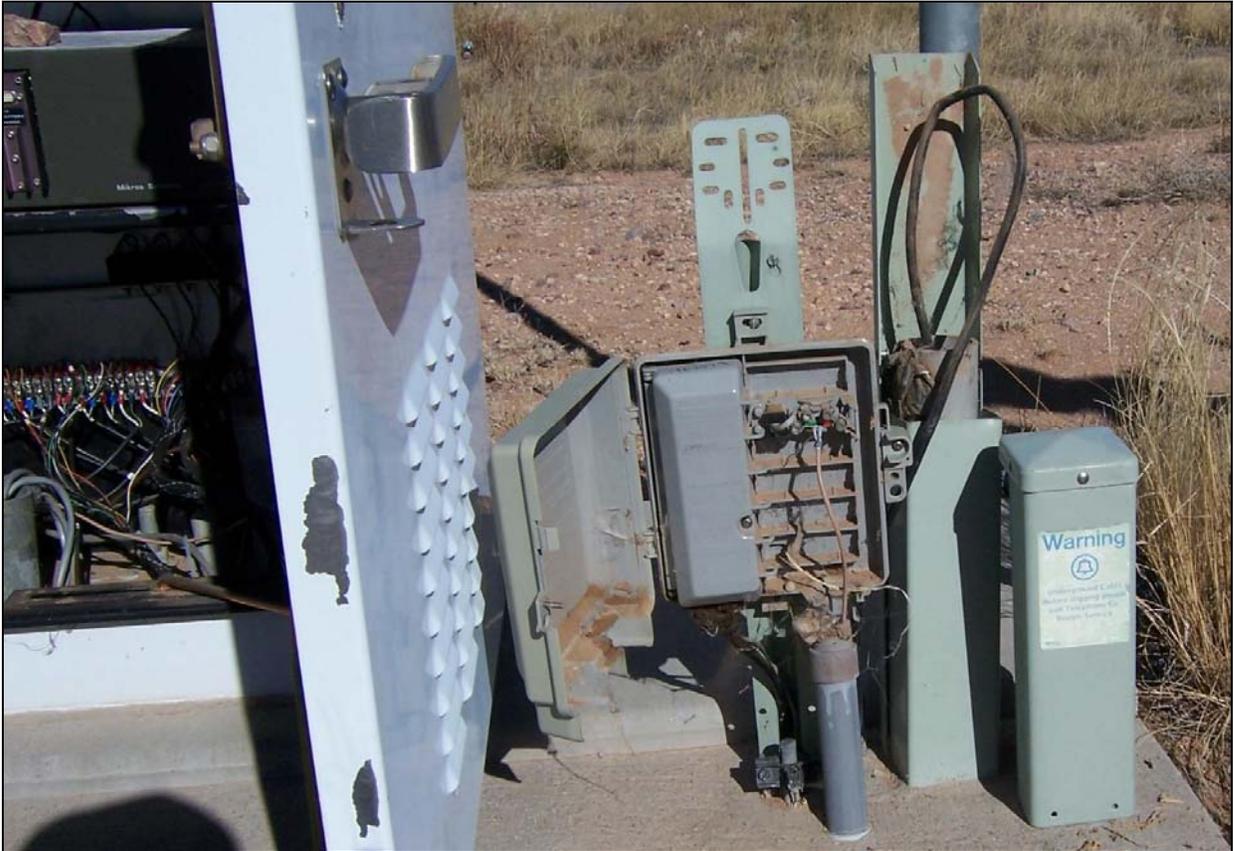
E.1.15 EXISTING TELEPHONE SERVICE AT EXISTING WIM CABINET

is to utilize solar power whenever possible. Wired telephone service is available at the state's existing WIM cabinet and can be extended to the location selected for the LTPP WIM system cabinet.
