Assessment Report for
New Mexico, SPS 5

Visit date: February 18, 2004

A visit was made to the New Mexico SPS-5 site on February 17th and 18th, 2004 for the purpose of conducting an assessment of the WIM system located on Interstate 10, at milepost 50.214, approximately 2 miles west of the Grant/Luna County Line. **This site is not recommended for evaluation/calibration.**

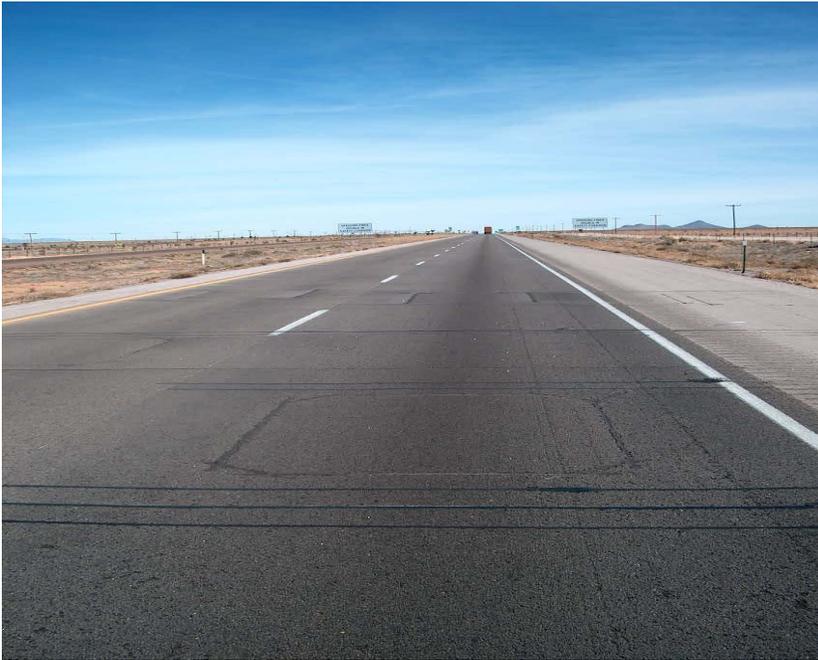
Figure 13-1 Pavement Condition of 350500 in downstream direction (Distress Photo 1)

A visual inspection of the pavement 425 feet in advance of the WIM area and 75 feet following the WIM area was conducted. No pavement distress that would affect the performance of the WIM scales was discovered.

Figure 13-1 shows the condition of the pavement in downstream direction, Figure 13-2 shows the condition of the pavement in the upstream direction. Figure 13-3 shows the abandoned WIM sensors.

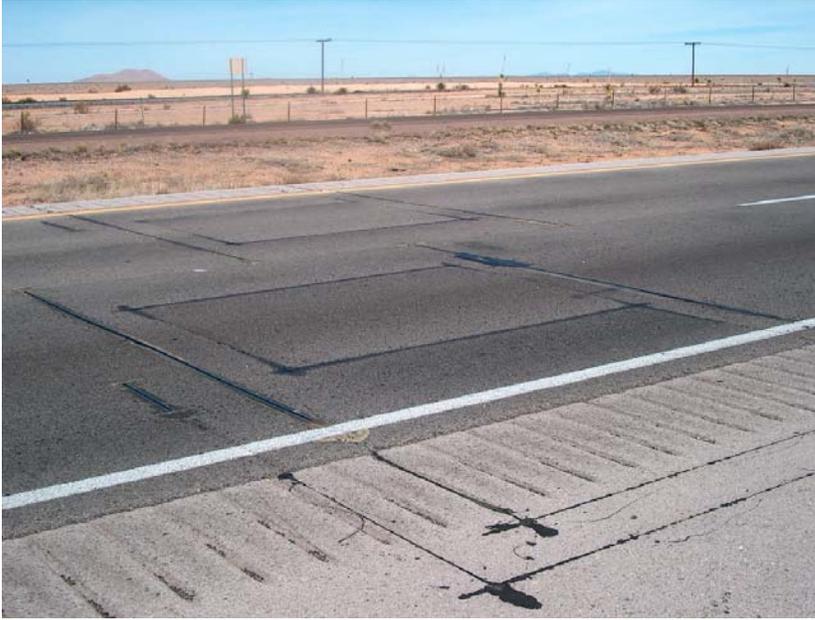
Figure 13-3 Abandoned WIM Sensors at 350500

There are several abandoned WIM sensor installations within the present WIM installation as well as an abandoned WIM site approximately 27 feet after the present WIM installation. None of these sensors or installations appears to be adversely affecting the trucks dynamics as they pass over the WIM scale area.

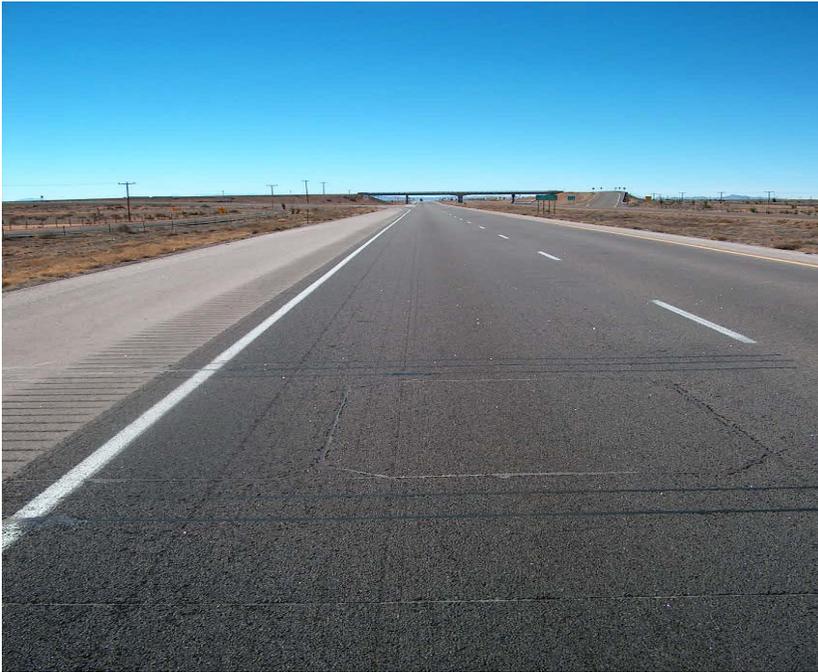
Upstream_TO_4_35_22A_0500_02_17_04.JPG (Distress Photo 2)

Figure 13-2 Pavement Condition of 350500 in upstream direction (Distress Photo 2)

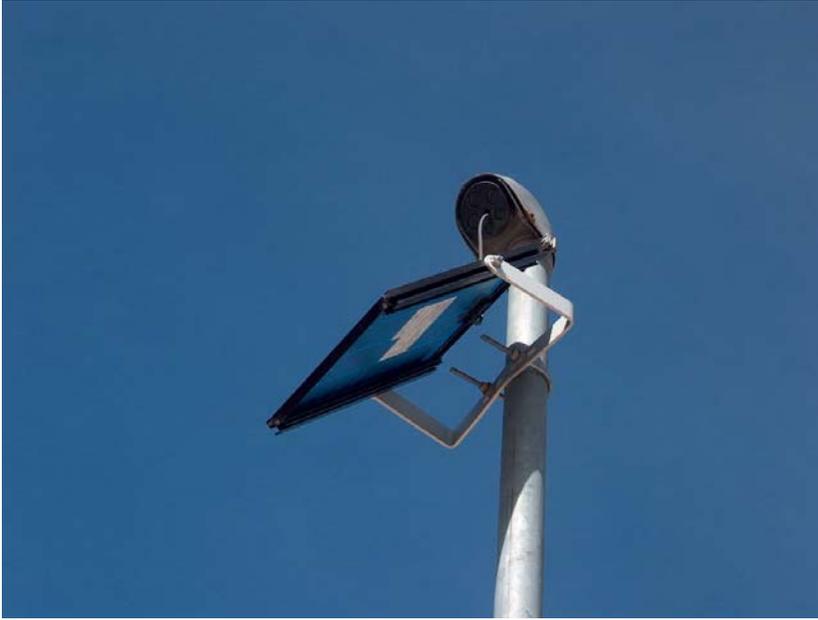
Solar_Panel_Mast_TO_4_35_22A_0500_02_17_04.JPG

During a visual inspection of all system components, including in-road sensors, cabinet, pull boxes, service mast, solar panels and conduit as well as the telephone service components, it was discovered that the steel conduit used for the solar panel lead-in is not grounded. All other components are in excellent physical condition.

The steel conduit used to route the power leads from the solar panel is not grounded. A ground bushing should be installed at the conduit end and a #8 bare copper wire should be attached to the bushing and to the ground rod installed in the bottom of the cabinet.

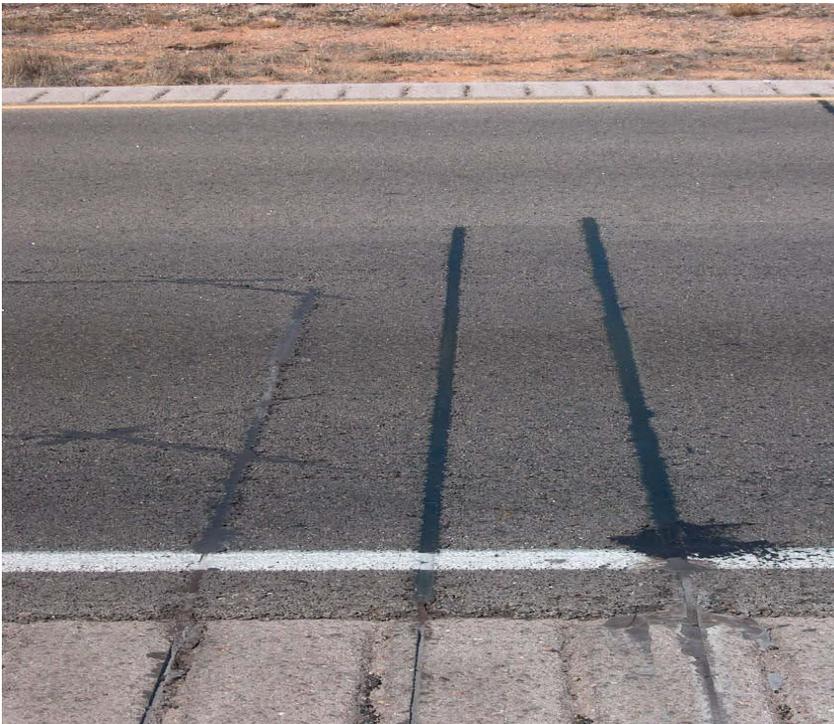
Trailing_Sensor_TO_4_35_22A_0500_02_17_04.JPG

An electronic check of all WIM components was performed. The trailing sensor measured below resistance tolerance levels. All other in-road sensors and the WIM controller are working properly.

The trailing sensor has a low resistance reading and should be replaced. Since piezo weighing sensors are considered a “matched set”, the leading sensor should be replaced at the same time.
