Assessment Report for
Ohio, SPS Experiment 2

Visit date: November 12, 2003

A visit was made to the Ohio SPS-2 site on November 12th, 2003 for the purpose of conducting an assessment of the WIM system located on US Route 23 northbound at milepost 19.7. The equipment is also used for the SPS-1 site in the southbound lanes at the same location.

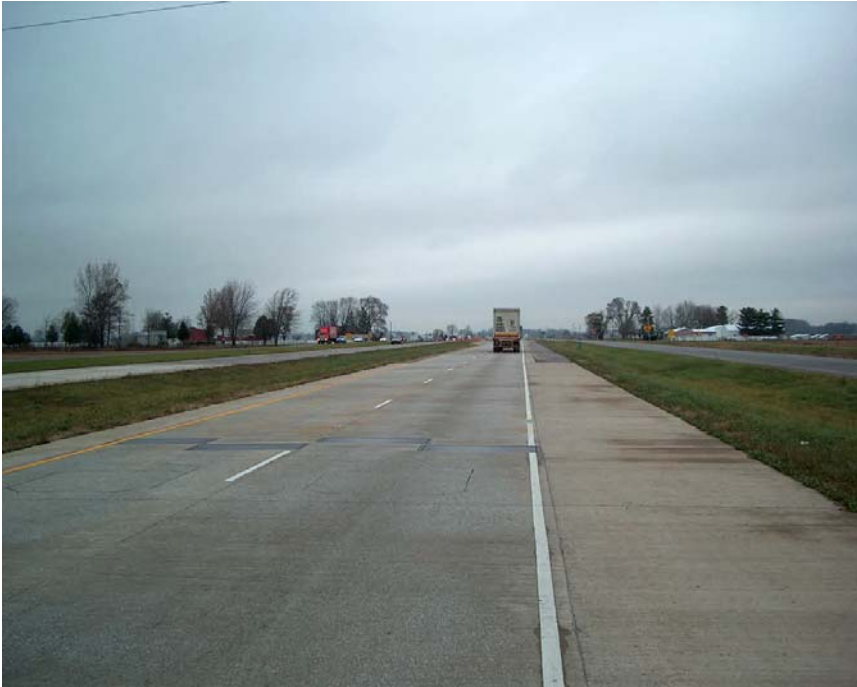
Figure 13-1 Pavement condition of 390200 site (Downstream)

The pavement condition is satisfactory for conducting a performance evaluation. There were no distresses observed that would influence truck motions significantly.

Figure 13-1 shows the condition of the pavement in the downstream direction and Figure 13-2 shows the condition of the pavement in the upstream direction

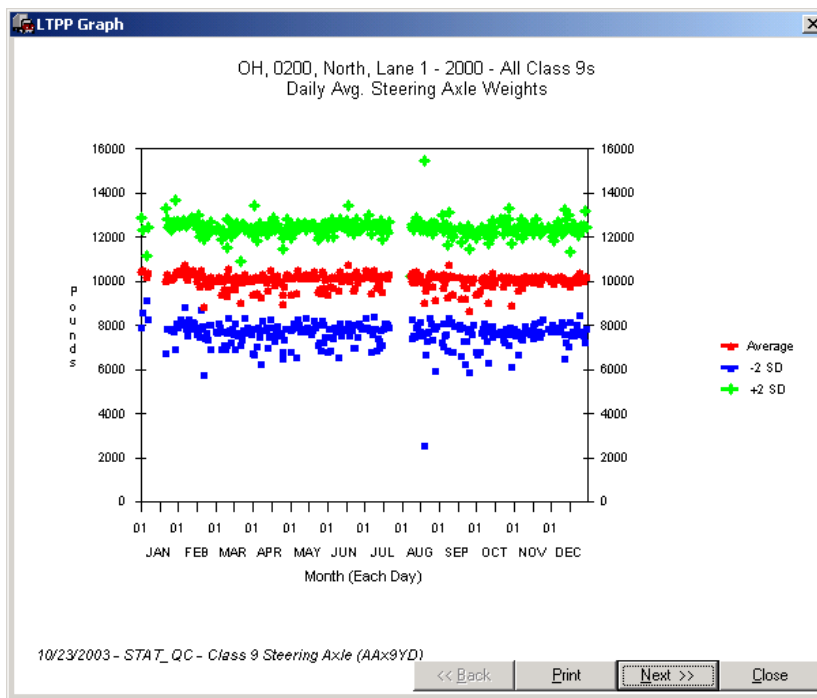
Figure 14-6 Average Daily Class 9 Steering Axle Weight - 2000 for 390200

A frequently used statistic for checking scale calibration and doing auto-calibration of WIM equipment is the weight of the front axle. This value is site specific and should be relatively constant particularly for loaded Class 9s (vehicles in excess of 60,000 lbs.). Typically when auto calibration is used this value either cycles repeatedly or with very large truck volumes results in an essentially straight line for the mean. As shown in Figure 14-6 the weight of the front axle was essentially constant in the months the data was collected.

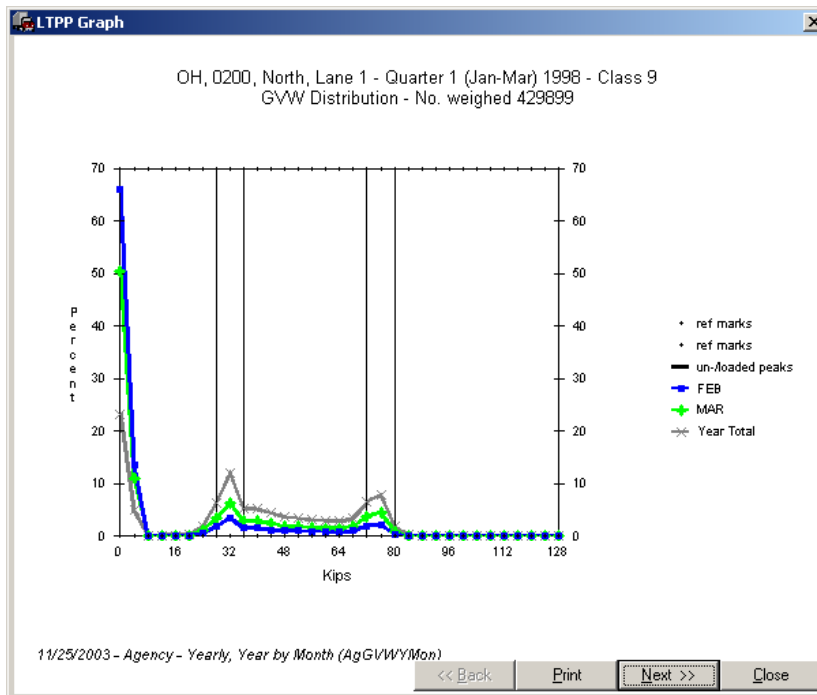
Figure 14-8 February and March 1998 abnormal Class 9 GVW data for 390200

The February and March 1998 data is bad with an excessive number of 4,000 pound Class 9s (20 percent) when a tractor weighs 12,000 lbs by itself. It should be removed from the database.

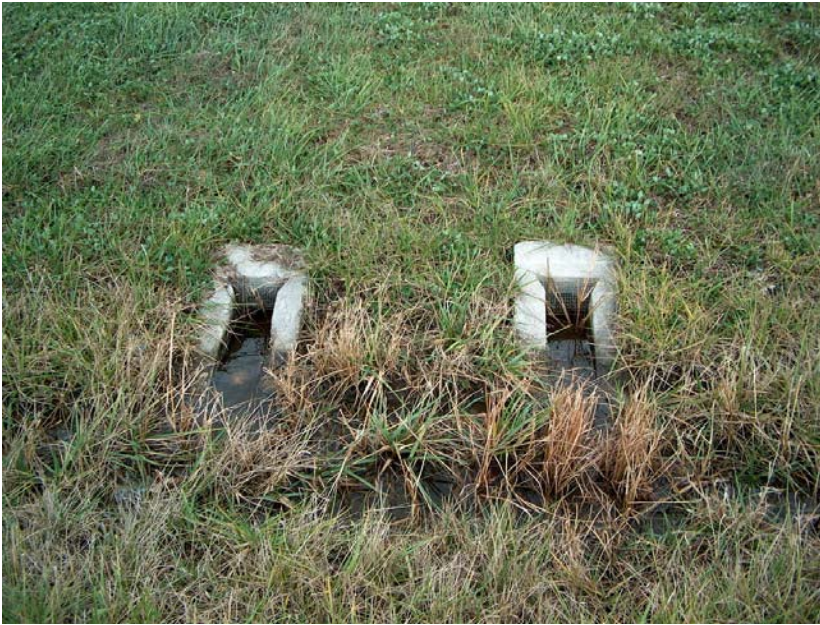
Figure 15-1 Drainage Culvert at 390200

A visual inspection discovered that the drainage area for the load cells is inadequate and needs to be improved. Figure 15-1 shows the drainage culvert at the site. The culvert needs to be dug deeper or made larger to permit the proper permeation of water being drained from the load cell sensor.
