Assessment Report for  
Tennessee, SPS Experiment 6

Visit date: November 18, 2003

A visit was made to the Tennessee SPS-6 site on November 18, 2003 for the purposes of conducting an assessment of the WIM system located on US 40 at milepost 91.67.

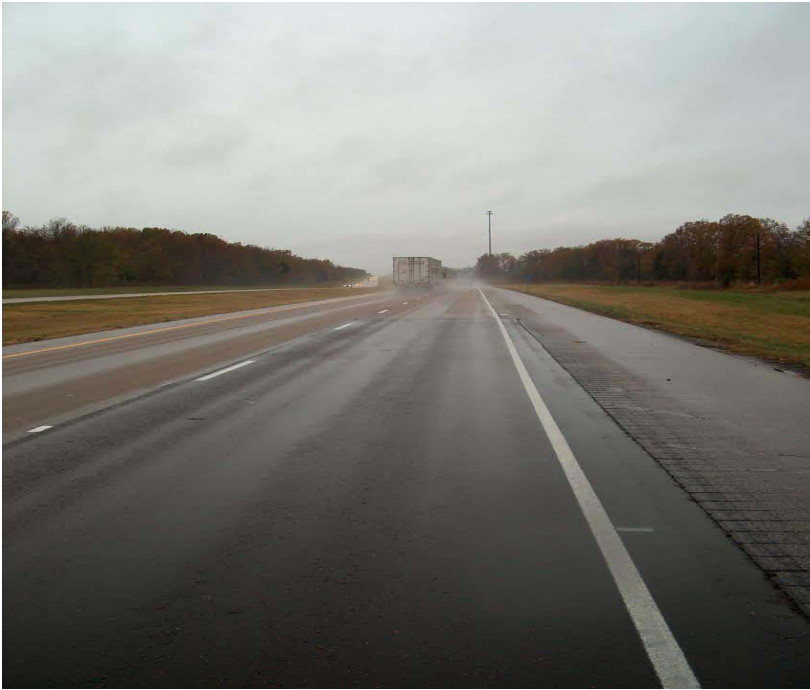
**Figure 13-1 Pavement Condition at Site 470600 (Downstream)**

The pavement is in an excellent condition since it was recently overlaid. Figure 13-1 shows the new overlay in the downstream direction and Figure 13-2 new overlay in the upstream direction.

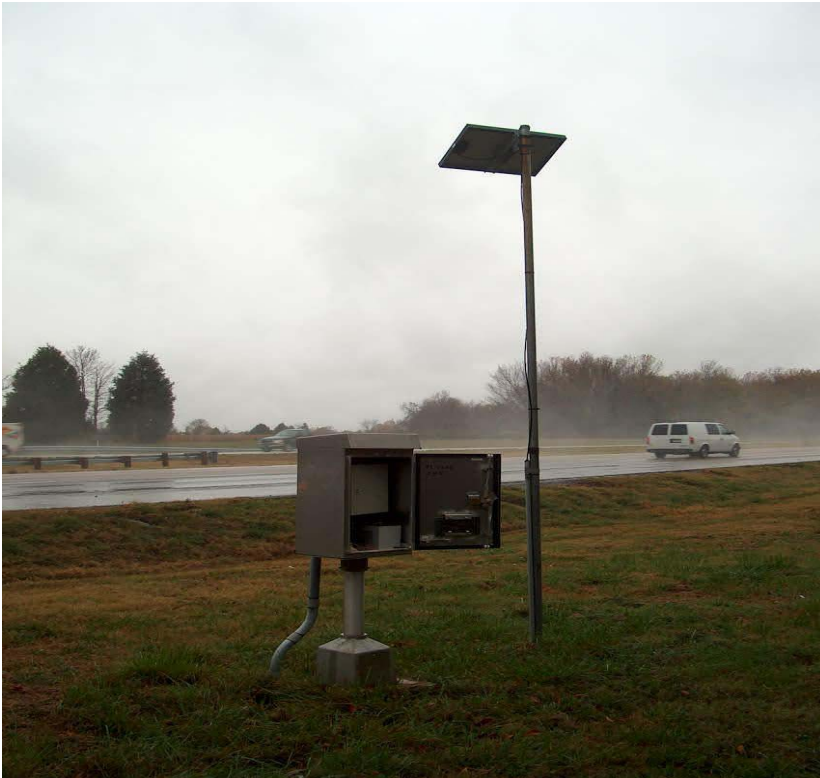
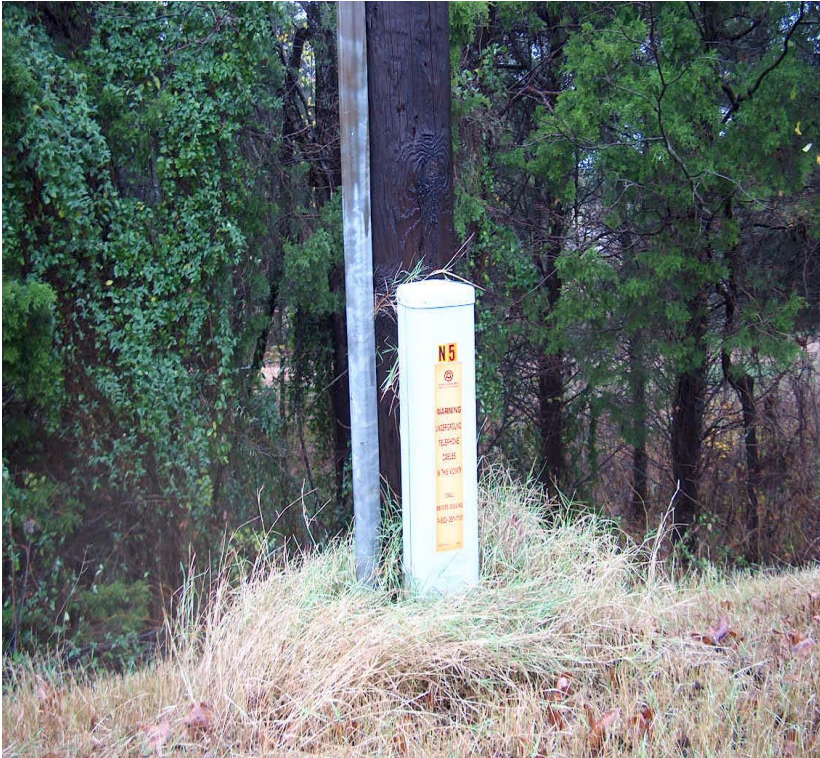
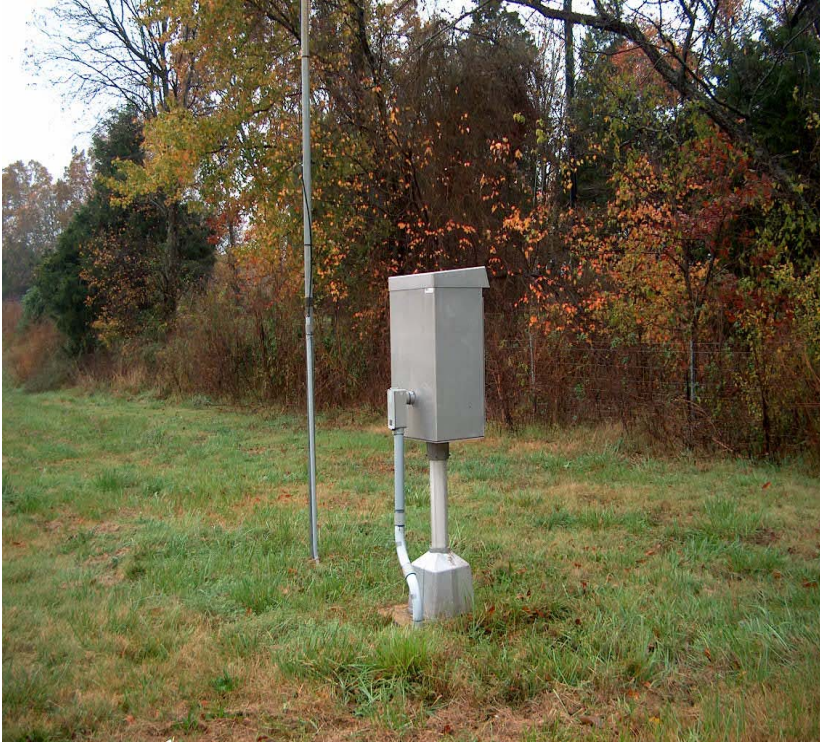
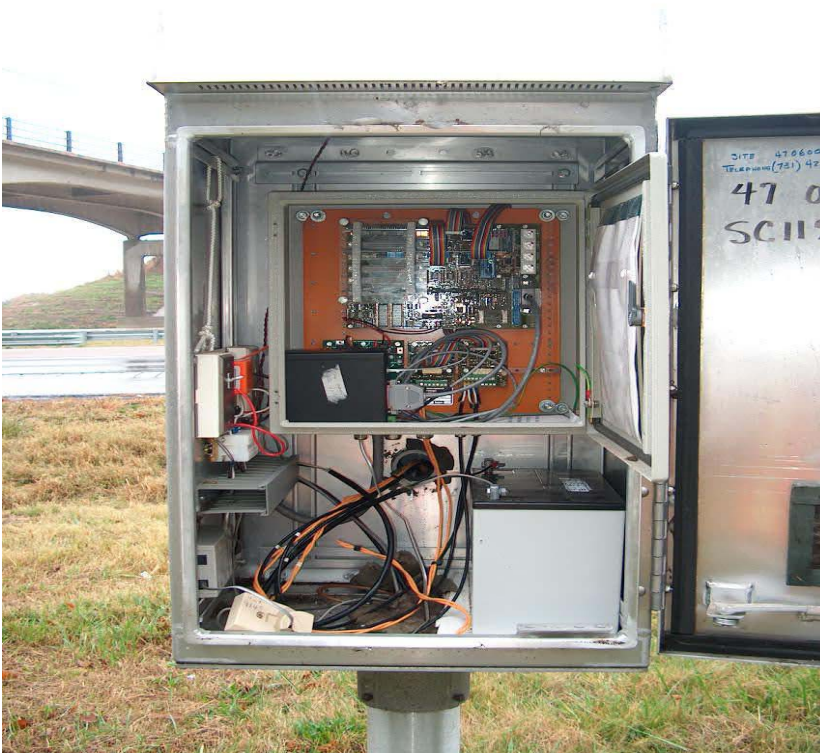
A visual inspection of all on-site equipment such as service masts, telephone pedestal, cabinet, conduit and solar panel verified that they are in good operational and physical condition.
